**Re: Remedial Investigation Report**  
Elks Plaza, LLC.  
157-189 West Merrick Road, Freeport NY  
NYSDEC Site No.: 1-30-193

## **REMEDIAL INVESTIGATION REPORT**

**ELKS PLAZA LLC.  
157-189 West Merrick Road  
Freeport, New York  
NYSDEC SITE #1-30-193**

**January 2014**

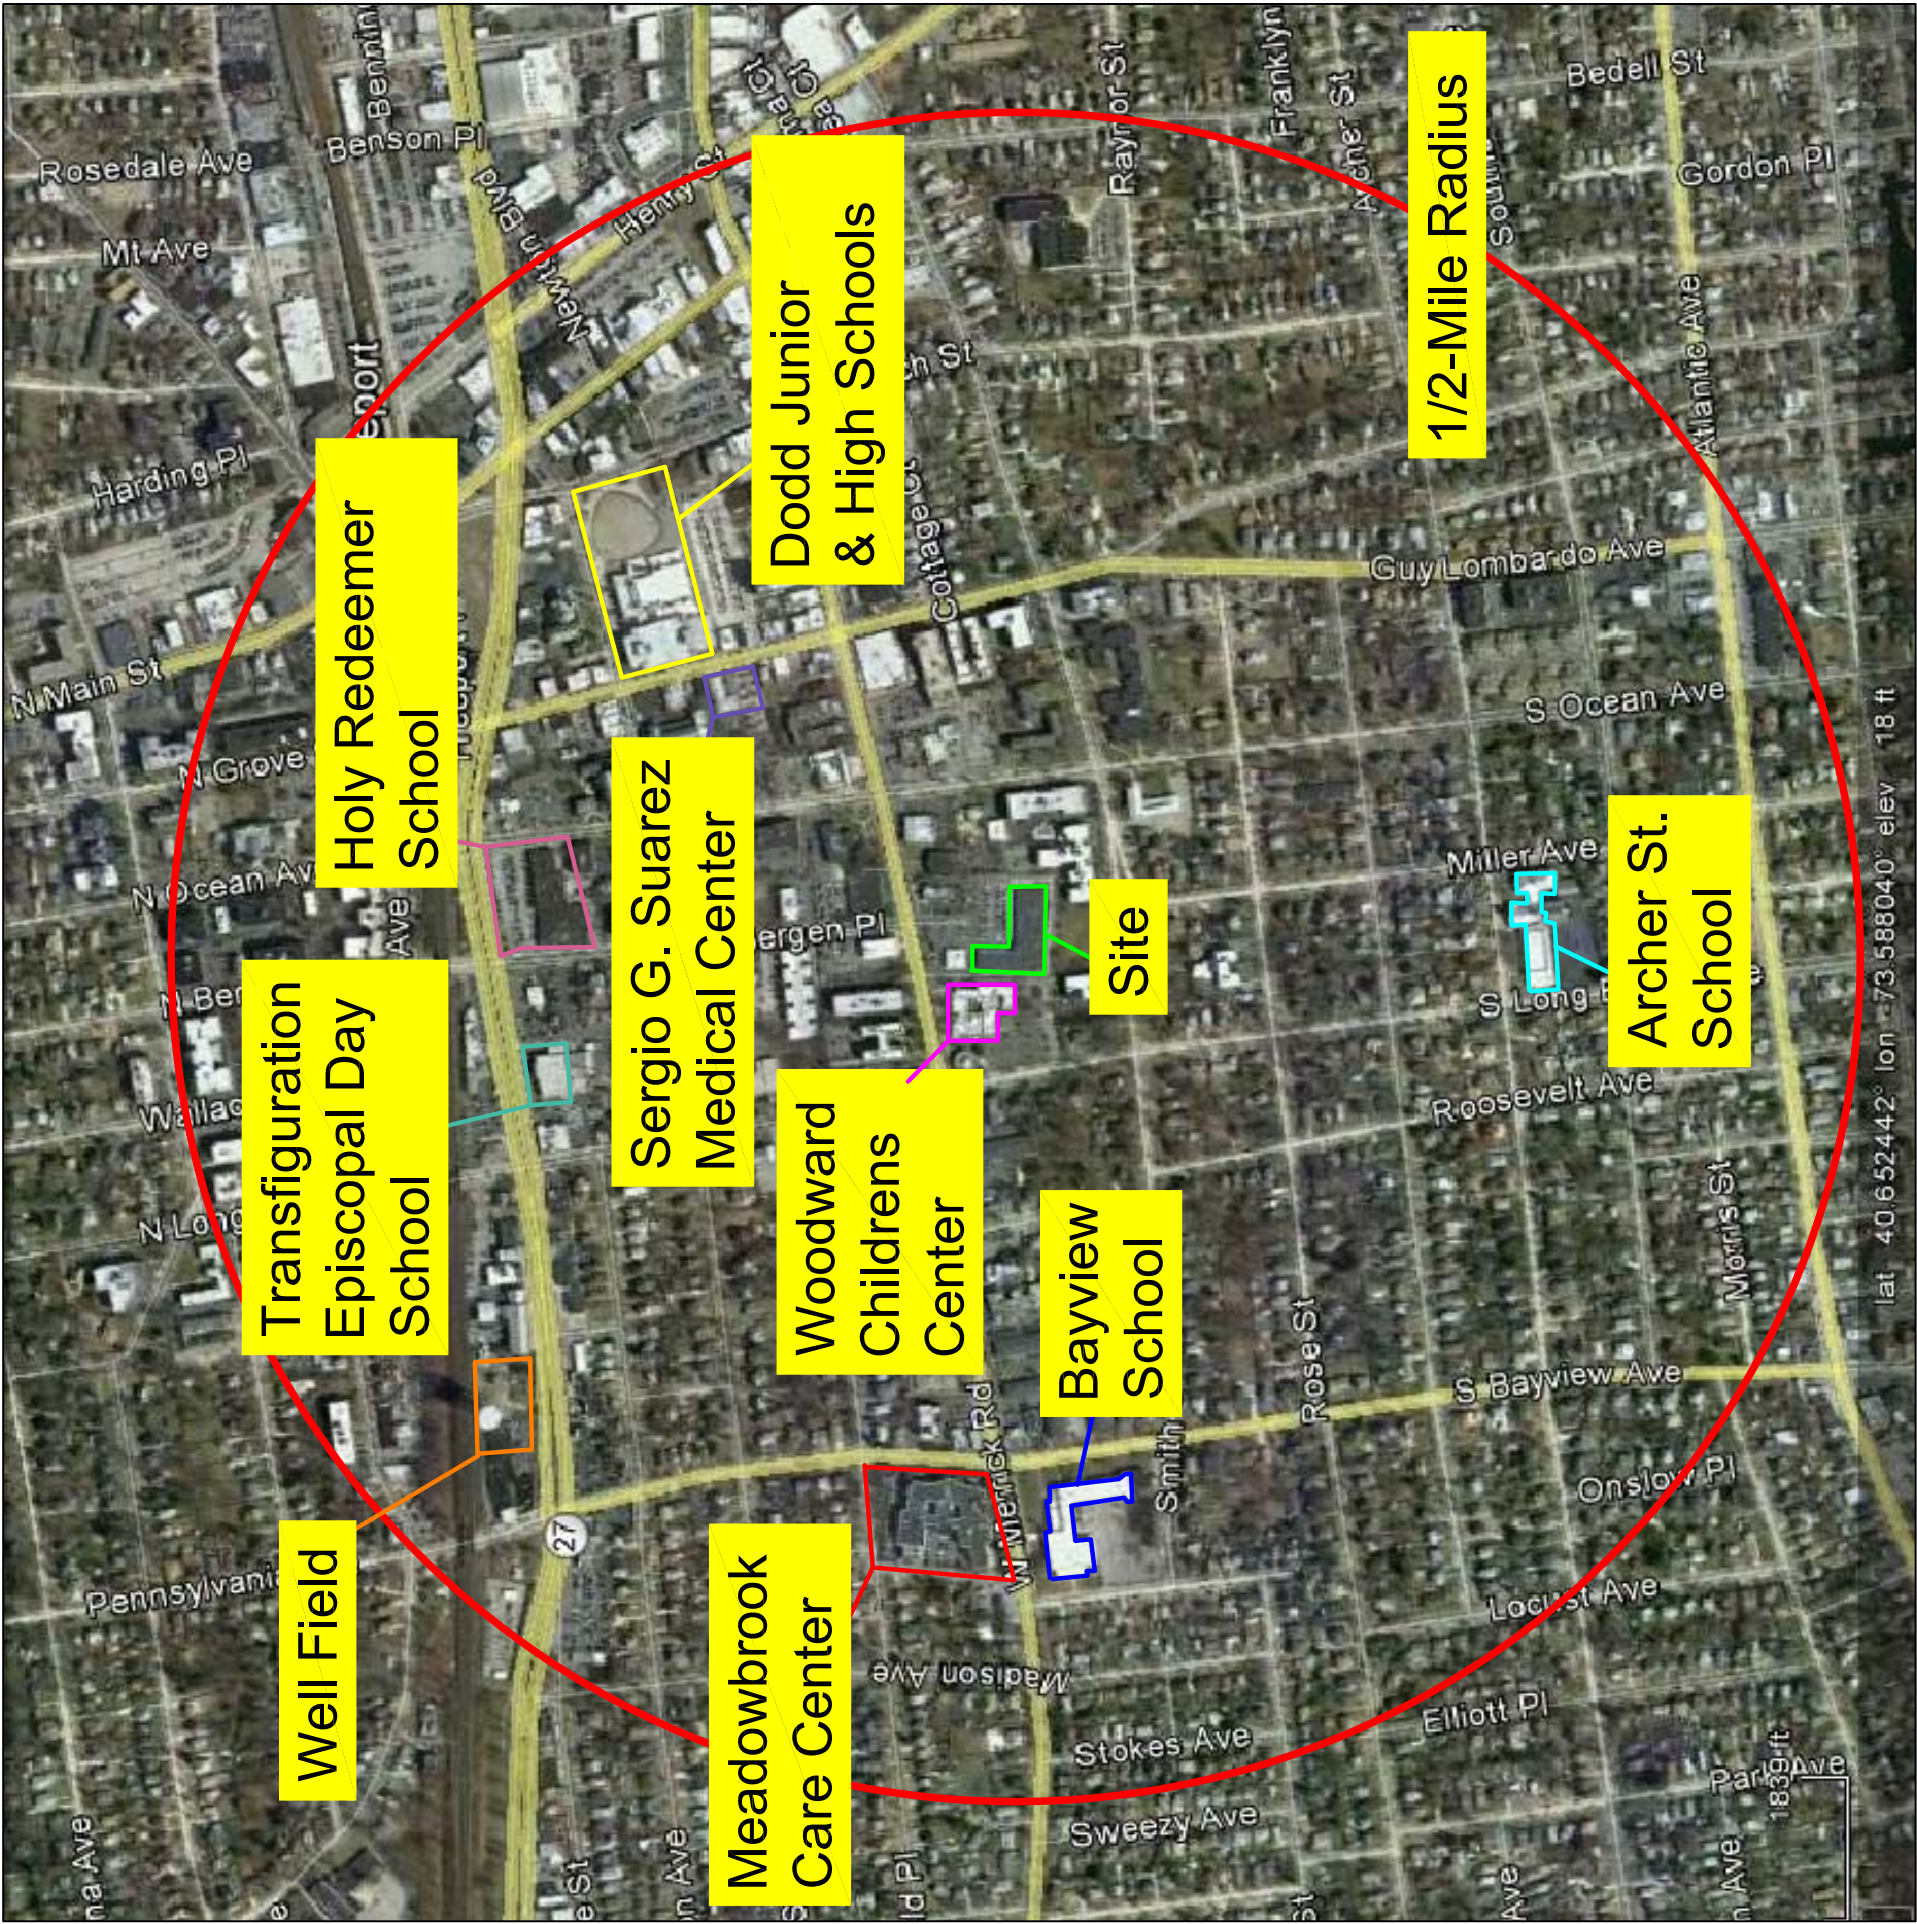
TITLE Water Table Elevation and Groundwater Contour Map		DATE 1/9/2013
FIGURE 3		SCALE As Shown
DRAWING NO: 2012-7		DRAWN BY: J.T.C./T.R.B.
		APPR. BY: E.A.W.

The elevation of the top-of-inner PVC casing of each well was surveyed by a NYS-licensed land surveyor to the nearest 0.01 of a foot mean sea level (MSL). The survey is included on Figure 3. Based on the survey and depth to water measurements, the direction of groundwater flow is to the south-southeast.

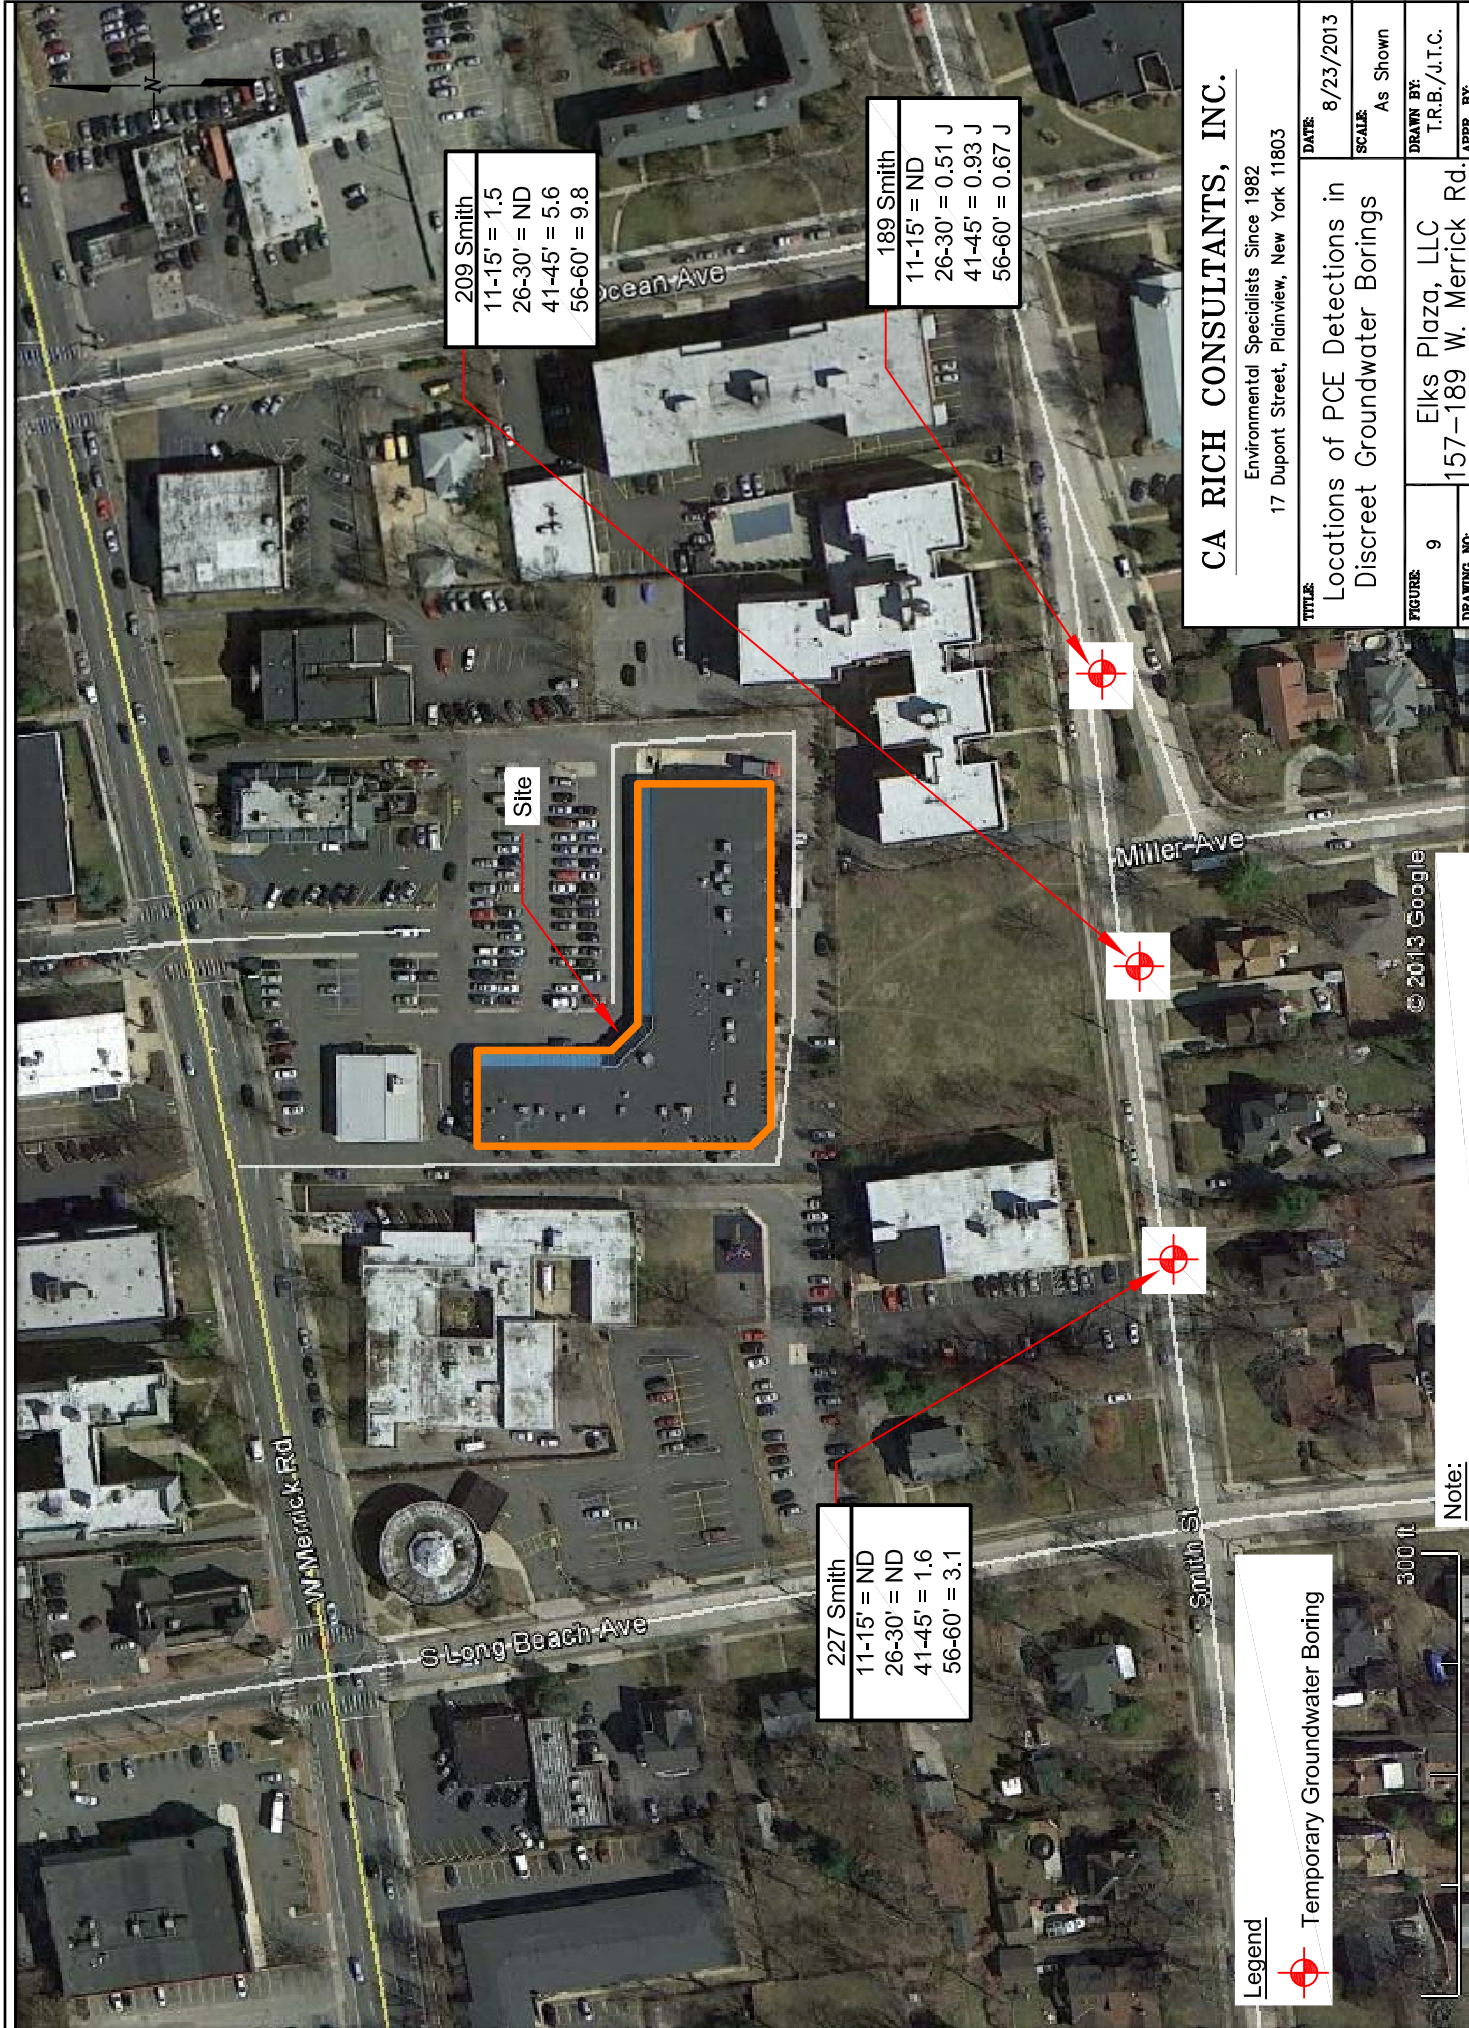
209 Smith
11-15' = 1.5
26-30' = ND
41-45' = 5.6
56-60' = 9.8

189 Smith
11-15' = ND
26-30' = 0.51 J
41-45' = 0.93 J
56-60' = 0.67 J

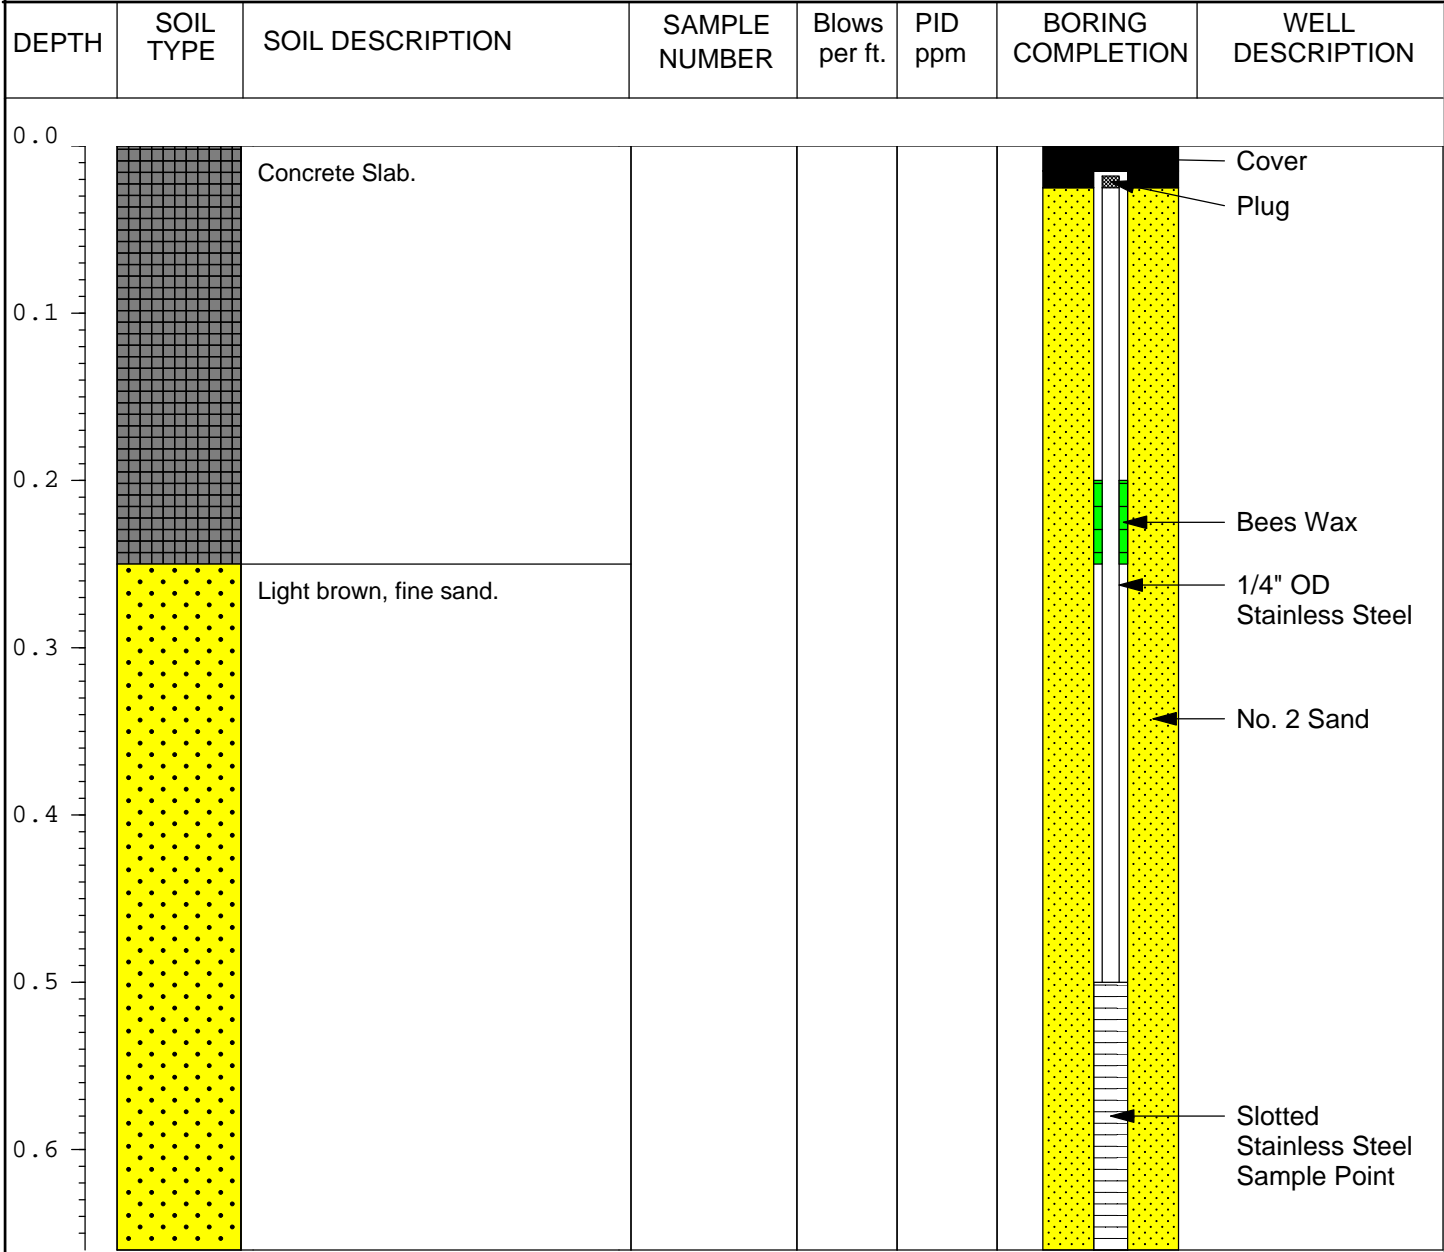
PROJECT INFORMATION				DRILLING INFORMATION			
PROJECT:	<b>Elks Plaza</b>			DRILLING CO.:	<b>NA</b>		
SITE LOCATION:	<b>Woodward Childrens Center</b>			DRILLER:	<b>Jason &amp; Tom</b>		
JOB NO.:	<b>Elks Plaza</b>			RIG TYPE:	<b>Hammer Drill</b>		
LOGGED BY:	<b>Tom Brown</b>			METHOD OF DRILLING:	<b>NA</b>		
PROJECT MANAGER:	<b>Eric Weinstock</b>			SAMPLING METHODS:	<b>8 hr. Summa Can</b>		
DATES DRILLED:	<b>8/21/12</b>			HAMMER WT./DROP	<b>NA</b>

On August 21, 2012 one permanent sub-slab vapor sampling point identified as SSV-Basement was installed in the basement of the Woodward Children's Center (201 Merrick Road). Construction details are included on Table 7. A second and third temporary sub-slab vapor sampling point was installed on the ground floor of the building in classrooms B12 and G5 (Figure 2) were also installed on August 21, 2012. On August 22, 2012 both the purge volume from the sampling tube and the helium-enriched air within the container were screened for the tracer gas using a Gowmac® Model 21-250 gas leak detector. The following Helium readings were recorded prior to sampling: SSV-Basement 0.0 ppm; SSV-B-12 750 ppm or 0.075%; and SSV-G-5 0.0 ppm. These readings are also below the 10% level outlined in the NYSDOH guidance manual (Ref. 6).
