**Pilot Test Report
and
Interim Remedial Measures Work Plan
Elks Plaza, LLC
157-189 West Merrick Road
Freeport, NY
NYSDEC Site No.: 130193**

January 2012

**CA RICH CONSULTANTS, INC.
17 Dupont Street
Plainview, NY 11803-1614**

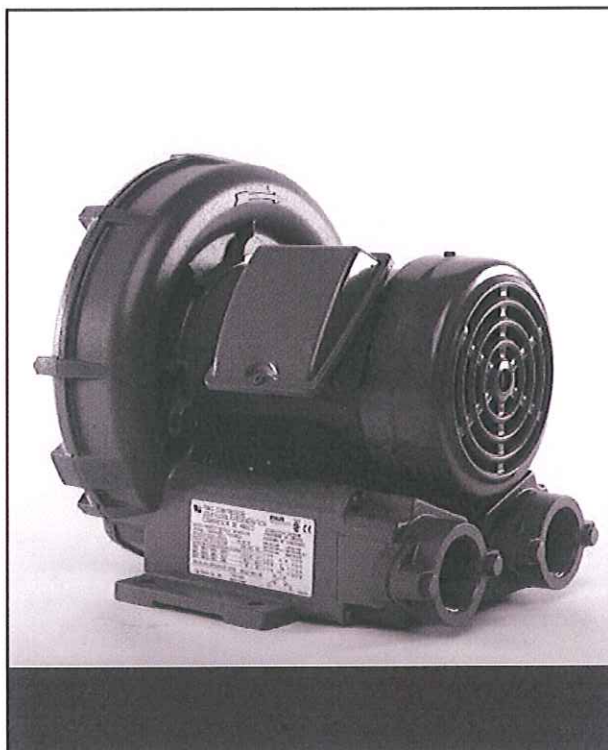
The VFC40 is a single-stage ring compressor with a maximum pressure of 54.5 in. H₂O, a maximum vacuum of 50 in. H₂O, and a maximum capacity of 98 SCFM. It comes complete with a direct-drive, 1 horsepower, TEFC motor capable of operating on a wide range of voltages, and on 50 or 60 Hz. A pilot-duty thermal protector is standard equipment on all 3-phase and 1-phase models. All versions have NEMA class B insulation, are UL recognized, CSA certified, and CE. 575V units are CSA certified only.

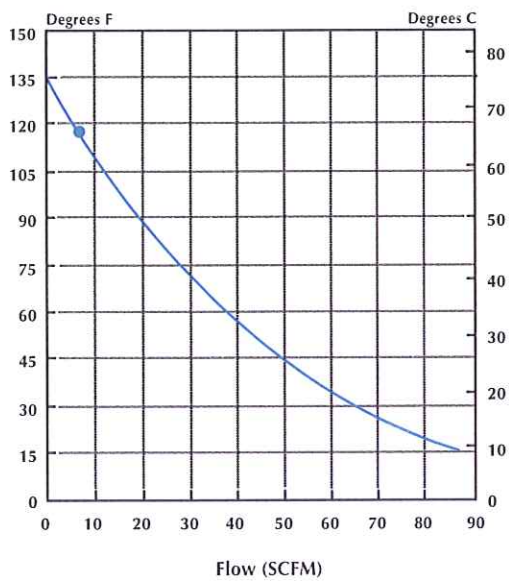
Max. Air Temperature is Value Marked •
plus 40 Degrees C Ambient Temperature
