Re: Monthly Progress Report for July 2023  
Former Quick and Clean Cleaners  
380 Rockaway Turnpike Cedarhurst, NY  
Site No.: 130198

# Sub Slab Depressurization System (SSDS) Monthly Inspection Form

380 Rockaway Turnpike, Cedarhurst, NY

Former Quick & Clean – DEC Site #130198

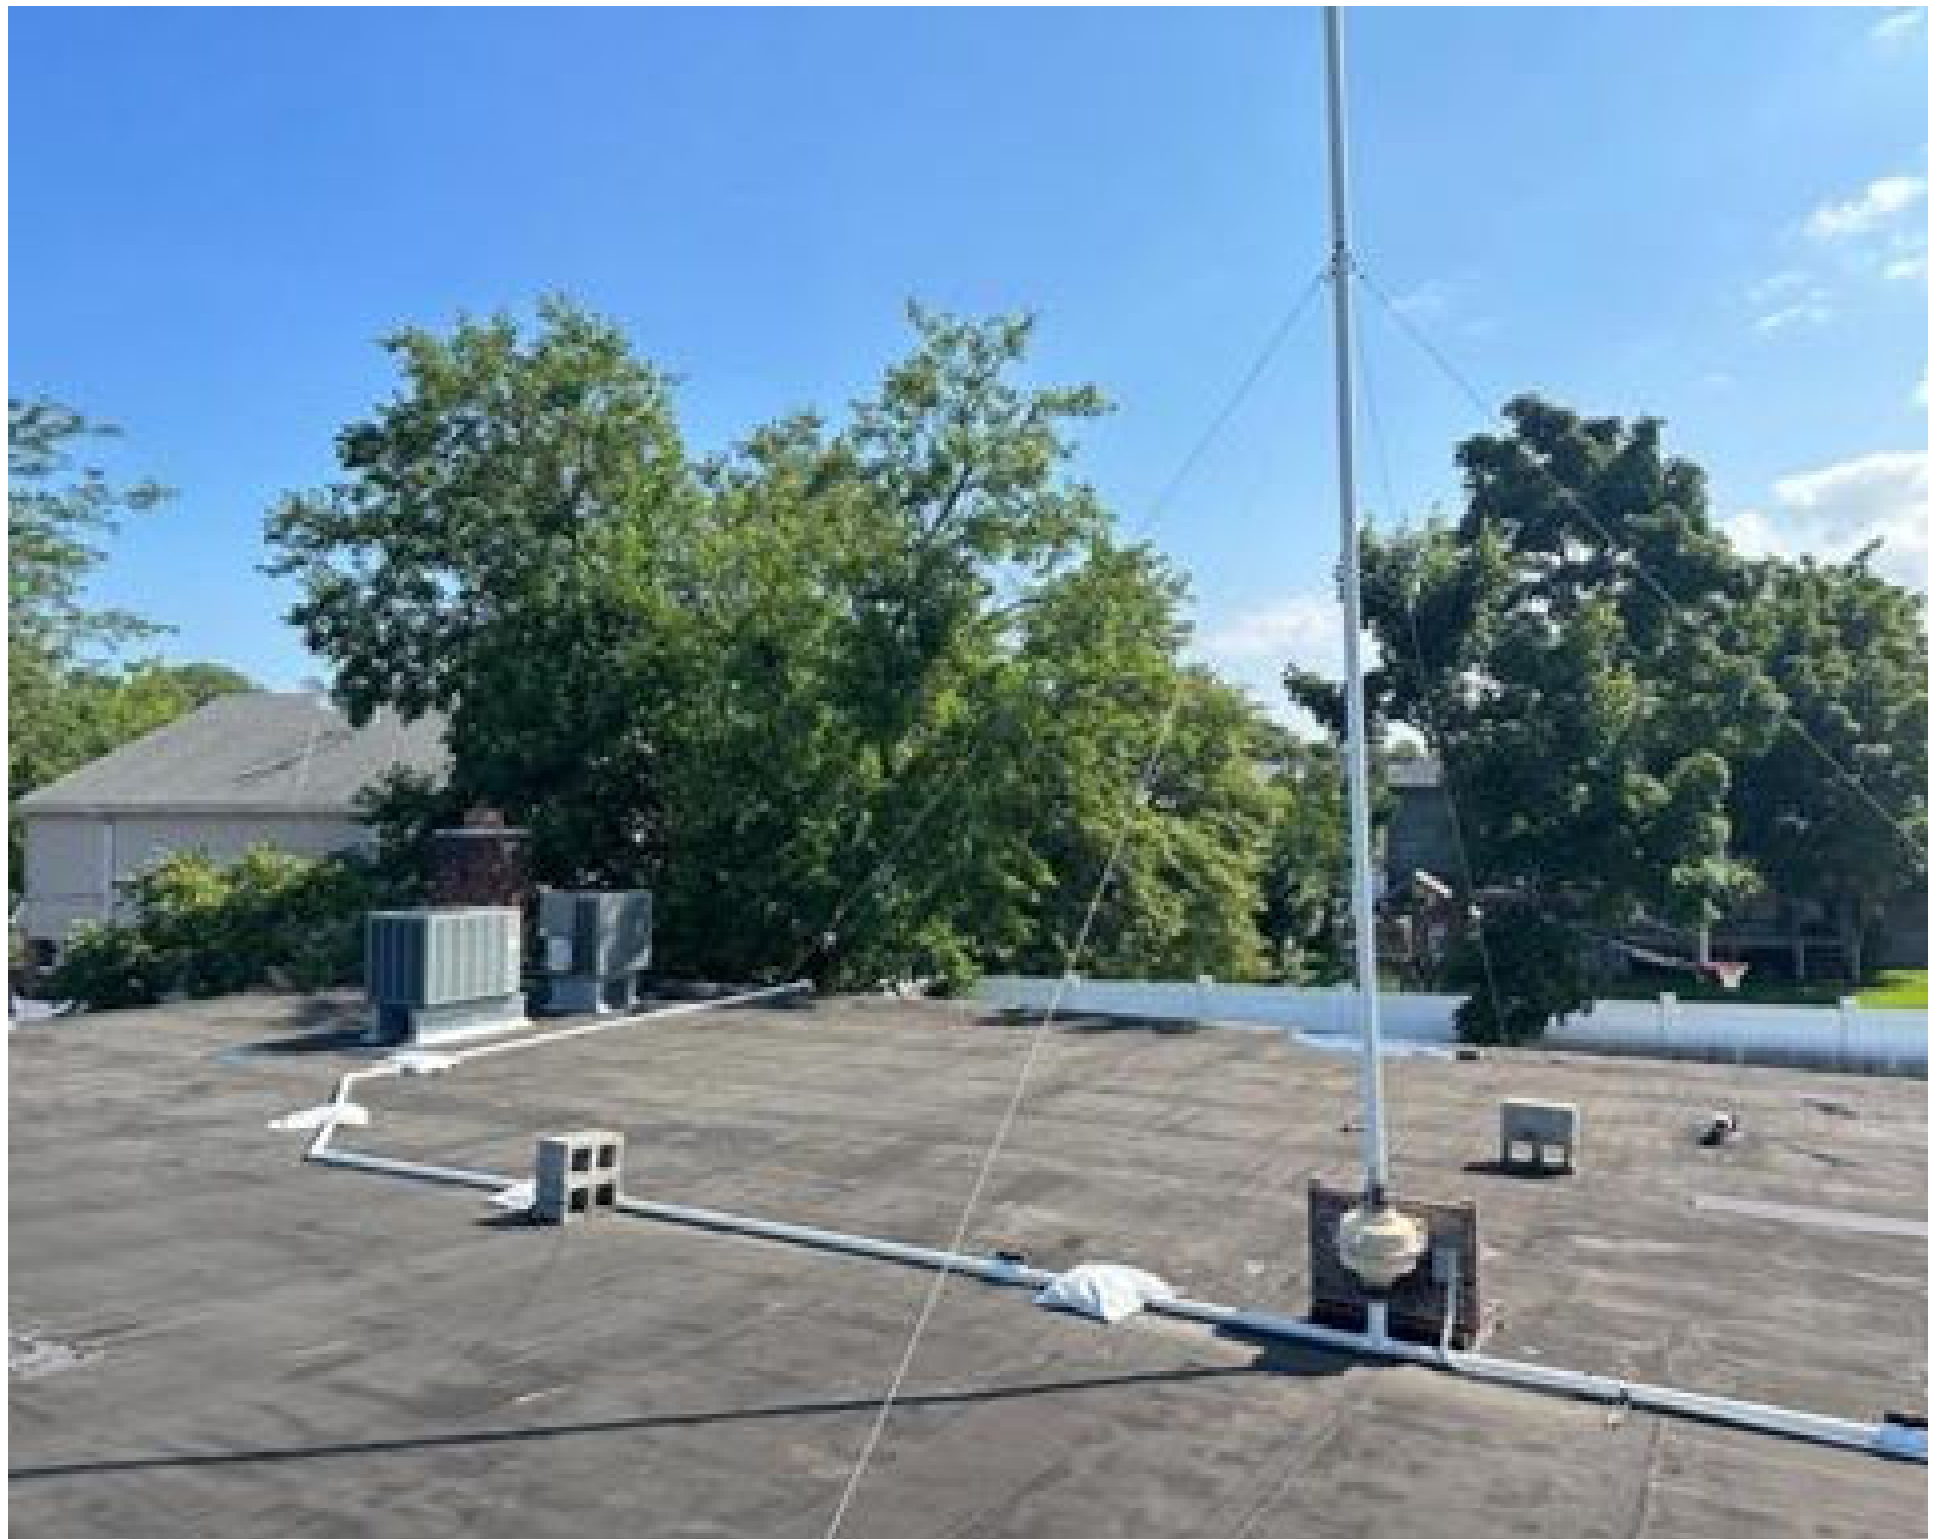
- On July 3rd, 2023, I met Contractor, PG Environmental, at the Site to see the Site and speak to the Building Manager.
- On July 28<sup>th</sup>, PG Environmental visited the Site and completed their first inspection of the Site SSDS. They documented their inspection on the attached form. A photo of the SSDS Stack is attached. An effluent air sample was not collected during this visit.
