Re: Former Quick and Clean
Monitoring Frequency Reduction
SSDS System OMM

Re: Former Quick and Clean Cleaners (Site: 130198)
Response to Comments (RTC)
revised Interim Site Management Plan (ISMP)

FORMER QUICK AND CLEAN CLEANERS

INTERIM SITE MANAGEMENT PLAN (ISMP)

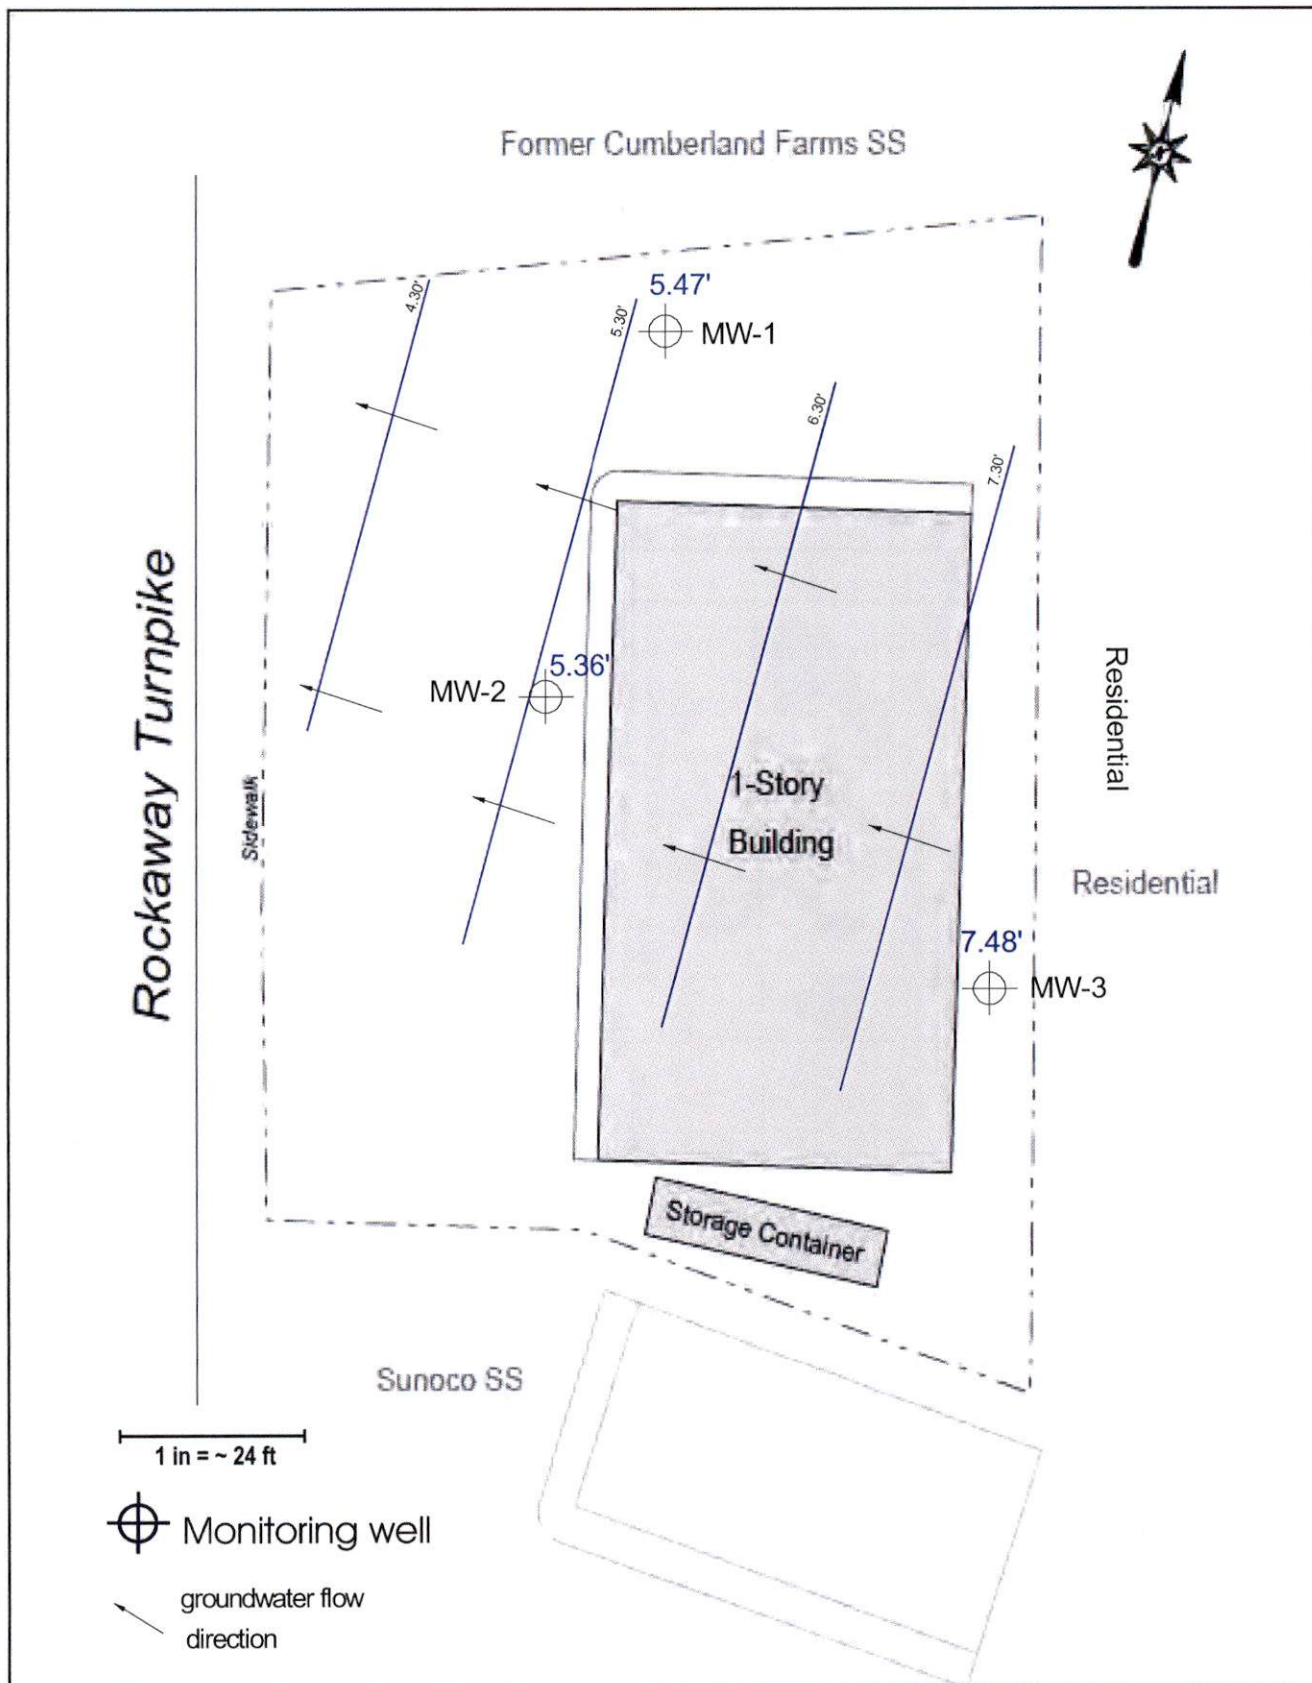
Figure-3
Groundwater
Flow

The depth to groundwater beneath the site, as determined from field measurements, is between 5.0' and 10.0' feet below grade surface (bgs). Groundwater flow has been reported as ranging from north to southwest at the adjacent property to the north (former Cumberland Farms Service Station). Despite this wide range of anticipated flow the actual direction of groundwater flow is presumably to the west northwest (>270 degrees). This notion is based upon previously conducted investigation data indicating elevated contamination found northwest of the Site and/or source area. A groundwater flow survey has been conducted as part of the RIWP at the subject property and all indications lead to a west northwest flow direction. Please refer to Figure-3 for the groundwater contour map.

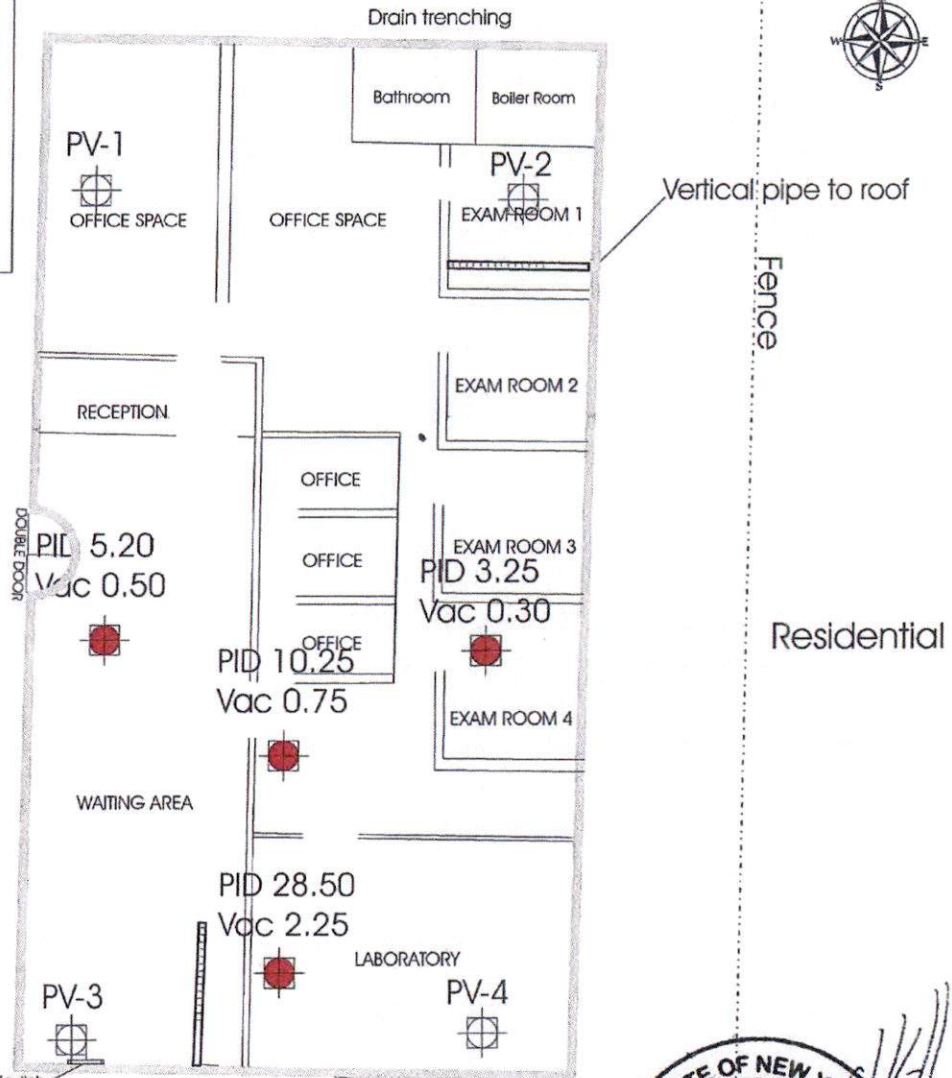
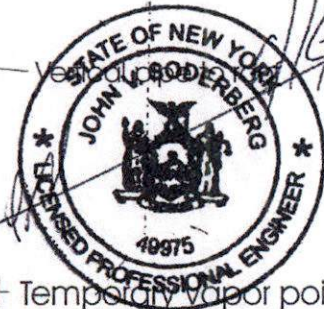
PLAN VIEW ROOFTOP
CONSTRUCTION

Well#	PID (PPM)	Vacuum (In./H ₂ O)
PV-1	0.35	0.50
PV-2	2.40	0.25
PV-3	48.1	2.50
PV-4	2.40	0.25

- Temporary vapor point
- Permanent vapor point

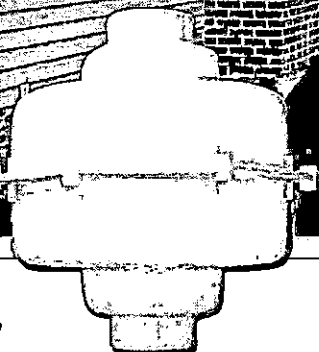
- ♦ Five-year hassle-free warranty
- ♦ Mounts on duct pipe or with integral flange
- ♦ 3.5" diameter ducts for use with 3" or 4" pipe
- ♦ Electrical box for hard wire or plug in
- ♦ ETL Listed - for indoor or outdoor use
- ♦ Meets all electrical code requirements
- ♦ Thermally protected
- ♦ Rated for commercial and residential use.

Model	Watts	Max. Pressure "WC	Typical CFM vs. Static Pressure WC						
			1.0"	1.5"	2.0"	2.5"	3.0"	3.5"	4.0"
GP201	40-60	2.0	82	58	5	-	-	-	-
GP301	55-90	2.6	92	77	45	10	-	-	-
GP401	60-110	3.4	93	82	60	40	15	-	-
GP501	70-140	4.2	95	87	80	70	57	30	10

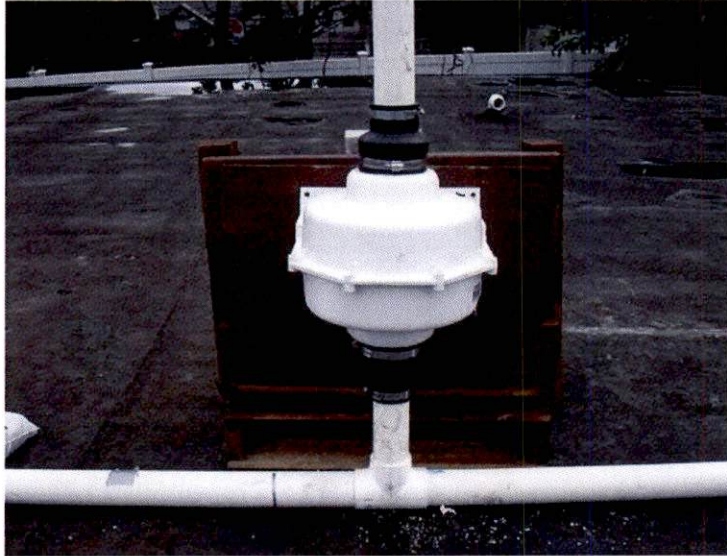
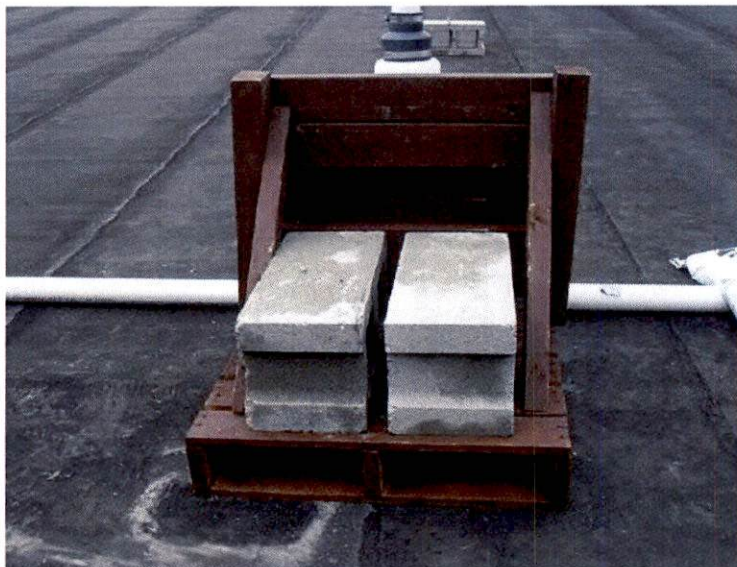
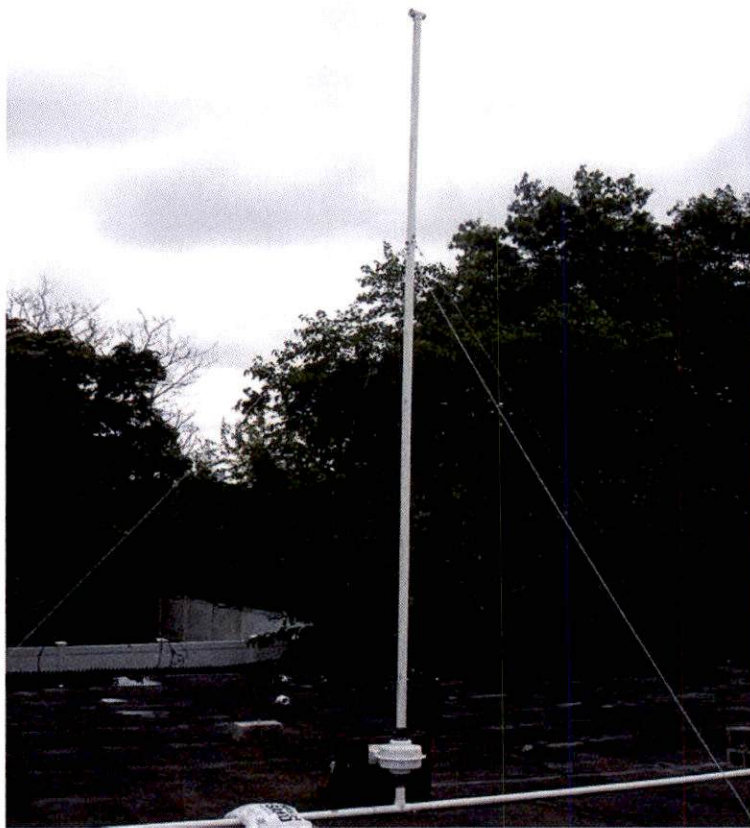
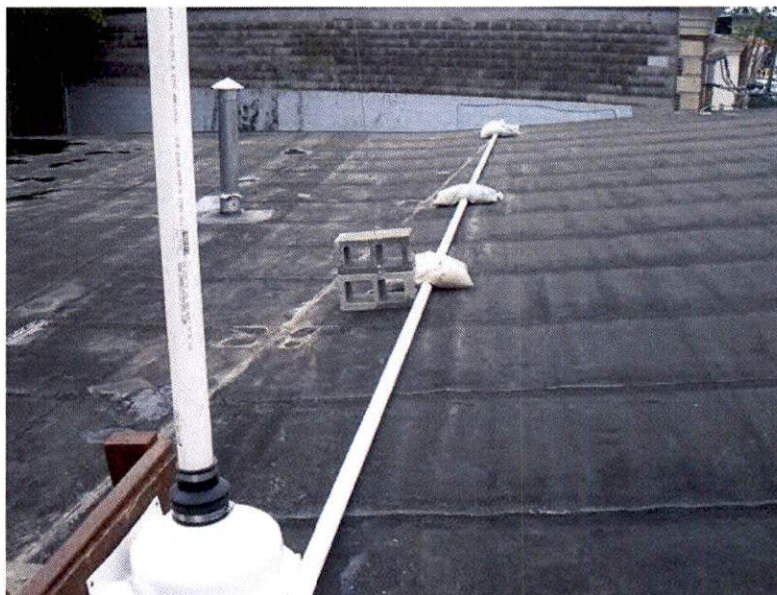
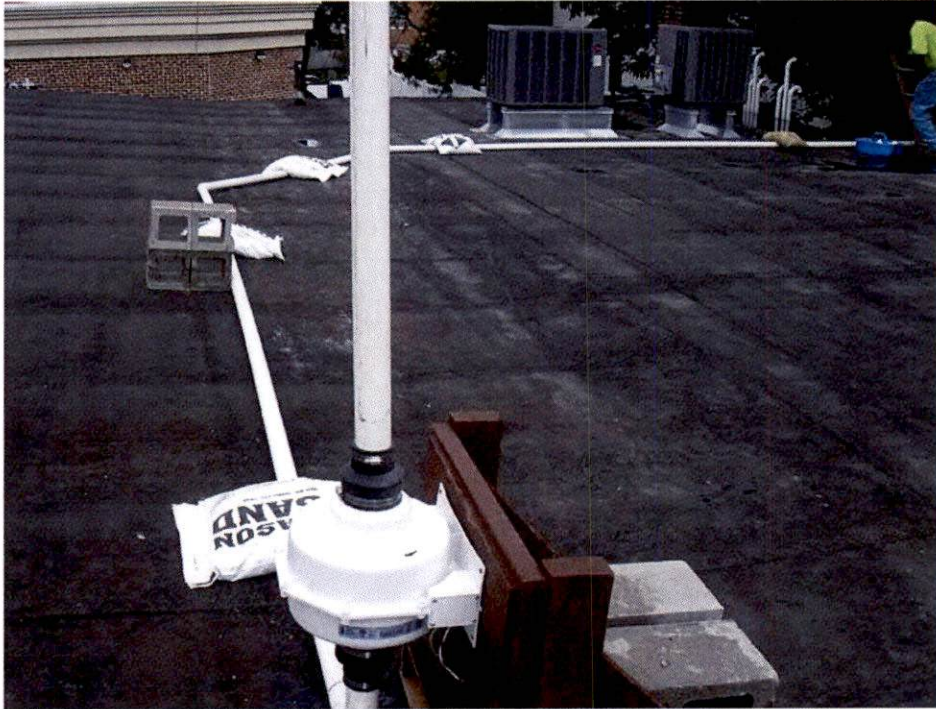
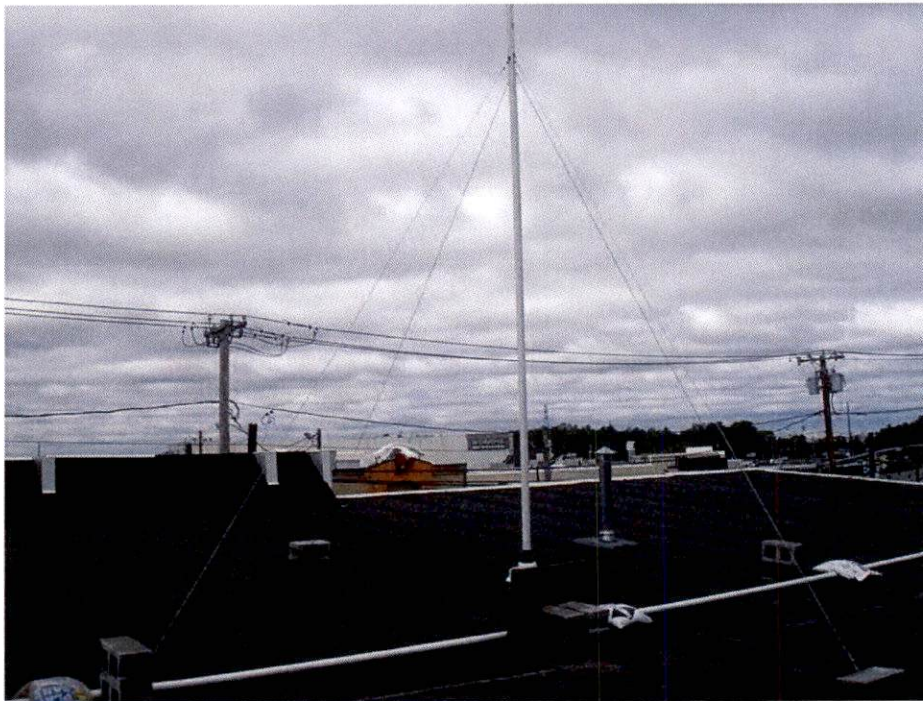
SSDS Roof Construction

Sub-slab vapor contamination discovered under the building is currently being removed via active sub-slab depressurization (SSDS). On September 10 and 11, 2015 two inch (2") diameter PVC screened piping was installed at two (2) different locations within the building. Drain entry points have been utilized exiting the building in order to route SSDS piping to the exterior of the building and the roof. Two (2) five (5') lengths of screened piping, wrapped in filter fabric were installed approximately 1' below the slab in order to remove sub-slab vapors from underneath the building's foundation. Solid PVC riser pipe finishes the system to grade and continues to the roof where vapors are exhausted into the atmosphere. Please refer to Figure-4 (engineer as-built) which portrays the layout of the system. The engineering control (E.C) associated with the system is a small powered GP 501 vacuum/blower specifically designed for sub-slab vapor removal. The E.C specs have been attached as Appendix-A to this report. The blower does not need an enclosure due to its relatively quiet operation and minimal vibration. The blower motor was wired with a 110v grounded plug and mounted on the roof top. The mounting location of the blower was based upon the piping scheme and is fixed onto the roof, with the exhaust stack extending to 10' above the nearest neighboring roof line. A system shut-down warning has been installed to the motor wiring to indicate its "on" operation. If the light is ever discovered to be "off" the site staff will contact the project manager in order to diagnose the issue. Please see Appendix-B for photos of the roof-top construction.

In the event the exhaust stack is found collapsed, BEI should be immediately notified of this issue. BEI will then assess the issue with the collapse, determine the cause and repair the stack with added reinforcement. This will involve inspecting the old stack for damage, resetting the stack or a new length of pipe in position and assuring that the proper reinforcement is applied to the stack. Reinforcements may include but not be limited to: added guide wires to add stabilization and durability to the stack positioning.

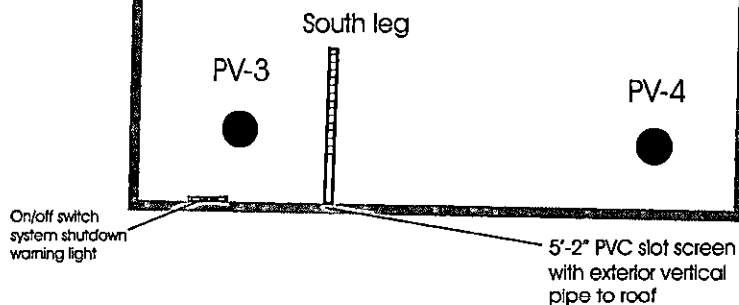
On/off switch system shutdown warning light

The system shutdown warning light will be periodically inspected for failure. The light could also be down due to the fact that the bulb has expired. Inspection of this will be conducted as part of the monthly maintenance. In the event that the system shutdown warning light is found to be off, **the building occupant should immediately report this issue to upper management. The management team should then immediately contact BEI, the contractor, in order to inspect and resolve the issue.**
