**Blydenburgh Road Landfill Complex
Town of Islip, New York**

**2016 Periodic Review
Report**

May 2017

**D&B ENGINEERS
AND
ARCHITECTS, P.C.**

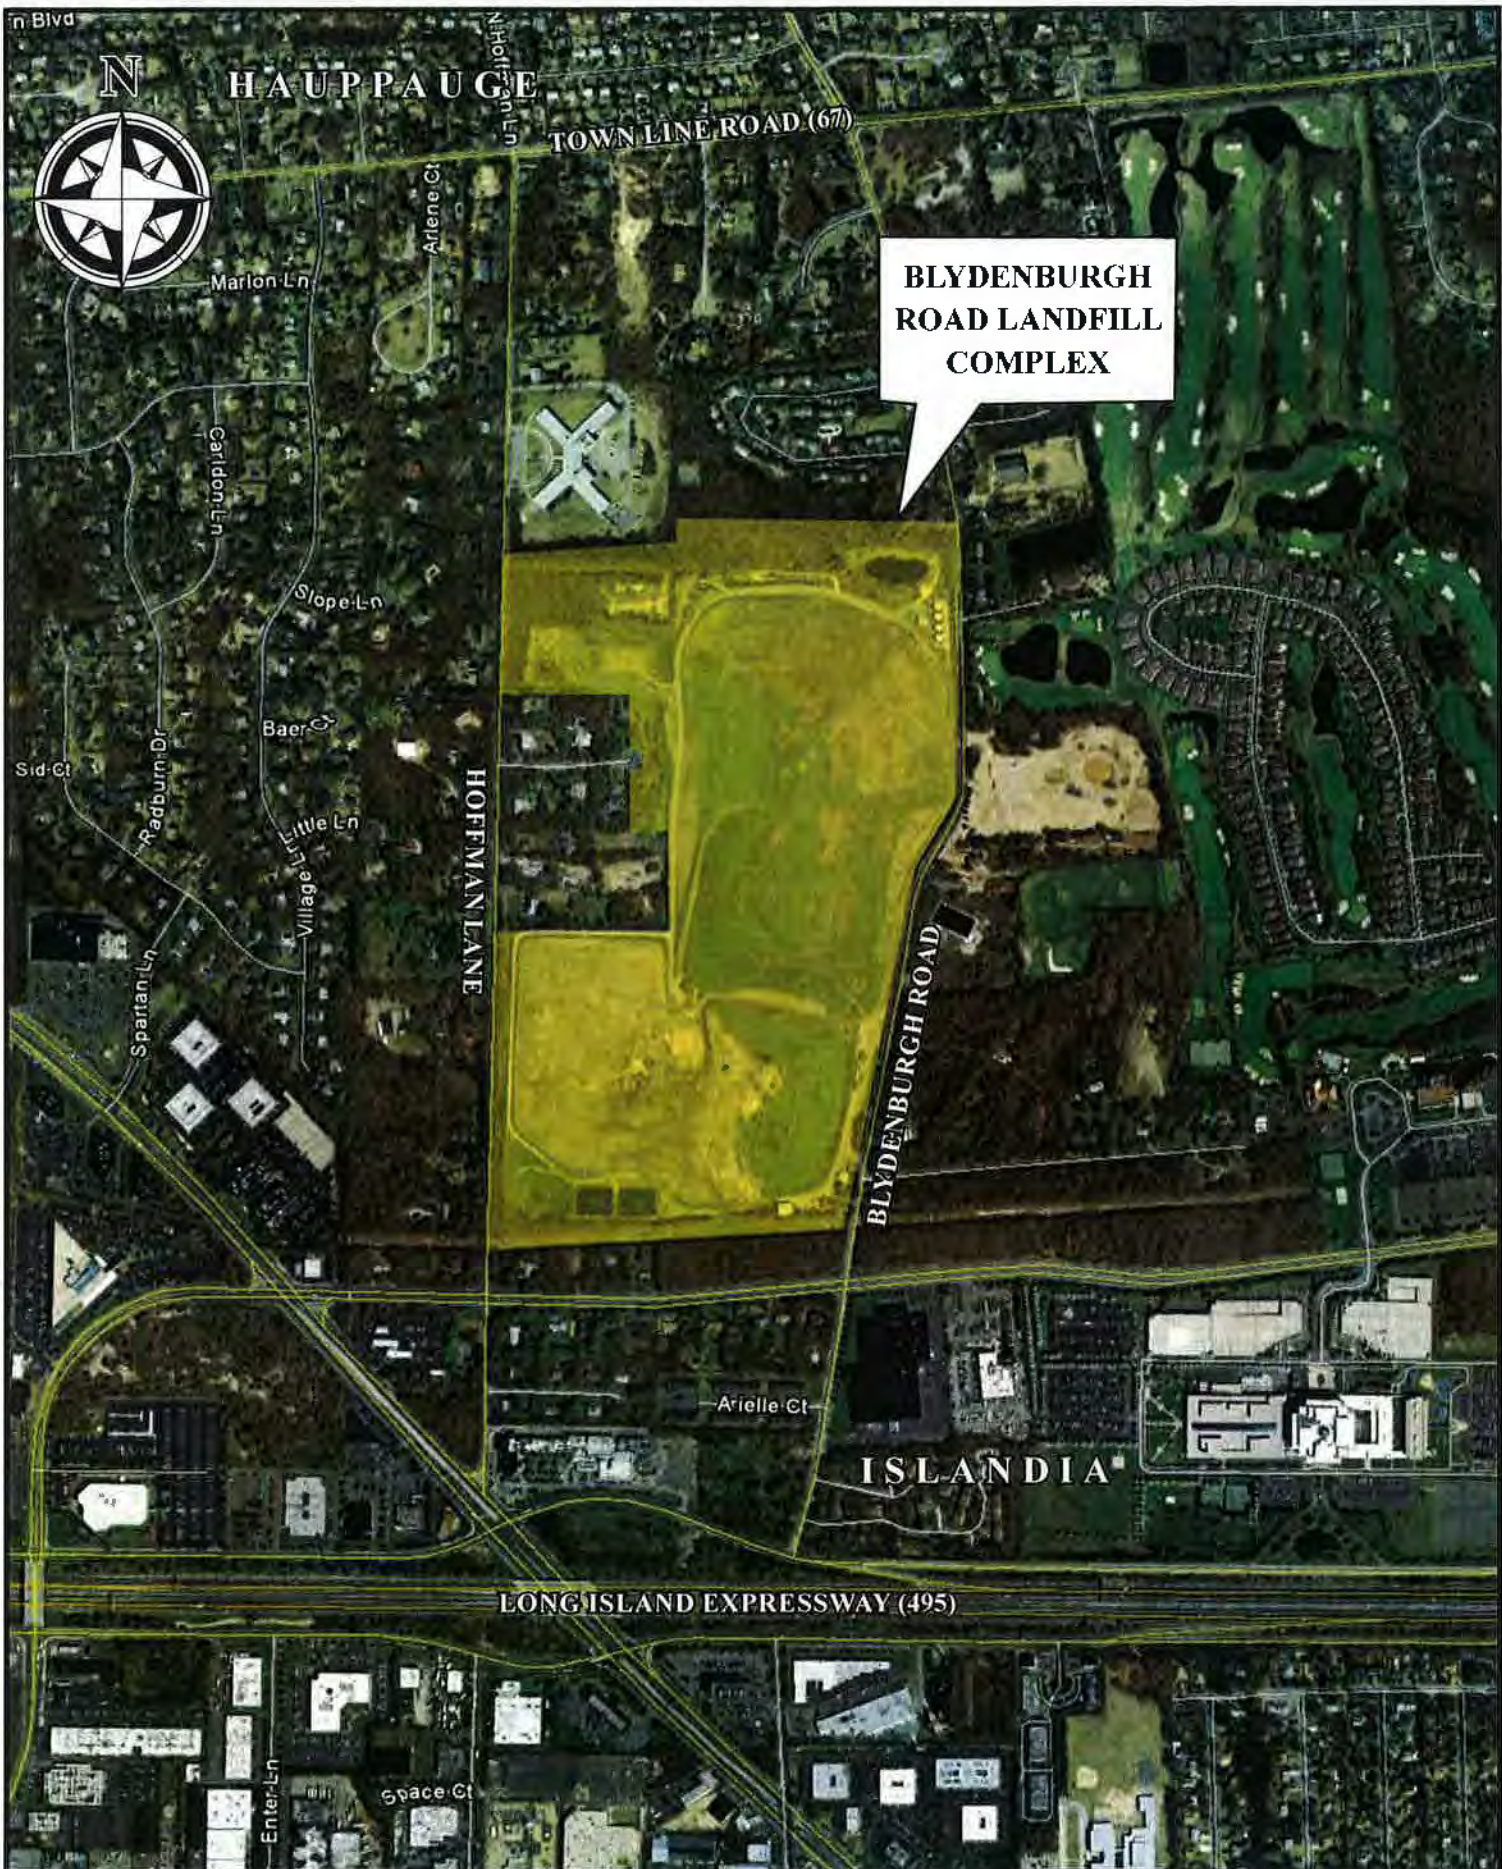
BLYDENBURGH ROAD LANDFILL COMPLEX

The Site (also known as the Islip Municipal Sanitary Landfill) is located in Hauppauge, Town of Islip, Suffolk County, New York (see **Figure 1-I**). The landfill complex consists of:

- An approximate, 52-acre, capped and closed Municipal Solid Waste (MSW) landfill;
- An approximate 2-acre, capped and closed ash Monofill; and
- An approximate 30-acre, lined operational Cleanfill landfill.

The Site also includes buffer zones, a leachate collection system, leachate storage tanks, surface water management, a landfill gas collection system, an office and maintenance buildings, roadways and a groundwater treatment system.

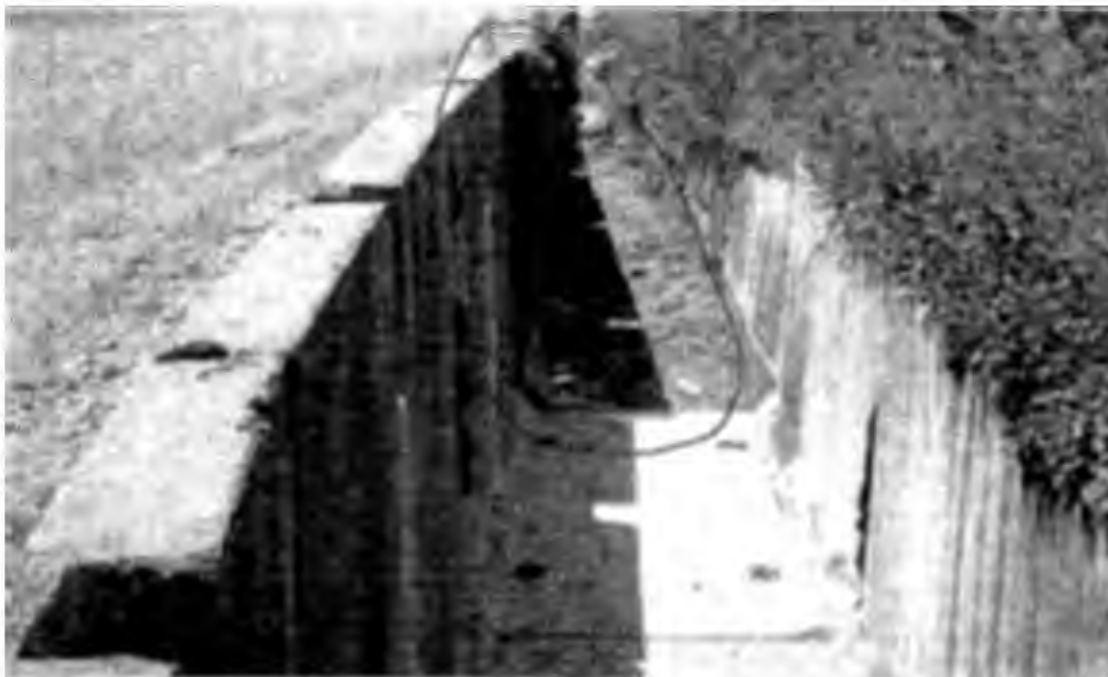
6/7/16 DOWN CHUTE #1

Inspectors should be alert for and possibly noted relating to Item 4.0 – Culverts (Above-grade inspection): condition of exterior of access way/manhole structures, condition of inlet and outlet, etc.

Inspectors should be alert for and possibly noted relating to Item 5.0 – Recharge Basins and Appurtenances: general condition, storage capability, sliding/soughing of structures, burrowing, sediment accumulation, integrity of outfall structures, undermining of culvert barrel, etc.
