Feasibility Study Report

Fairchild Republic Aircraft: Old Sump

**Route 110 (Broadway)
Village of East Farmingdale
Town of Babylon
Suffolk County, New York**

NYSDEC Site Number: 152004

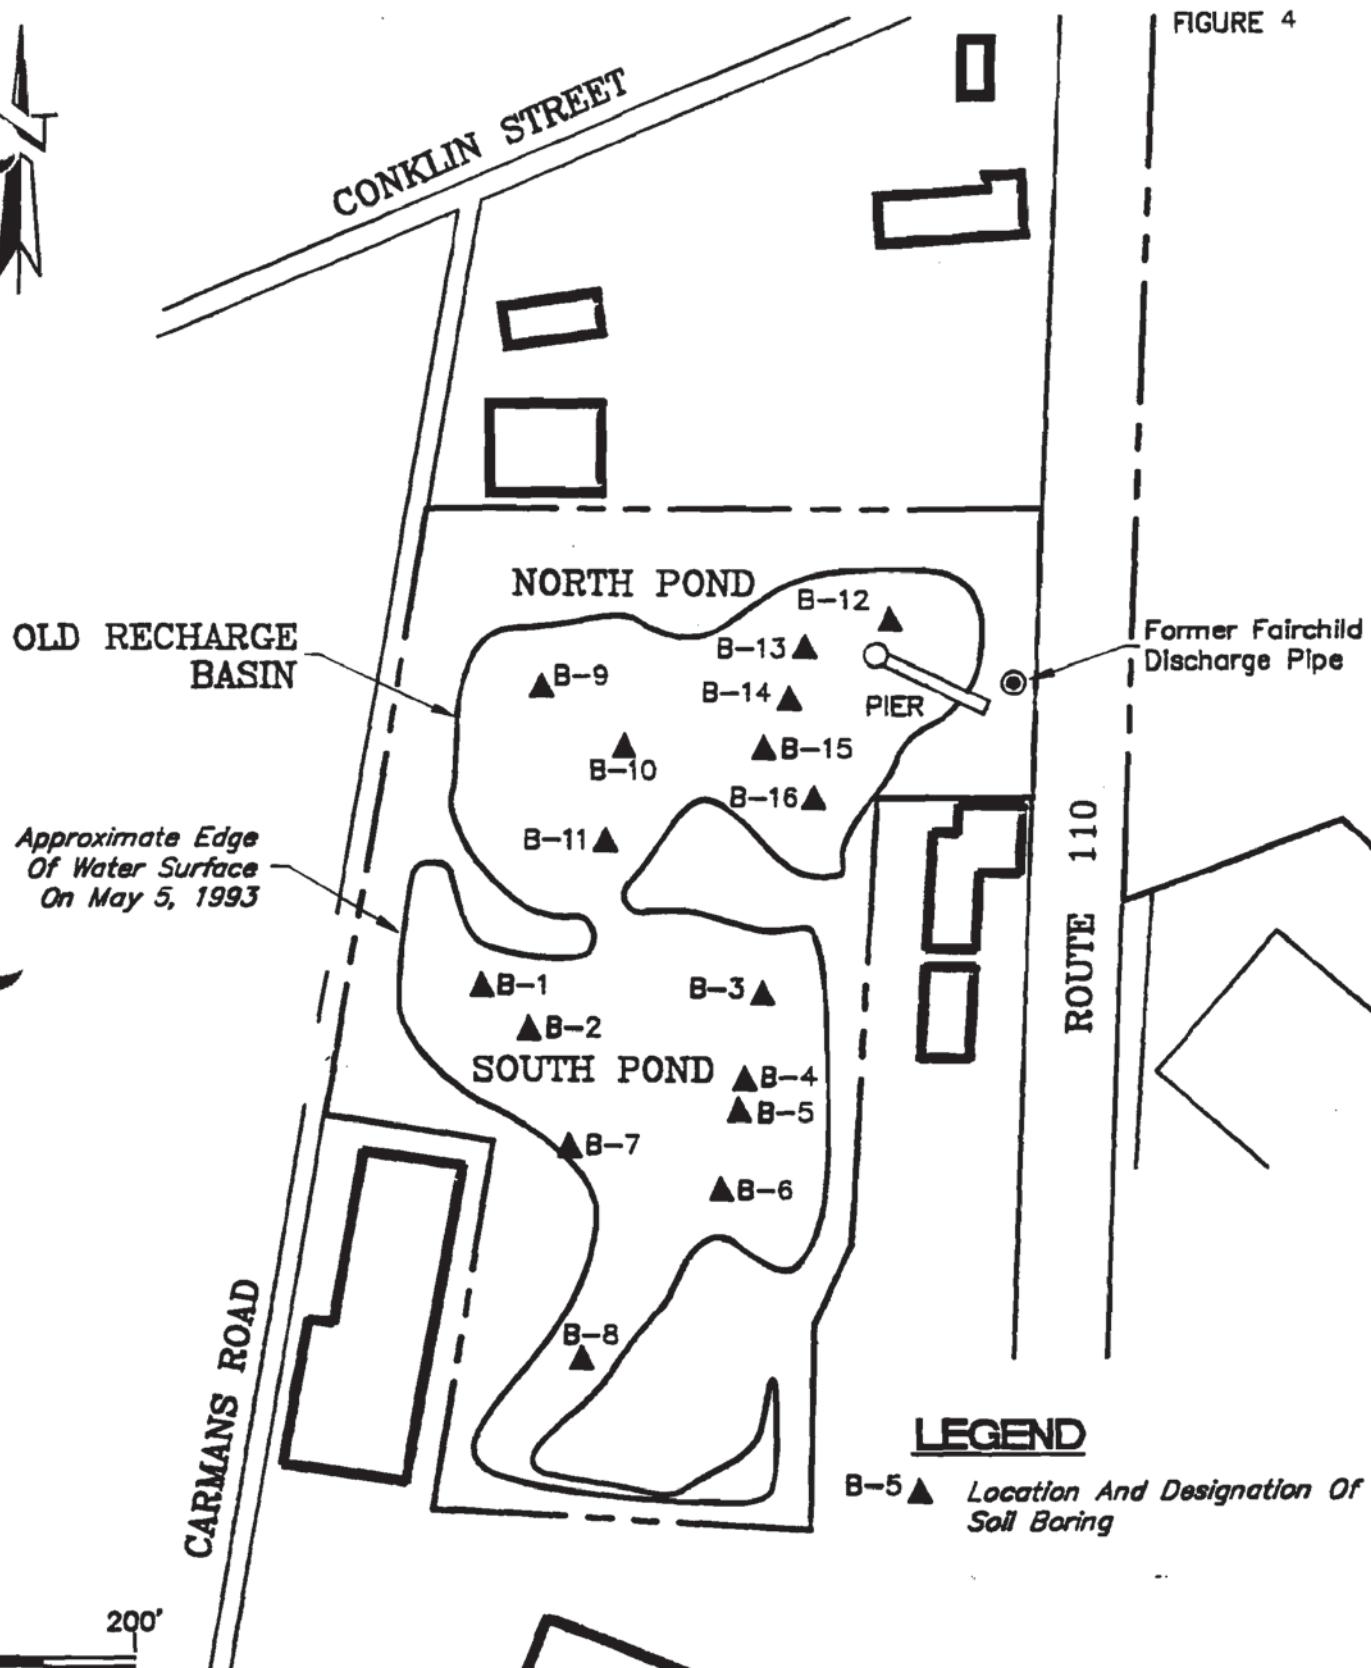
GERAGHTY AND MILLER SEDIMENT SAMPLING LOCATIONS

FAIRCHILD INDUSTRIES INC.
EAST FARMINGDALE, NEW YORK

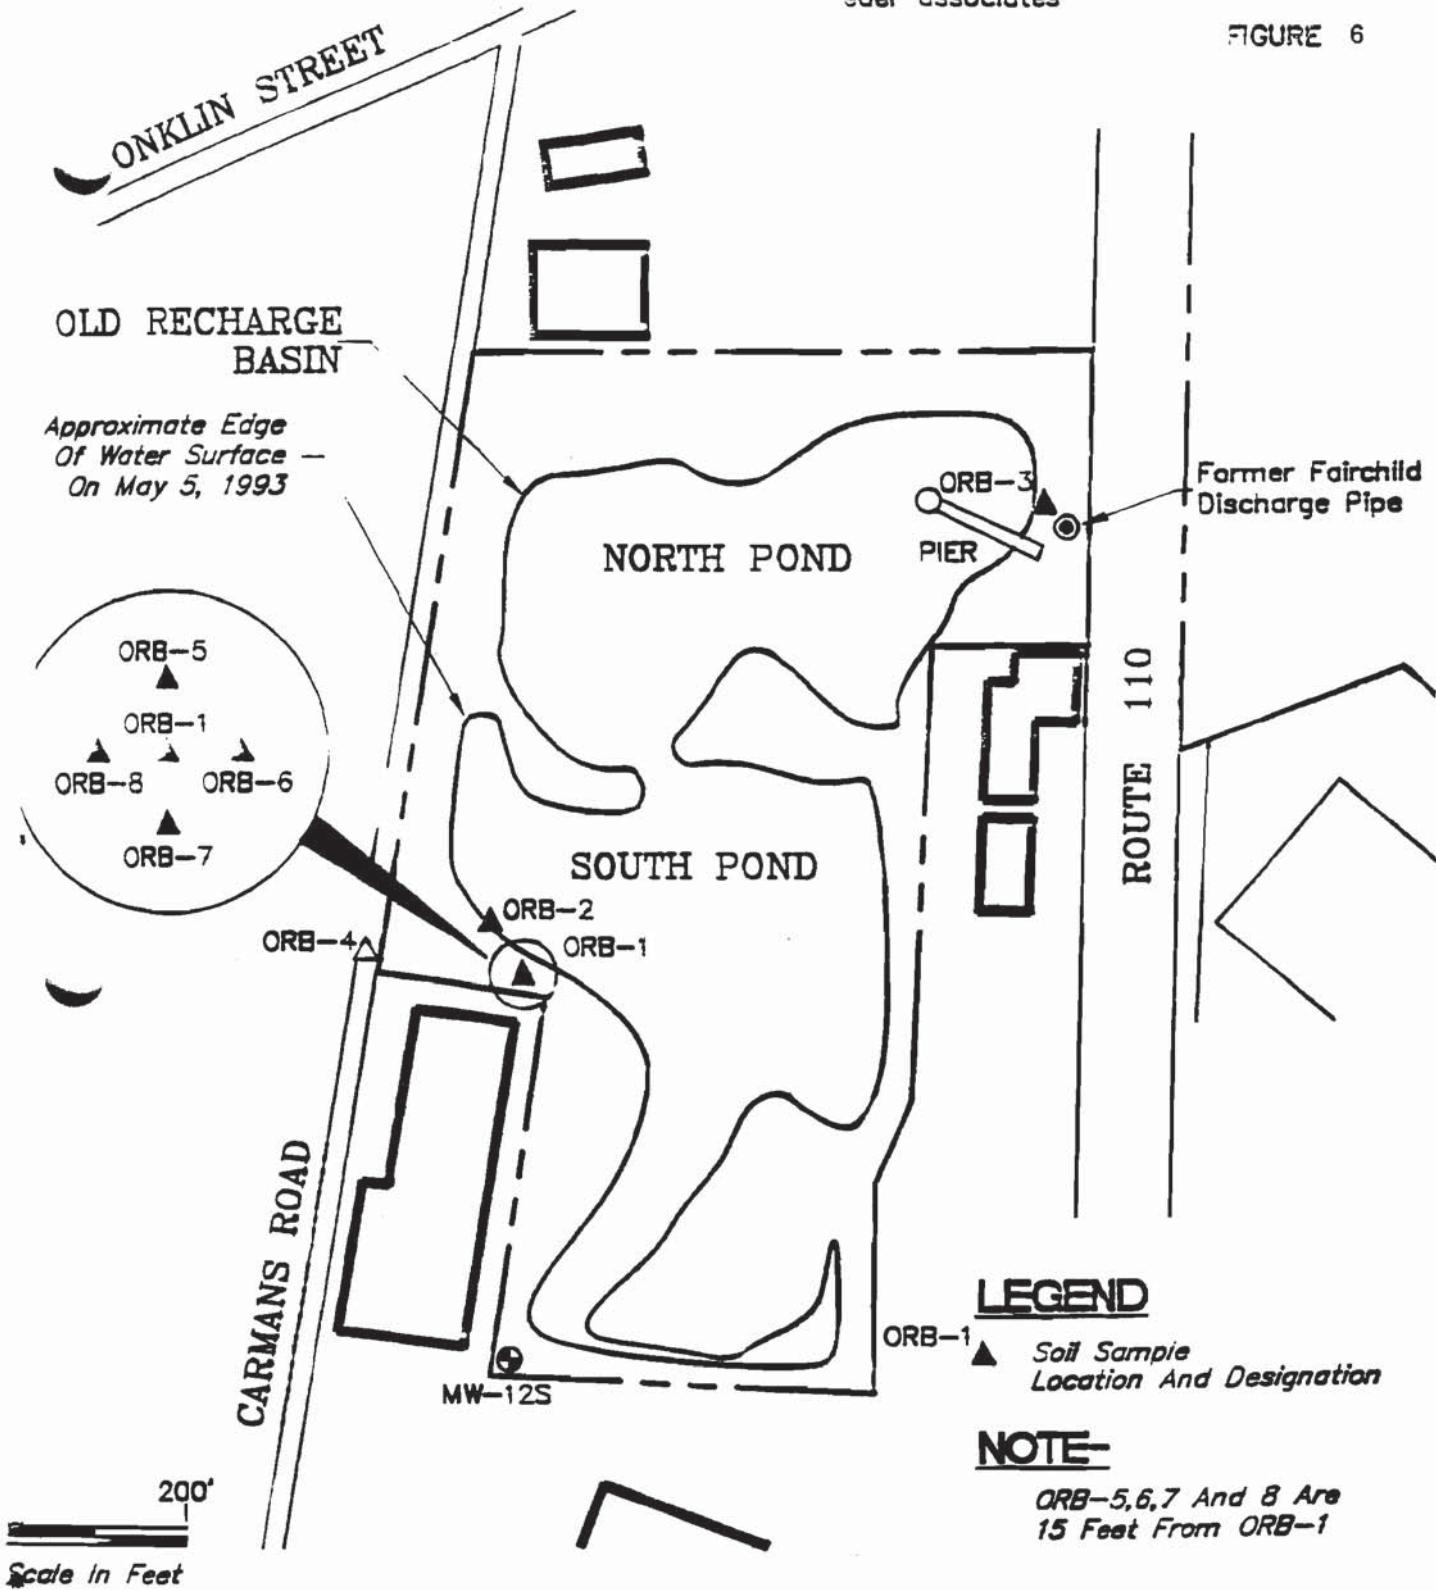
SURFACE SOIL SAMPLE LOCATIONS

REMEDIAL INVESTIGATION
OLD RECHARGE BASIN
FAIRCHILD INDUSTRIES INC.
EAST FARMINGDALE, NEW YORK

During the 1992/1995 remedial investigation, surface soil samples were collected at three locations on-site (see Appendix B, Figure 6) at the request of NYSDEC and Nassau County Department of Health. The samples were collected from zero to six inches below grade, and the analytical data are contained in Tables 22 through 25 in Appendix B. VOCs were found at very low concentrations which the validator attributed to the blanks or to concentrations below the method detection limits. Polycyclic aromatic hydrocarbons (PAHs) and PCBs were found at concentrations above ambient levels at sample location ORB-1. Concentrations of arsenic, beryllium, cadmium, chromium, copper, iron, lead, mercury, nickel, and zinc exceeded NYSDEC-recommended soil cleanup levels (The Soil Chemistry of Hazardous Materials, Dragun, Jr., Ph.D., 1988 and NYSDEC Memorandum: Determination of Soil Cleanup Levels, November 16, 1992). Concentrations of copper, lead, mercury, silver and zinc exceeded ambient levels. All metals, except mercury, where concentrations exceed the ambient level, were regulated by SPDES permits.

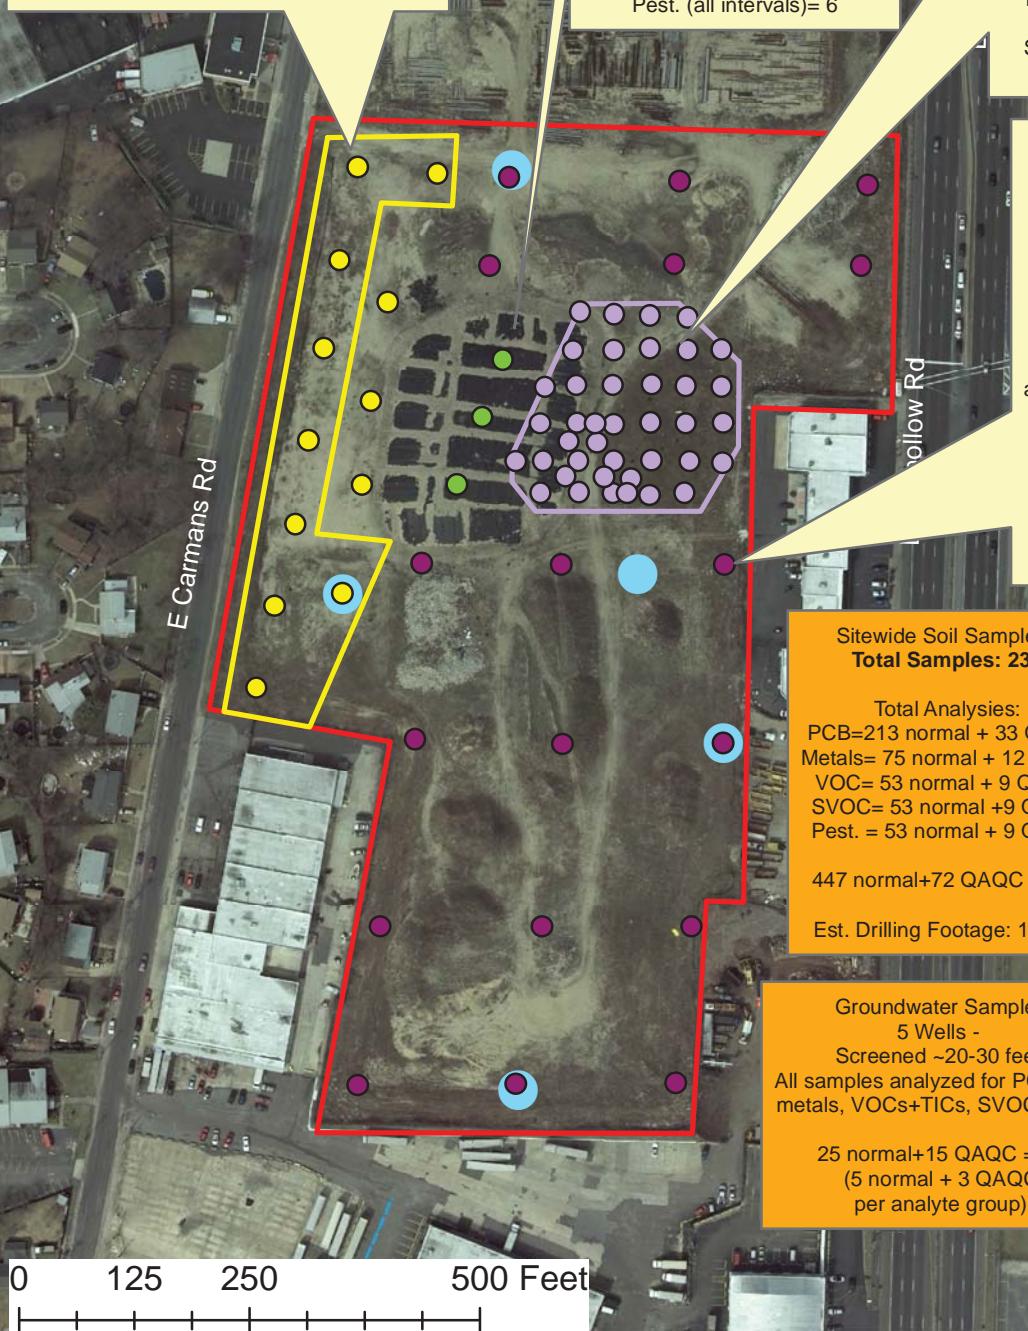
Figure 1: Remedial
Investigation Proposed
Sampling Locations June 2014

Groundwater Samples
5 Wells -
Screened ~20-30 feet
All samples analyzed for PCB,pest,
metals, VOCs+TICs, SVOCs+TICs

25 normal+15 QAQC = 40
(5 normal + 3 QAQC
per analyte group)

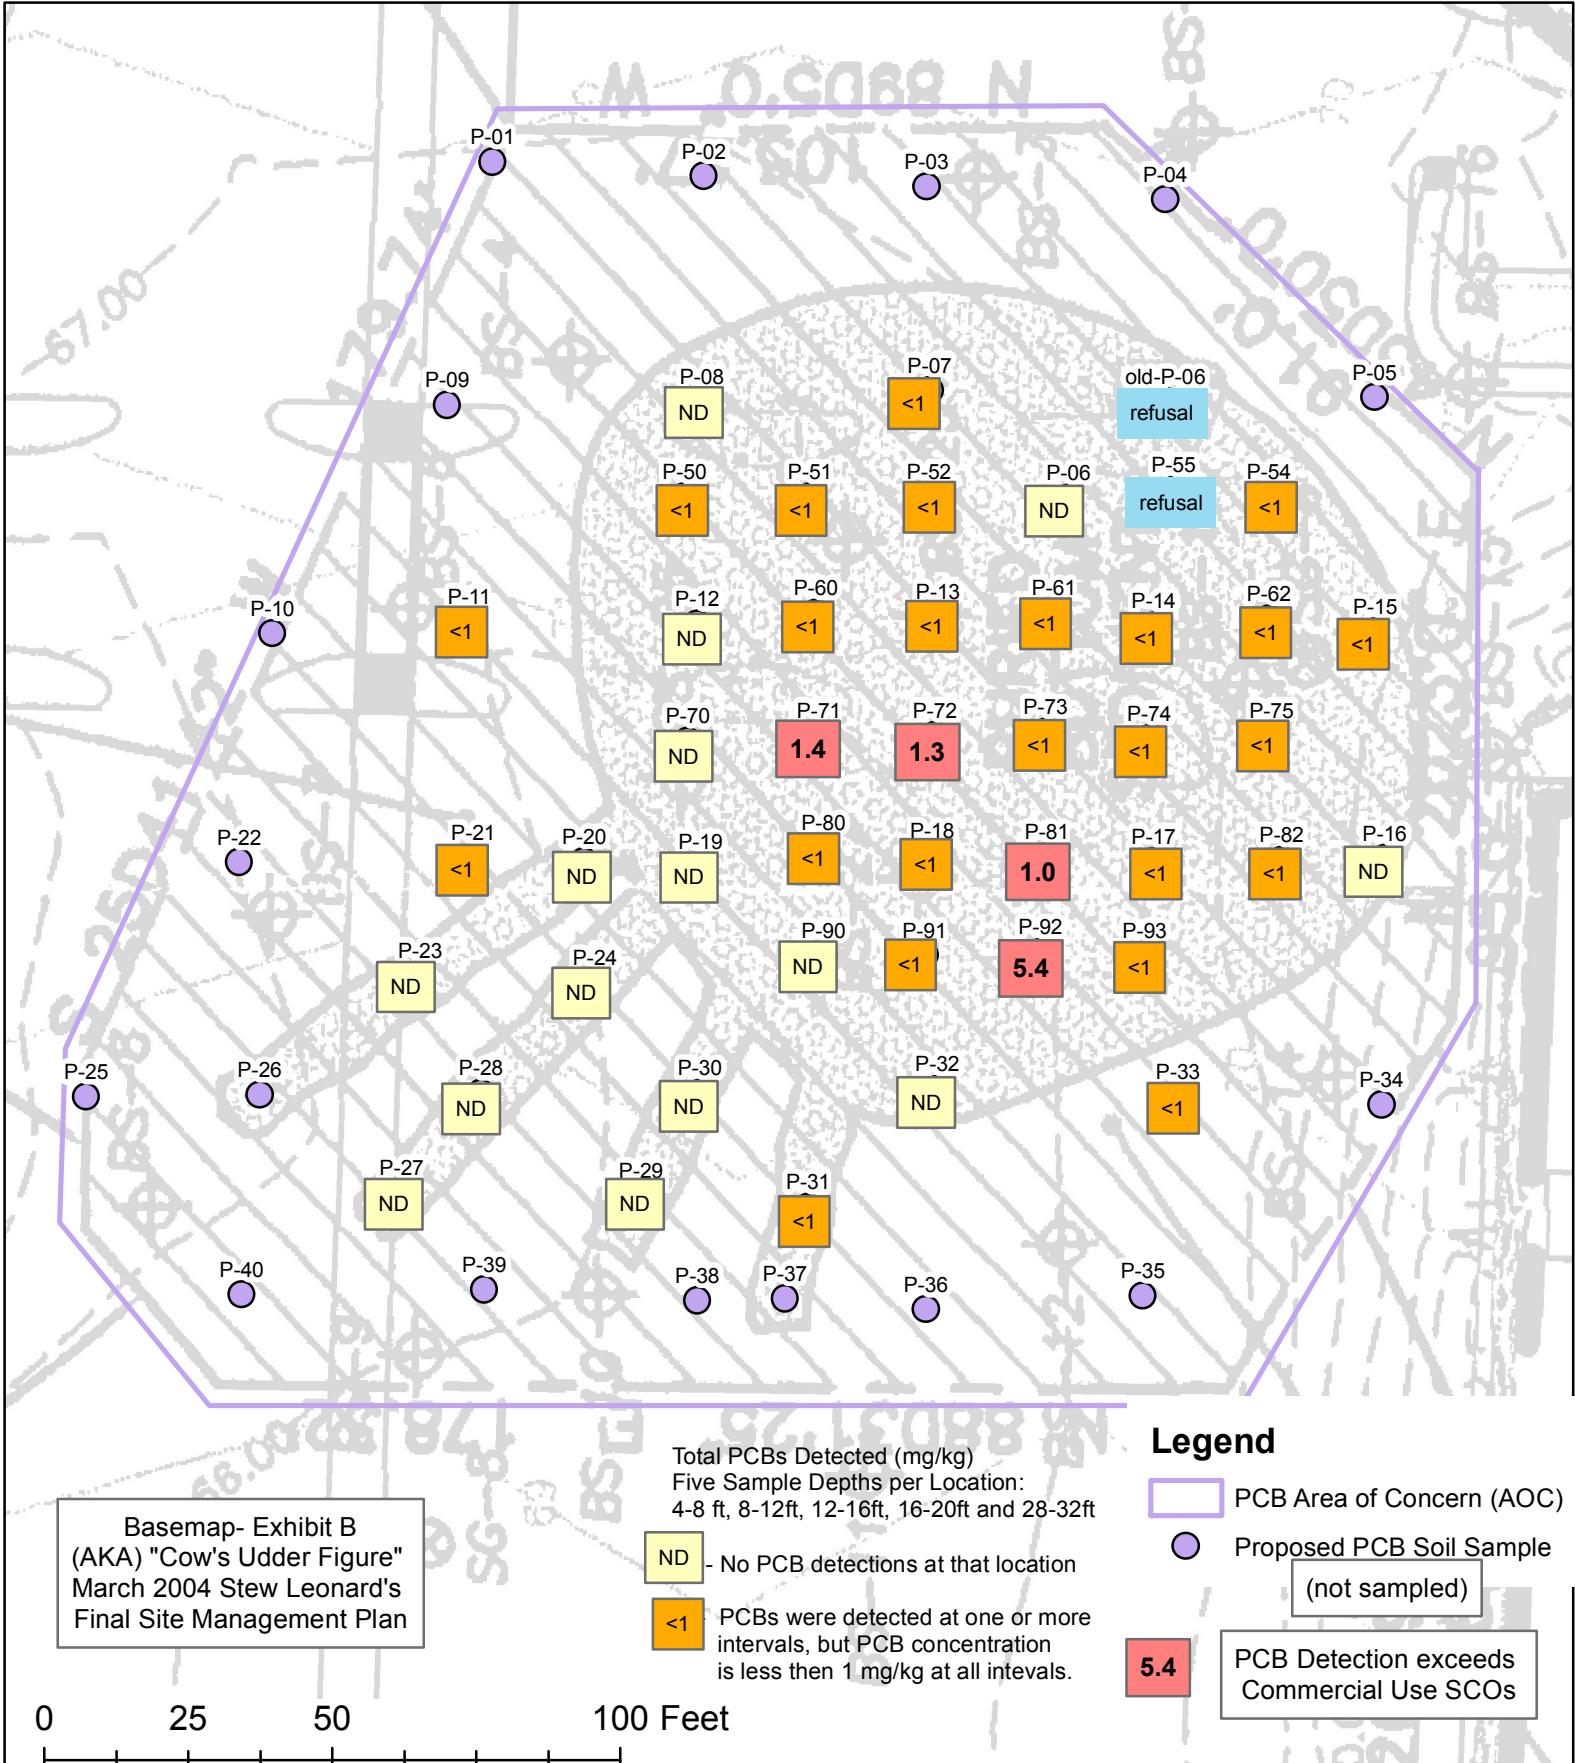
Remedial Investigation
Sample Results
PCB Area of Concern
June/July 2014

The soil sampling results indicated PCB concentrations in exceedance of unrestricted use soil cleanup objectives (UUSCOs) at 25 locations at depth intervals ranging from 4-8 feet bgs to 28-32 feet bgs. PCB concentrations were also found in exceedance of CUSCOs at 4 locations at

depth intervals ranging from 12 to 32 feet bgs. Chromium was also found in this area of concern at 2 locations, P-06 and P-08, in the 28-32 foot depth interval. Samples analyzed for VOCs, SVOCs, and pesticides did not exceed UUSCOs or CUSCOs. Please see Table 3 of Appendix D for the data summary of the PCB soil analytical results.

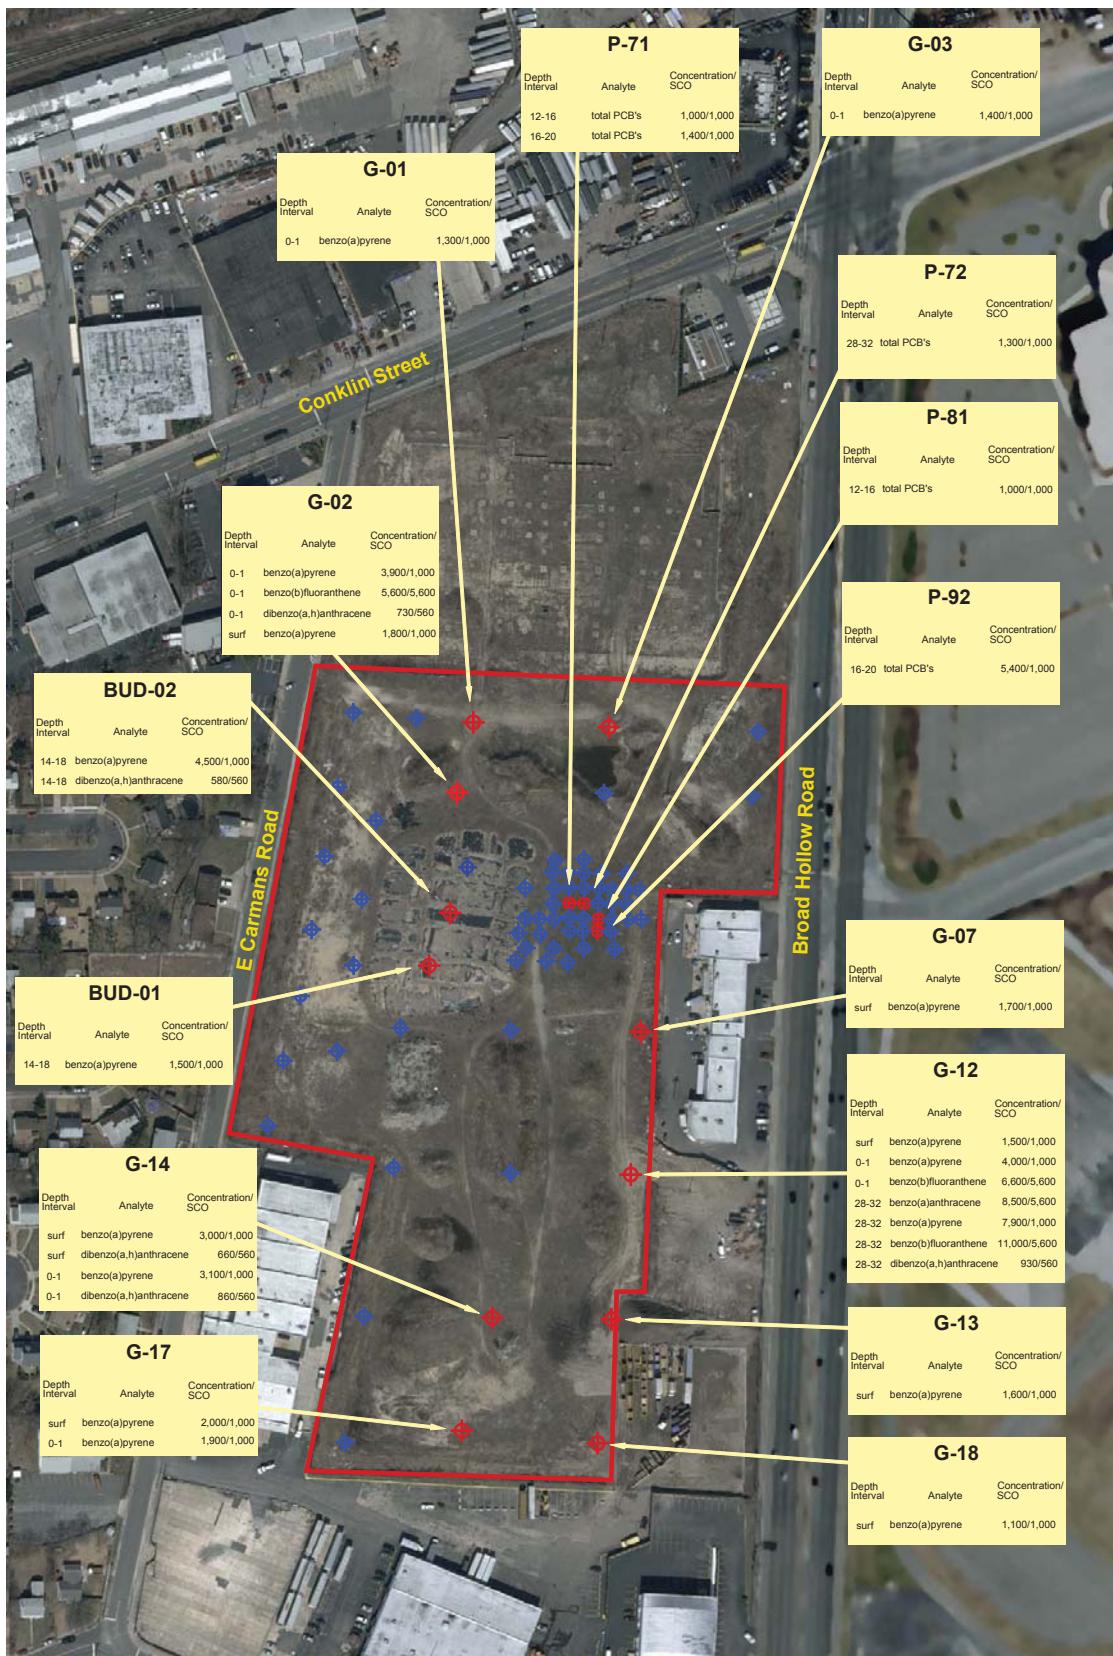
Figure 3
Commercial SCO Exceedances
June-July 2014 Remedial Investigation
6 NYCRR 375-6.8 Commercial Use Soil Cleanup Objectives

◆ - Soil Sampling Location w/ Commercial SCO Exceedance

◆ - Soil Sampling Location

The investigation found concentrations of benzo(a)anthracene, benzo(a)pyrene, benzo(b)fluoranthene, and dibenzo(a,h)anthracene in exceedance of CUSCOs in the surface and shallow subsurface soils at 9 different locations (see Appendix D, Figure 6). SVOCs were also found in exceedance of UUSCOs at 10 locations in shallow-subsurface soils including benzo(a)anthracene, benzo(a)pyrene, benzo(b)fluoranthene, benzo(k)fluoranthene, chrysene, dibenzo(a,h)anthracene, and indeno(1,2,3-cd)pyrene. PCBs were also detected at three locations in exceedance of UUSCOs. Chromium, Copper, lead, mercury, silver, and zinc were also detected at multiple locations in the shallow subsurface in exceedance of UUSCOs. Please see Tables 18 through 22 in Appendix D for a data summary of the above results.

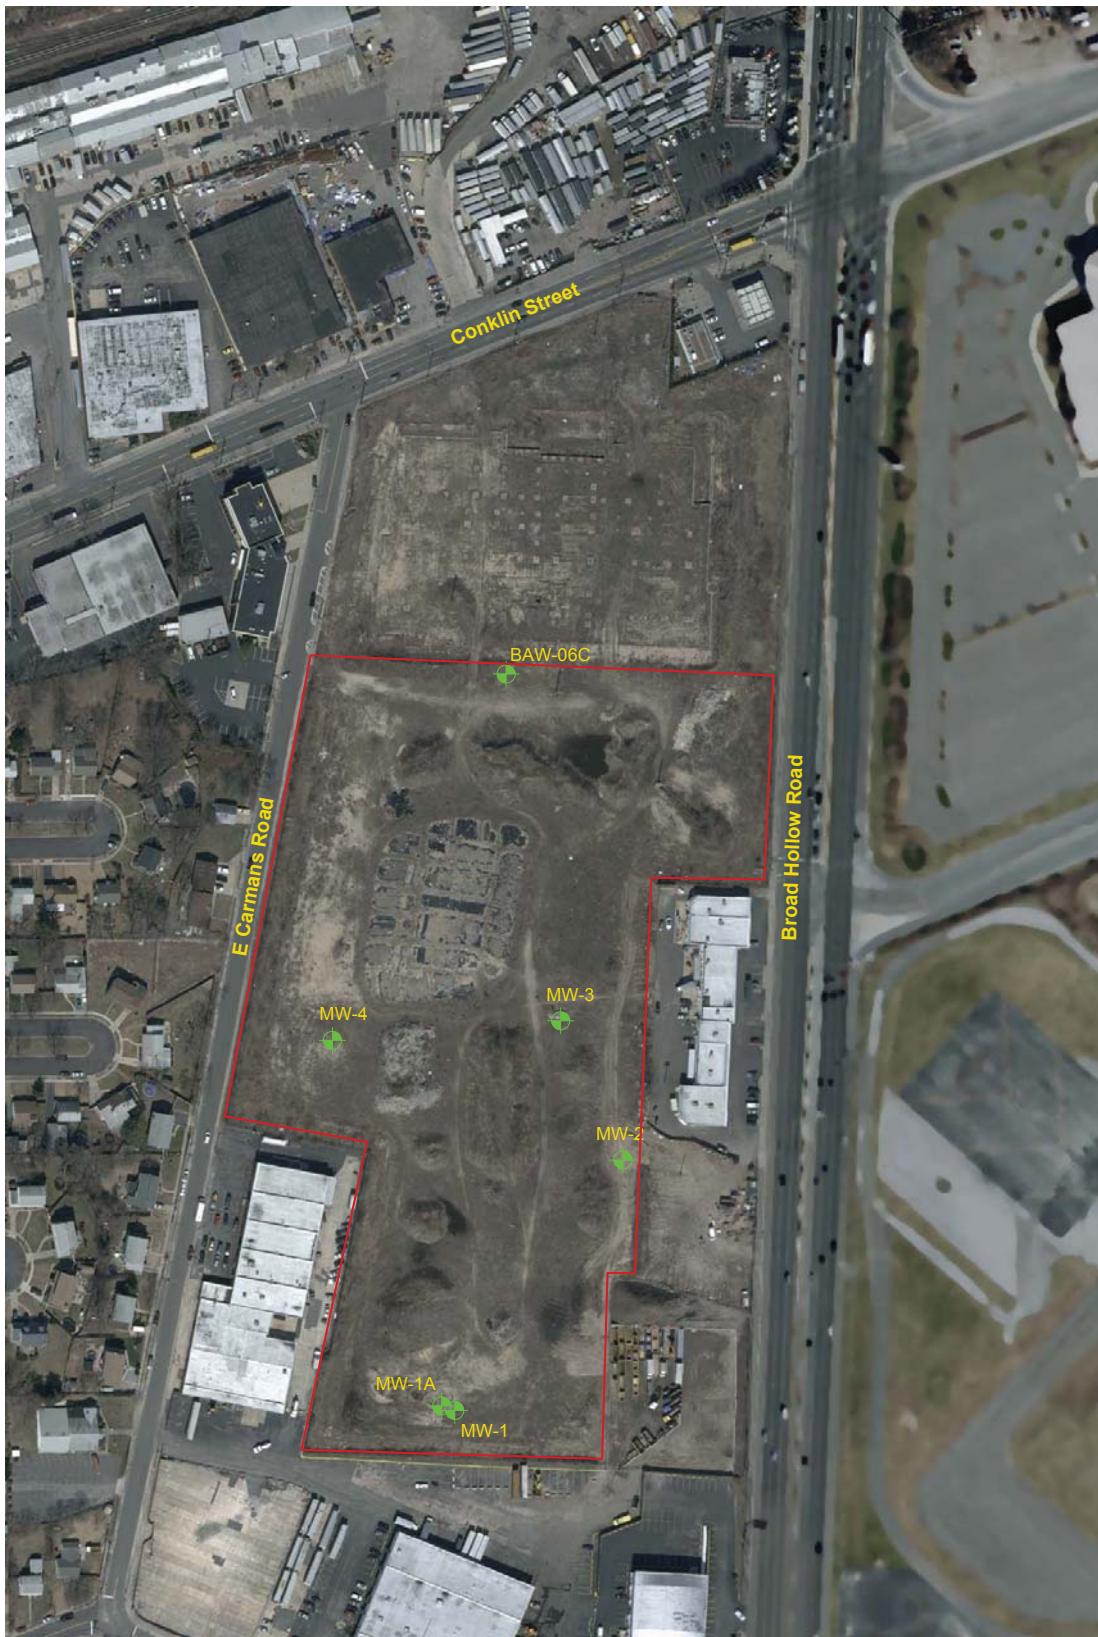
Fairchild Republic Aircraft; Old Sump
Broad Hollow Road
East Farmingdale, NY
Site No.152004

This investigation was conducted from May through July 2014 by a NYSDEC contractor. The investigation called for soils to be investigated at 76 different locations at varying depths and the sampling/installation of 6 groundwater monitoring wells. The locations of these soil borings and groundwater monitoring locations can be seen on Figures 3 and 4 within Appendix D.

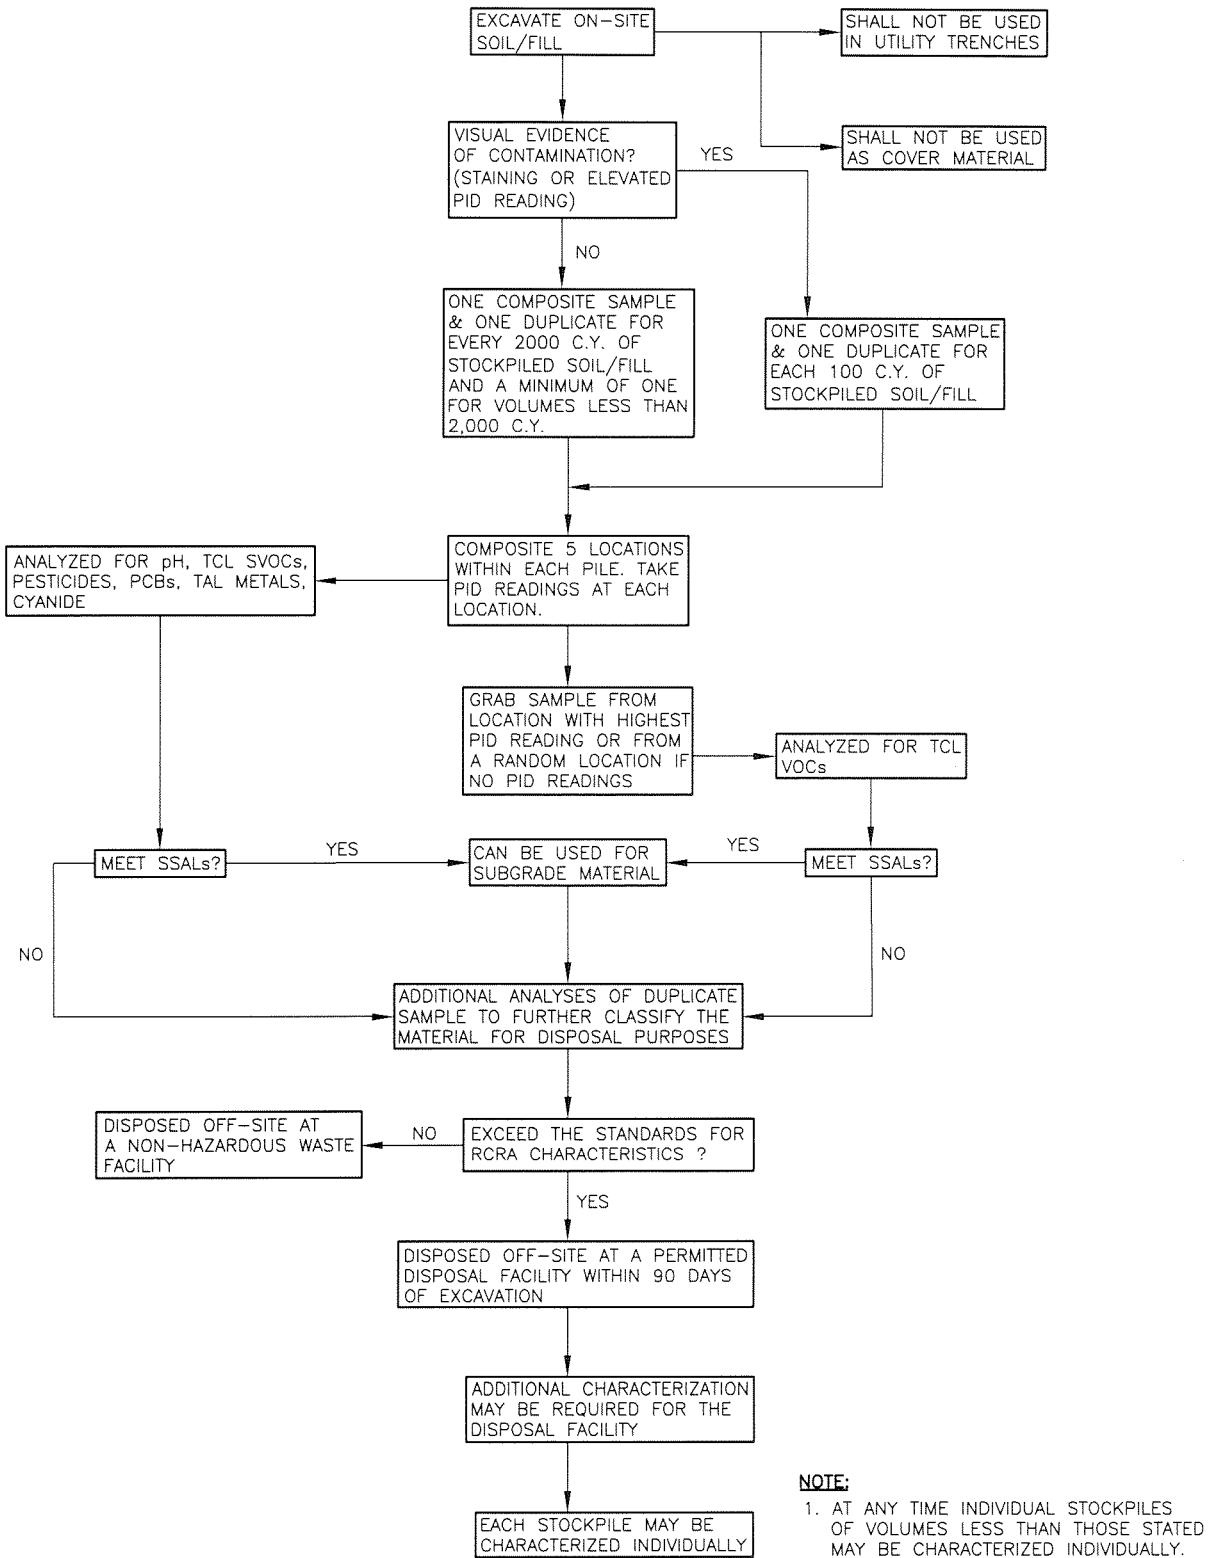
FIGURE 6-2

Soil Characterization Flow Chart

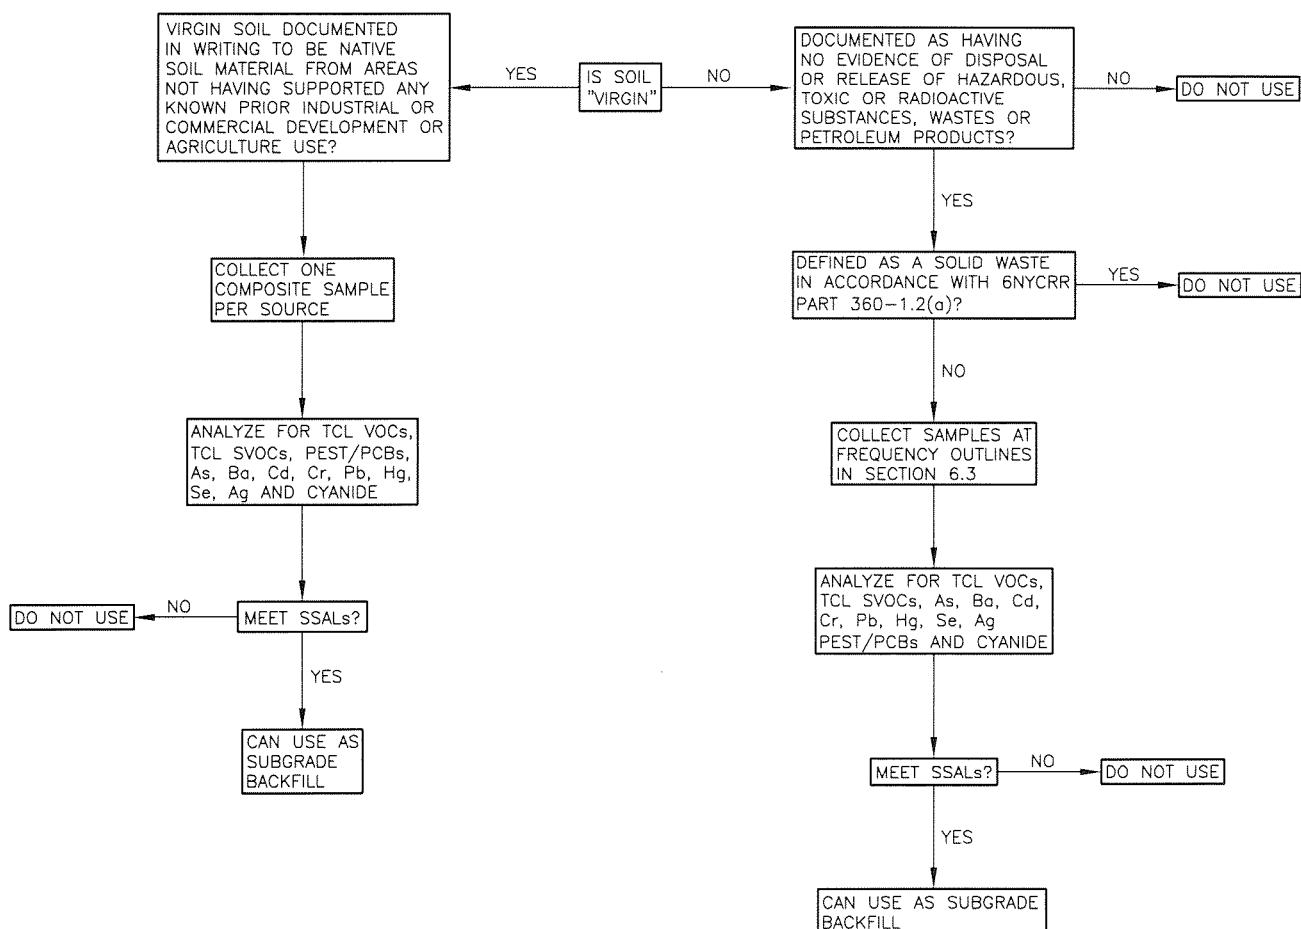
FIGURE 6-3

Flow Chart for Subgrade Backfill Using Offsite Sources

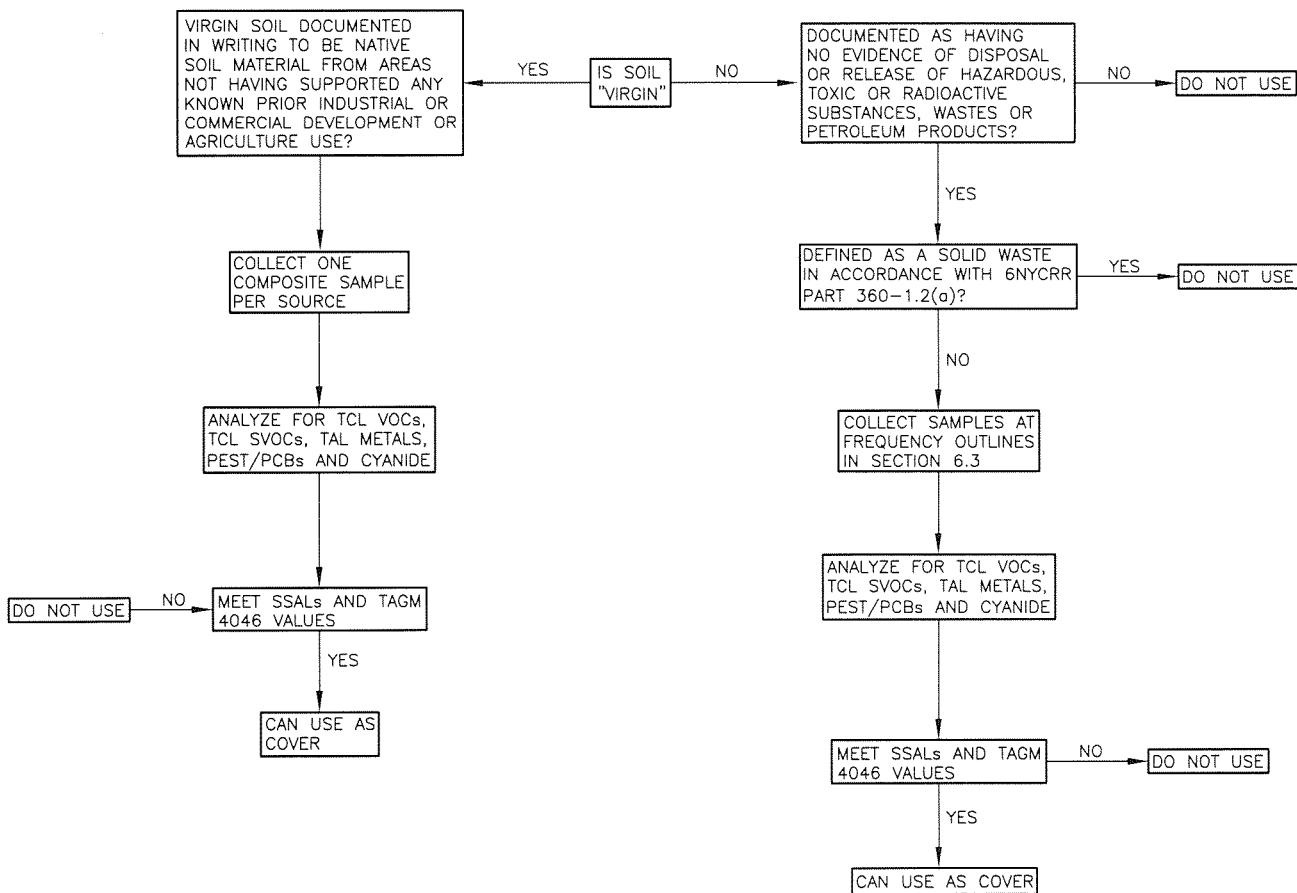
Flow Chart for Cover Soil Using Offsite Sources

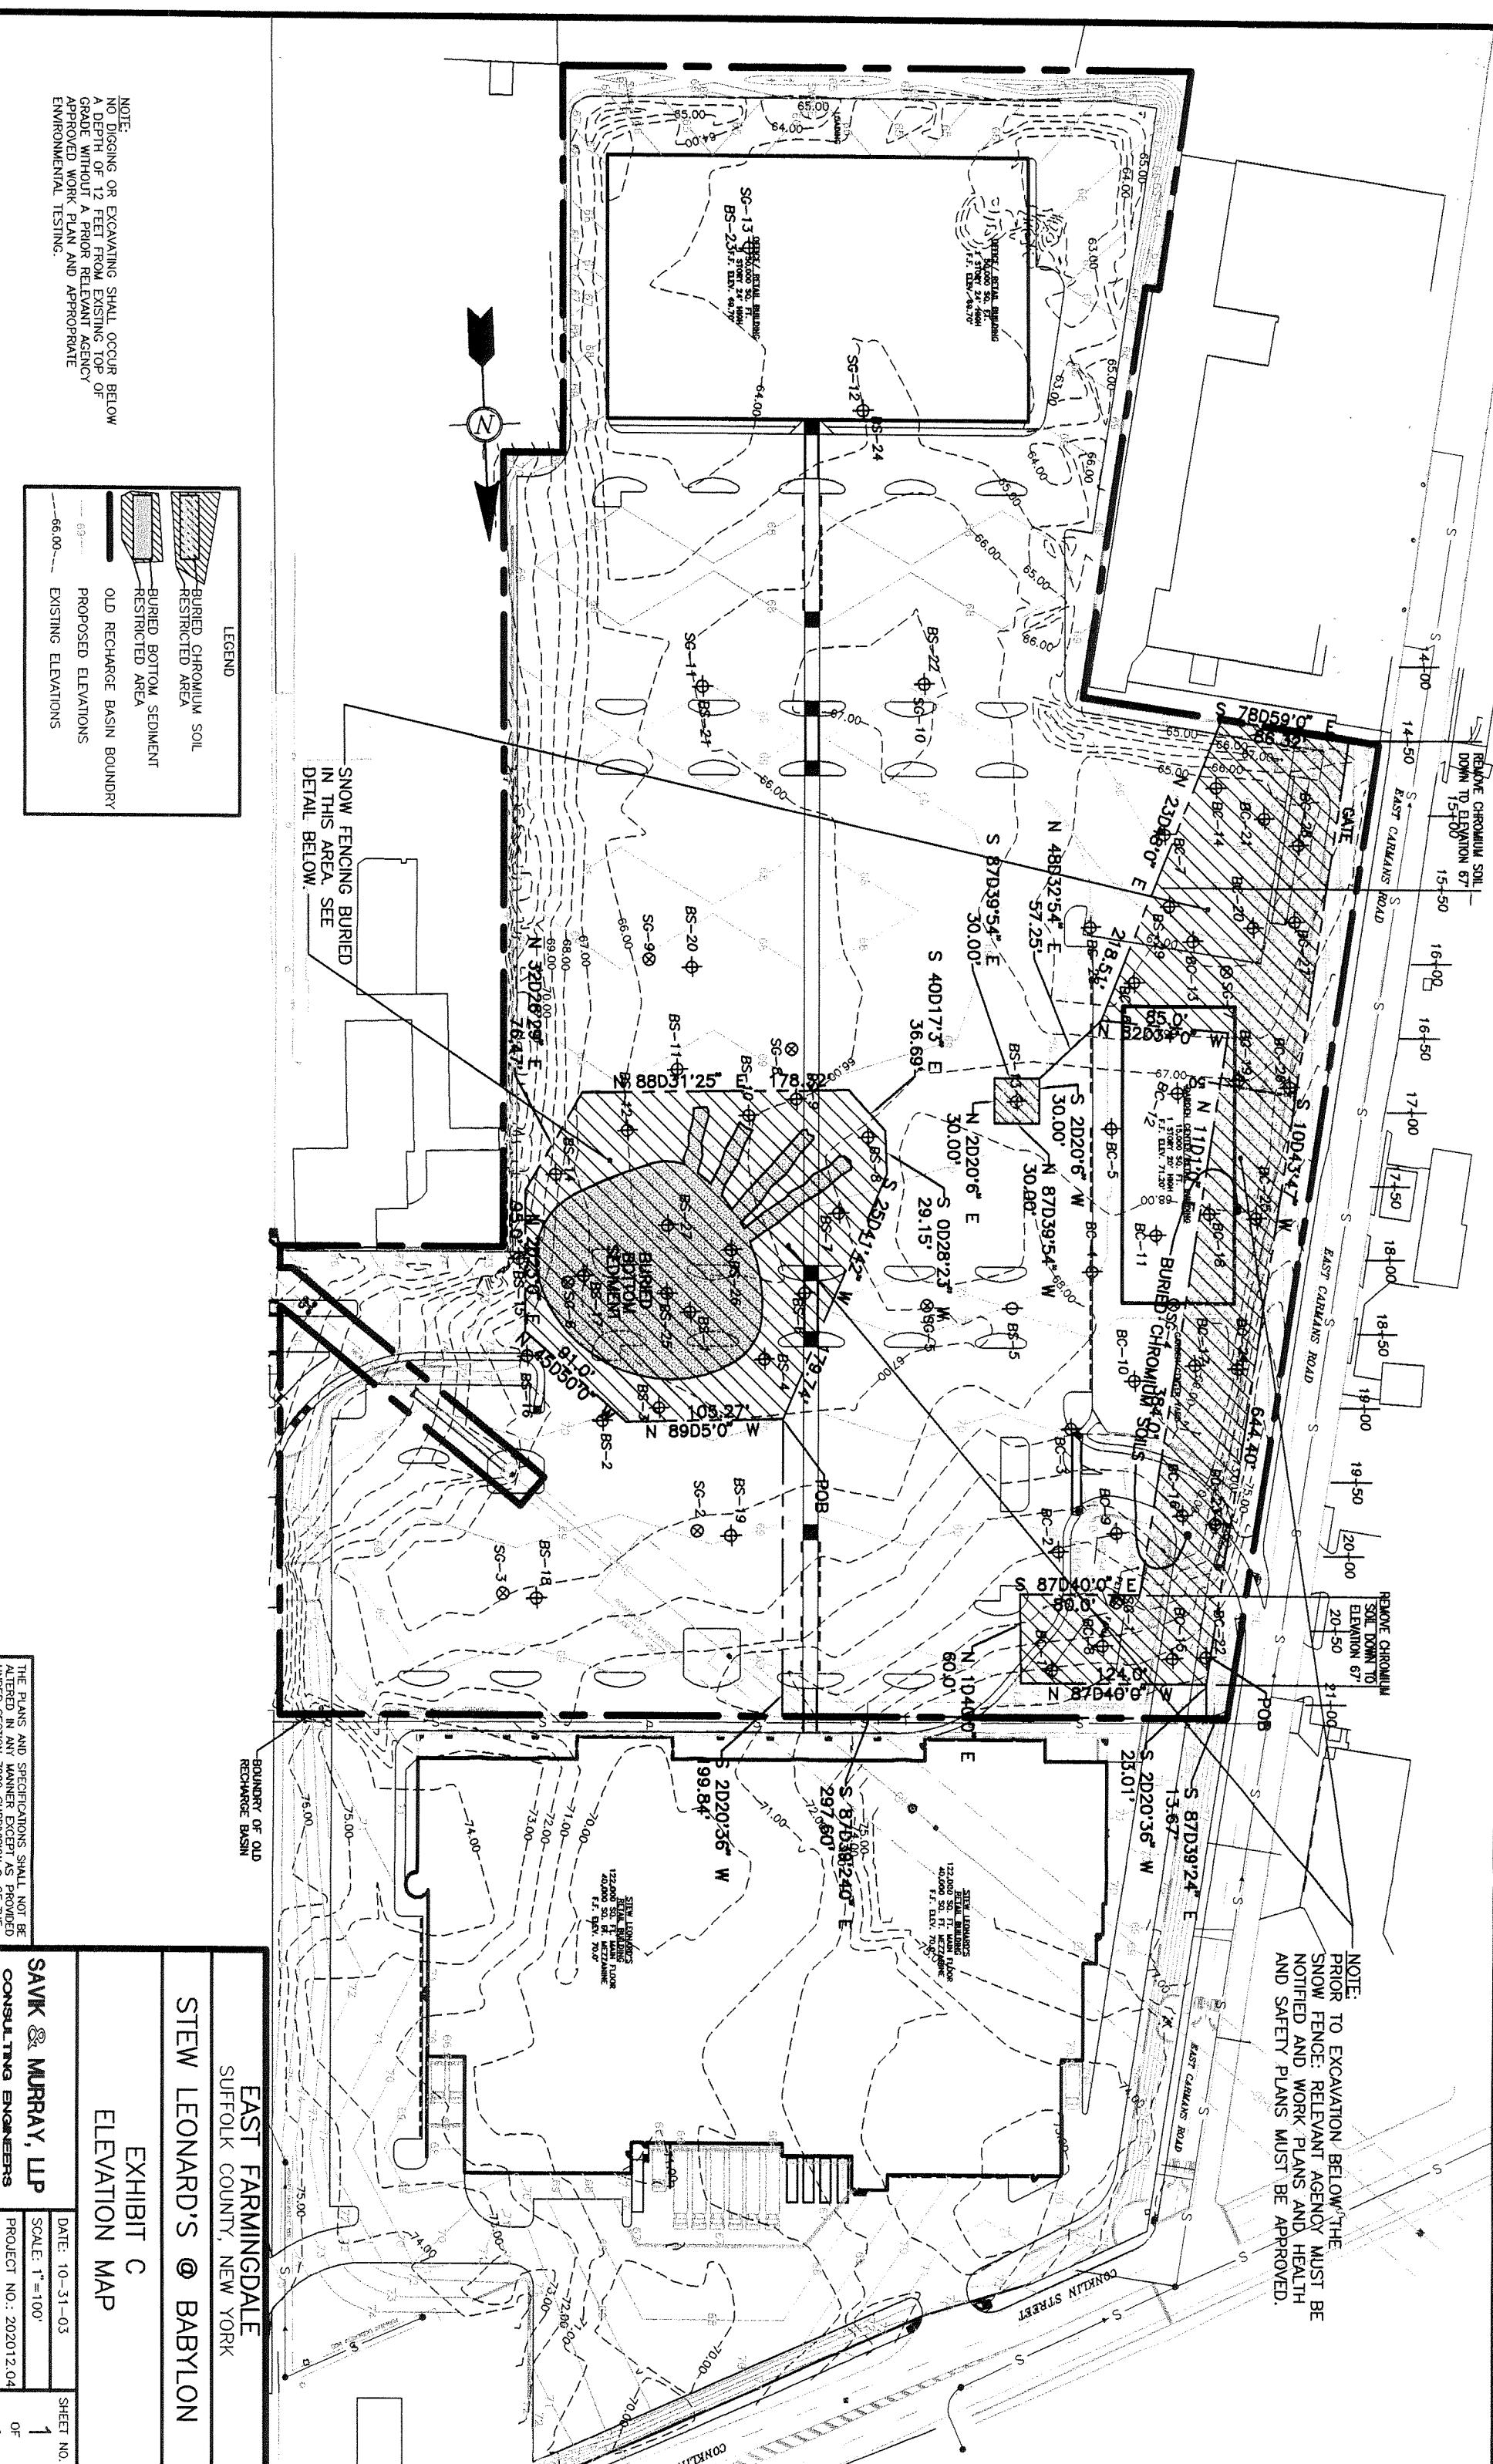
Exhibit C
Elevation Map

NO DIGGING OR EXCAVATING SHALL OCCUR BELOW A DEPTH OF 12 FEET FROM EXISTING TOP OF GRADE WITHOUT A PRIOR RELEVANT AGENCY APPROVED WORK PLAN AND APPROPRIATE ENVIRONMENTAL TESTING.
