**Jameco Industries Site**  
**WYANDANCH, SUFFOLK COUNTY, NEW YORK**

**Final Engineering Report**

**NYSDEC Site Number: #1-52-006**

**AUGUST 2011**

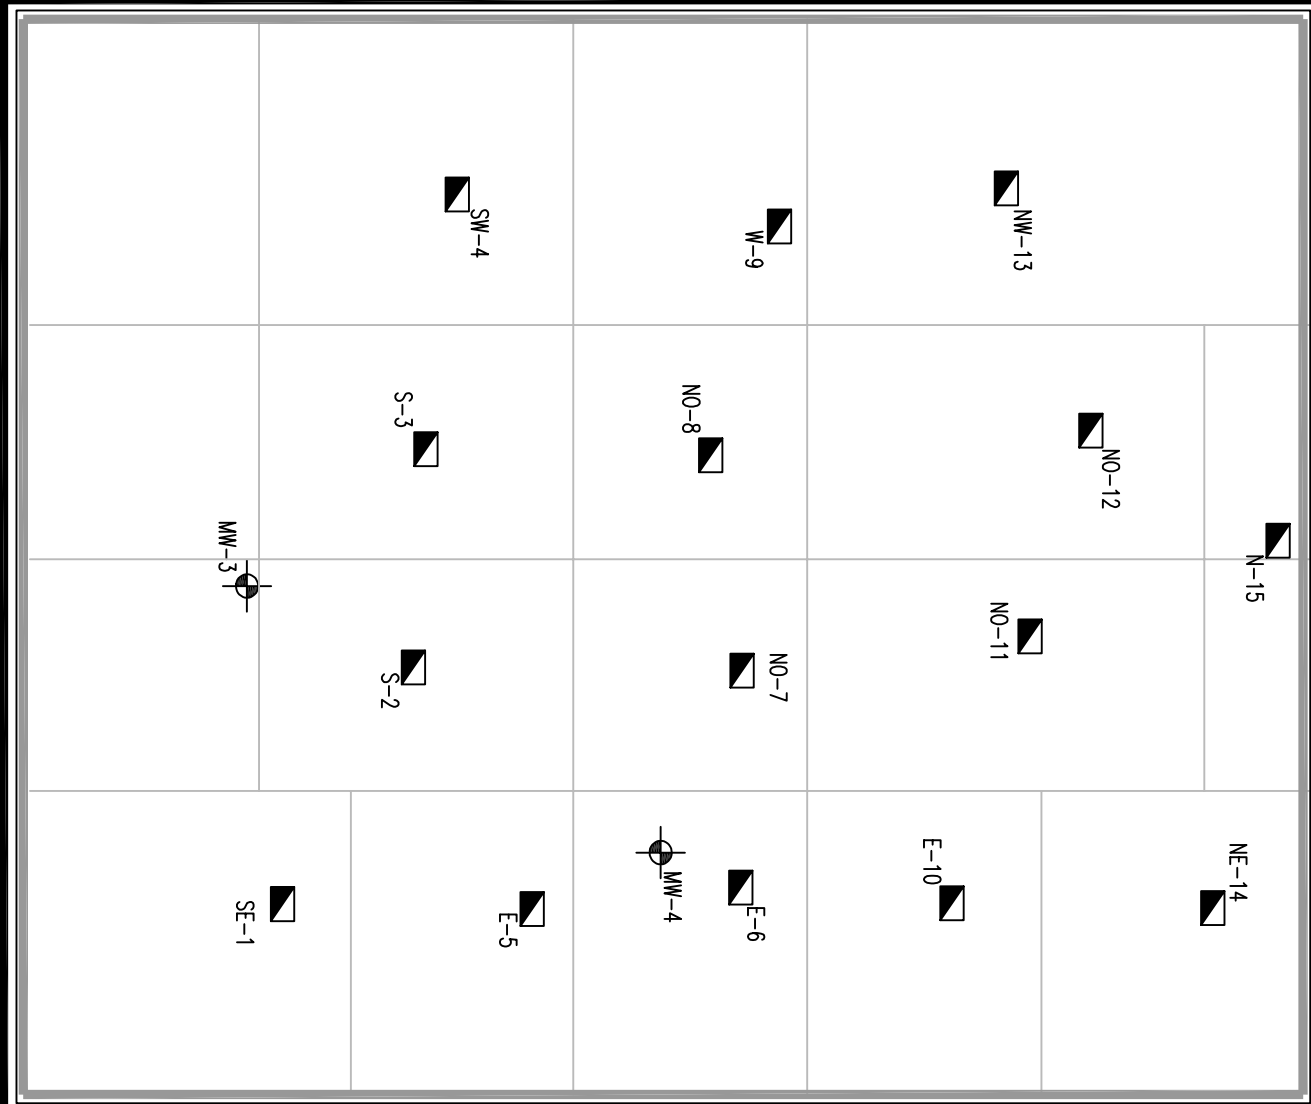
FORMER LEACHING  
PIT AREA

The floor plan shows a building layout with a red cross-hatched area indicating a restricted zone. The plan includes various rooms and corridors, with labels for doors (e.g., MW-3R, MW-4R, E-WALL, IN-WALL, TW-WALL) and structural elements (e.g., TS, TSF, F). The red cross-hatching covers a large portion of the central and right side of the plan.
