Former Jameco Industries Site
WYANDANCH, SUFFOLK COUNTY, NEW YORK

Periodic Review Report

NYSDEC Site Number: #1-52-006

JUNE 2013

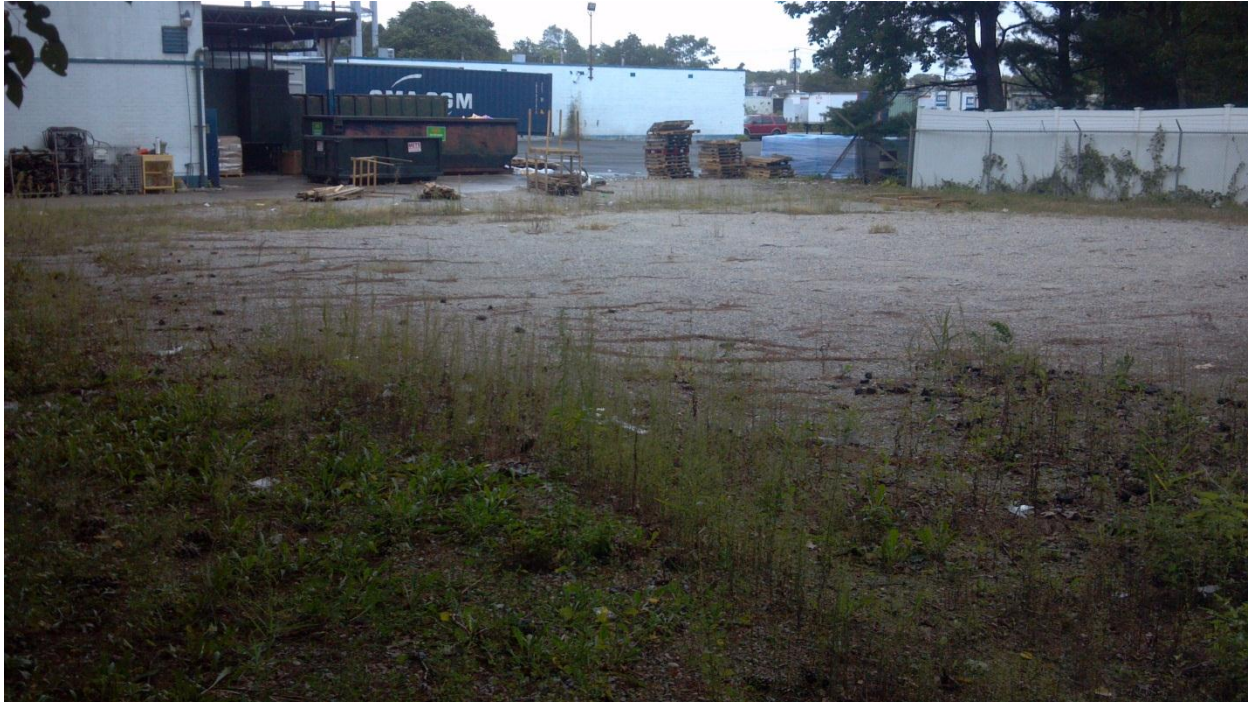
Photo 1: (9-18-2012, 11:35) AOC 3 Looking northeast towards Site building and AOC 1

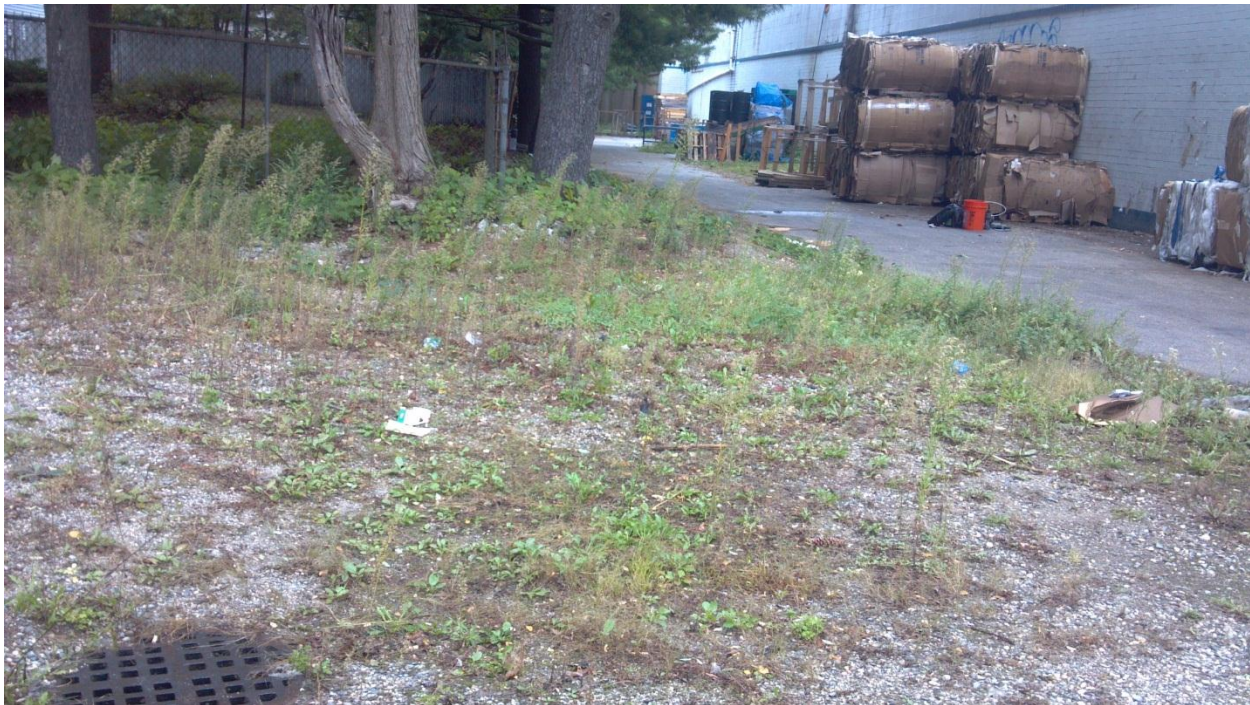
Photo 2: (9-18-2013 12:22) AOC 2 and 5 Looking at South side of Site Building. MW-2 is located by the orange bucket in background.

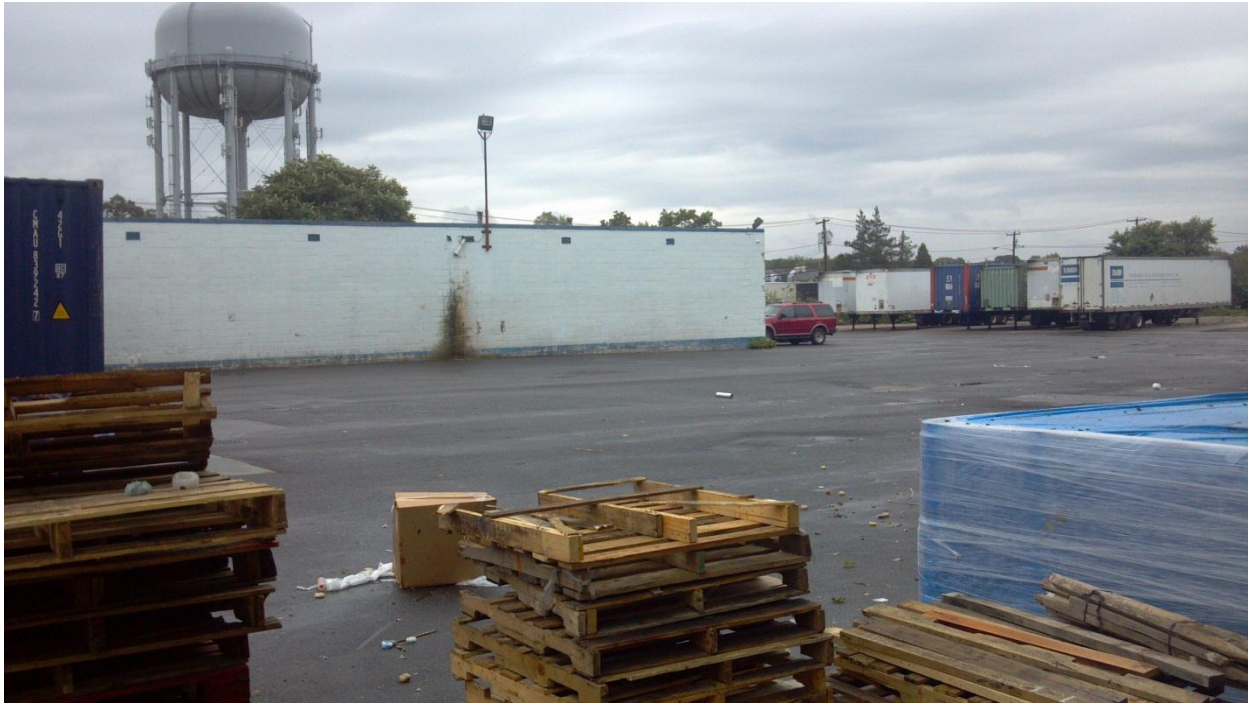
Photo 3: (9-18-2012, 12:22) View of AOC-1 looking from northeast corner of AOC-3

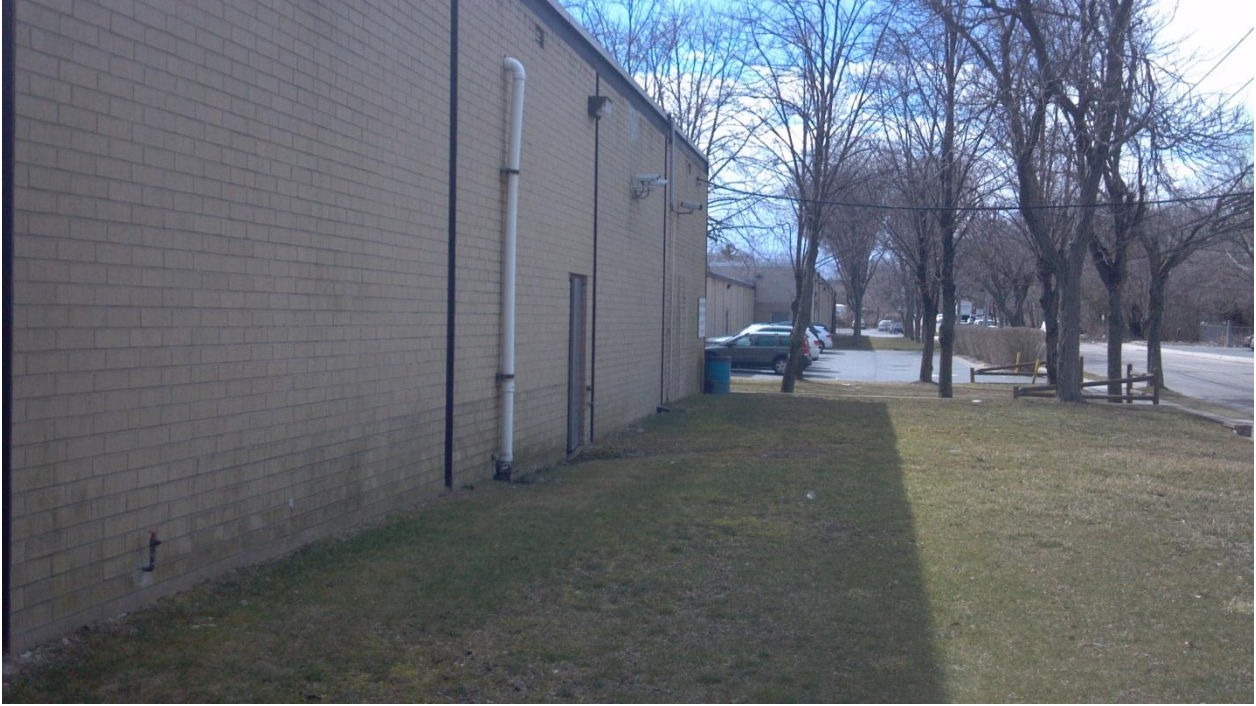
Photo 1: (3-27-2013, 14:35)—AOC 4 North Side of Site Building looking west along Wyandanch Ave from approximate location of MW-23.

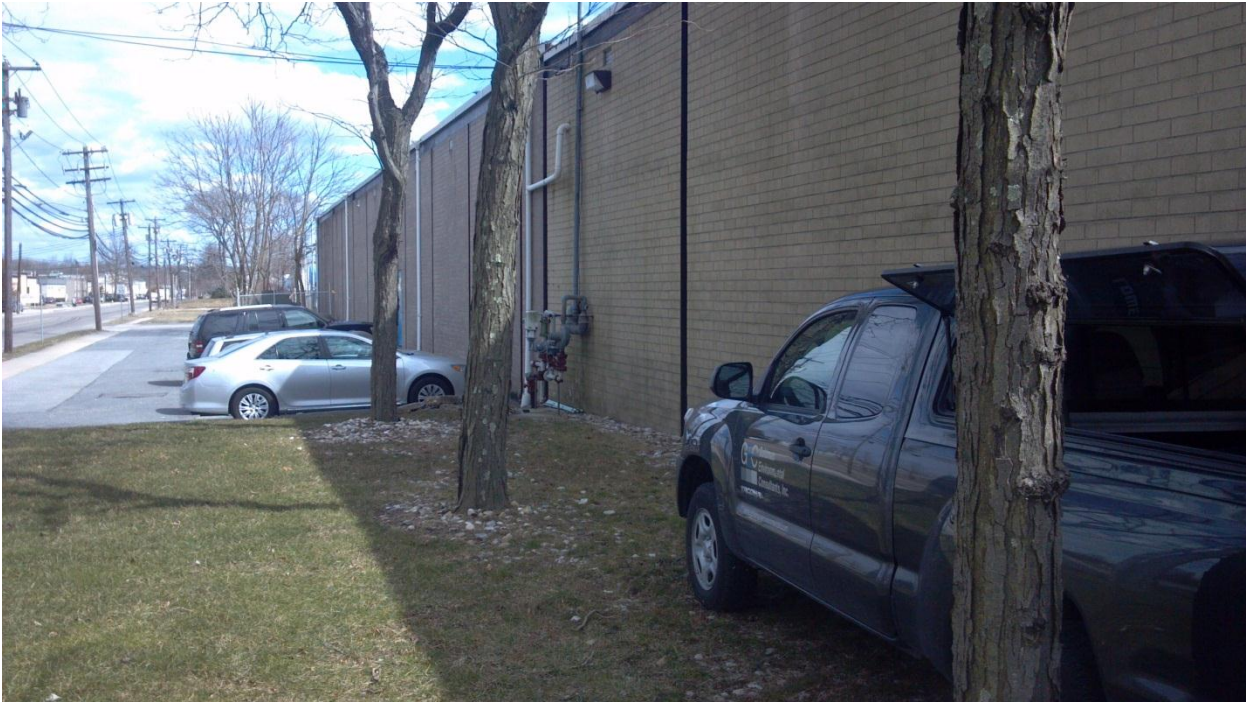
Photo 2: (3-27-2013, 14:35)—AOC 4 North Side of Site Building looking east along Wyandanch Ave from approximate location of MW-23.

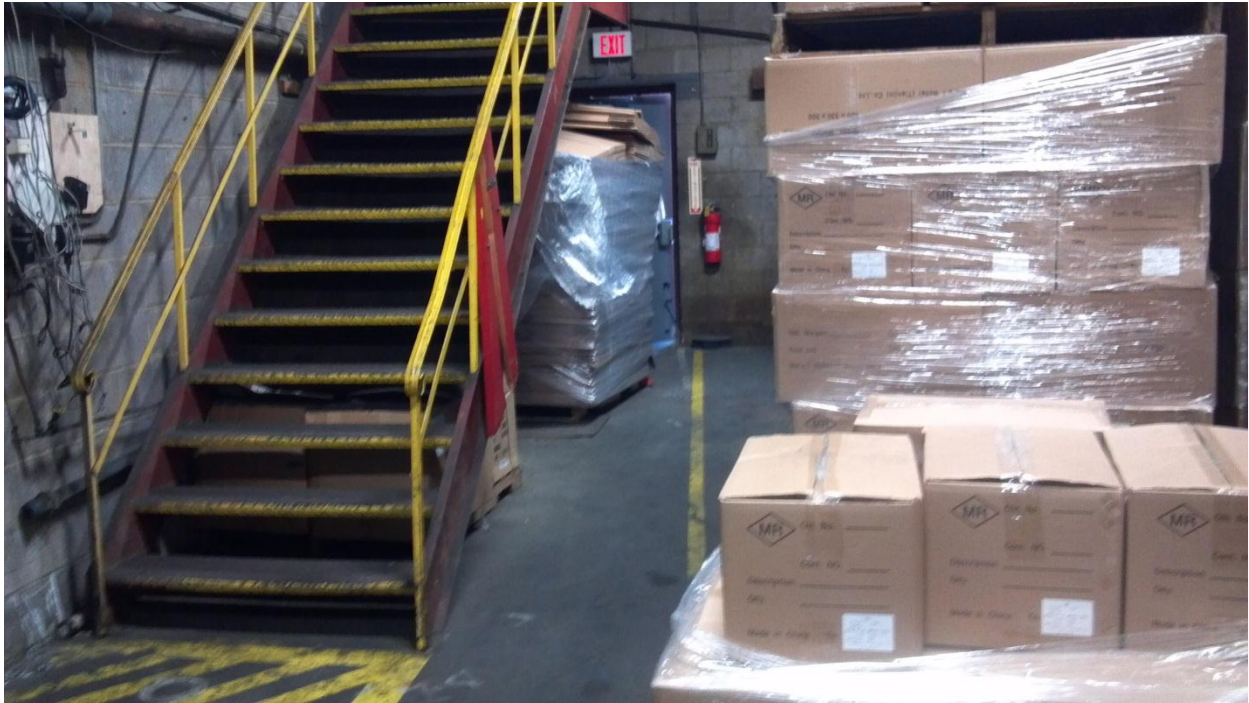
Photo 3: (3-27-2013, 15:43) AOC-4 Warehouse area of Site Building looking north towards exit to Wyandanch Avenue. Photo taken from west side of warehouse.

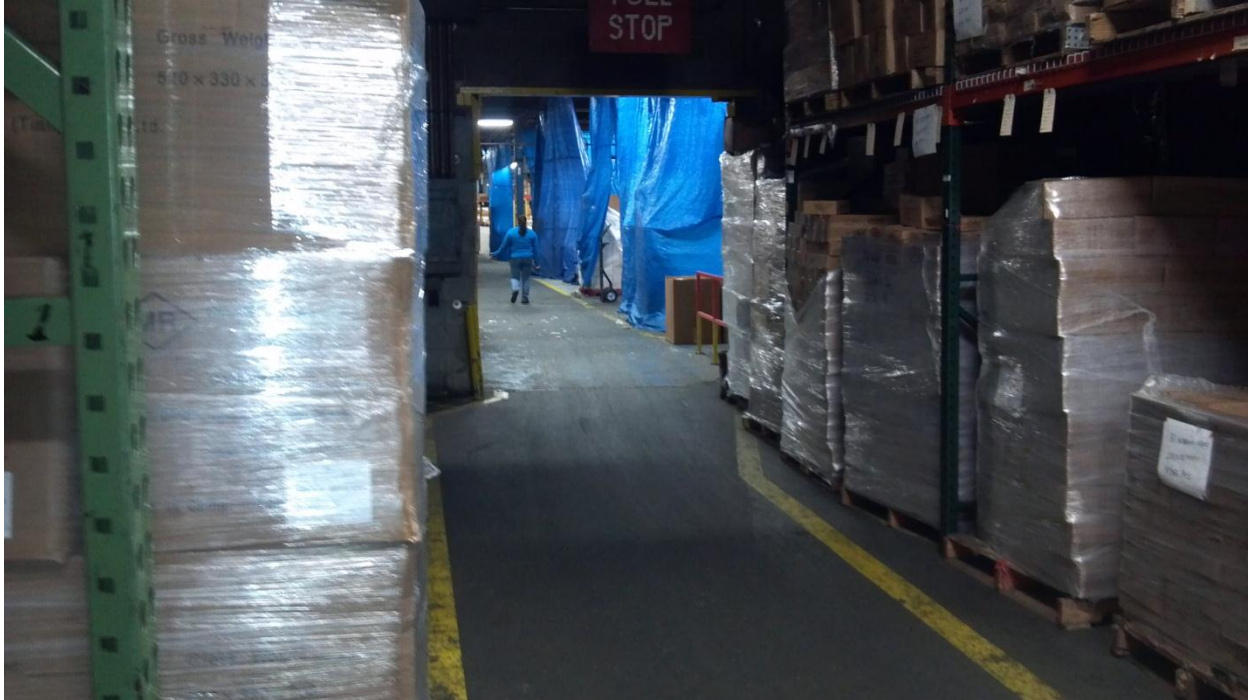
Photo 5 (3-27-2013, 15:44) AOC 4 Warehouse area of Site Building looking south into production area. Area to right of blue tarp is AOC 2 and 5. Photo taken from west side of warehouse.

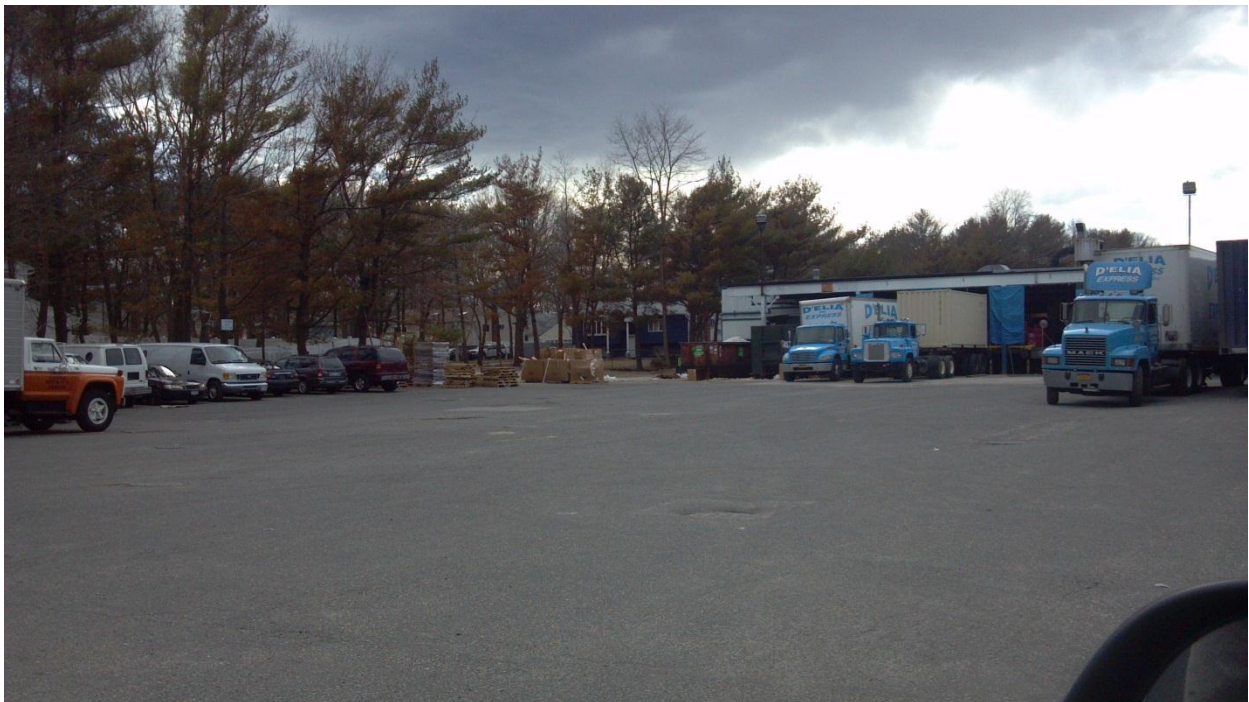
Photo 6: (3-27-2013 16:13) AOC 1. Taken from northeast corner of AOC 1 with view of AOC 3 in background.

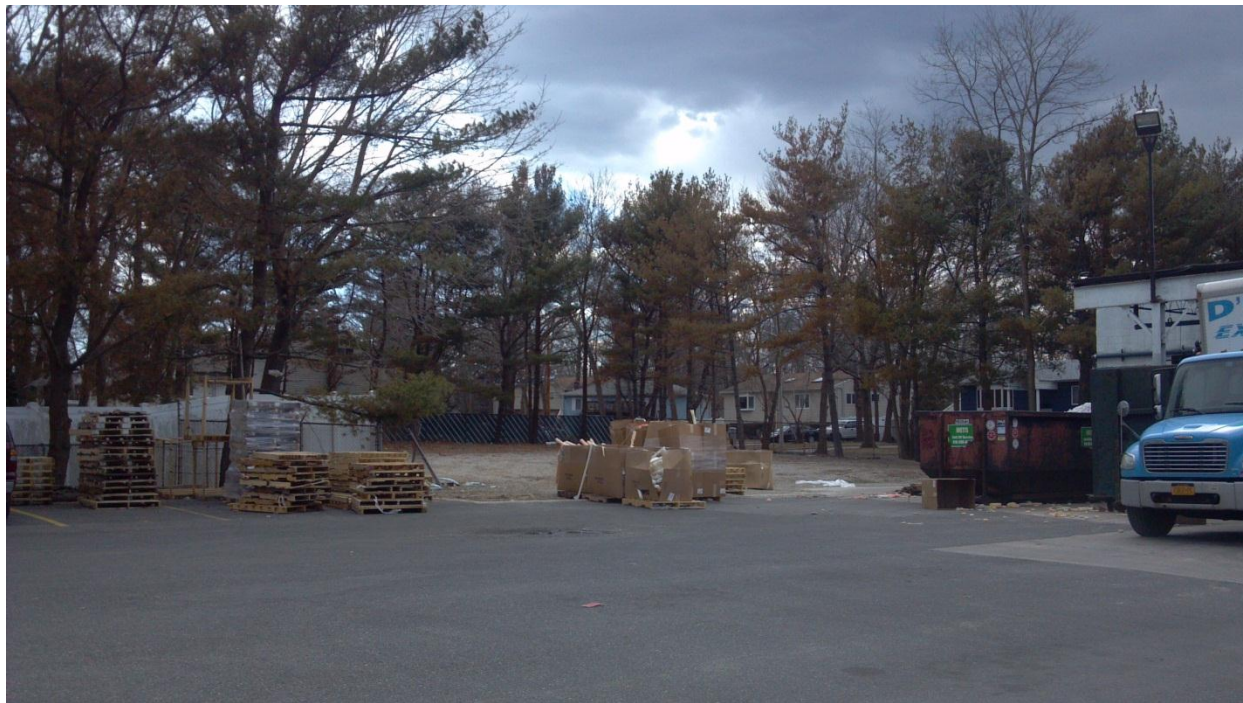
Photo 7: (3-27-2013 16:14) AOC 3 View looking south west from AOC-1.

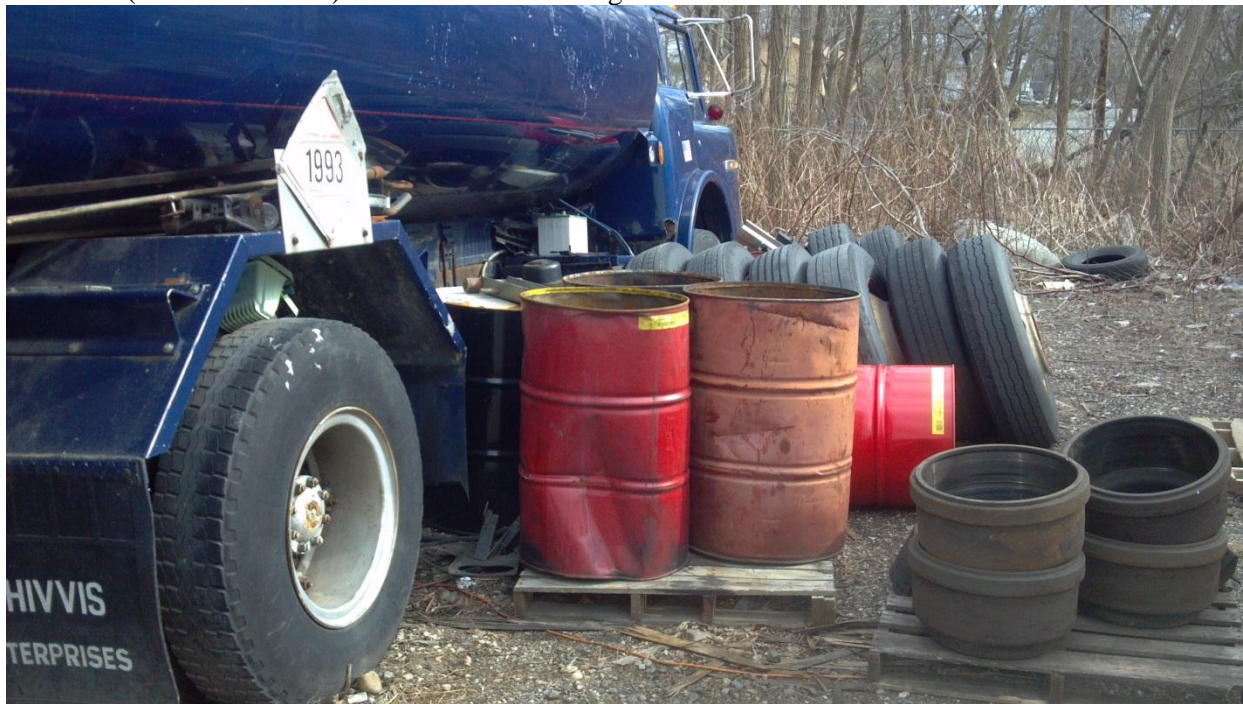
Photo 8: (3-27-2013, 16:11) Outside of all AOCs. View of abandoned fuel oil truck with several discarded empty motor oil 55 G drums. Located near eastern property boundary

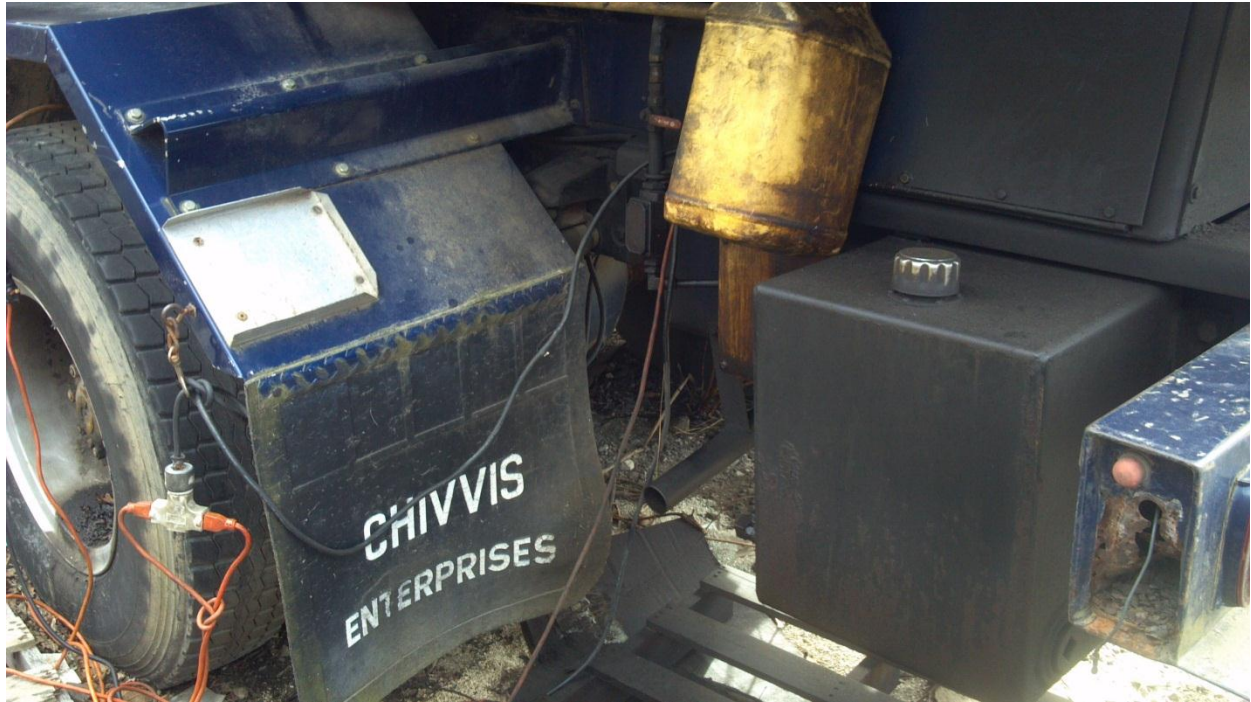
Photo 9: (3-27-2013, 16:11) Outside of all AOCs View of drivers side rear of abandoned fuel oil truck. Some soil staining and speedi-dri observed.
