DEMOLITION COMPLETION REPORT

Brookhaven Medical Research Reactor Stack

**Brookhaven National Laboratory
Upton, New York**

January 20, 2023

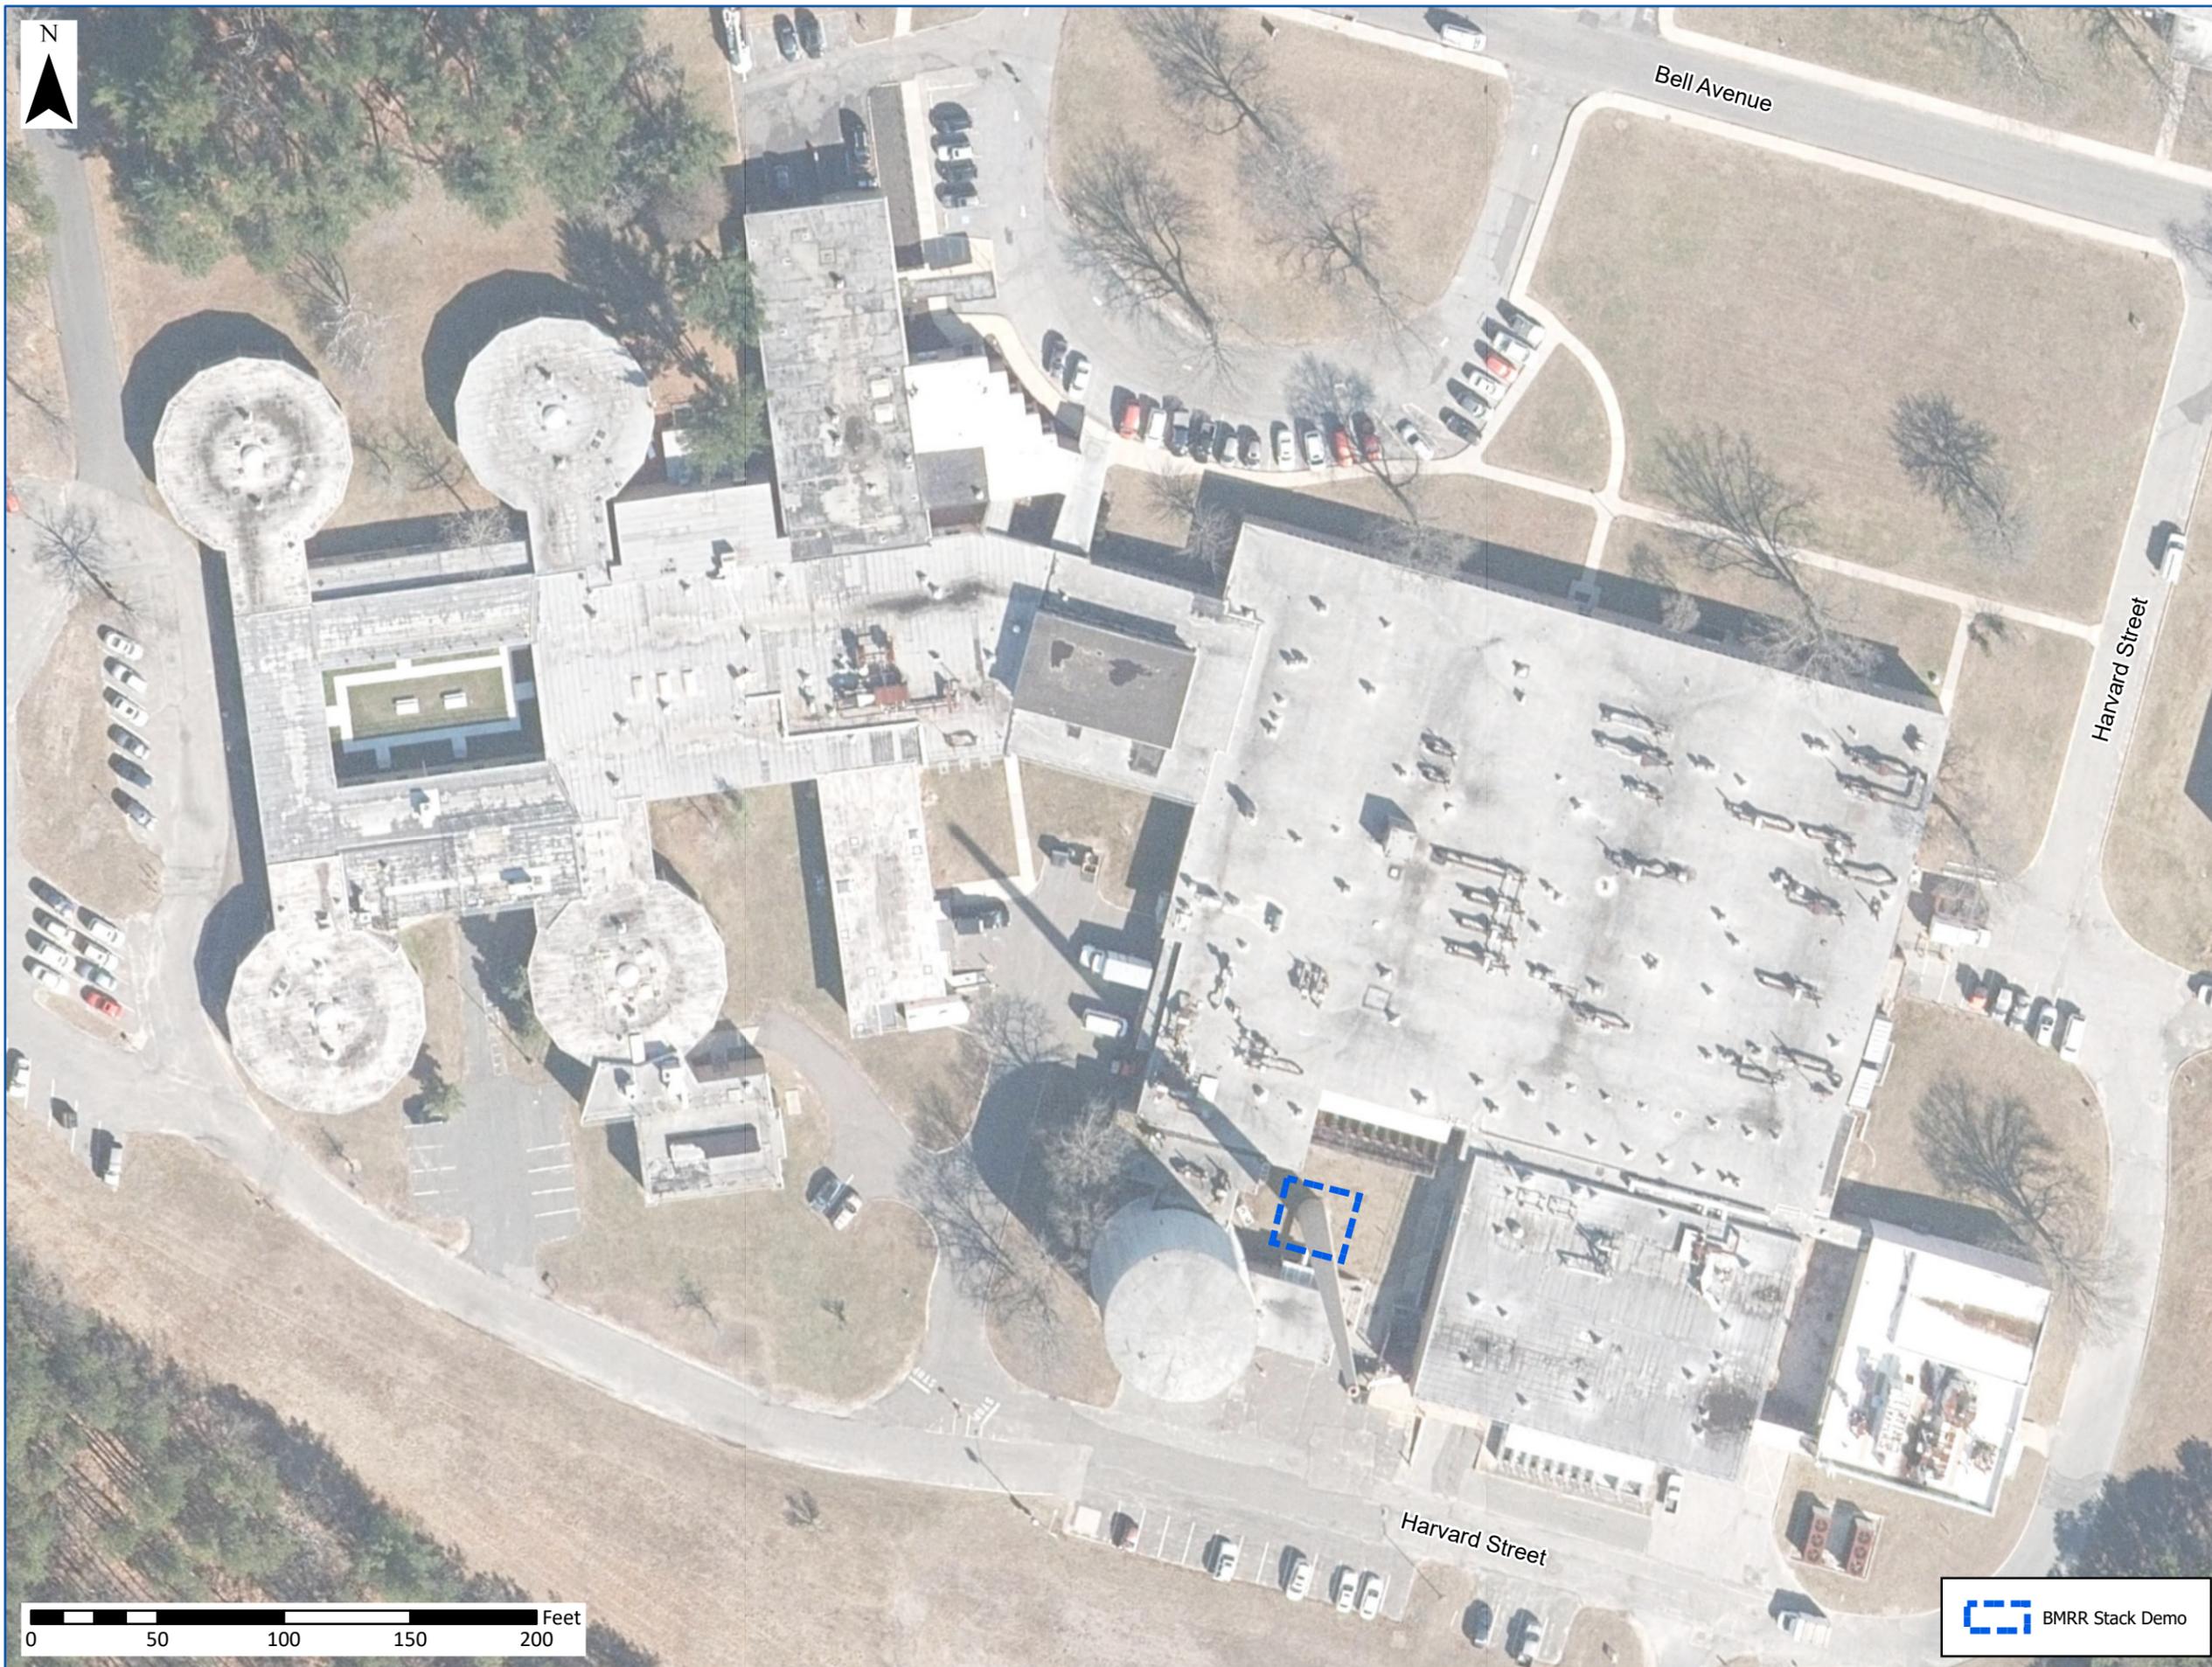
The BMRR Stack Site Plan is provided as **Figure 1**.

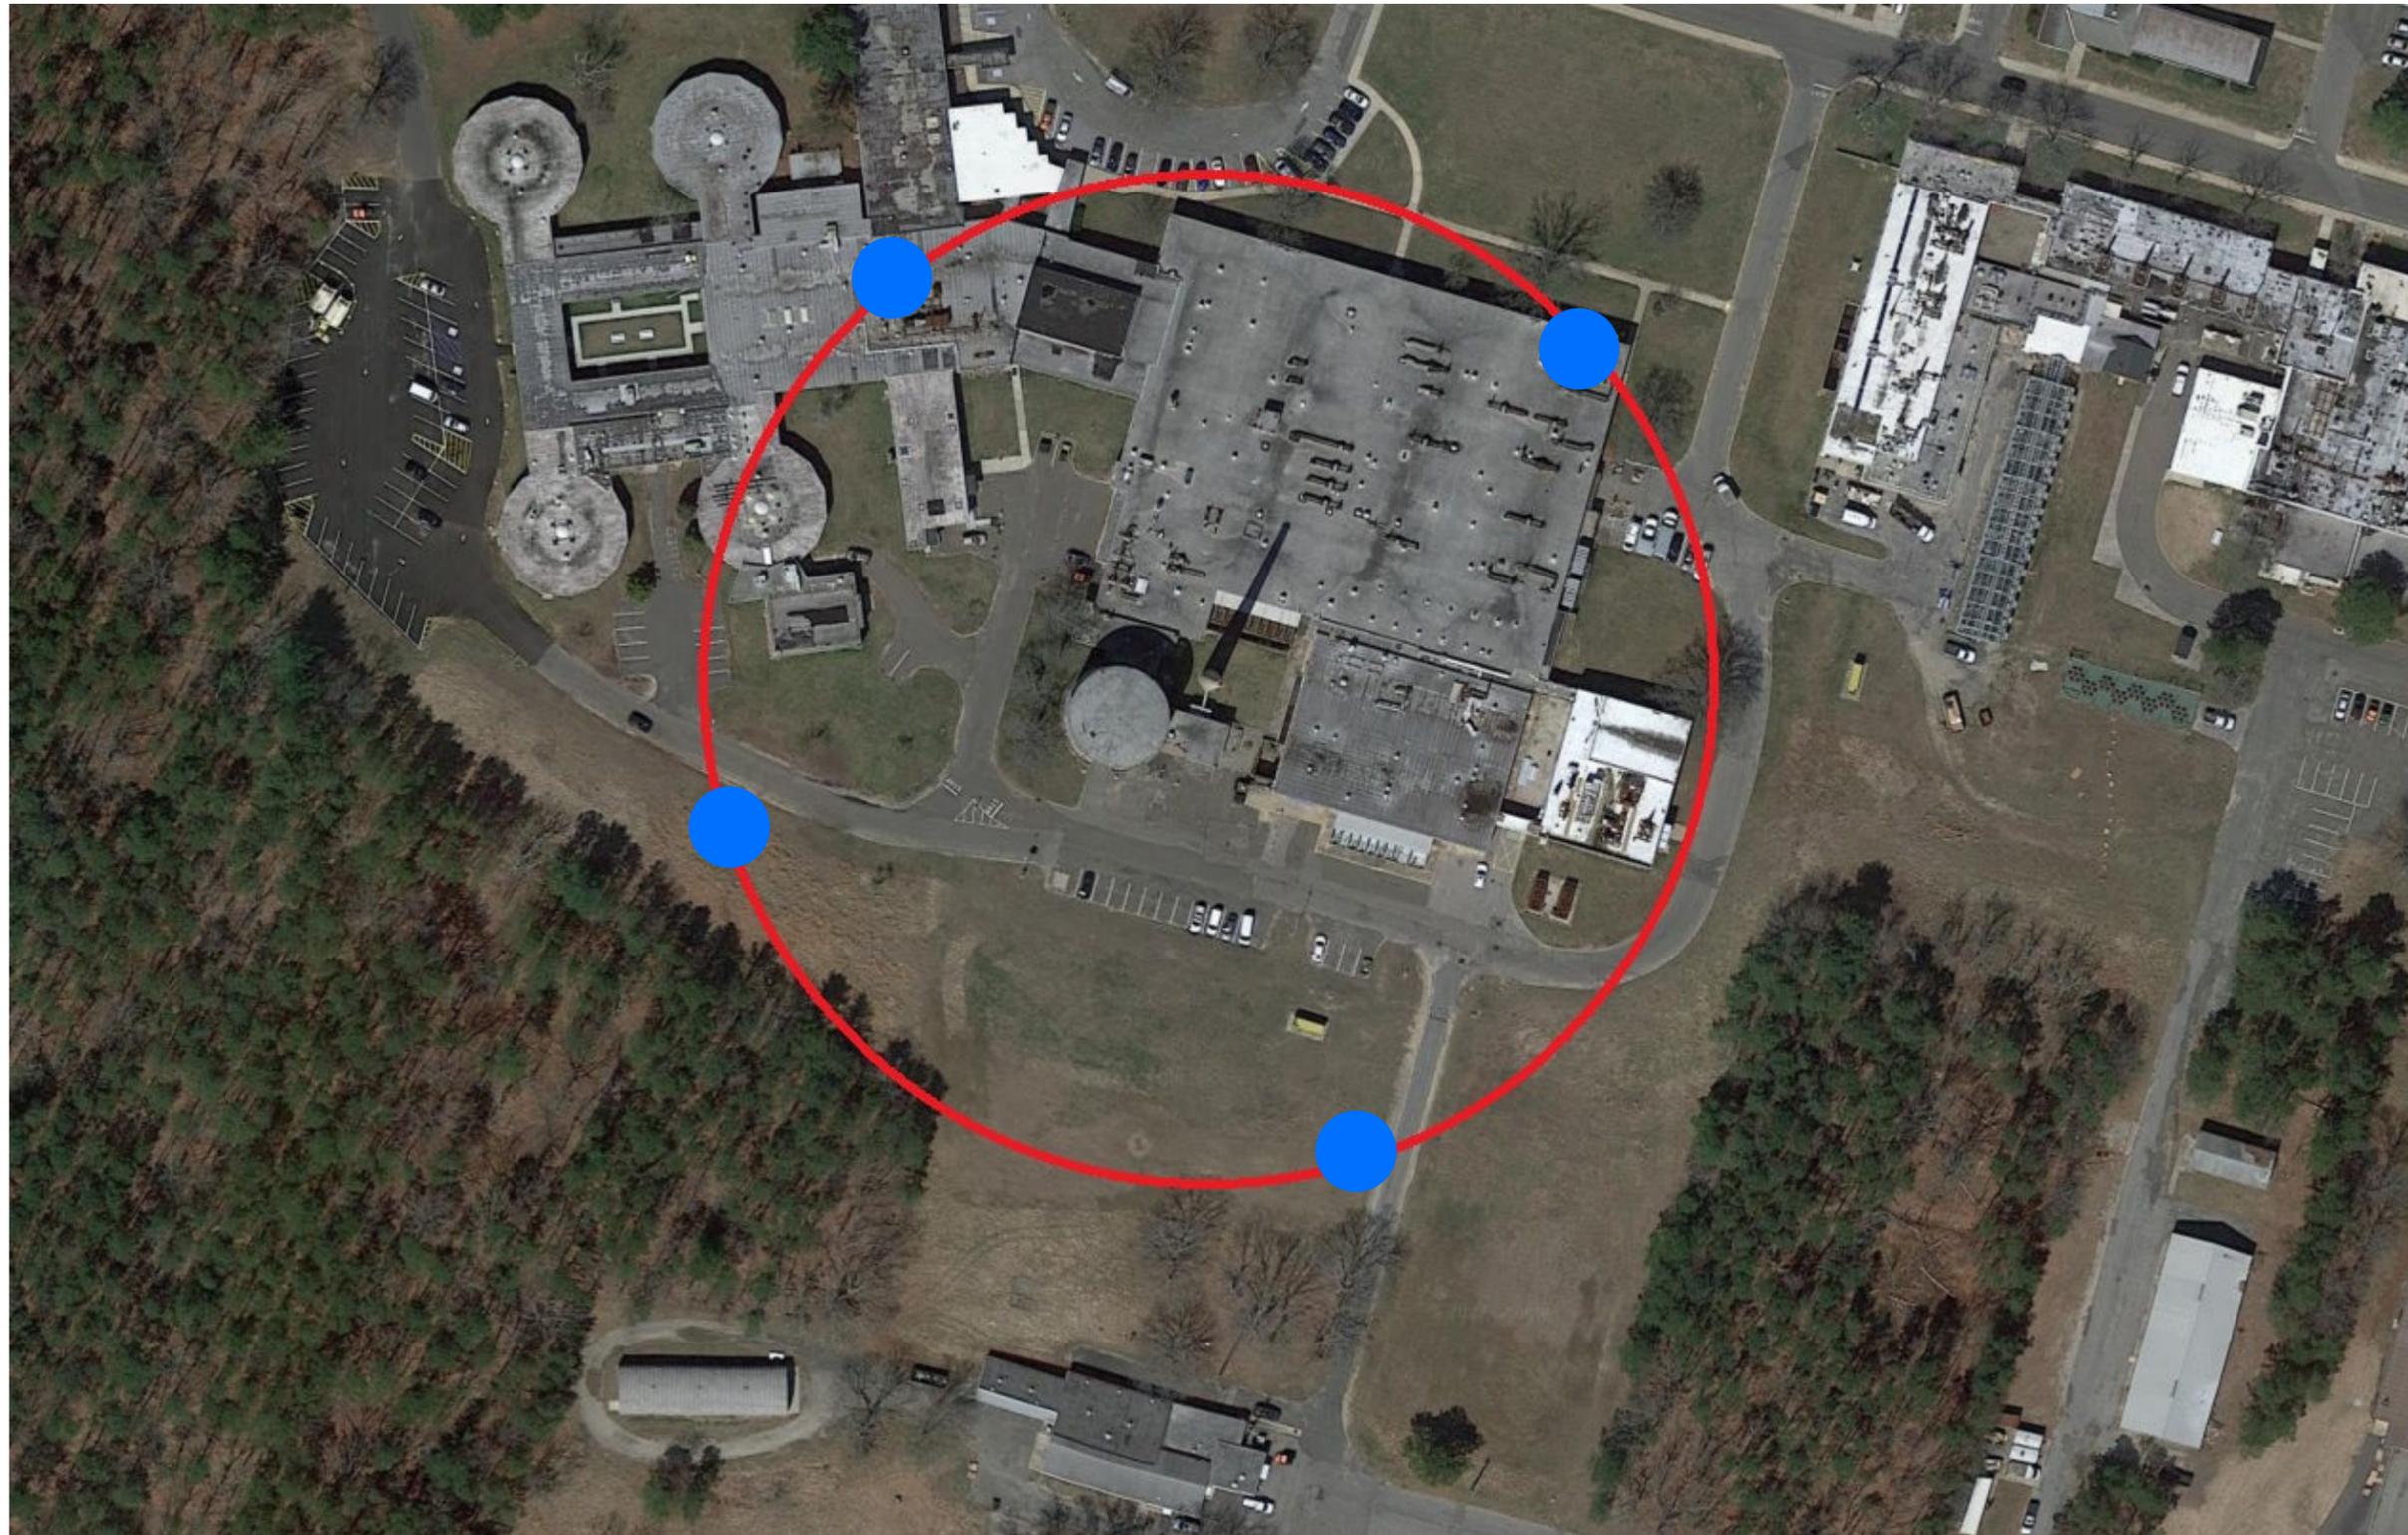
Locations of Air Monitoring
Stations (Industrial Hygiene
and Radiological Concerns)

The locations of air monitoring stations for industrial hygiene and radiological concerns are provided in **Figure 2**.

- Four air monitoring stations were located approximately 100-meters from the Stack, consistent with other Stack demolition projects that were completed at BNL. The rationale behind the locations of the air monitoring stations - shown on Figure 2 - was to place one upwind and one downwind of the Stack along the primary wind direction of southwest-to-northeast which occurs during the months of July and August on Long Island. The remaining two stations were aligned perpendicularly in a northwest-to-southeast line for coverage. The northwest and northeast monitoring stations were located on the roof of Building 490 and not on the ground due to concerns that building walls create cavity zones (i.e., turbulent areas) on the leeward side and thus could negatively affect the air monitoring data.

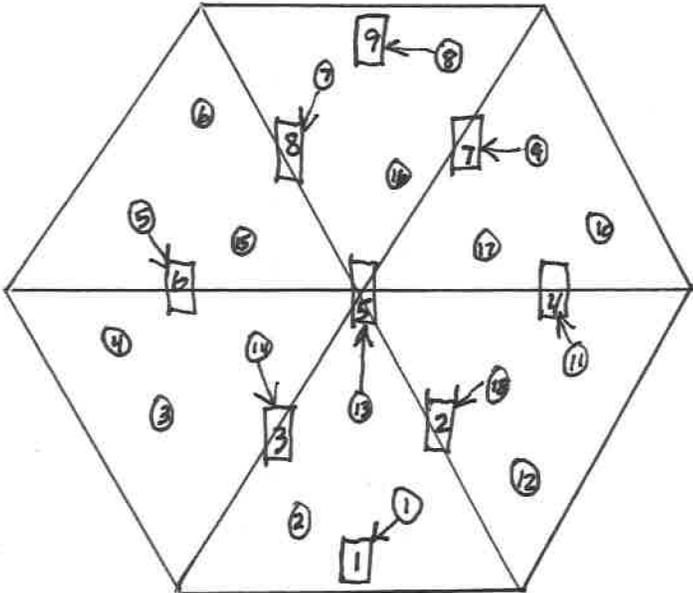
- Direct Static Counts
1. 3/126 cpm
 2. 2/125 cpm
 3. 1/168 cpm
 4. 1/150 cpm
 5. 0/149 cpm
 6. 1/152 cpm
 7. 0/135 cpm
 8. 1/141 cpm
 9. 3/160 cpm
- α/β cpm

100% Scan of Platform < BKG 3030 Eff: β-27%, α-37%, 3002 Eff: β-.11 α-.17
