# PERIODIC REVIEW REPORT

## December 2020 – December 2025

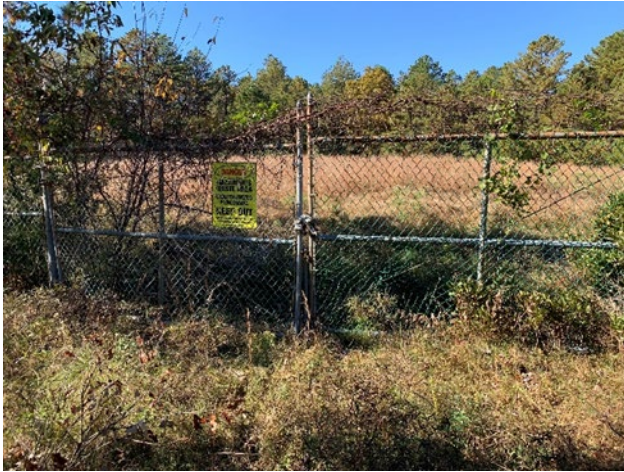
**Photo 1:** Access gate to the capped area is locked, however keys to locks are unavailable. "HAZARDOUS AREA" signage placed outward; no signage facing inwards.

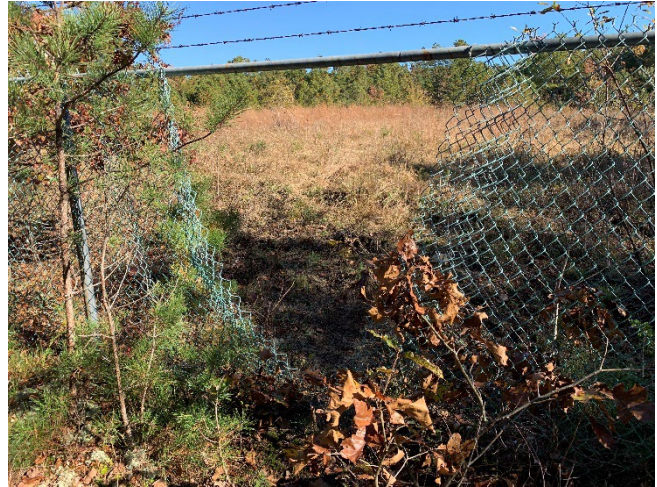
**Photo 2:** Hole in fencing leading to Capped Area.

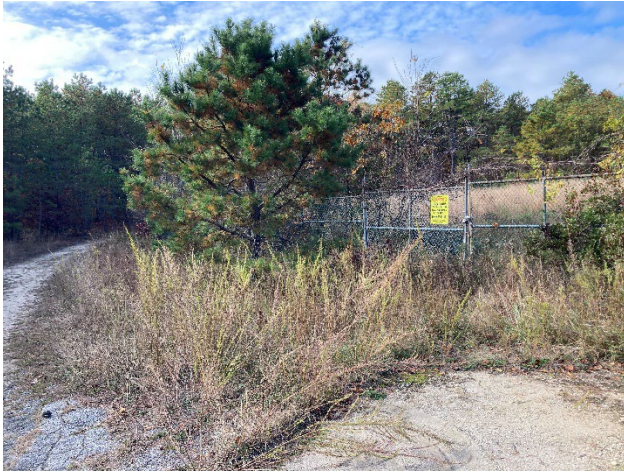
**Photo 1:** Access gate to the capped area is locked, however keys to locks are unavailable. "HAZARDOUS AREA" signage placed outward; no signage facing inwards.

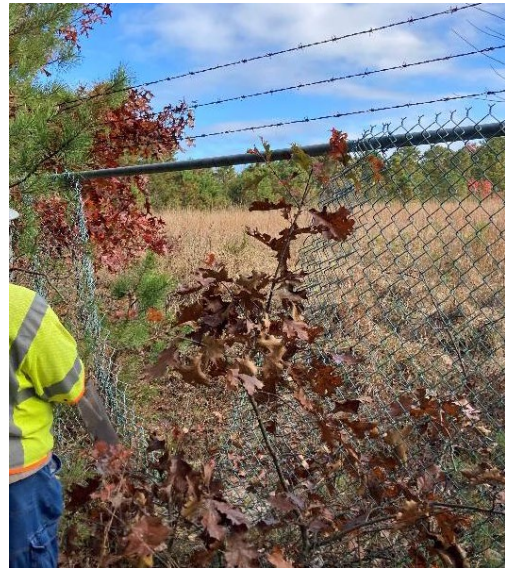
**Photo 2:** Hole in fencing leading to Capped Area.

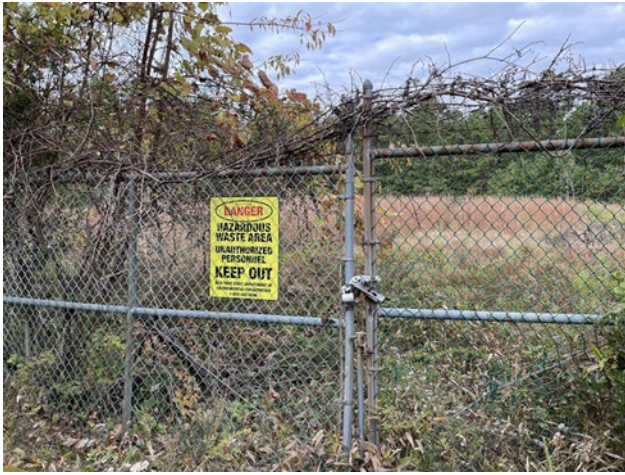
**Photo 1:** Access gate to the capped area is locked, however keys to locks are unavailable. "HAZARDOUS AREA" signage placed outward; no signage facing inwards.

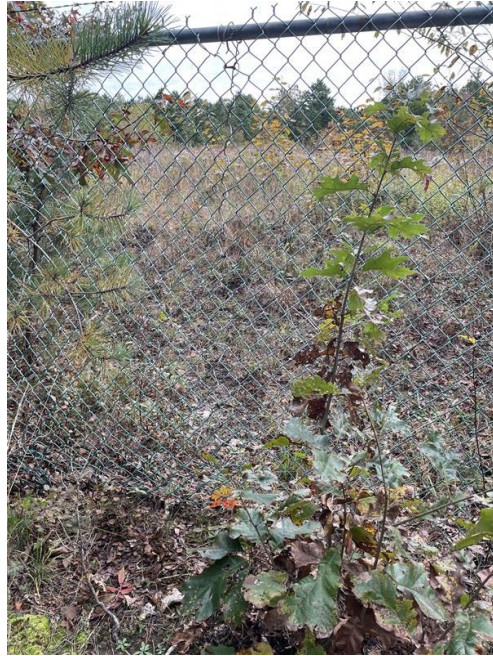
**Photo 2:** Repaired fencing securing Capped Area.

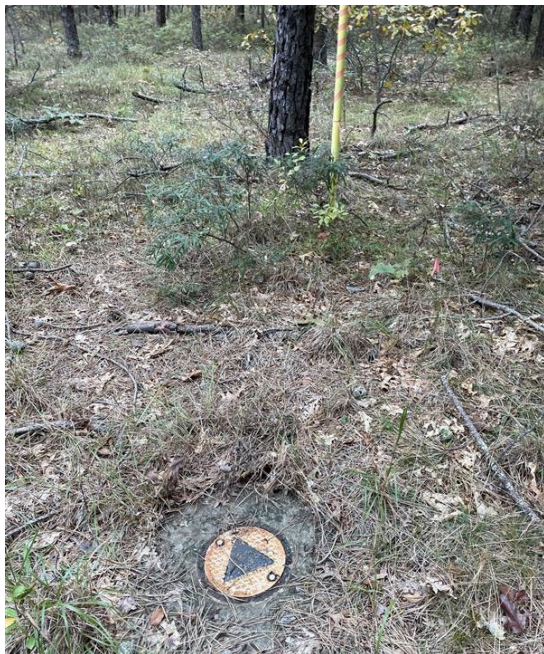
**Photo 3:** Monitoring well in the vicinity of the Landfill Area.

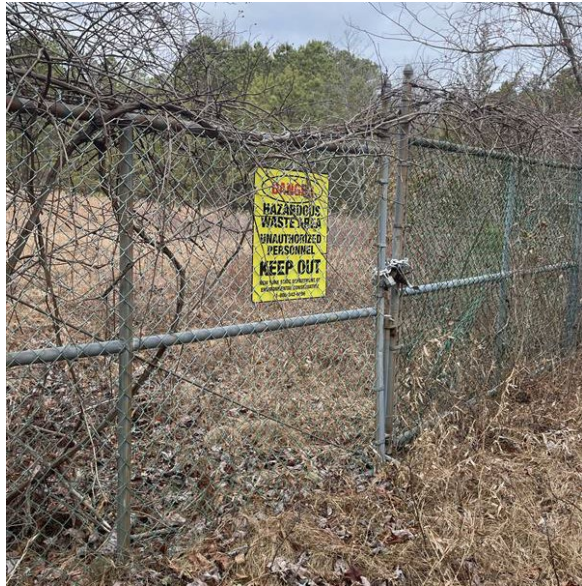
**Photo 1:** Access gate to the capped area is locked, however keys to locks are unavailable. "HAZARDOUS AREA" signage placed outward; no signage facing inwards.

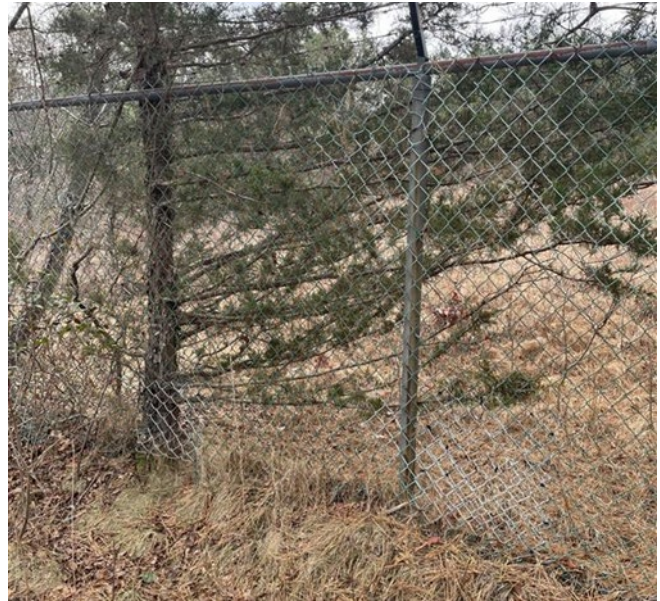
**Photo 2:** Repaired fencing securing Capped Area.

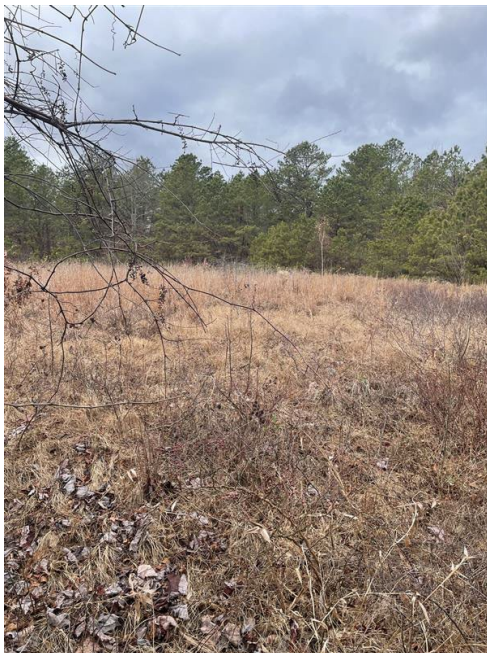
**Photo 3:** Vegetation within Capped Area.

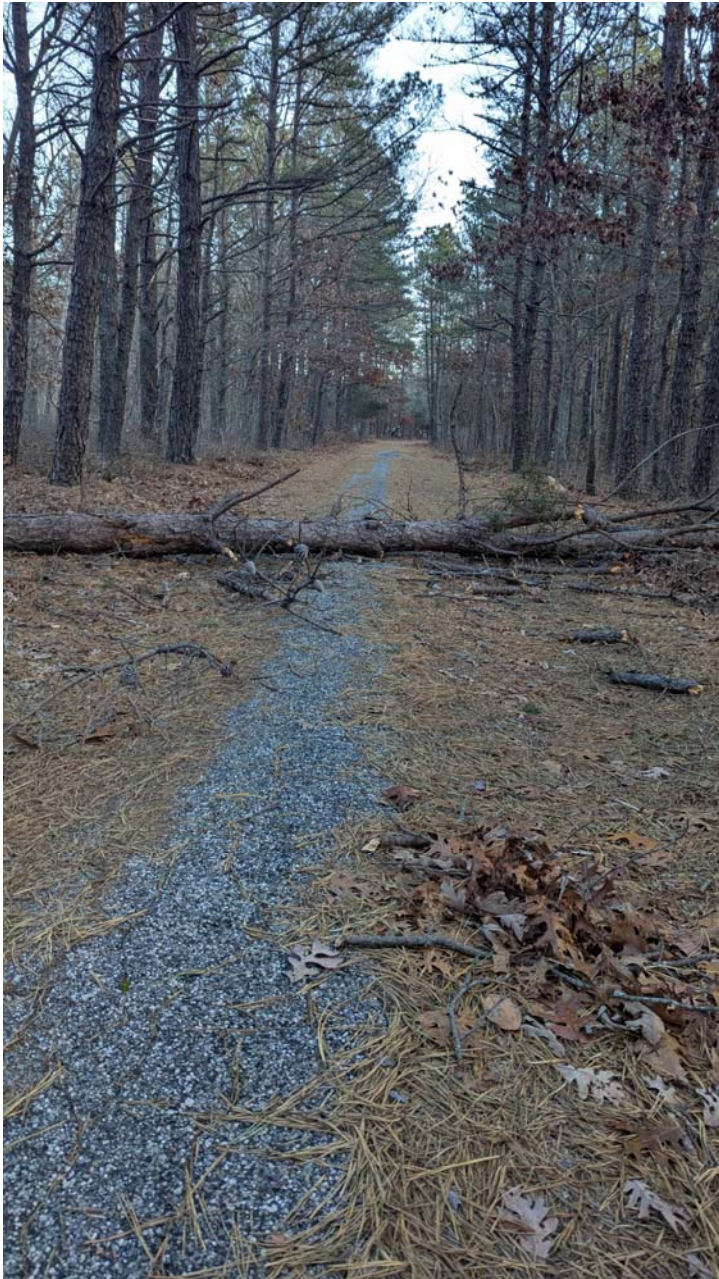
Downed tree blocking path to Capped Area  
(Fell after sampling of MW-1CA and MW-2CA)
