| NYSDEC<br>Division of Environmental Remediation | | | | Department of<br>Environmental<br>Conservation | | <b>Contract No.</b><br><br><b>DEC Insp.</b><br>DEC PM – Payson Long, P.E.<br>GES PM. – Scott McDonald<br>HRP Engineer PM – Tom Battles<br>HRP PM – Derek Roy | |
| <b>Site Location: NYSDEC Lawrence Aviation, Port Jefferson Station, NY</b> | | | | | | | |

## SITE DRAINAGE FEATURES 2025

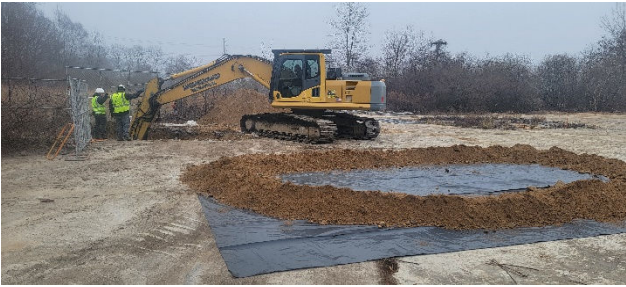
| Site Photographs (Descriptions Below) | |
|---|---|
| Photo 1 – Excavation of the bottom sediments at DW-6 structure. | Photo 2- Excavation of muddy sludge from DW-6 drywell. |

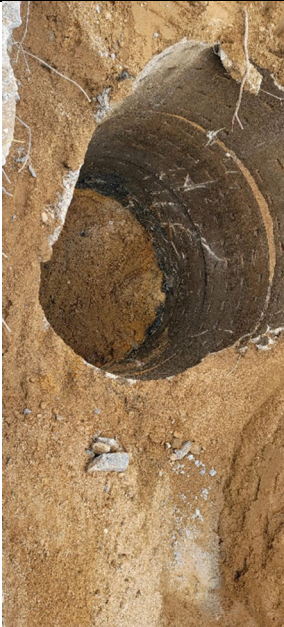
| Site Photographs (Descriptions Below) | |
|---|---|
| Photo 3 – DW-6 post remediation. Bottom of the structure excavated from 14ft down to 19ft below surface. | Photo 4 – Generated stockpile from DW-6 remediation |

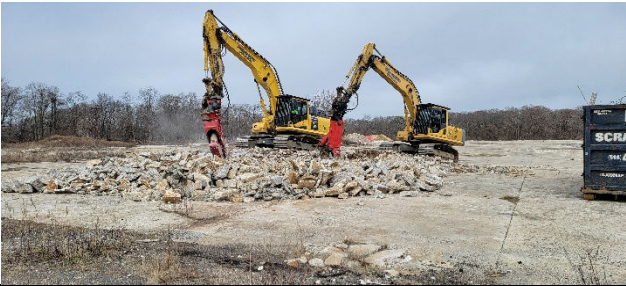
| Site Photographs (Descriptions Below) | |
|---|---|
| Photo 5 – Concrete processing activities. | |
