PERIODIC REVIEW REPORT
APRIL 15, 2025 THROUGH MAY 2, 2026

CARDWELL CONDENSER CORPORATION SITE
80 EAST MONTAUK HIGHWAY
LINDENHURST, NEW YORK

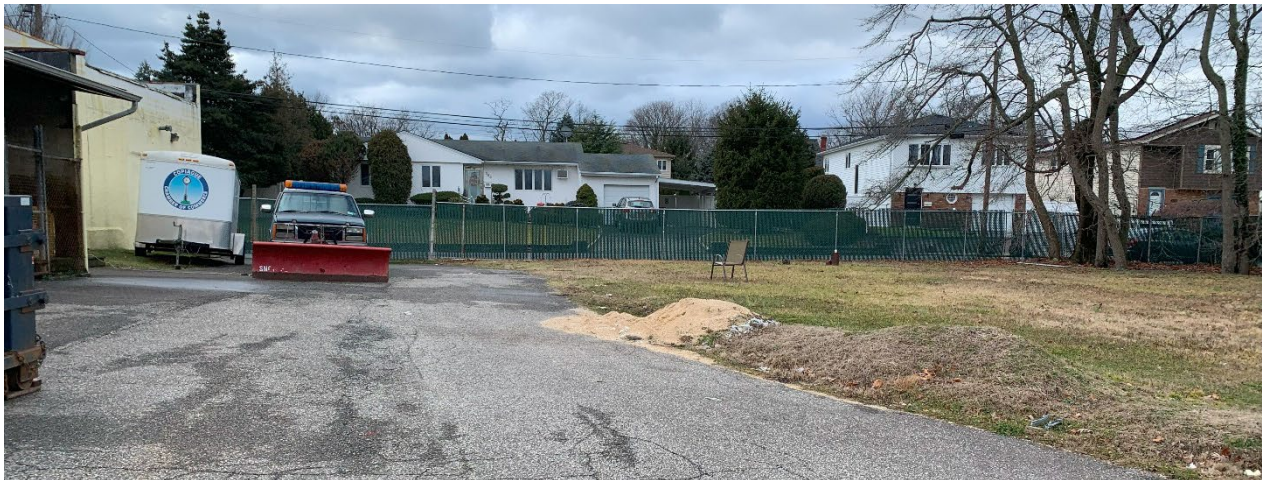
Above: View of part of the back of the industrial building (at left) at the subject property looking west. The asphalt pavement cover over the former LP-1 area was observed to be in good condition throughout the covered area. The small pile of sand (at center, not in the covered area) is used on the parking and driveway areas during snow and ice conditions. Well MW-1, which is upgradient of the capped area and protected by a steel standpipe, is visible in the right background.

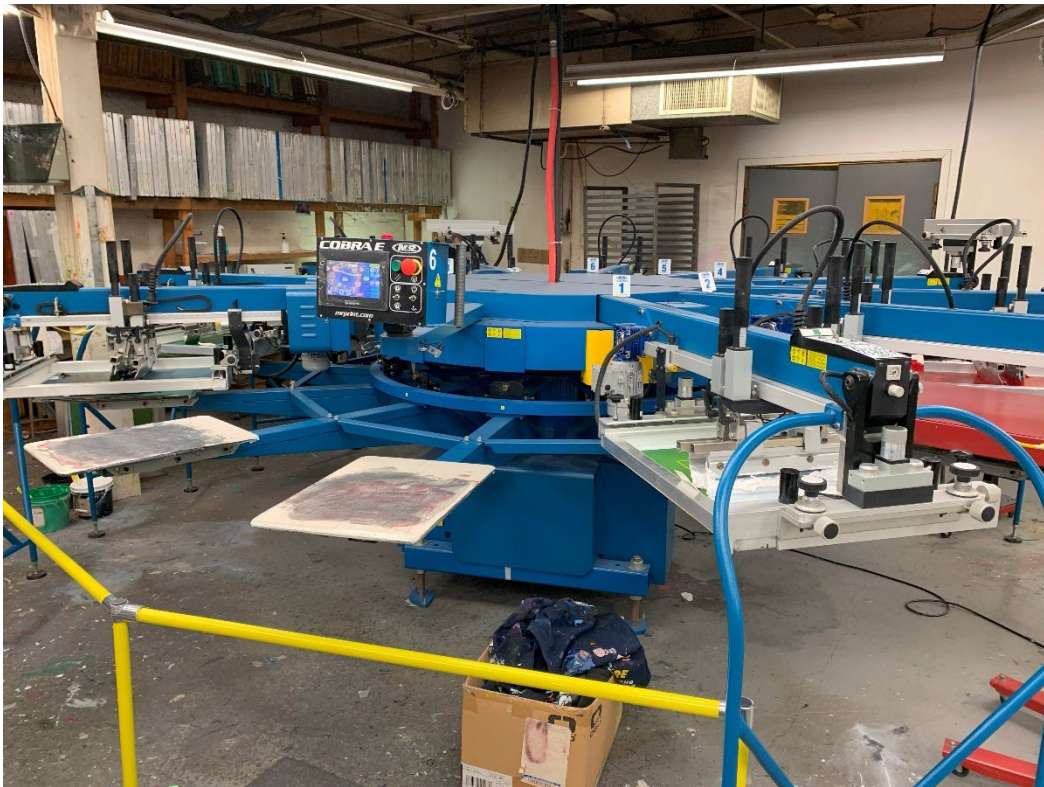
Above: Representative view of the first floor interior of the industrial building showing some of the equipment used in the screen printing operations. Much of the equipment is in active operation.

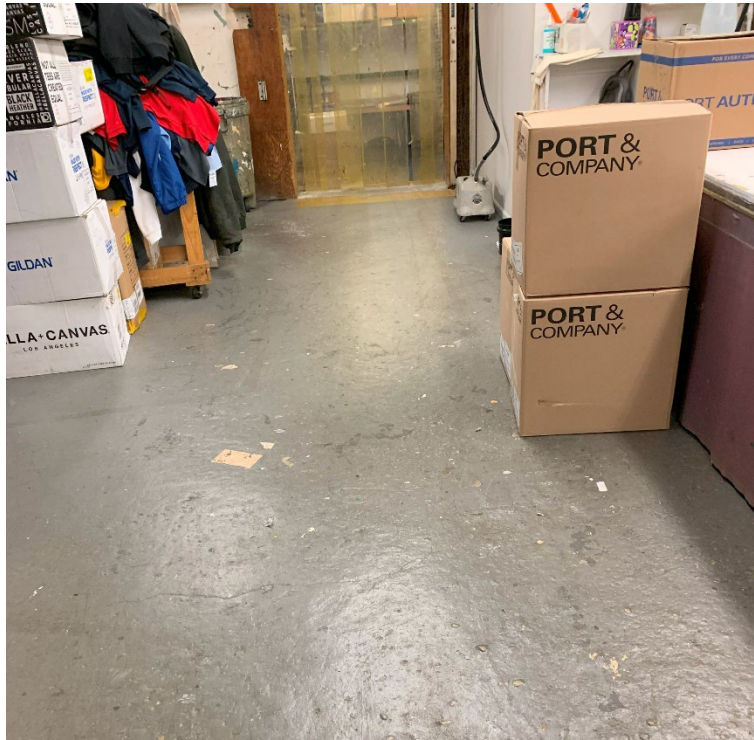
Above: Representative view of the concrete building slab in the manufacturing areas on the first floor of the building. The concrete was observed to be intact throughout the first floor, with much of its surface painted or coated.

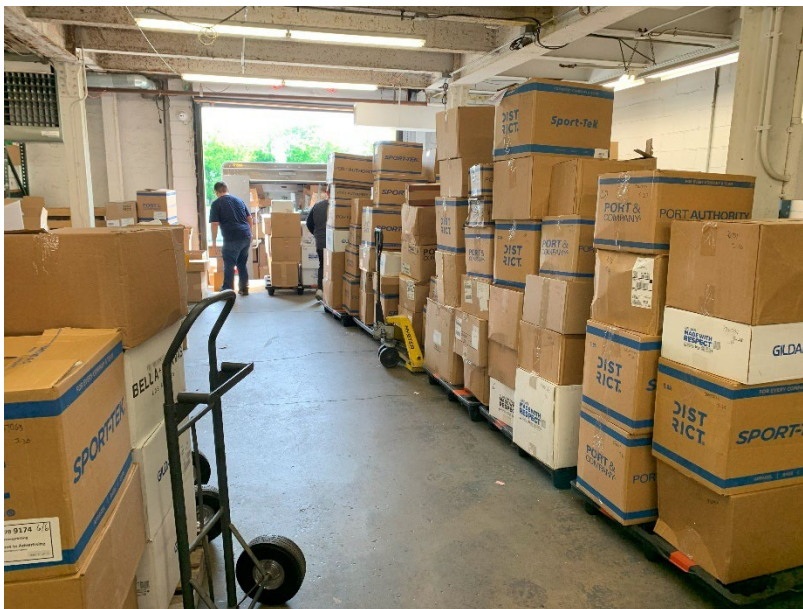
Above: Another representative view of the concrete building slab in the shipping area on the first floor of the building. The concrete was observed to be intact throughout the first floor, with much of its surface painted or coated.

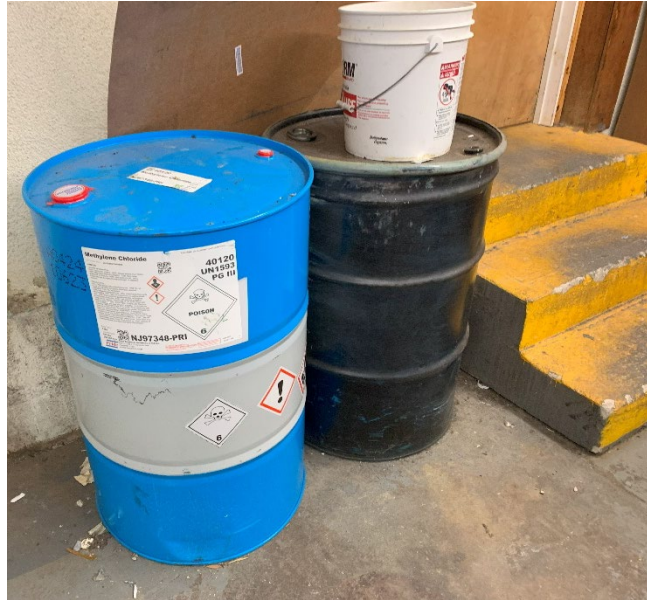
Above: Representative view of the concrete building slab in a chemical storage area on the first floor of the building. The drums include virgin methylene chloride and waste ink (black drum). No spills or evidence of releases was noted and the concrete was observed to be intact throughout this area, with much of its surface painted or coated.

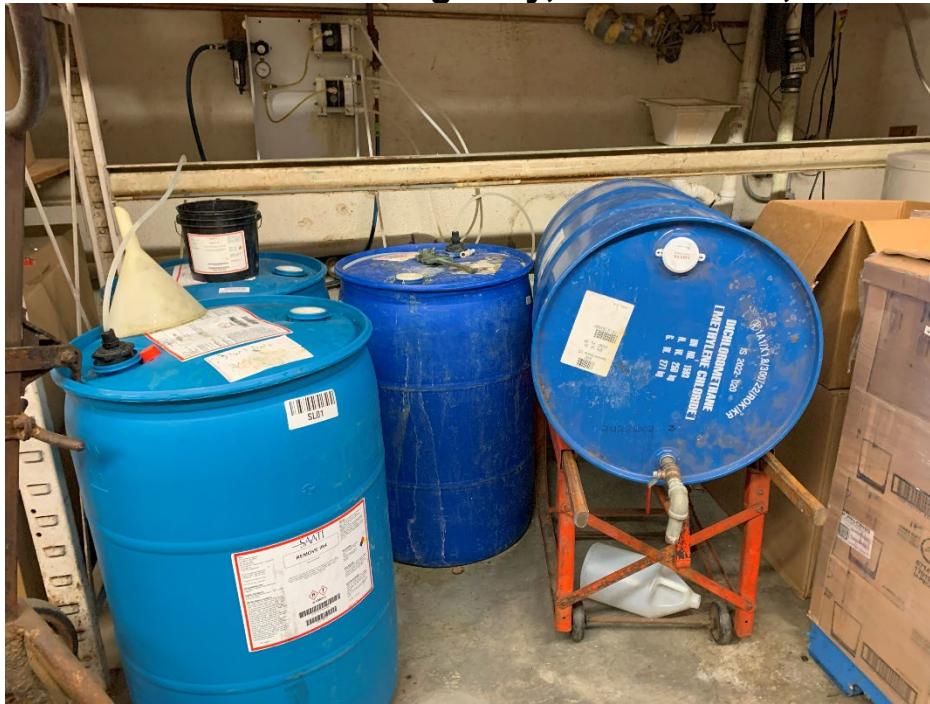
Above: In-use drums of methylene chloride and spot-removal chemicals.

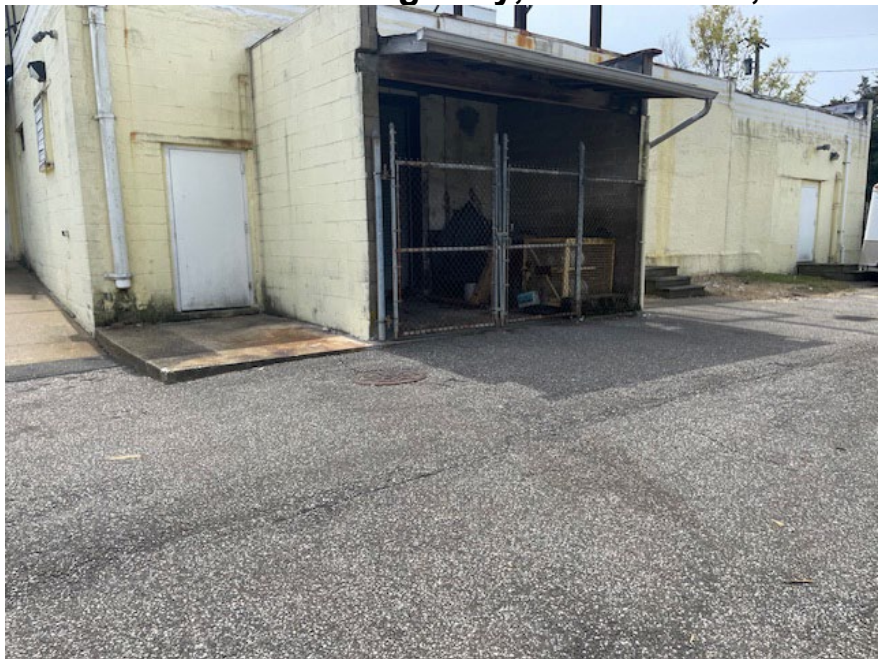
Above: View of the rear of the onsite building and part of the asphalt pavement cover over the former LP-1 area (far right). The pavement was observed to be in good condition throughout the covered area.

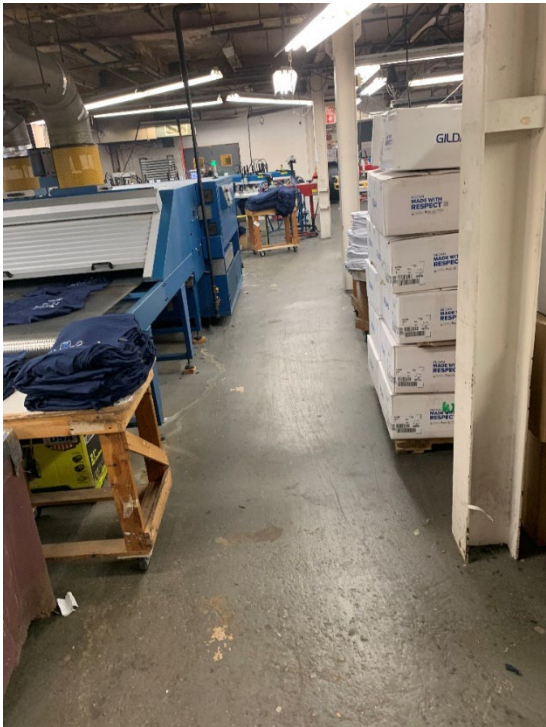
Above: Representative view of the concrete building slab in the manufacturing areas on the first floor of the building. The concrete was observed to be intact throughout the first floor, with much of its surface painted or coated.

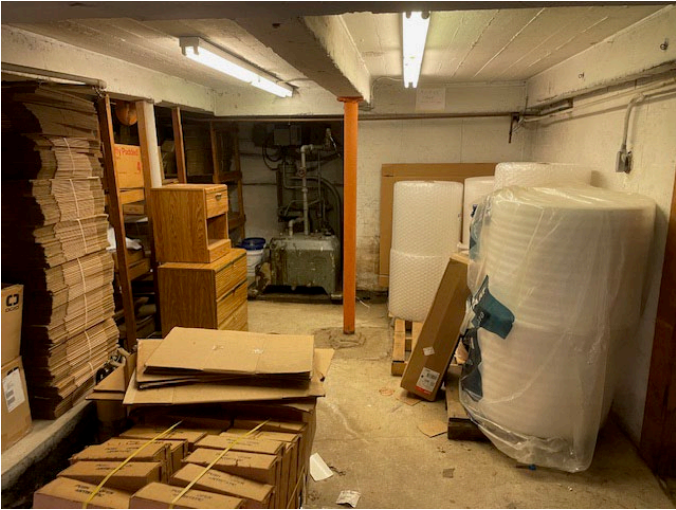
Above: Representative view of the concrete building slab in the basement, which underlies a portion of the building and is used solely for storage and utilities. The concrete was observed to be intact and in good condition throughout the basement.

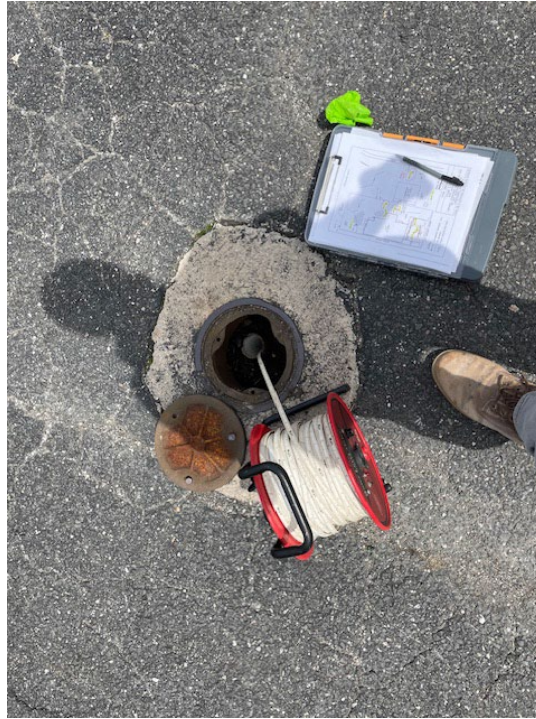
Above: View of monitoring well MW-6 in the employee parking area on the east side of the building.
