# **ENGINEERING INVESTIGATIONS AT INACTIVE HAZARDOUS WASTE SITES**

## **PHASE 1 INVESTIGATION**

**Old North Sea Landfill  
Site No. 152051  
Town of Southampton, Suffolk County**

**Final - July 1988**

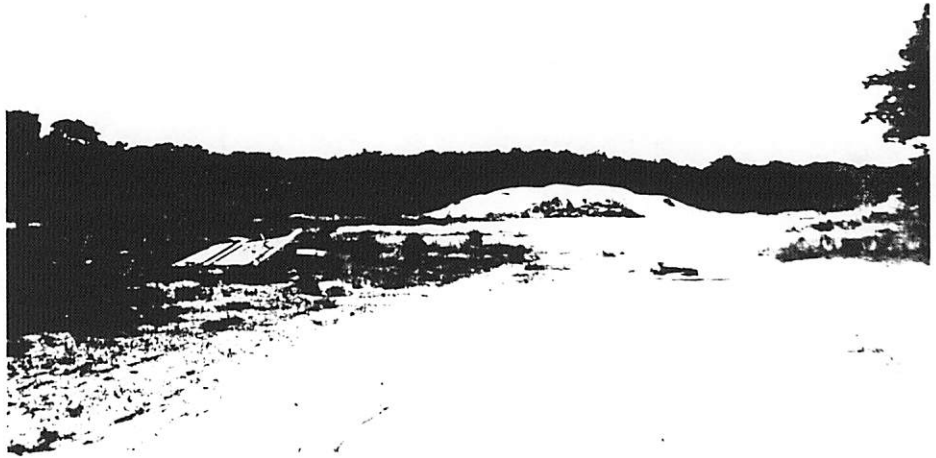
Looking north on the Old North Sea Landfill site.

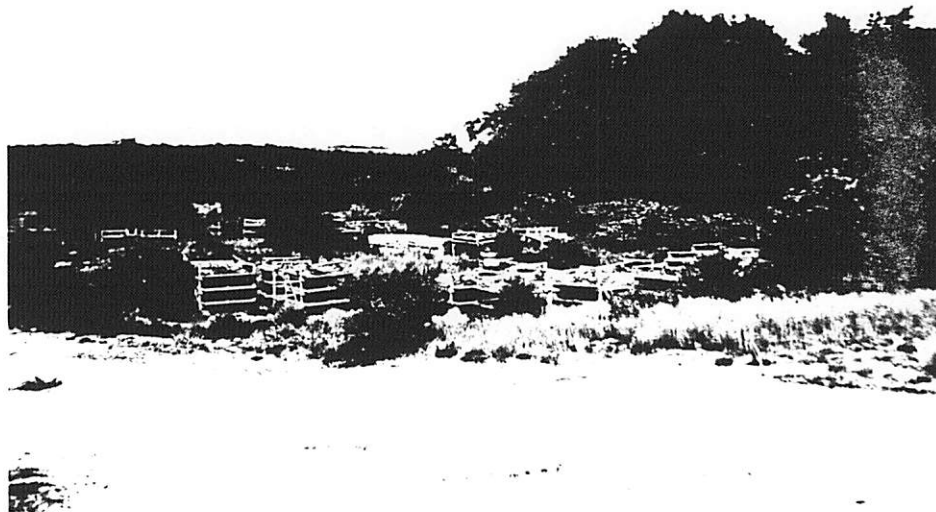
Looking east, the active North Sea Landfill can be seen in the distance.

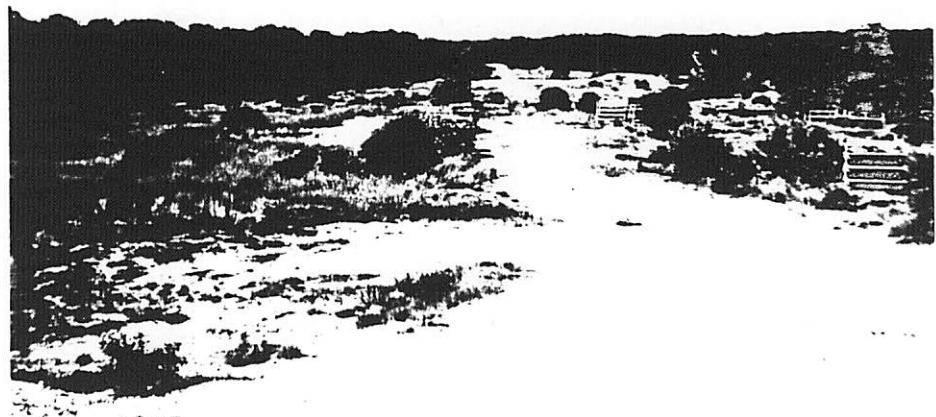
The whole site is sandy. The treeline marks the perimeter of the site. Beyond the tree-line is Fish Cove, less than one quarter mile away.
