Re: ServAll Laundry Site, # 1-52-077
Soil Vapor Intrusion Sampling Results

This letter report presents the results of the recent soil vapor sampling performed at the ServAll Laundry Site. The Site is located at 8 Drayton Avenue in Bay Shore, Suffolk County, New York (Figure 1) in a mixed use industrial/residential area. The ServAll Laundry facility was located on a 20,000 square foot property. The ServAll Uniform Rental, Inc. operated as a commercial laundry from 1969 to 1972, and as dry cleaner/laundry from 1972 to 1984. During this time, unknown quantities of wash water overflow containing tetrachloroethene (PCE) and heavy metals were pumped to, and occasionally overflowed from, on-Site cesspools.

Sub-Slab, Indoor Air and Outdoor Air
Sampling Results

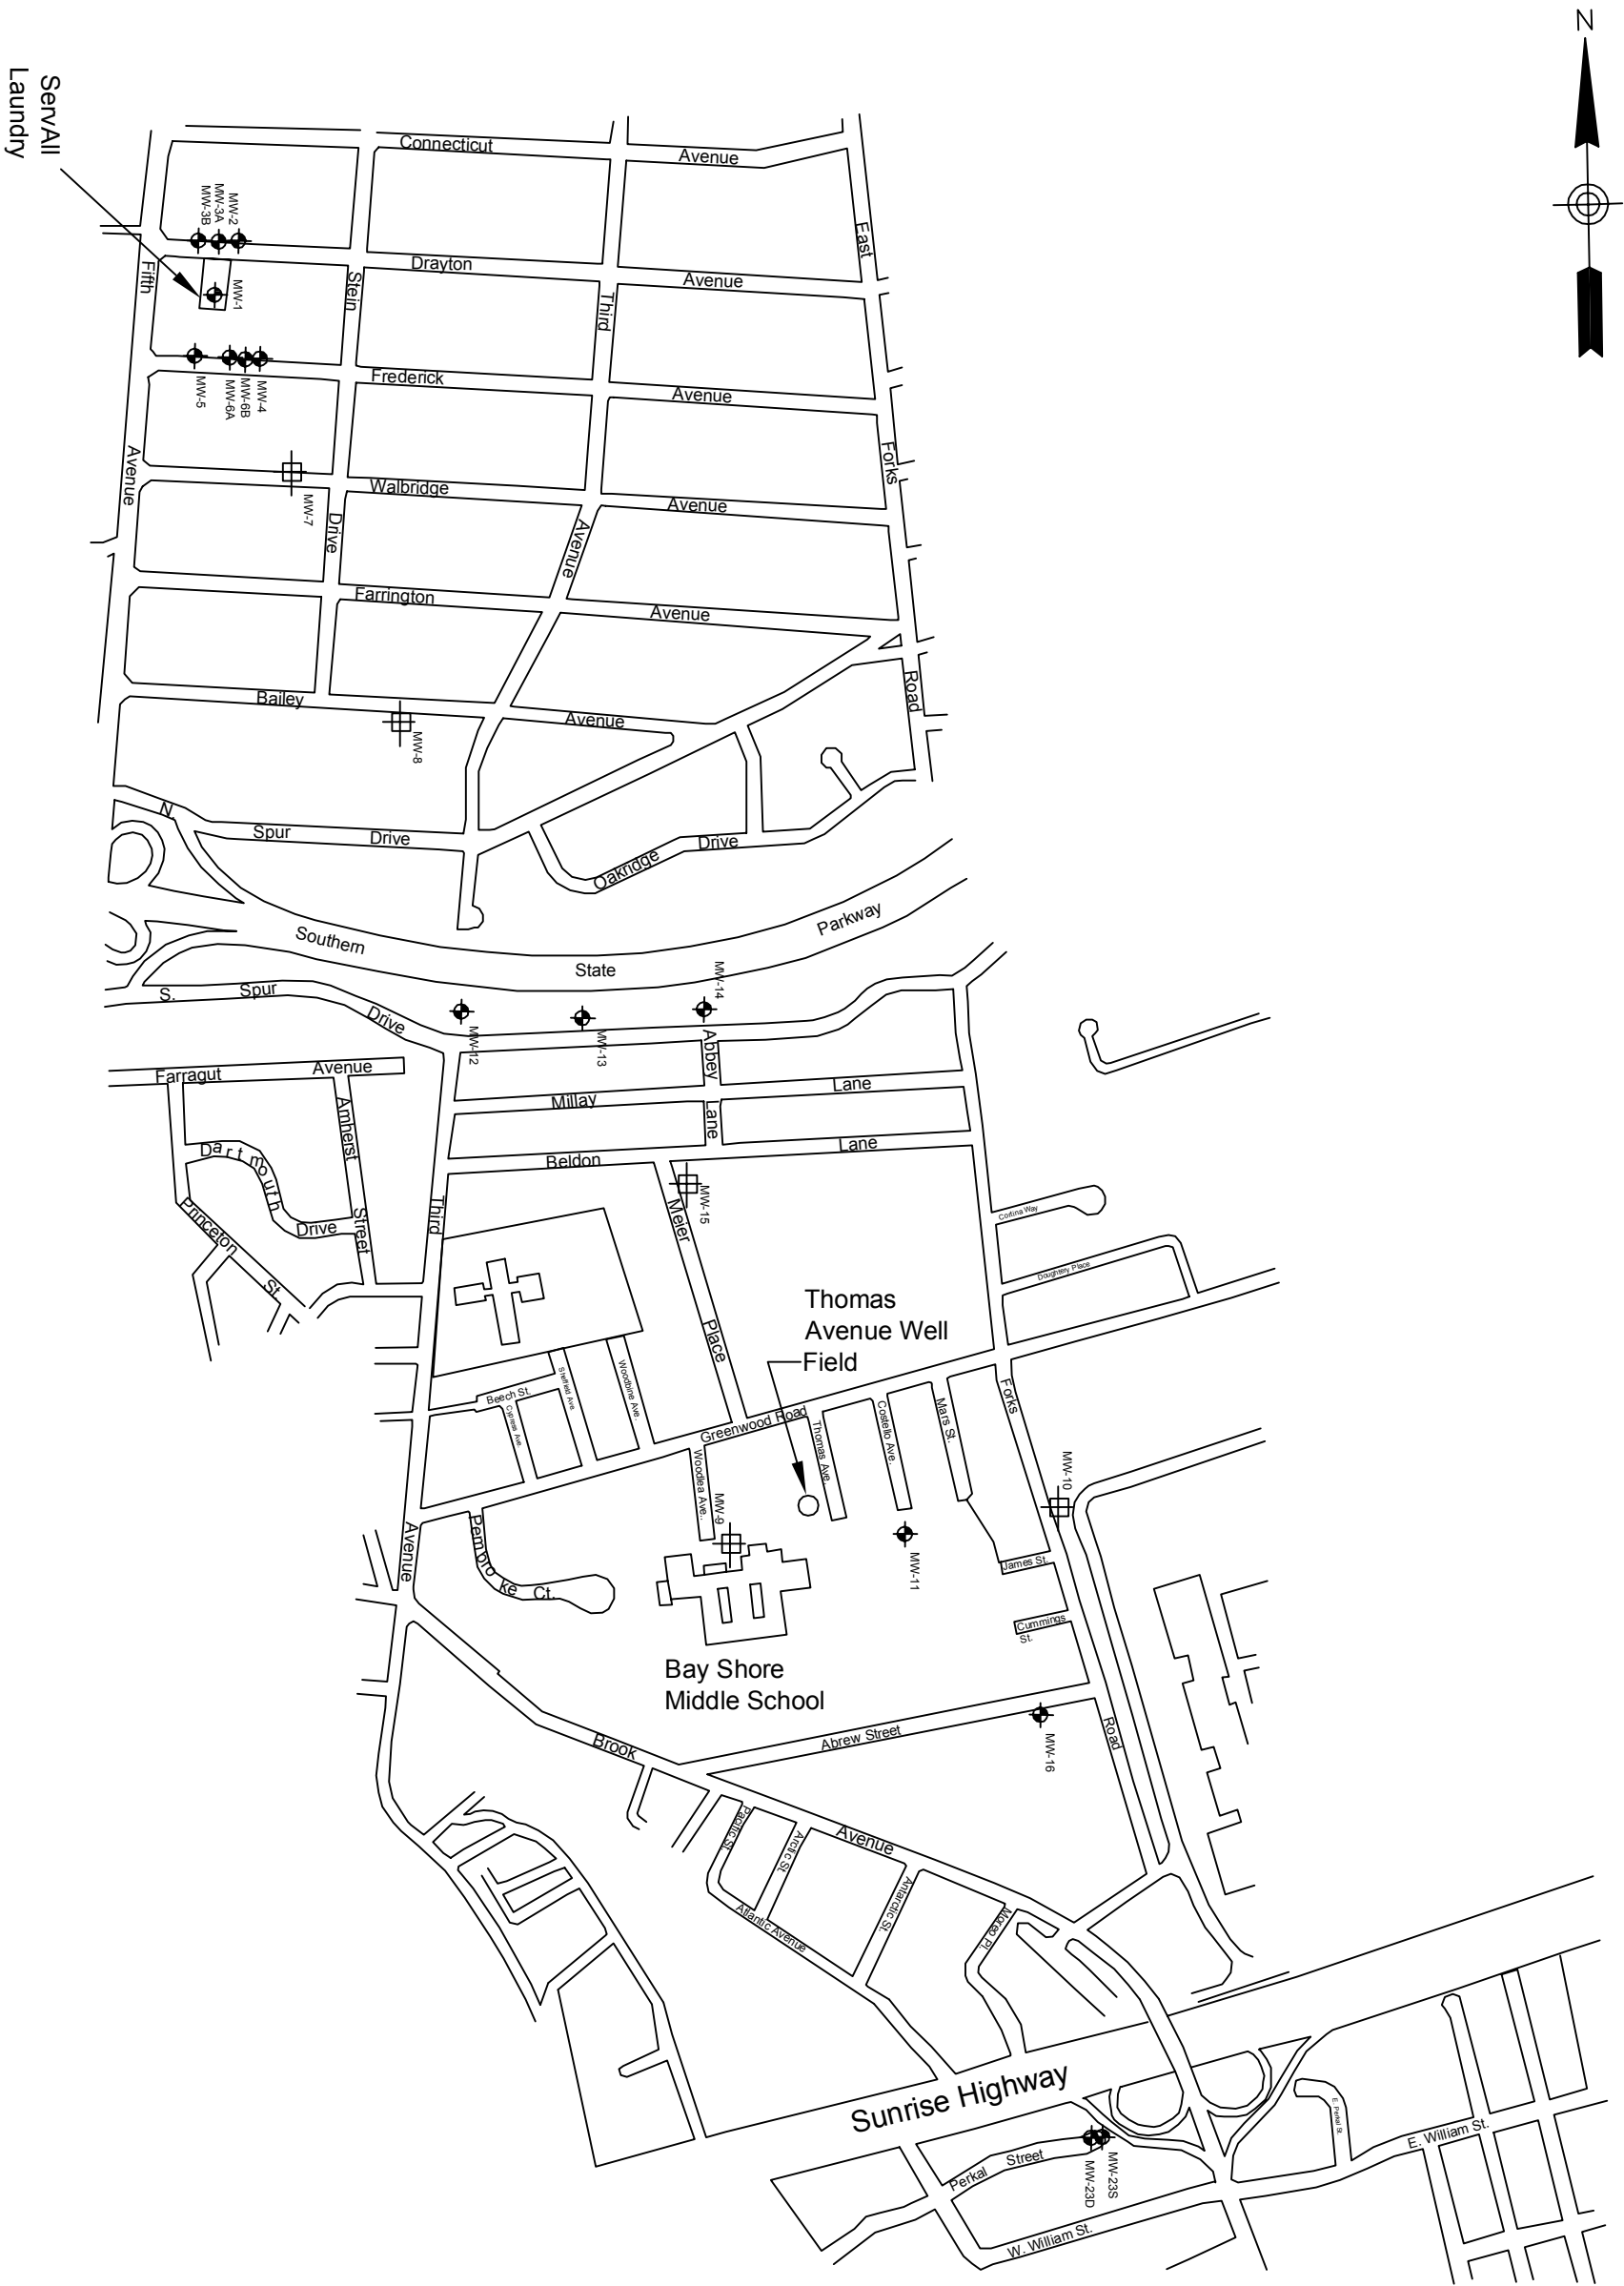
SUBMITTED BY :		MULTI SITE G - SERVALL LAUNDRY SITE SITE NO. 1-52-026		
PK/jk				
DRAWN BY :				
SC		MONITORING WELL LOCATION MAP		
APPROVED BY :				
PK		DATE :	SCALE :	DRAWING NO. :
		AUGUST 2016	AS SHOWN	2

In 1983, SCDHS performed a groundwater investigation and identified a volatile organics plume southeast of the Site. The plume was found to extend 0.3 miles upgradient from the Suffolk County Water Authority (SCWA) Thomas Avenue Wellfield (located 1 mile south of the Site). The Thomas Avenue Wellfield is located off Thomas Avenue, near the Bay Shore Middle School and northwest of MW-11 as shown on Figure 2).

The Site is currently in long term monitoring. Groundwater samples are collected from fifteen monitoring wells on a five-quarter basis. Samples are analyzed for VOCs. The results of the five-quarter sampling are summarized in a report after each sampling event. The last groundwater sampling event was conducted in May 2021. The next groundwater sampling event is scheduled for August 2022. The locations of the monitoring wells are shown on Figure 2.
