Re: Final Engineering Report - BB&S Treated Lumber Corporation Site, Town of  
Southampton, Suffolk County, New York (NYSDEC Site No. 152123)

**BB&S Treated Lumber Corporation Site  
Town of Southampton  
Suffolk County, New York**

**Final Engineering Report**

**Remedial Action Contract D007631  
NYSDEC Superfund Standby Contract  
NYSDEC Site Number: 152123**

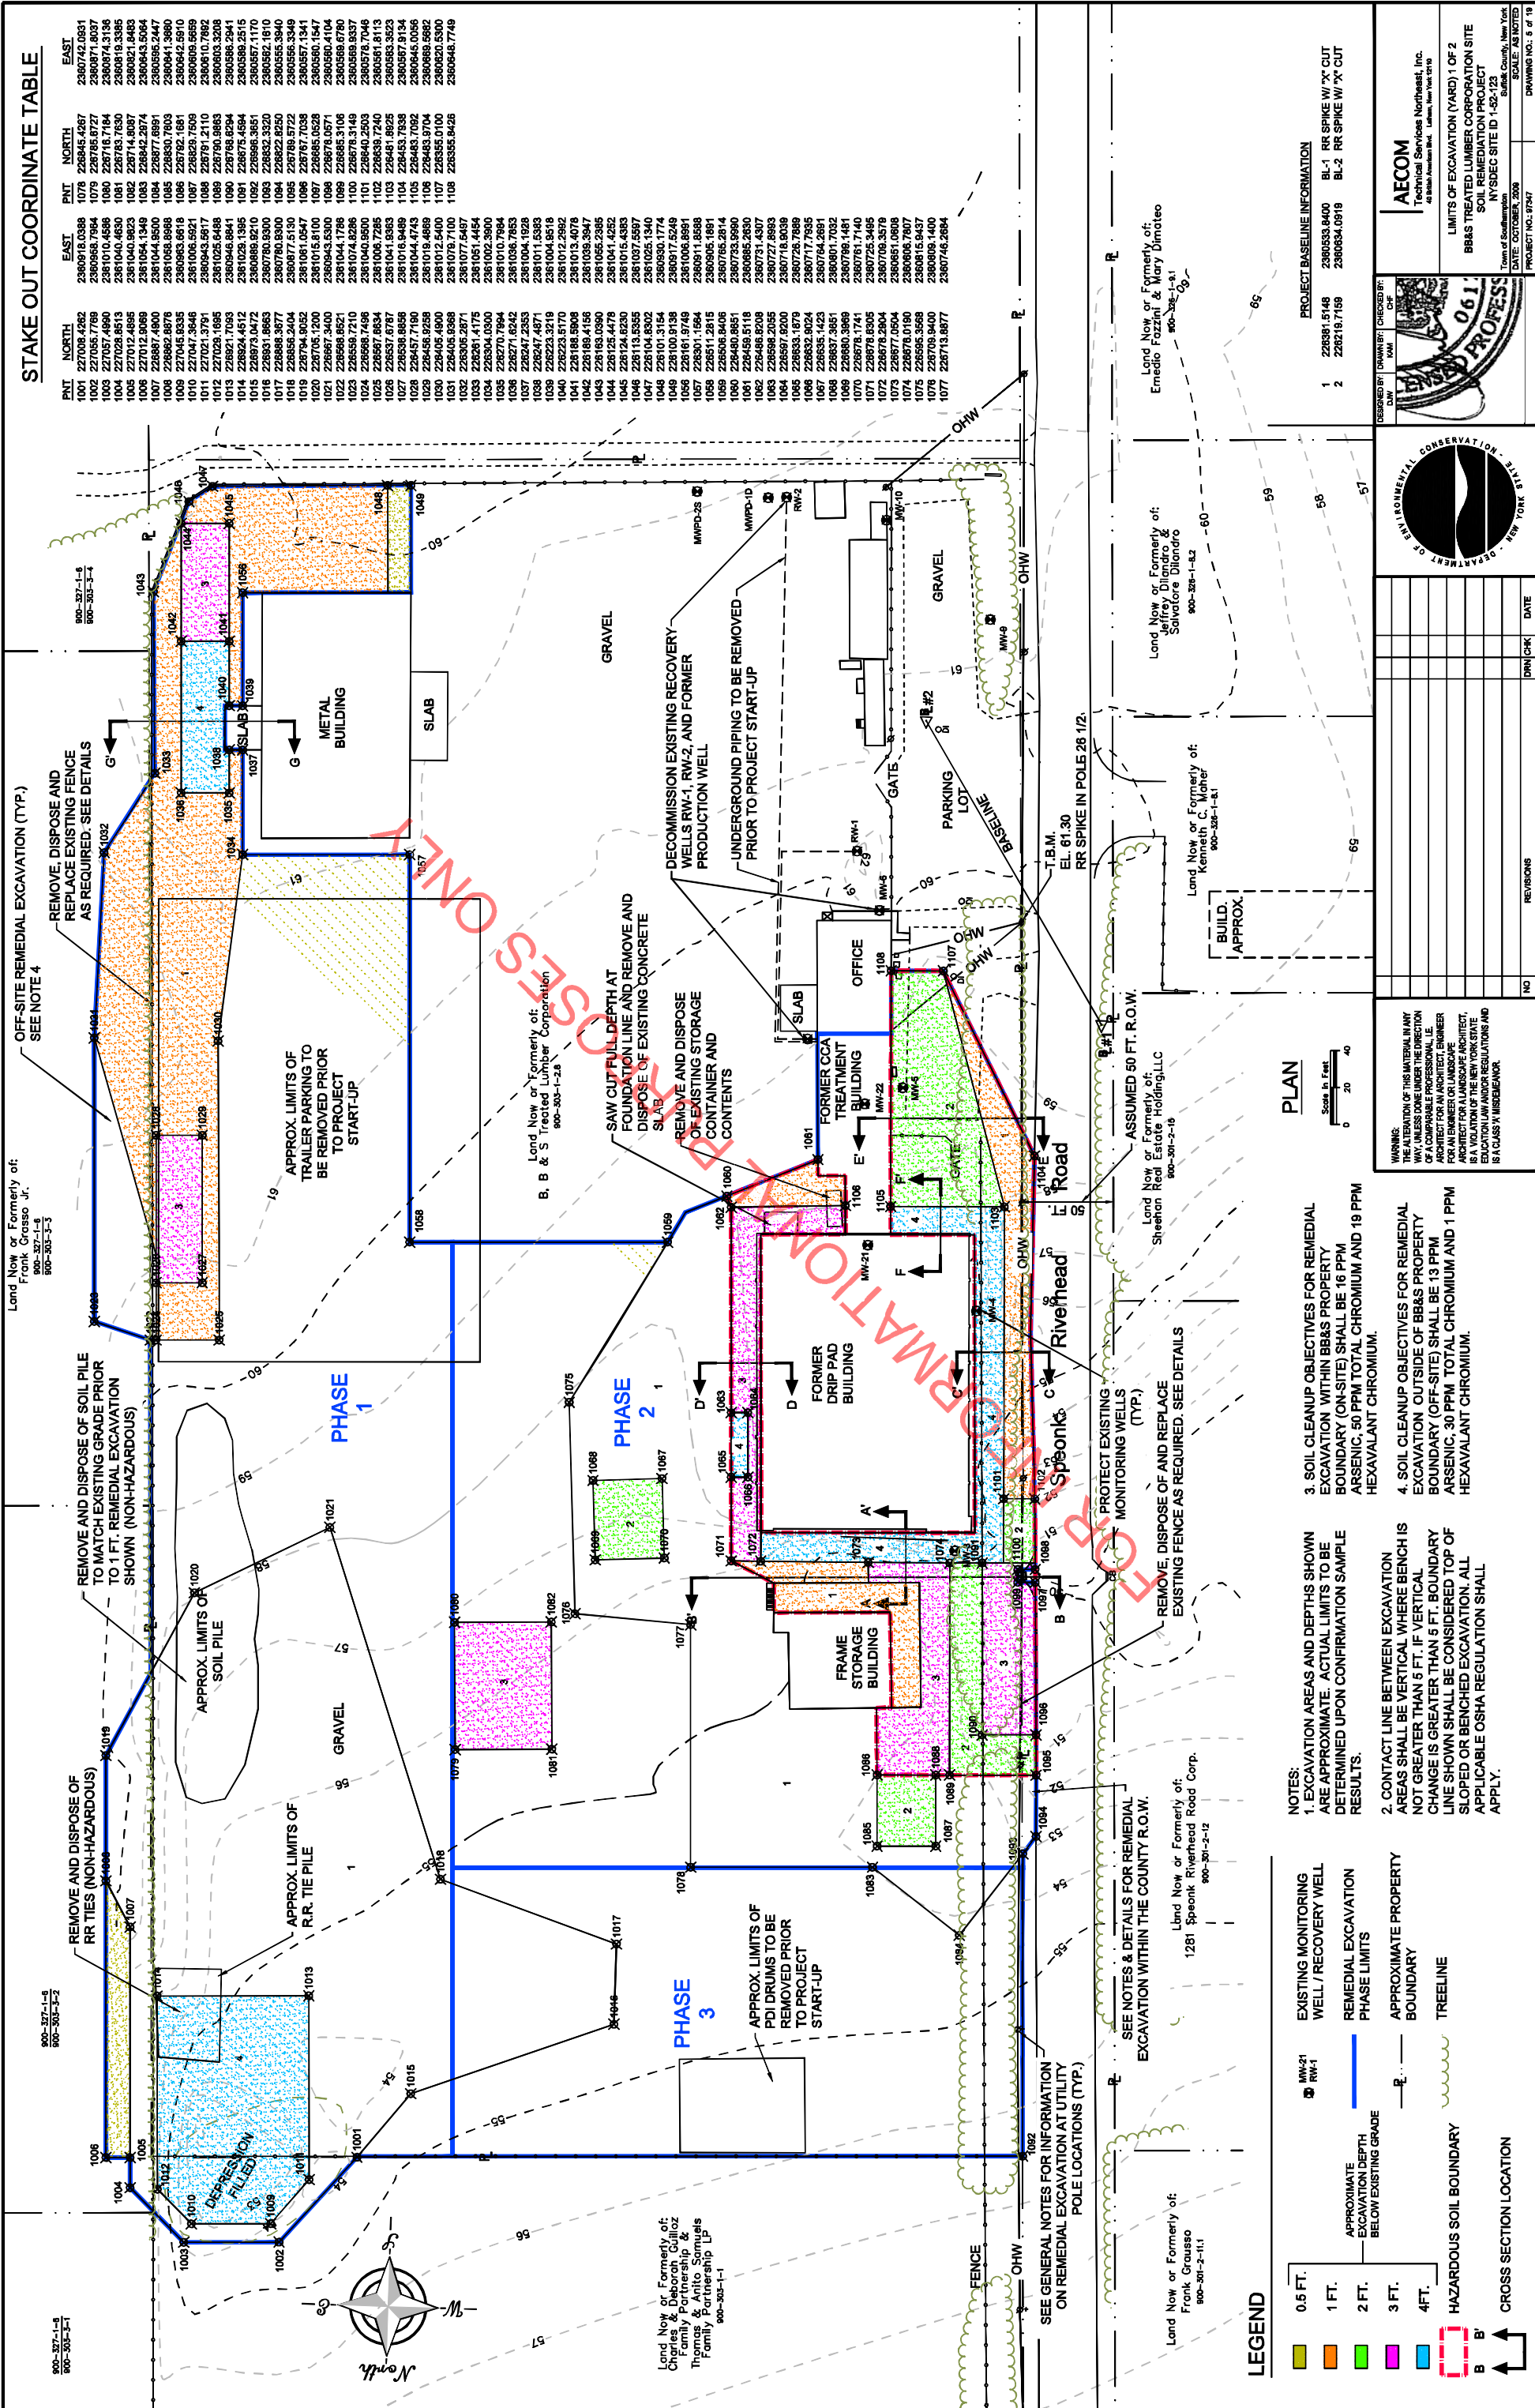
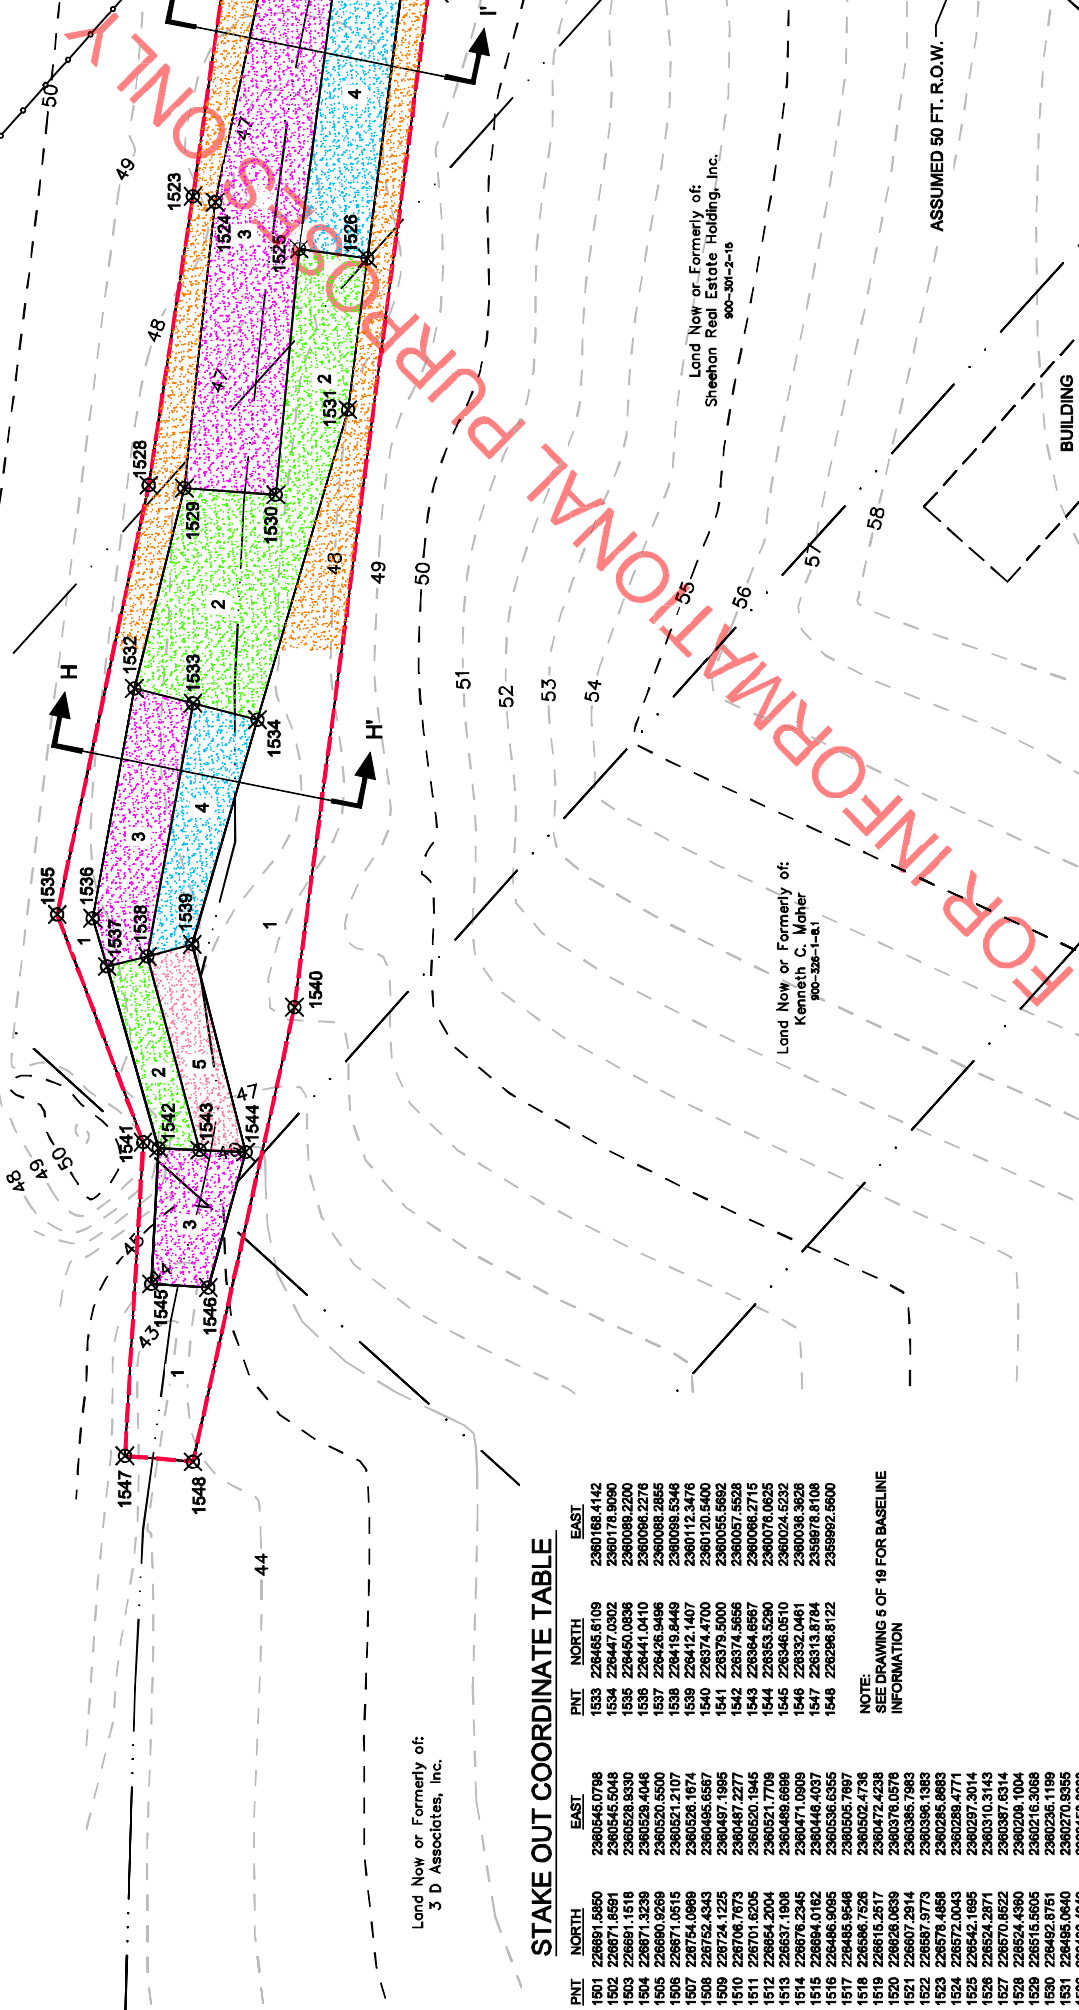
The RD for the BB&S Treated Lumber Corporation Site remedial project subsequently developed by AECOM for NYSDEC detailed the size, scope, and character of the site remediation. The RD combined information from the ROD and Amended ROD, the RI/FS, and additional data gathered during PDIs into a set of construction documents suitable for the competitive bidding process. Identification of the on-site and off-site boundaries and the limits of the proposed remedial work phases are shown on Figure 1-3 (AECOM Contract Drawing 5 of 19) and Figure 1-4 (AECOM Contract Drawing 6 of 19).

The services required for the remedial contract included the excavation and off-site disposal of approximately 10,400 cubic yards of non-hazardous soils and 8,000 cubic yards of hazardous soils contaminated with inorganic compounds from the BB&S site, a road-crossing culvert, and a downgradient drainage ditch. Clean backfill and restoration elements completed the balance of the scope of work. In addition, remediation and improvements were required of the three on-site buildings to immobilize the contamination beneath each.

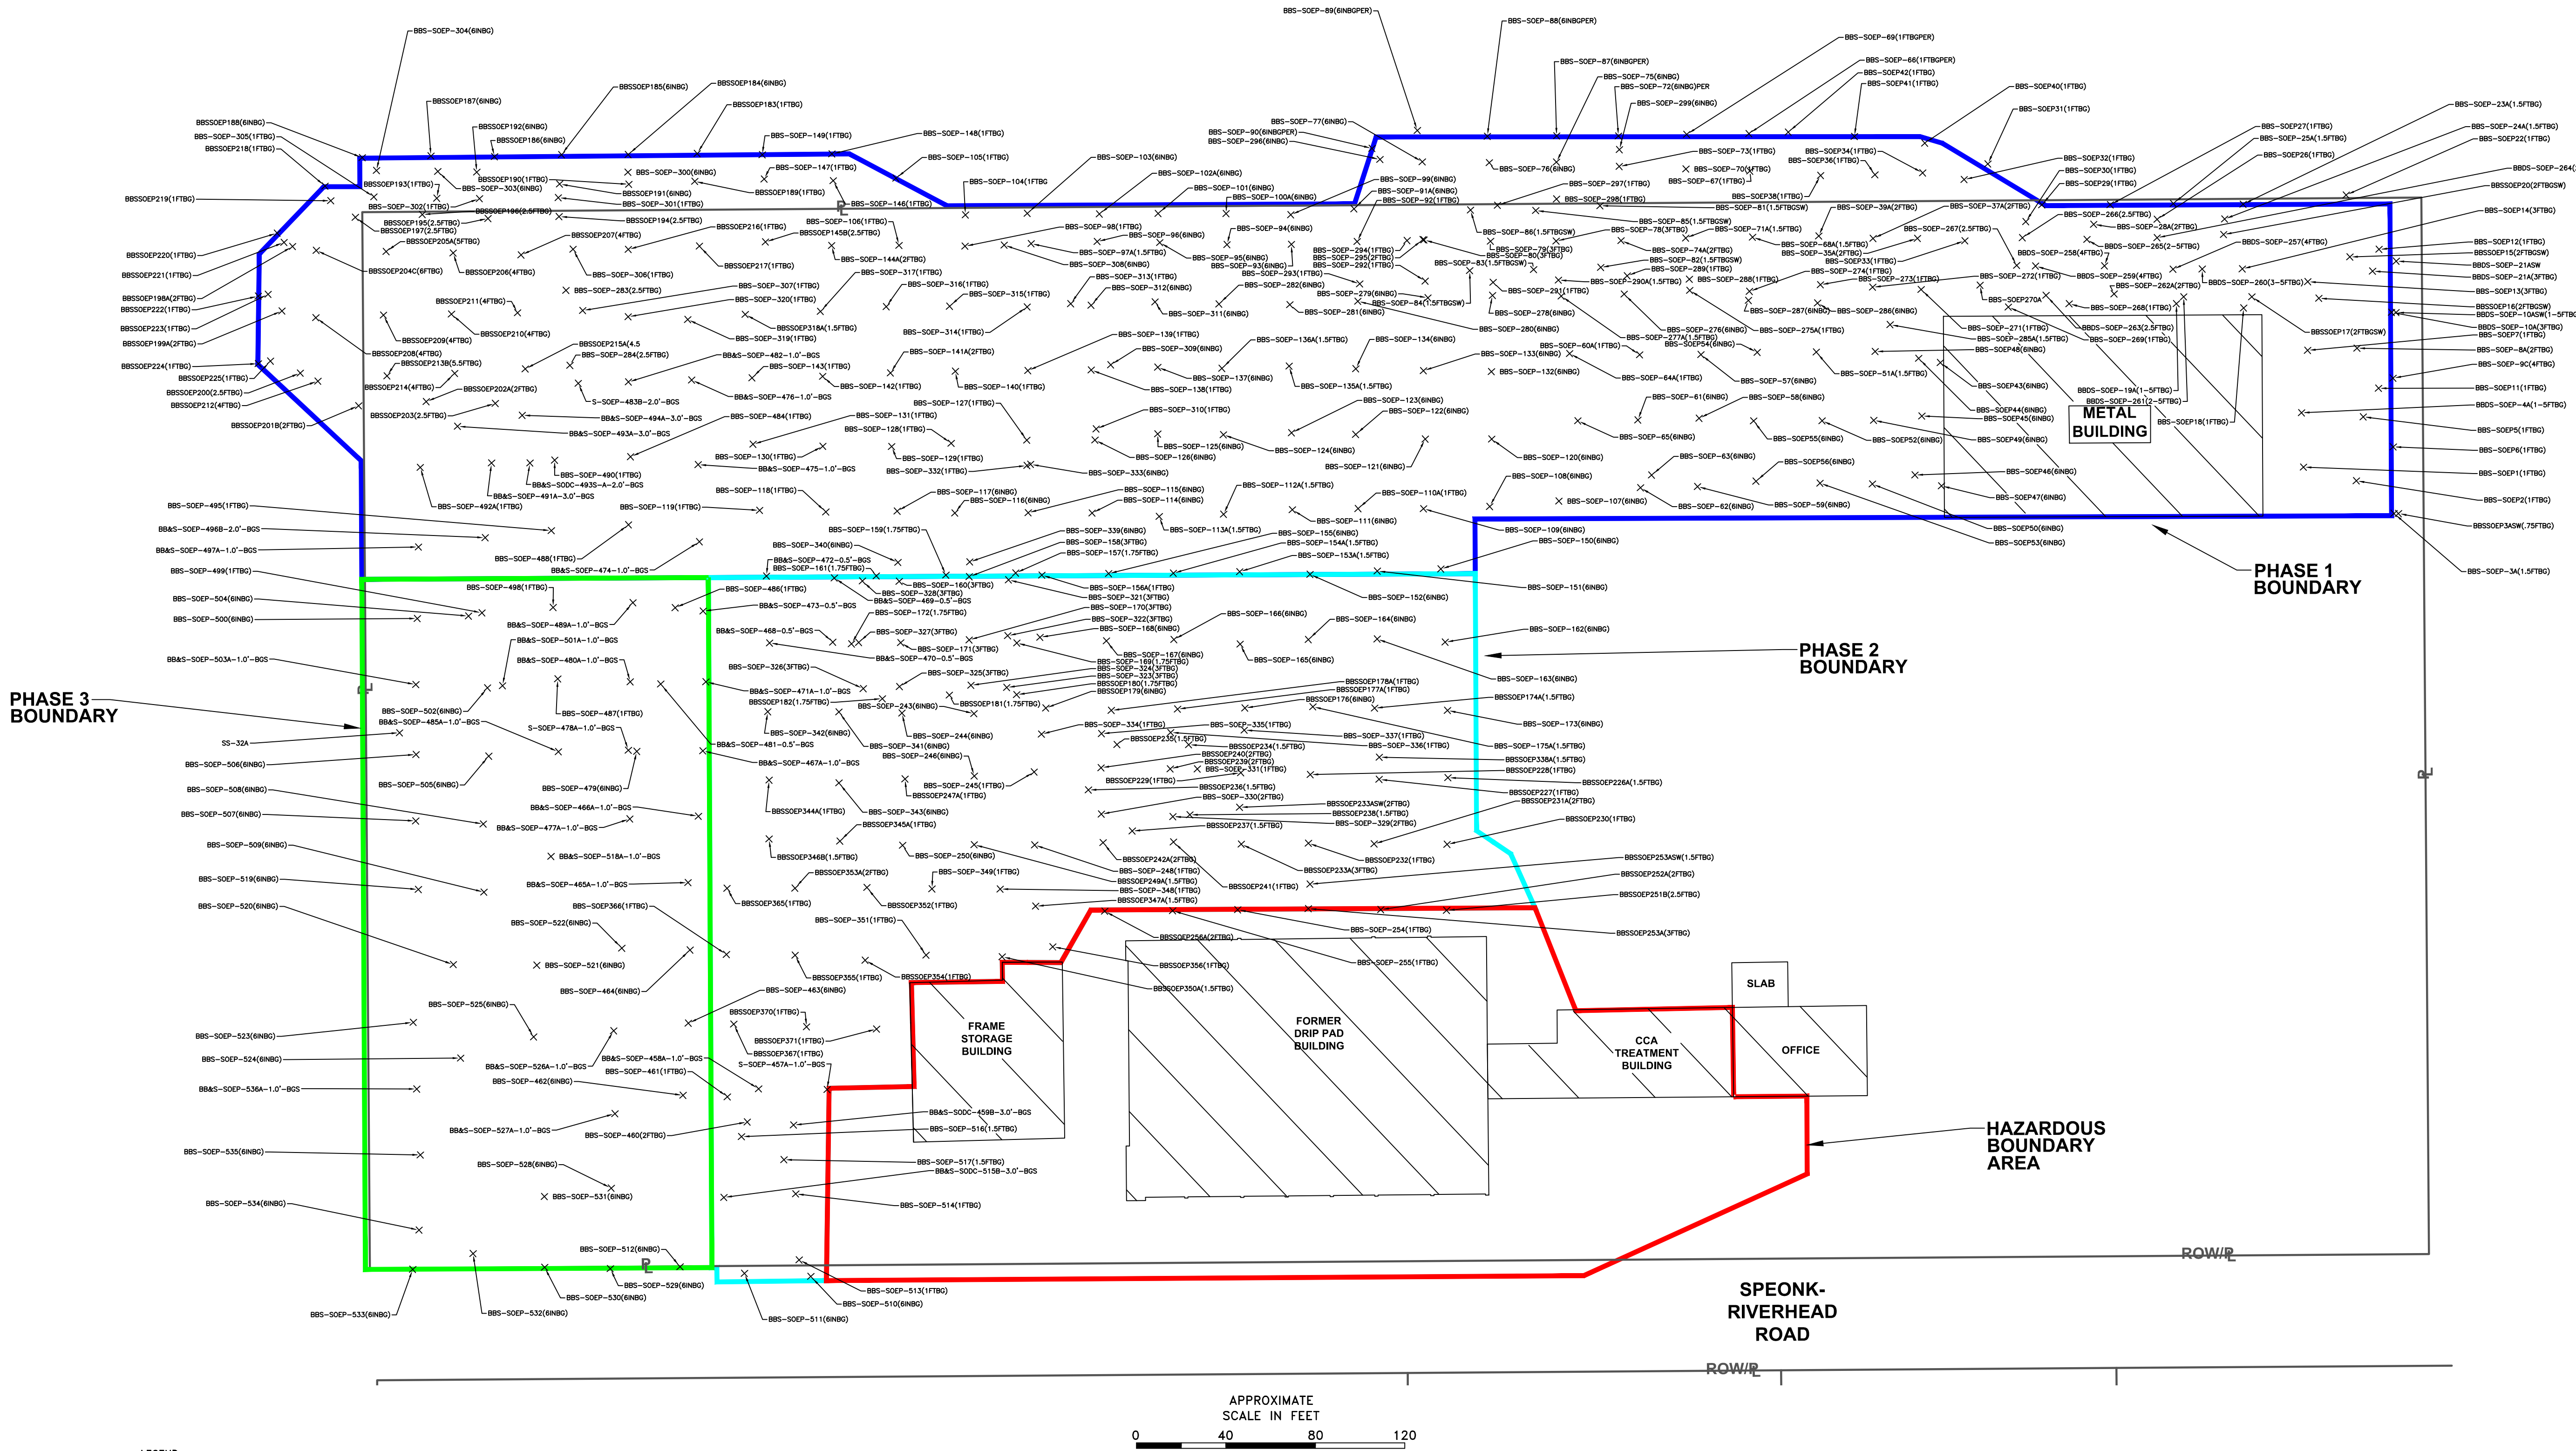
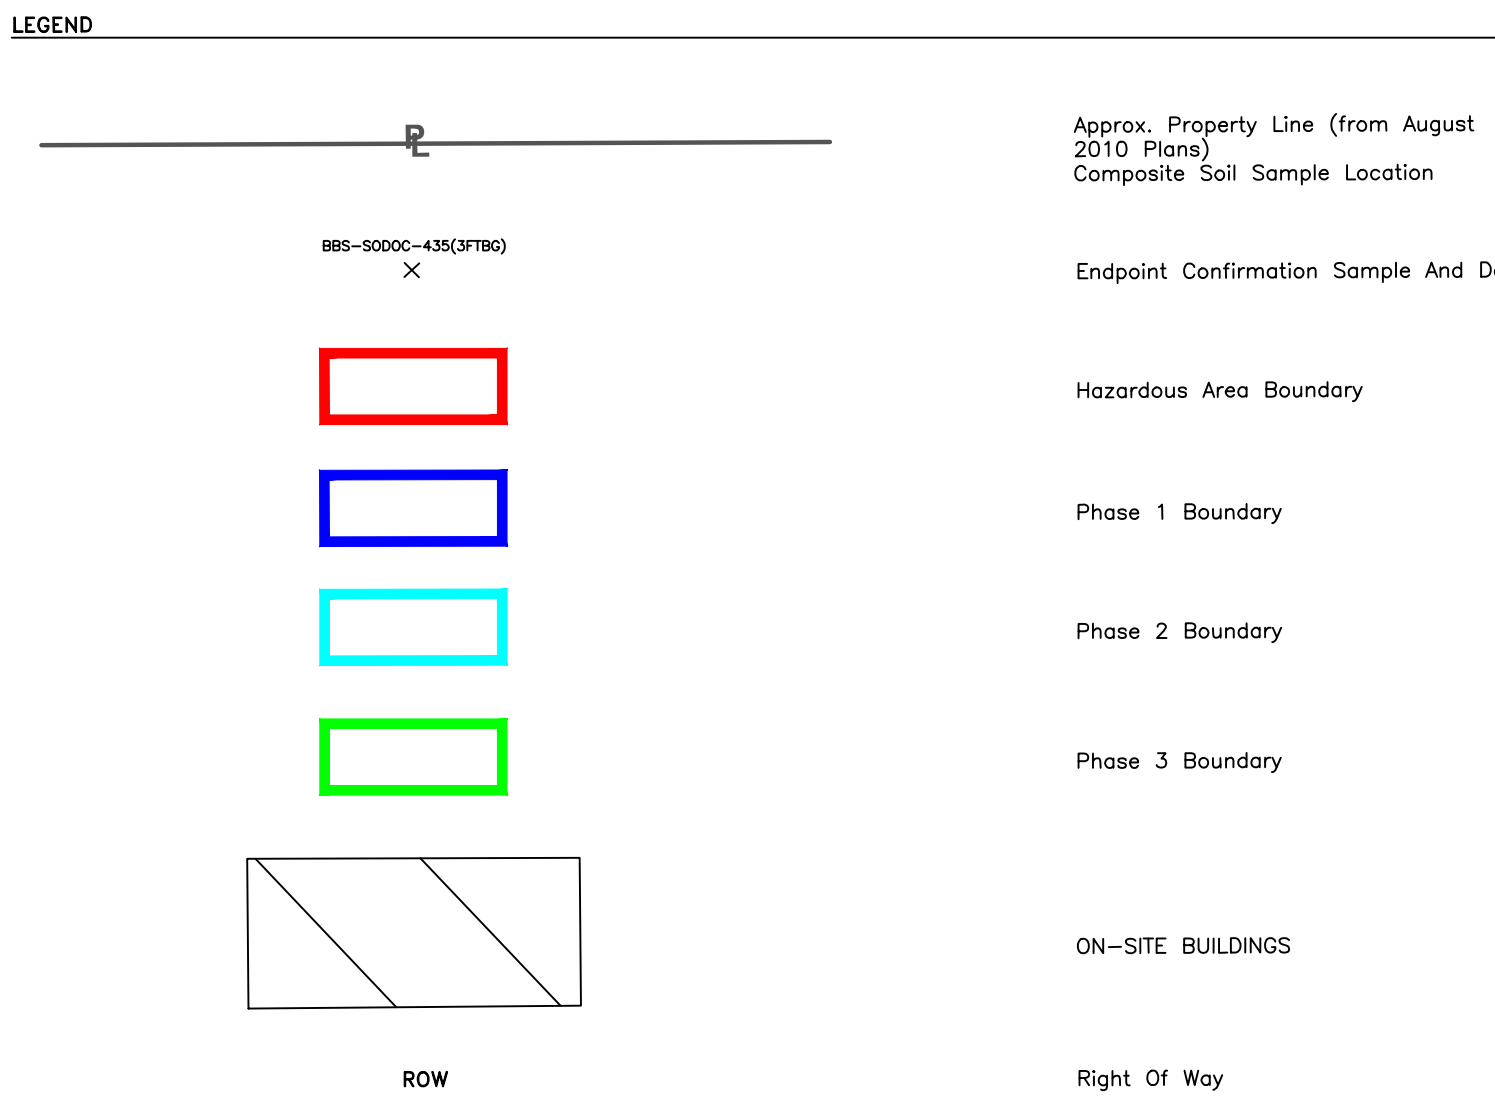
FIGURE 6-1 SAMPLE LOCATION MAP - PHASE 1, 2, & 3  
BB&S TREATED LUMBER CORPORATION SITE  
TOWN OF SOUTHAMPTON, SUFFOLK COUNTY, NY

**NOTE**  
1. THIS FIGURE IS ADAPTED FROM DRAWING 7/9, PROVIDED BY L.K. McLEAN ASSOCIATES P.C. (May 24TH, 2011).  
2. FOR CONFIRMATION ENDPOINT SAMPLE ANALYTICAL RESULTS, SEE FIGURE 6-1a.

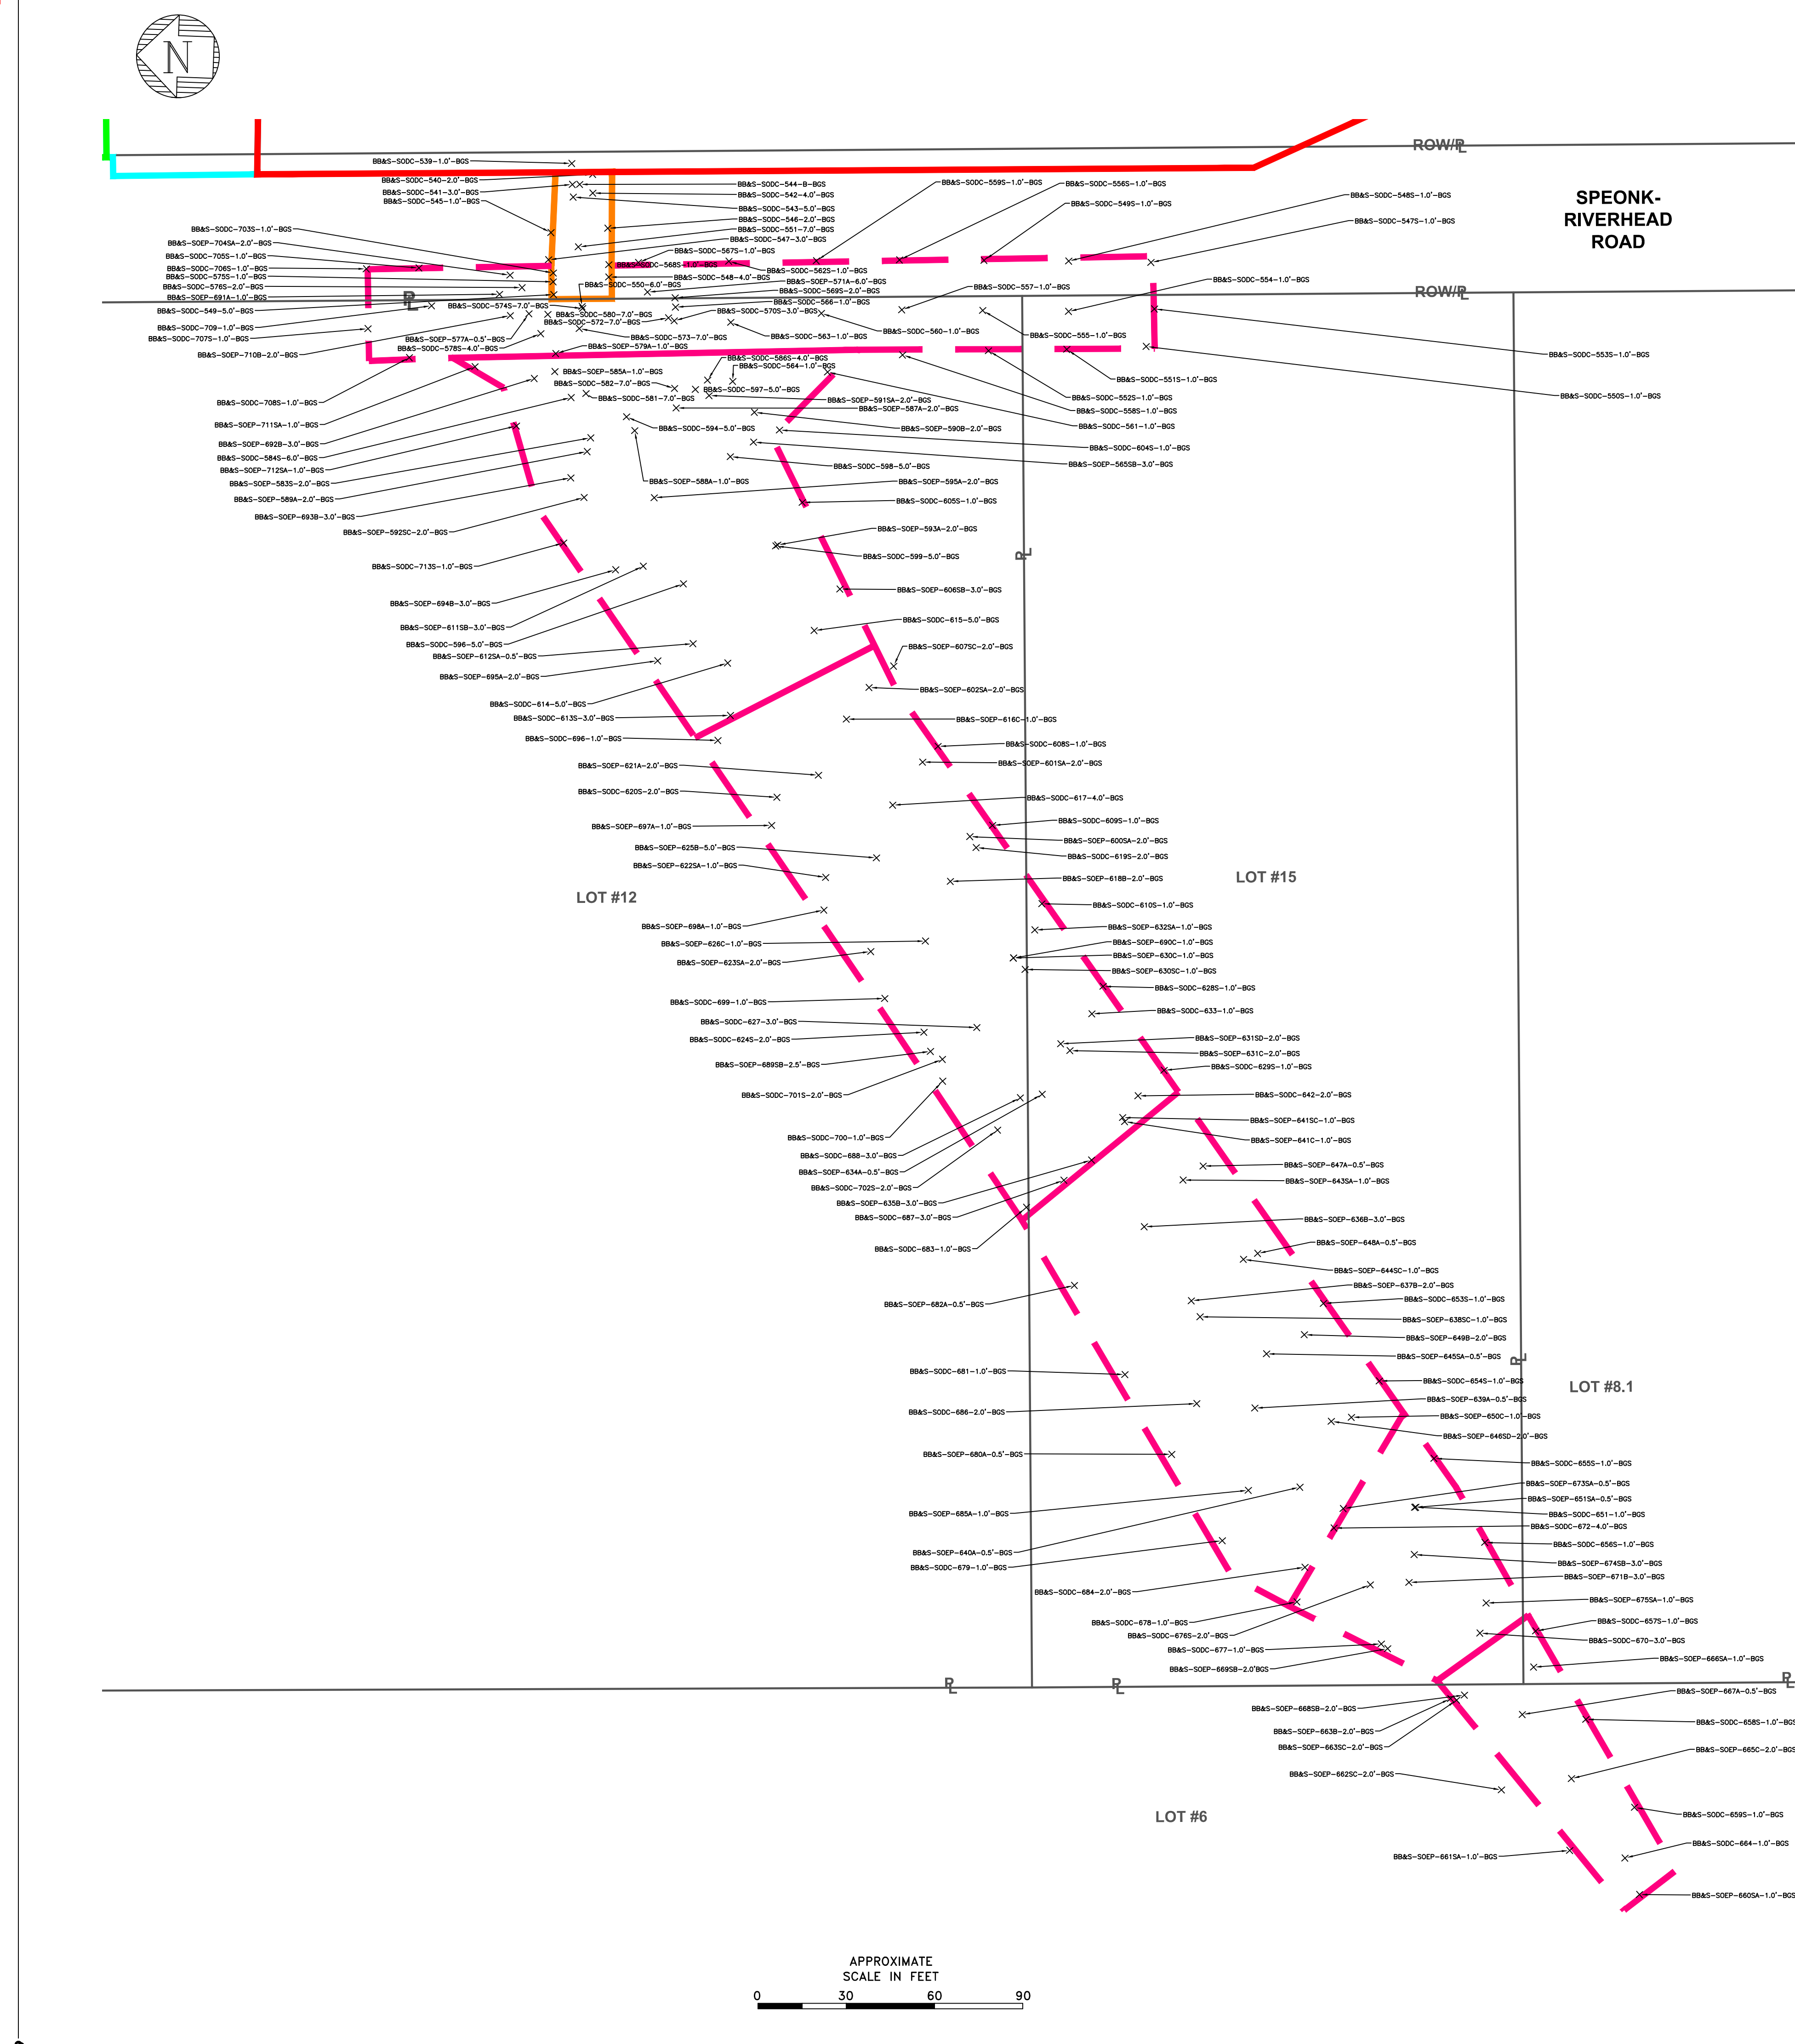
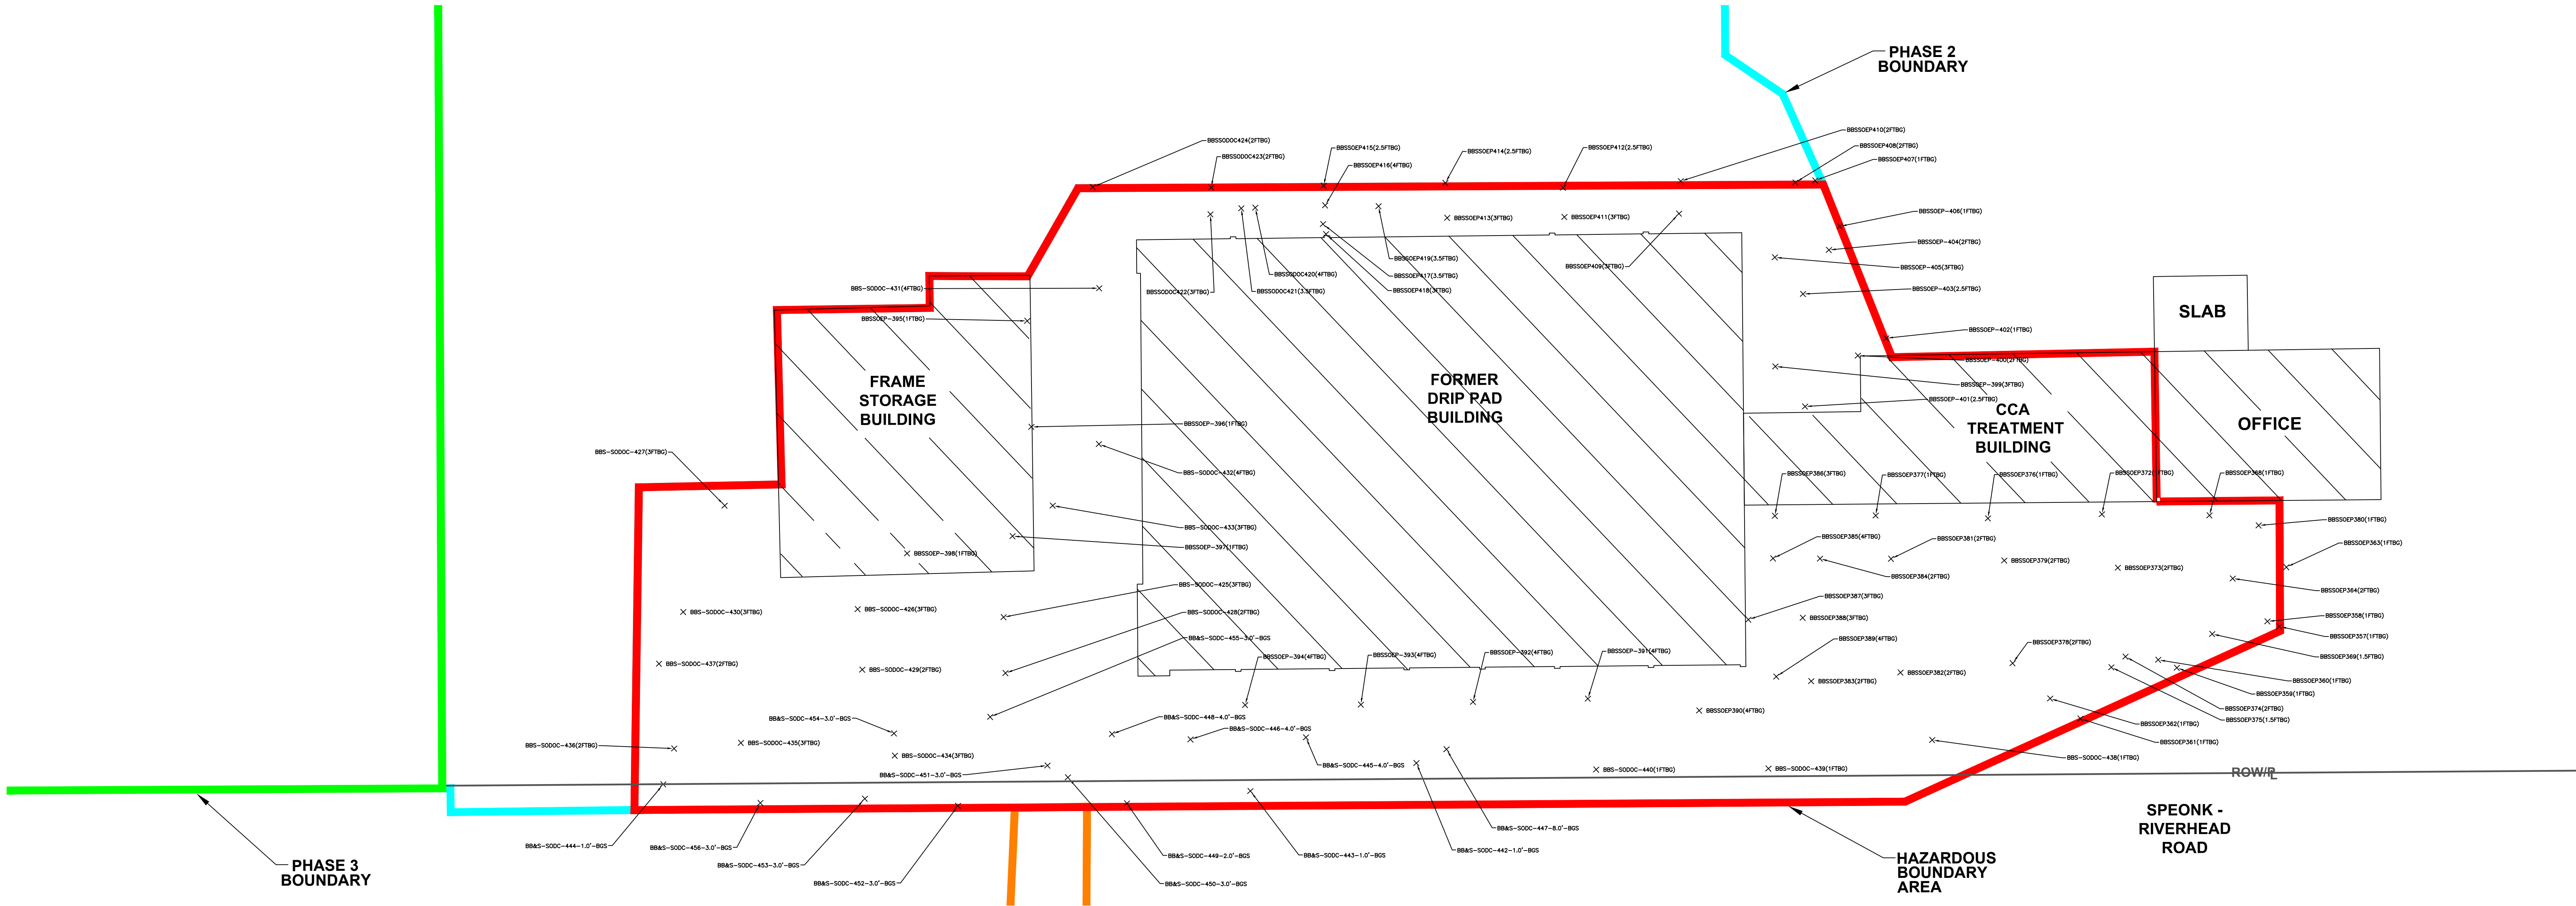
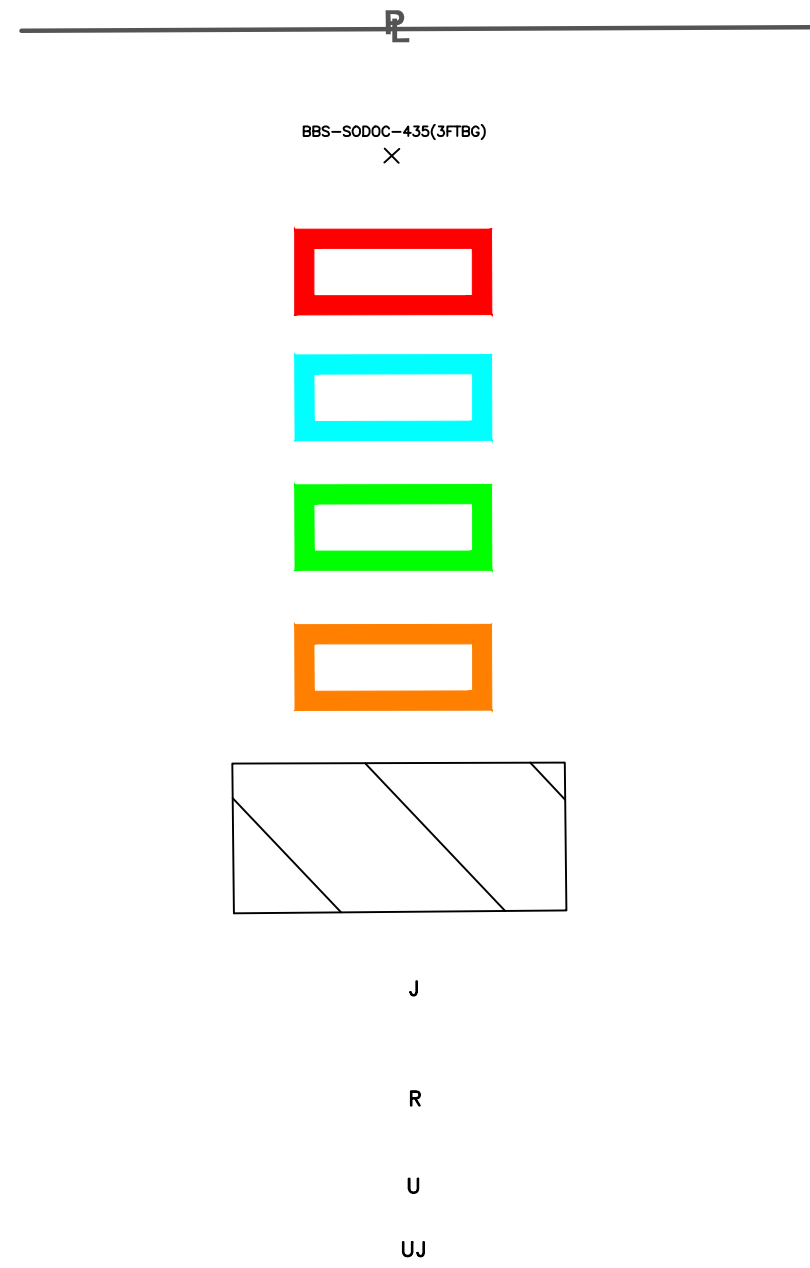
NOTE  
1. THIS FIGURE IS ADAPTED FROM DRAWING 7/9, PROVIDED BY L.K. McLEAN ASSOCIATES P.C. (May 24TH, 2011).  
2. ALL RESULTS IN mg/kg.  
3. REMEDIAL OBJECTIVES FOR THIS AREA WERE EXCAVATION TO SPECIFIED DEPTH ONLY, NOT TO MEET SCOS. THIS AREA TO REMAIN UNDER NYSDEC SITE MANAGEMENT.
