**Remedial Site Optimization for the  
BB&S Treated Lumber Corporation Site  
NYSDEC Site No. 152123  
Southampton, New York**

**May 2017**

**NEW YORK STATE DEPARTMENT OF ENVIRONMENTAL CONSERVATION**  
625 Broadway  
Albany, New York 12233

**ECOLOGY AND ENVIRONMENT ENGINEERING, P.C.**  
368 Pleasant View Drive  
Lancaster, New York 14086

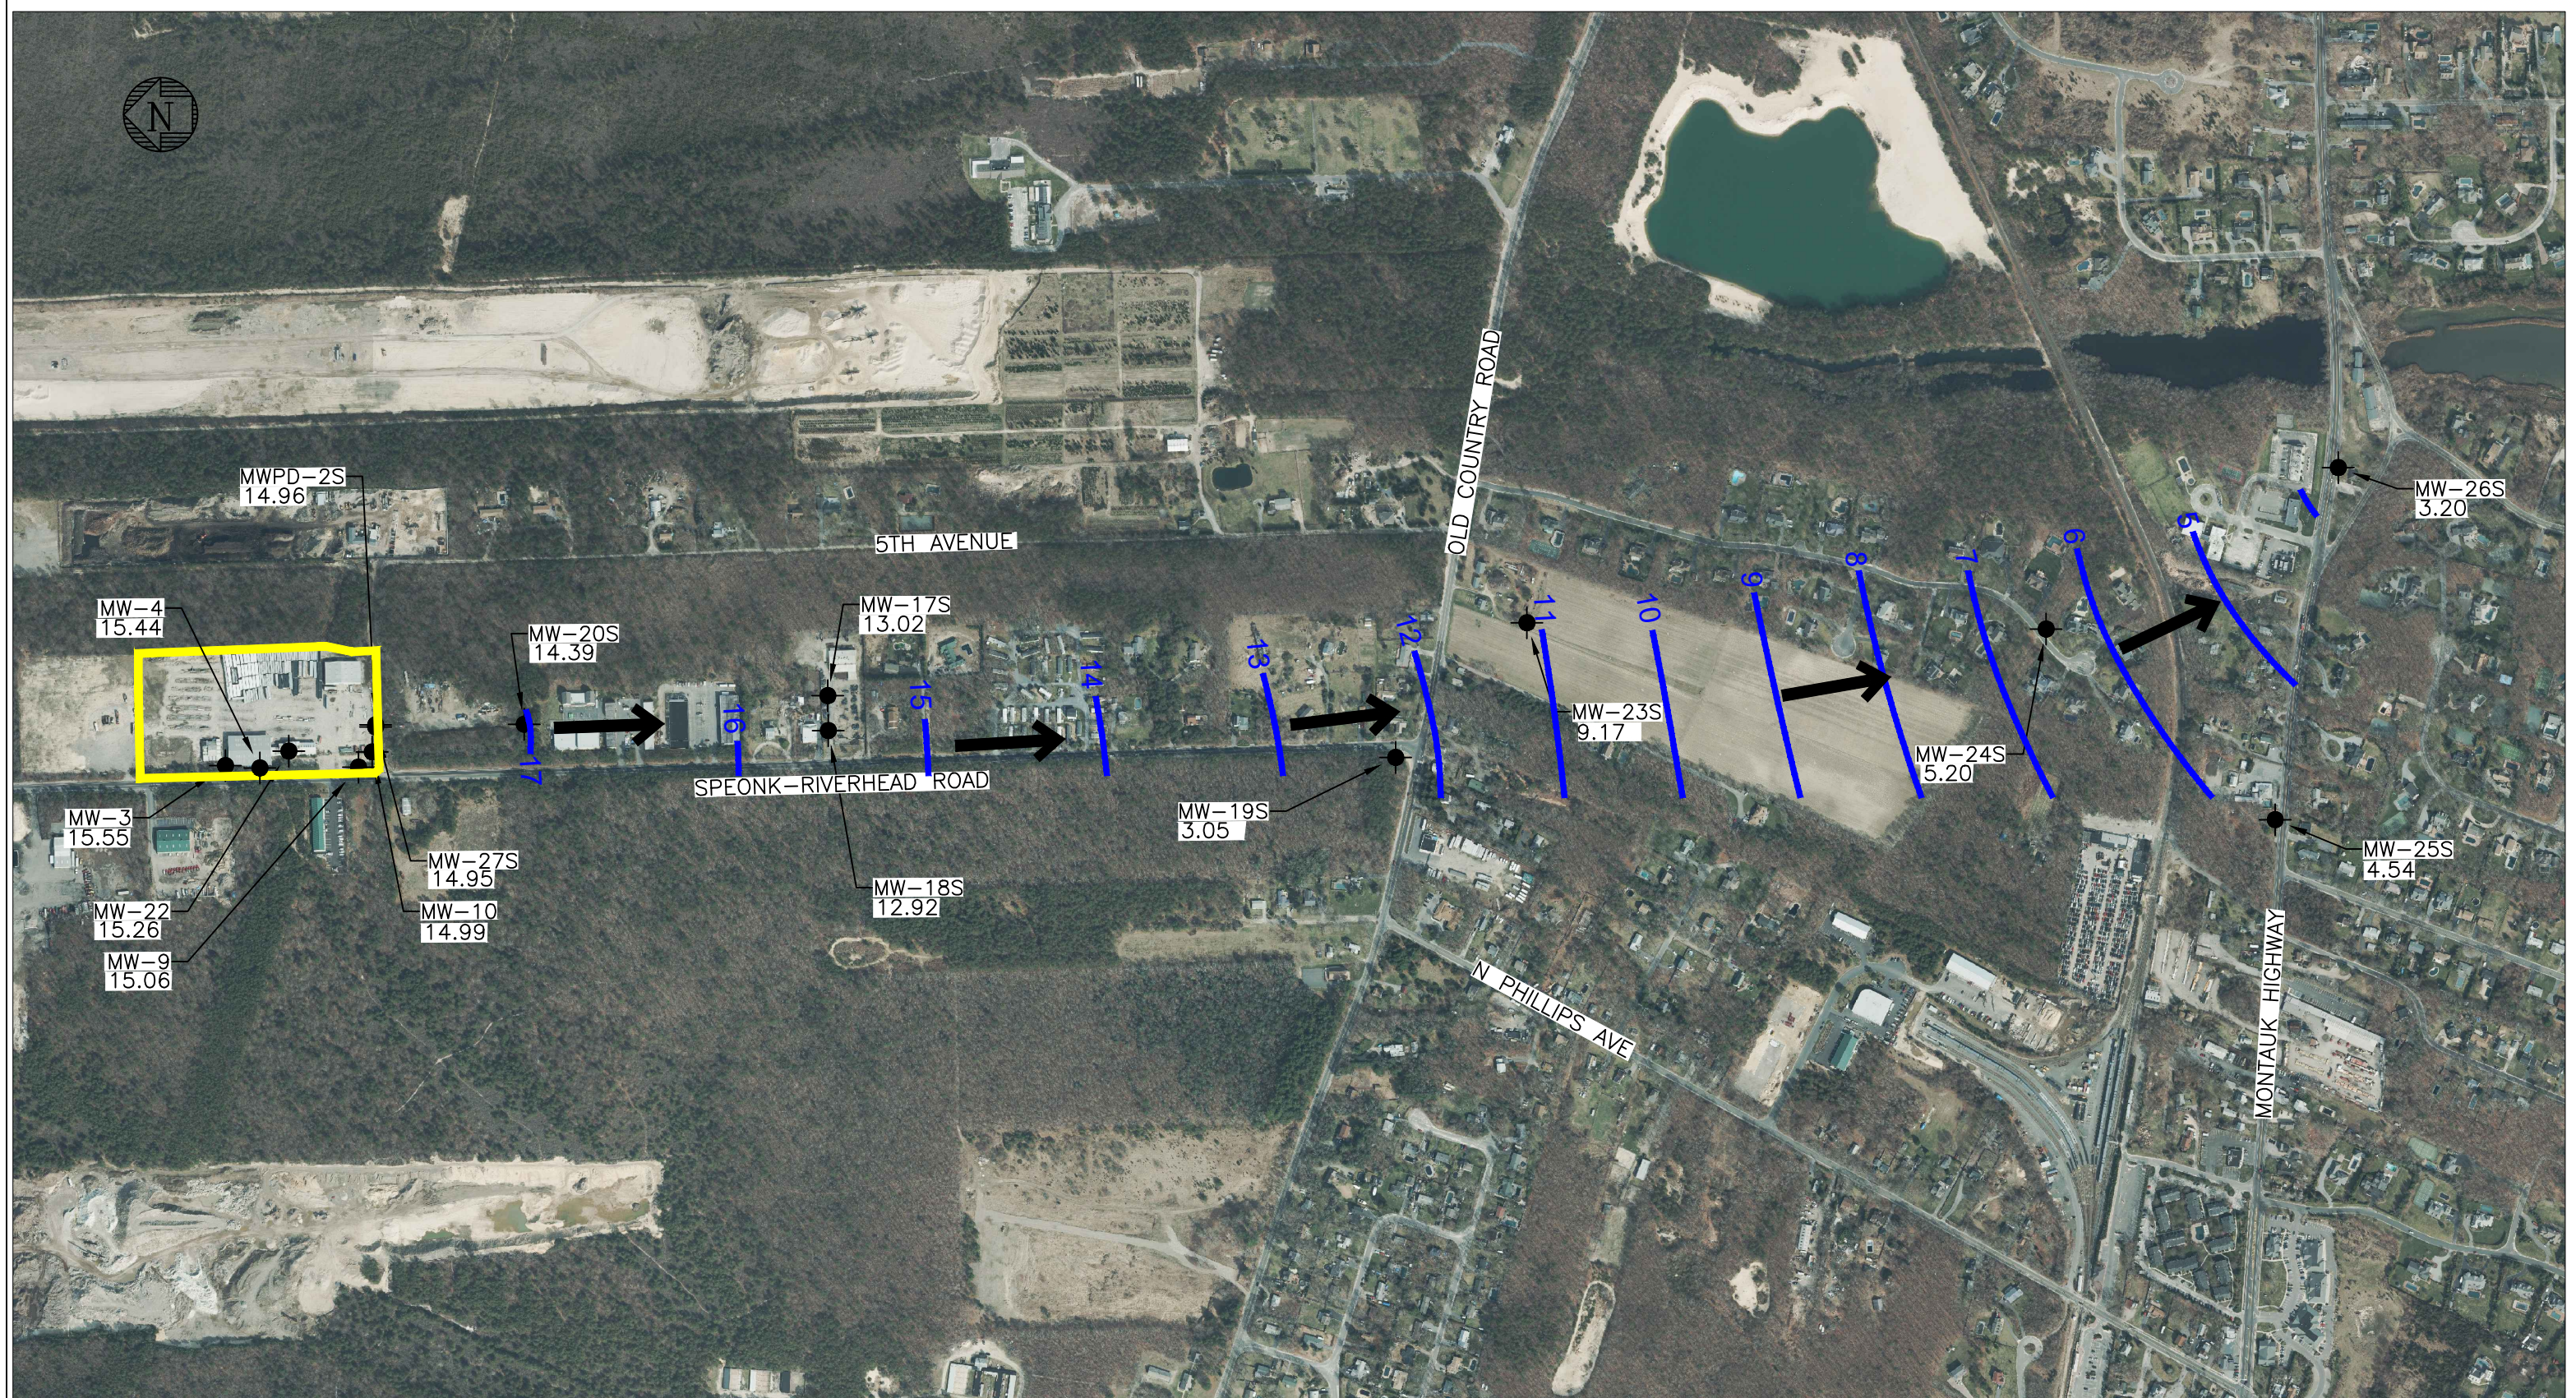
FIGURE 1-3 SHALLOW GROUNDWATER CONTOUR MAP (NOV-DEC 2016)  
BB&S TREATED LUMBER CORPORATION SITE  
TOWN OF SOUTHAMPTON, SUFFOLK COUNTY, NY

During all semi-annual monitoring events, well survey results were used in conjunction with static water level measurements to determine groundwater elevations. Each well is screened in the Upper Glacial Aquifer, and the vertical groundwater gradient appears to be negligible, with a slight downward gradient observed in Monitoring Events 1-3 and a very slight upward gradient observed between wells MW-18D and MW-18S during Monitoring Events 4-7. This indicates that flow is primarily horizontal throughout this aquifer. The software package Surfer® was used to interpolate groundwater elevation contours using the Kriging method. Figures 1-3 through 1-5 present the interpreted elevation contours for the shallow, intermediate, and deep monitoring wells, respectively. The groundwater flow direction was found to be predominantly to the south during all monitoring events. This is consistent with the findings of the PDI Report (Earth Tech Northeast, Inc. 2007) and with the United States Geological Survey regional model discussed in that report. However, it should be noted that the arrangement of the monitoring wells is linear with a north-south orientation, and this may prevent detection of slight flow direction variations (e.g., to the south-southeast or south-southwest).

During all monitoring events, the magnitude of the horizontal hydraulic gradient was greater off-site at the south end of the study area than on-site. The average hydraulic gradient across the plume was determined to be 0.25% for Monitoring Events 1-3, 0.14-0.15% for Monitoring Event 4, 0.20% for Monitoring Event 5, and 0.17% for Monitoring Events 6, 7, and 8.

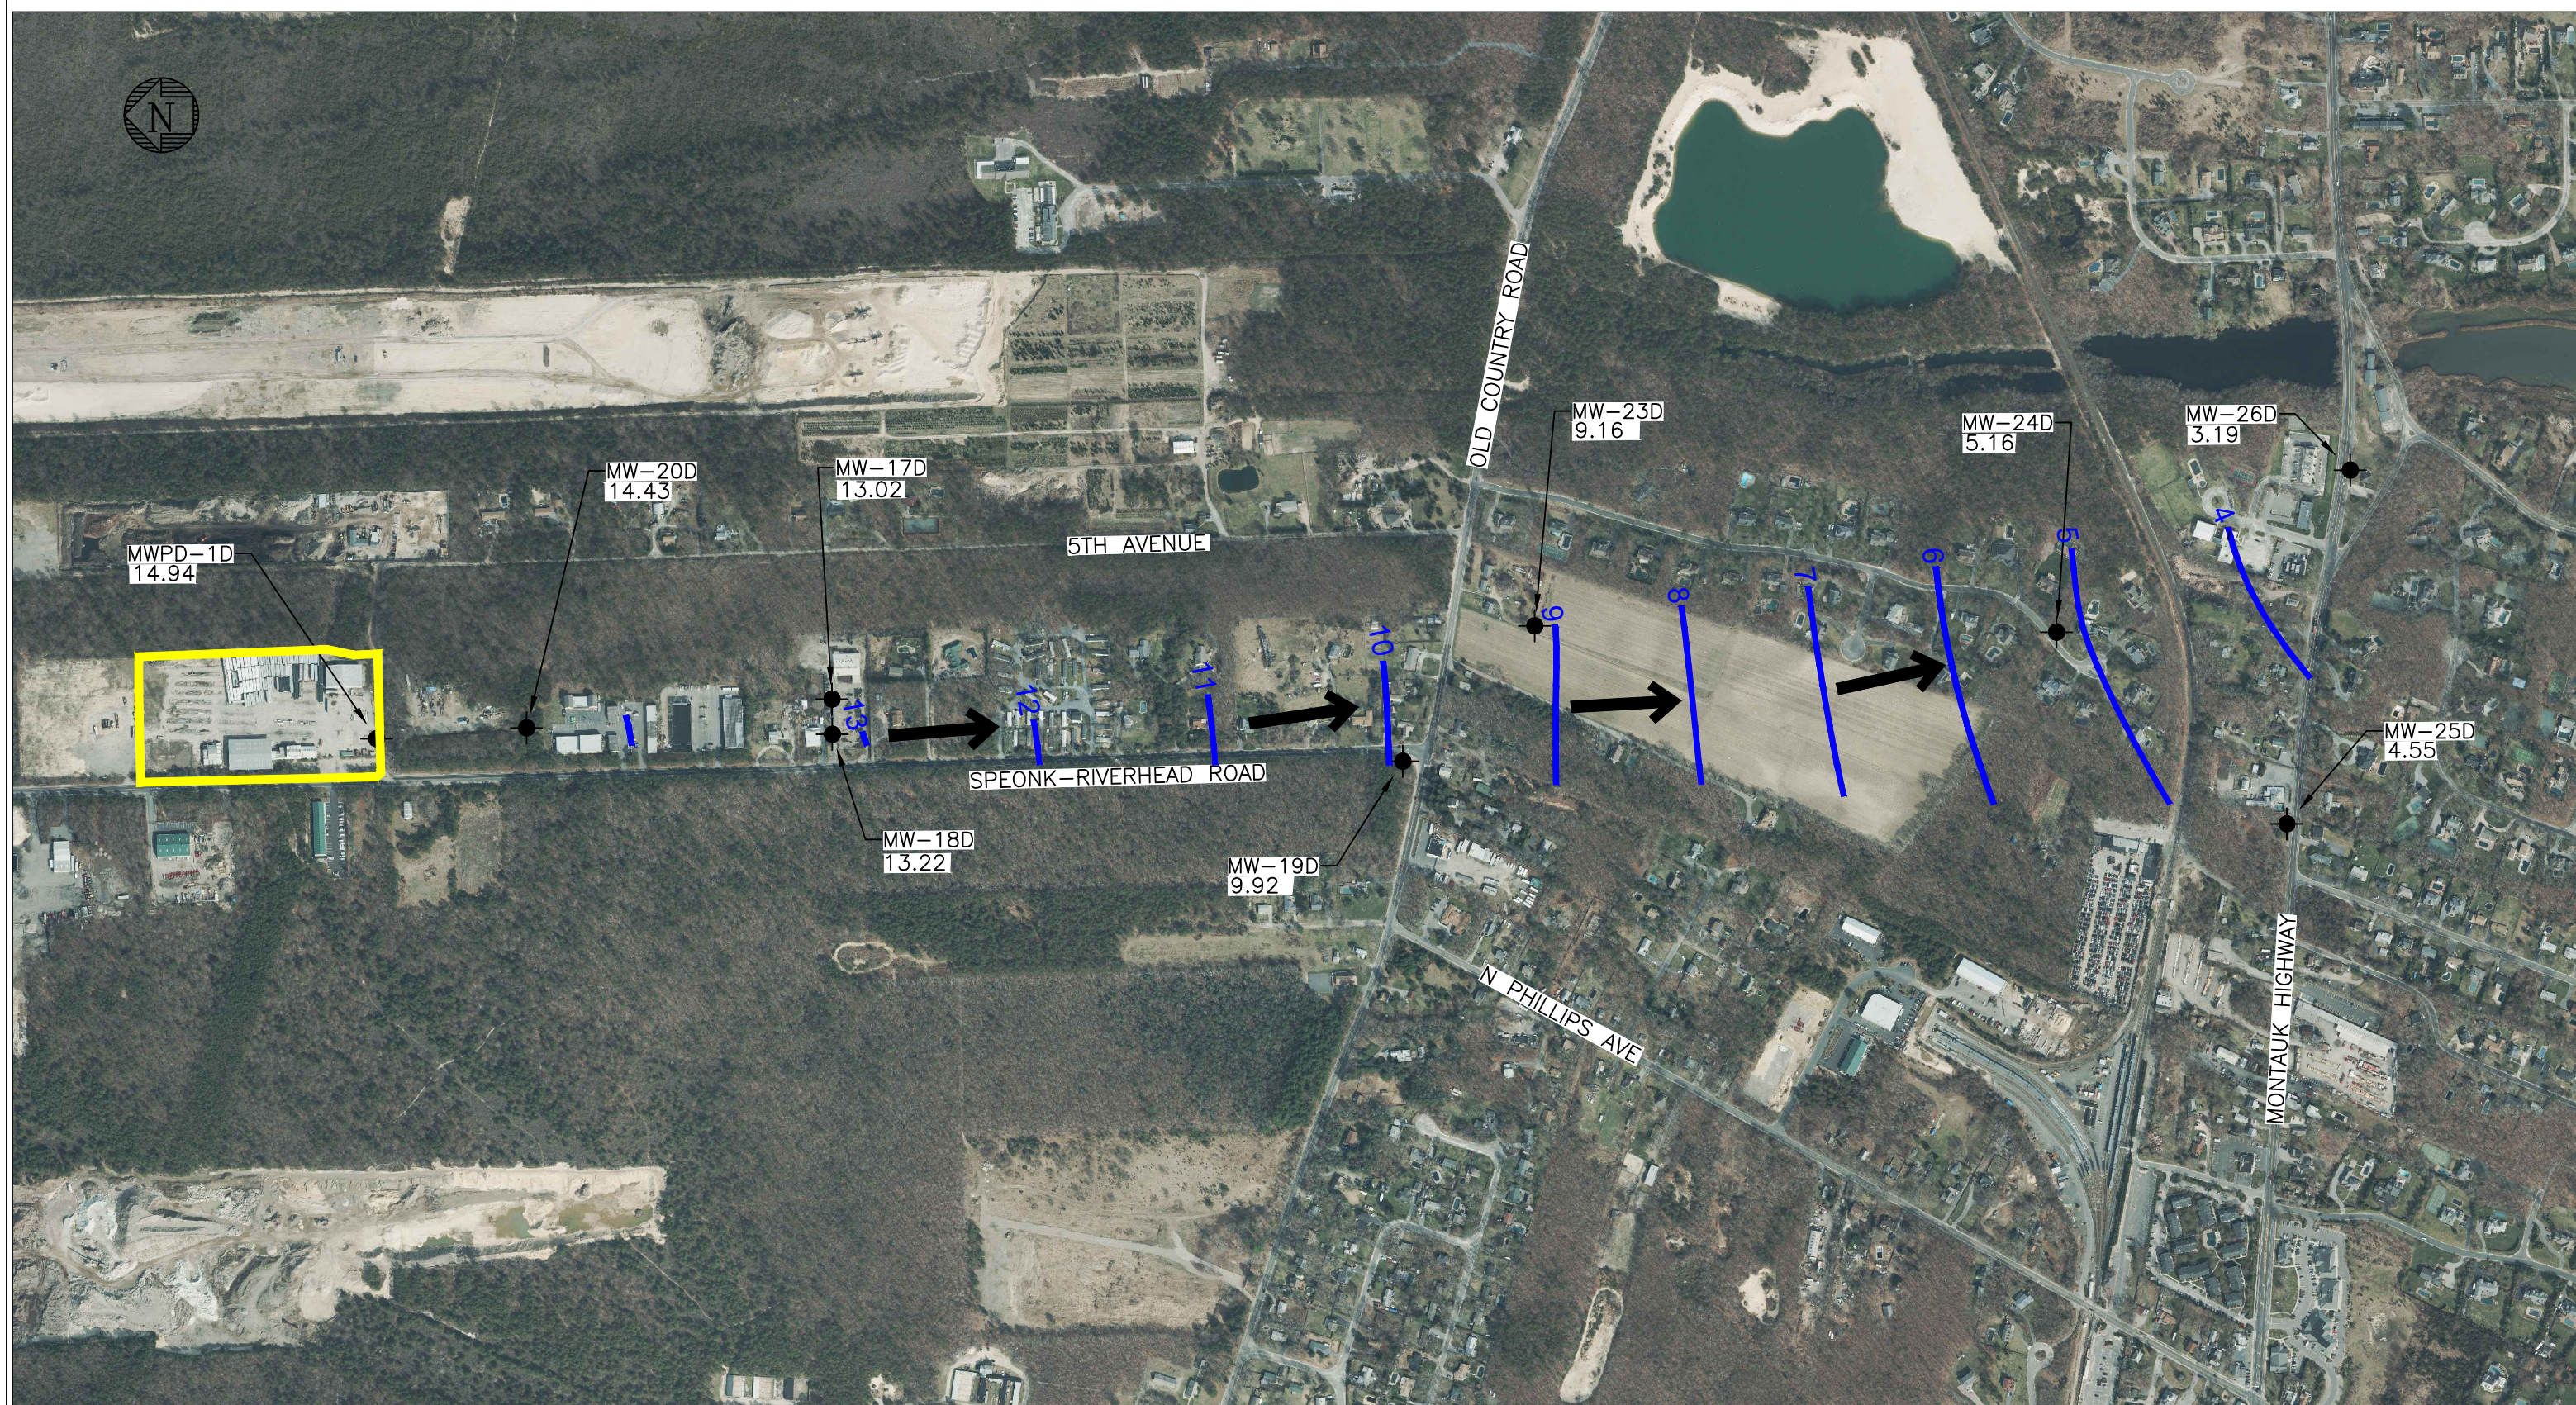
FIGURE 1-4 INTERMEDIATE GROUNDWATER CONTOUR MAP (NOV-DEC 2016)  
BB&S TREATED LUMBER CORPORATION SITE  
TOWN OF SOUTHAMPTON, SUFFOLK COUNTY, NY

1. AERIAL PHOTOGRAPHY WAS OBTAINED FROM THE NEW YORK STATE OFFICE OF CYBER SECURITY. THE FLYOVER WAS COMPLETED IN 2010. (SUFFOLK COUNTY ORTHO-IMAGERY 4BAND6inch).
2. DEPTH TO WATER MEASUREMENTS OBTAINED BY EEEPC AND ENVIRONMENTAL ASSESSMENT & REMEDIATIONS ON NOV 30, DEC 5, DEC 12, DEC 14, DEC 15, DEC 16, DEC 19, DEC 20 AND DEC 21 (2016).
