**REMEDIATION WORK FOR LEACHING BASIN SD-3**

**GLARO, INC.**

**TOWN OF SMITHTOWN, SUFFOLK COUNTY**

**SITE NUMBER 1-52-124**

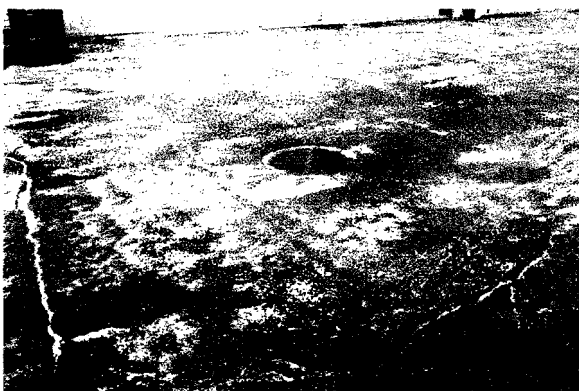
SD-3 Prior to cleanup

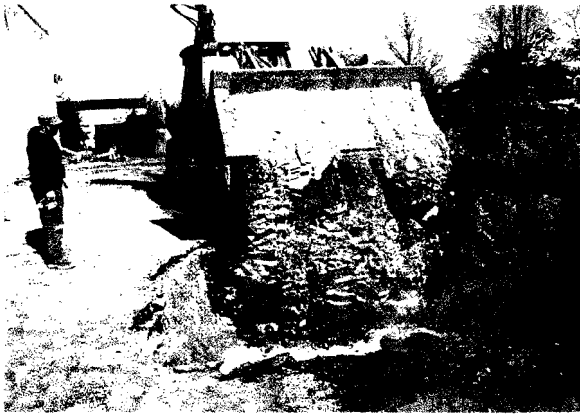
Clean backfill

The leaching basin was backfilled with "clean" sand and was made operational.

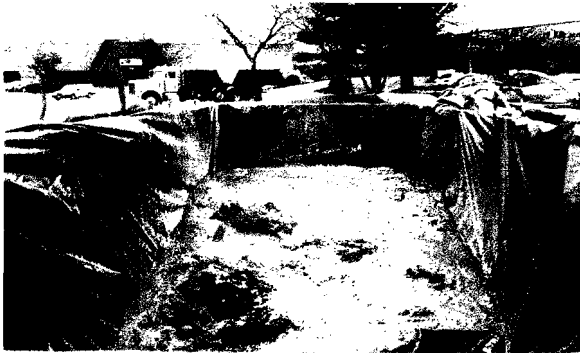
Containerized excavated soil

Subsequently, the VOC impacted soil from the 18 to 22 foot range was removed by a crane and was placed into an on-site lined roll-off container. The excavation was performed below the bottom of the last leaching basin ring resulting in a slight undermining of the structure. The leaching basin was backfilled with “clean” fill, which was also sampled and submitted for laboratory analysis (see Appendix). A photoionization detector (PID) was utilized to screen the excavated soil during the removal process (see Appendix for PID readings). An end point sample was collected at the twenty-two (22) foot depth and was submitted to EcoTest Laboratories, Inc. for analysis via EPA Method 8260 (see Appendix). The extracted soil underwent a waste characterization analysis and was stored on the site prior to its manifested disposal. On March 9, 2009 the soil was removed by AARCO and transported to Soil Safe, Inc. Bridgeport and disposed of as non-hazardous material (see Appendix for manifest)

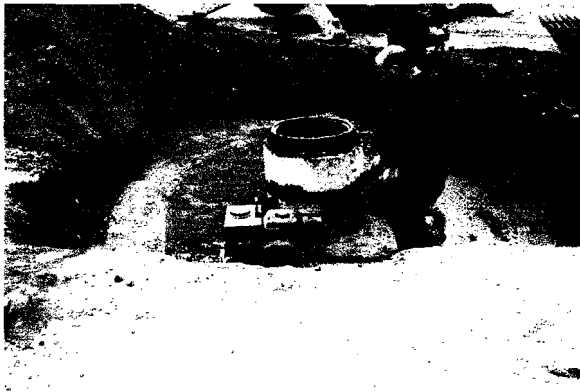
Backfill operation

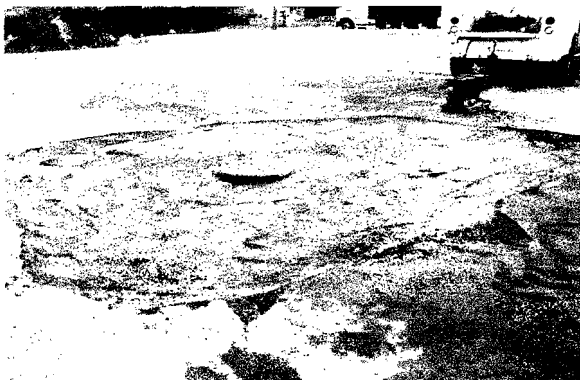
Restoration of area
