Re: Glaro, Inc. #1-52-124
Revised Groundwater & Air Sampling Results Report: November 2012

SUMMARY OF GROUNDWATER AND AIR SAMPLING RESULTS

**For
GLARO, INC.
Site No. 152124
735 Old Willets Path
Hauppauge, New York 11788**

**July 2012
Revised October 2012**

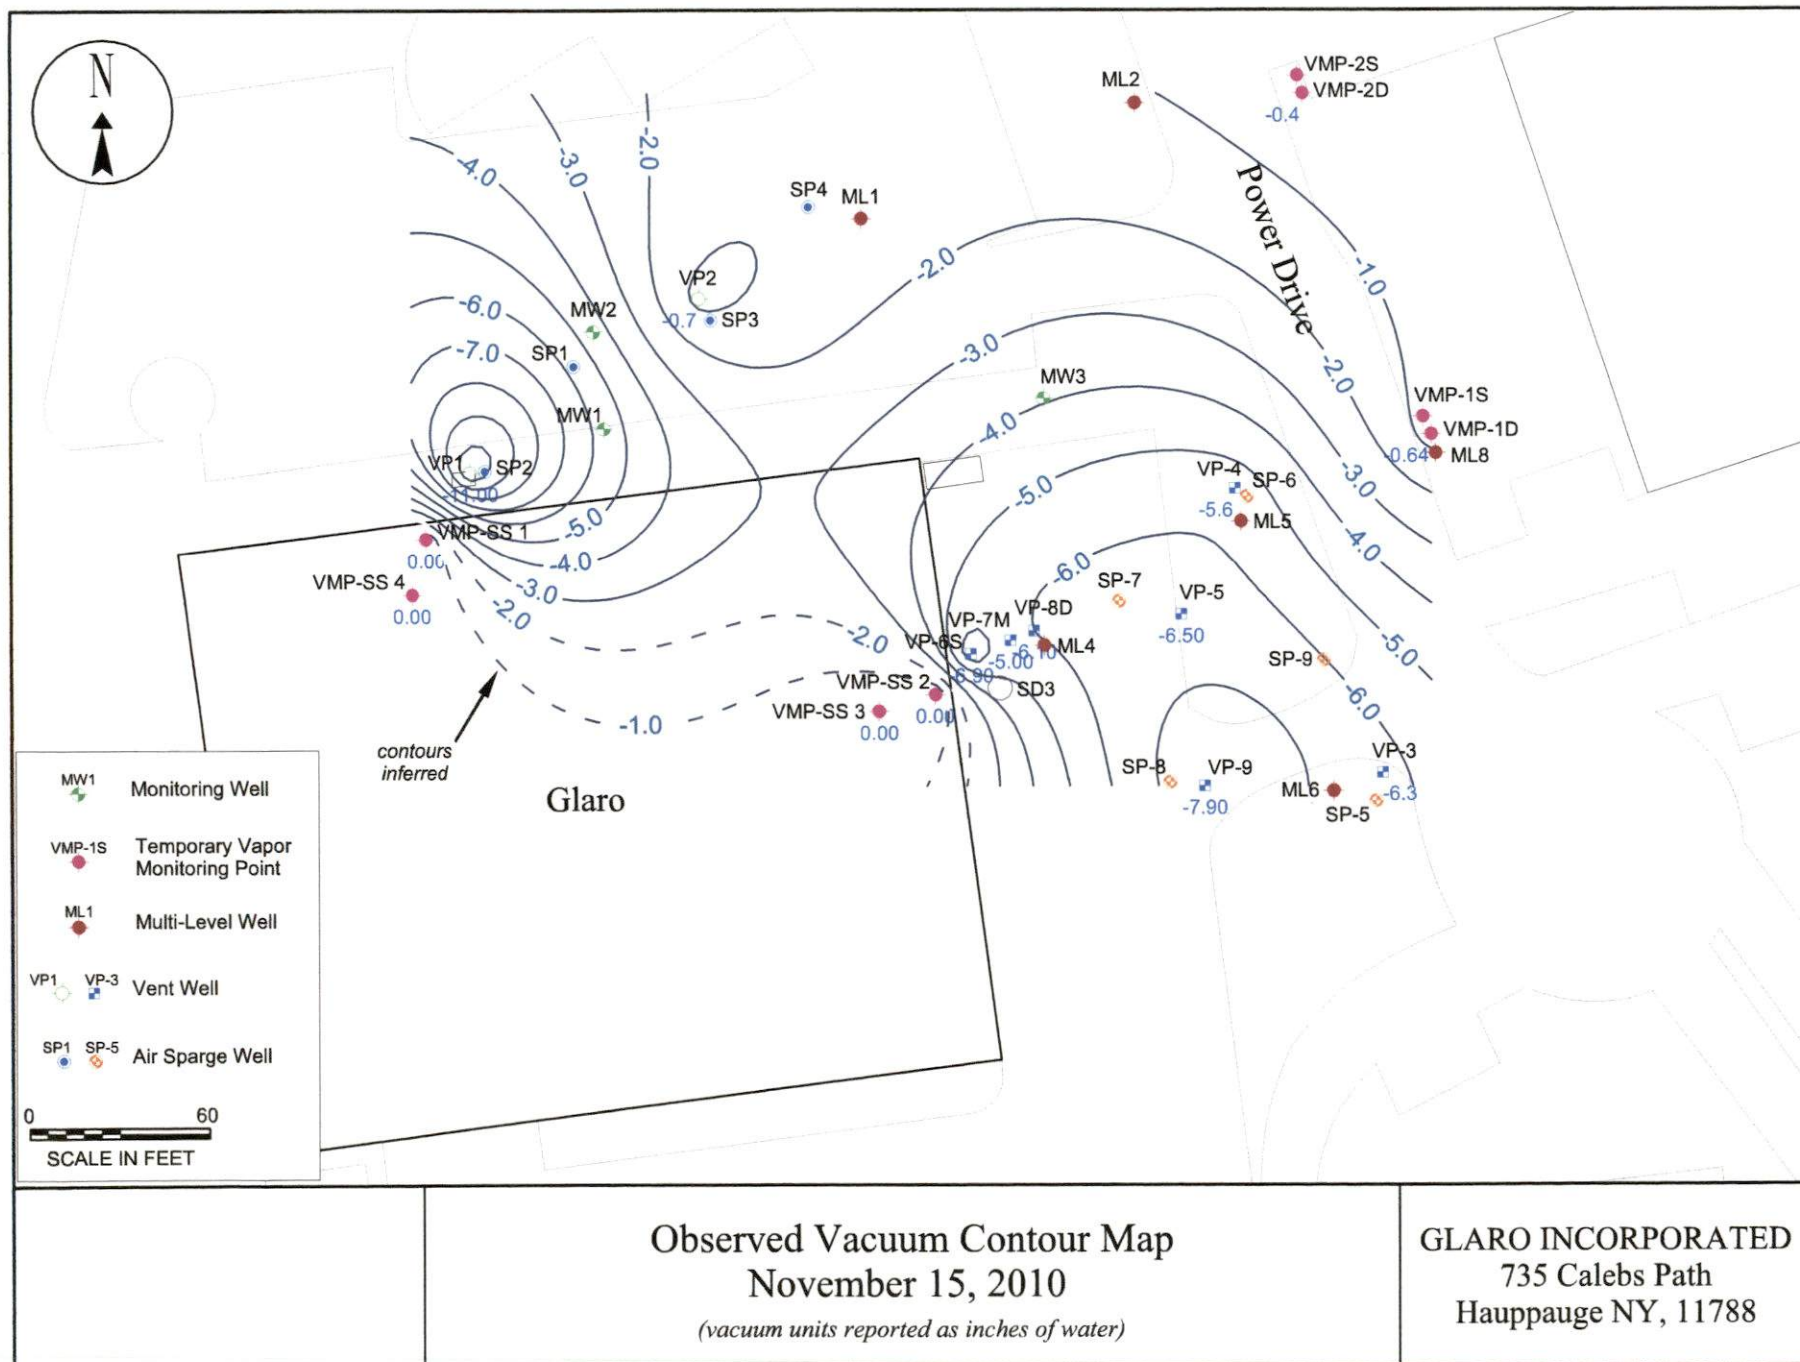
FIGURE 2

Comment: Figure 2 – Vacuum Contour Map, of the revised report indicates the zone of influence based upon vacuum measurements collected on November 15, 2010. Figure 3 indicates the site property boundaries.

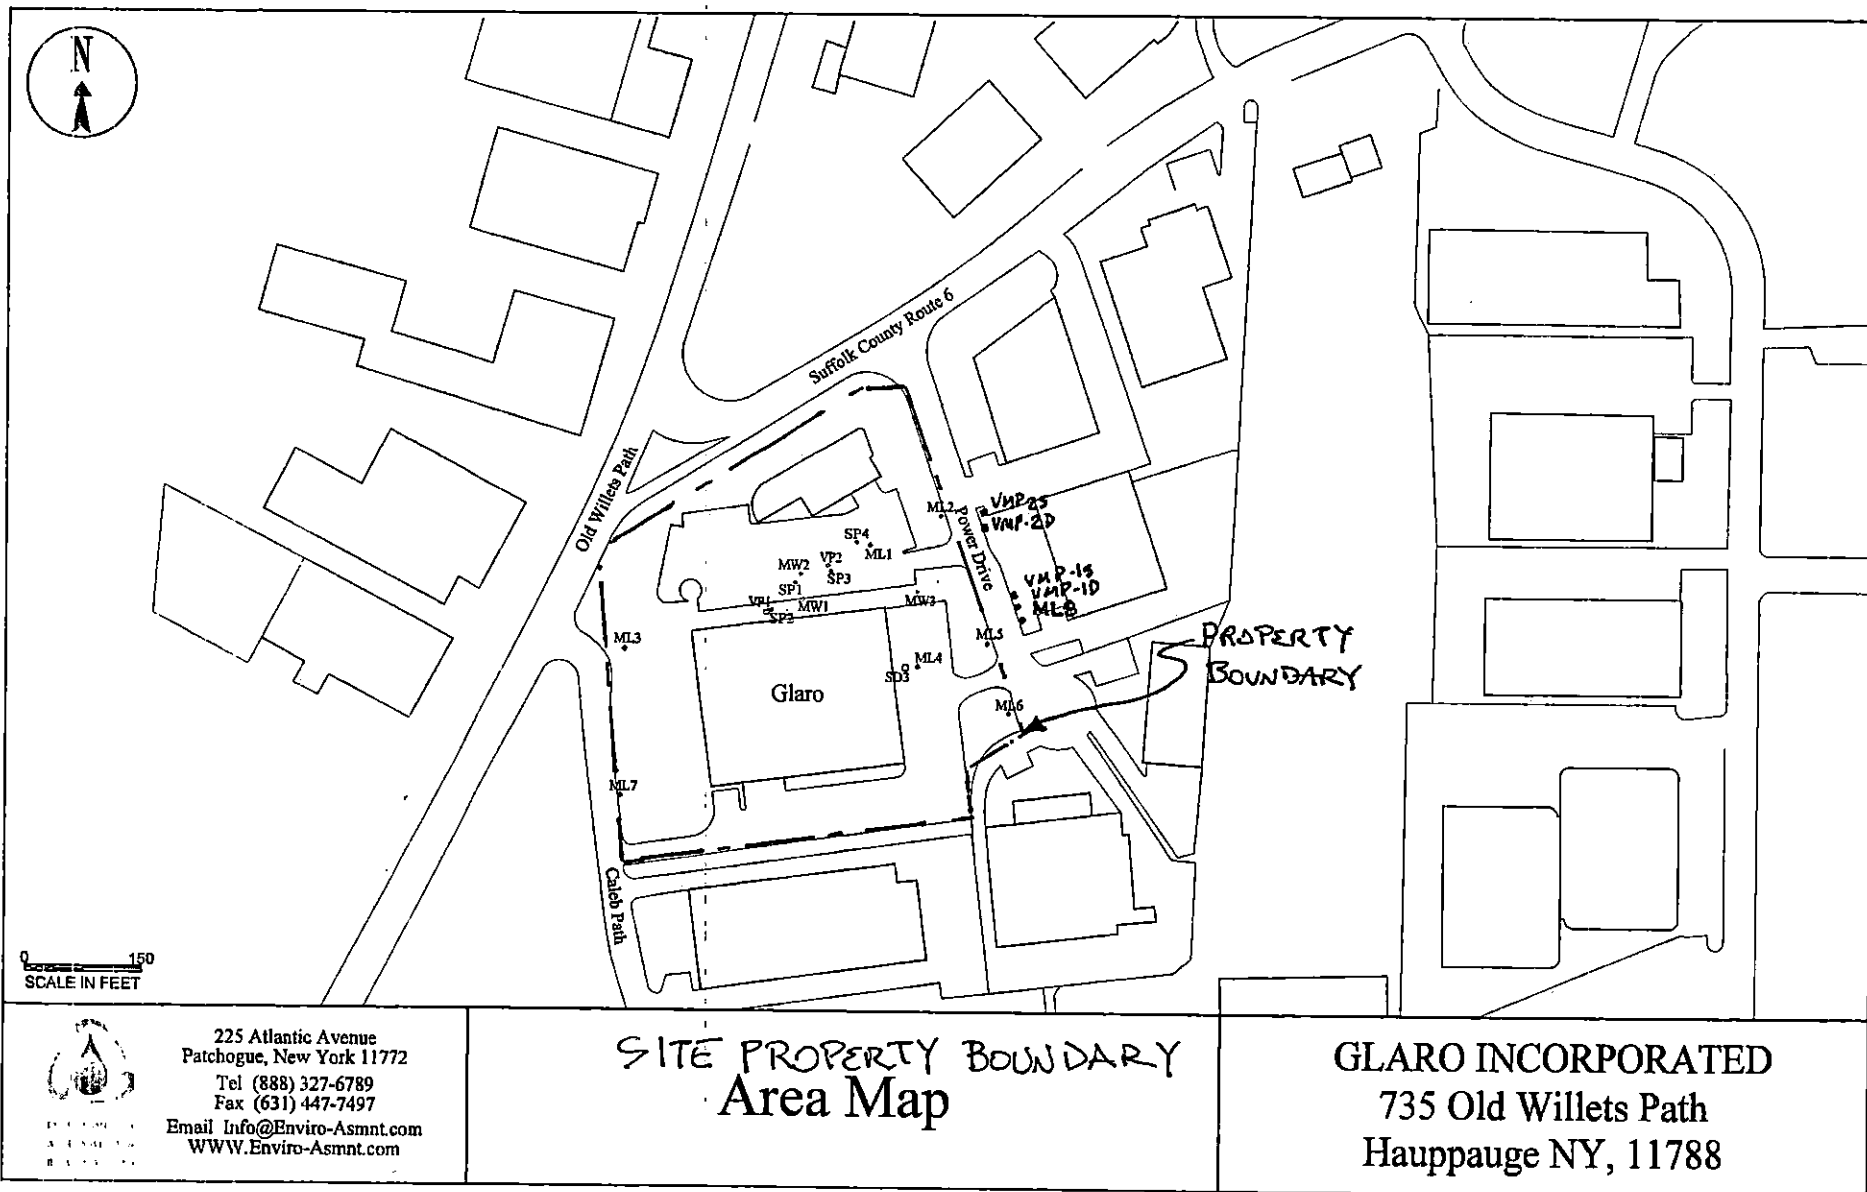
FIGURE 3

Comment: Figure 3 of the revised report indicate the site property boundaries relative to the building and soil gas points and the locations of all previously installed exterior soil gas sampling points which are all permanent. A table presenting all sample results will be provided shortly as soon as the environmental data is compiled in an approved electronic deliverables format.

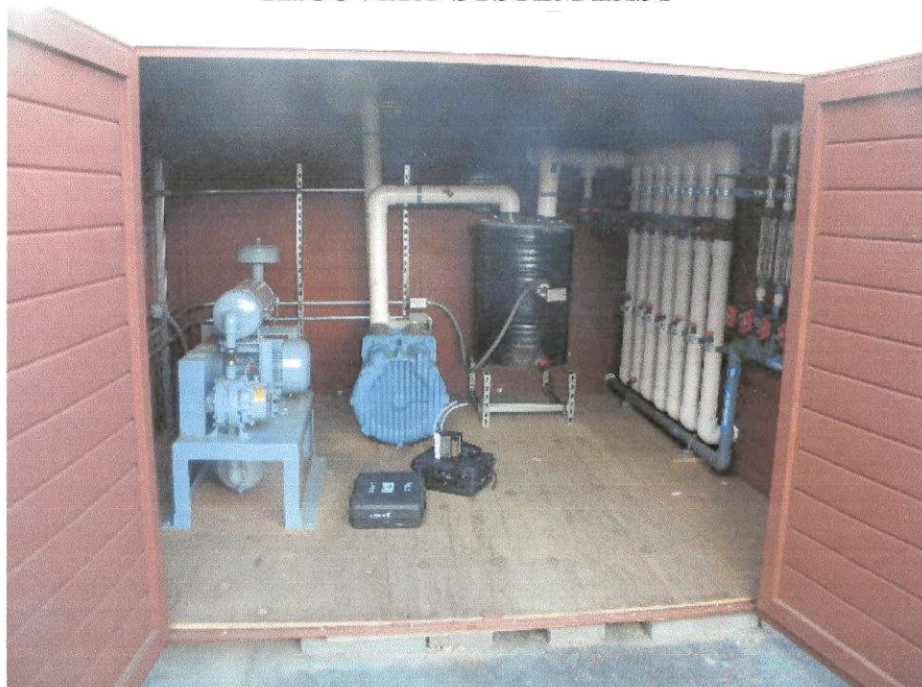
The two (2) exhaust pipes that are located on the northerly and easterly sides of the Glaro structure satisfy and exceed the above-noted criteria (See Appendix - Photolog for photos of systems).

RECOVERY SYSTEM EAST

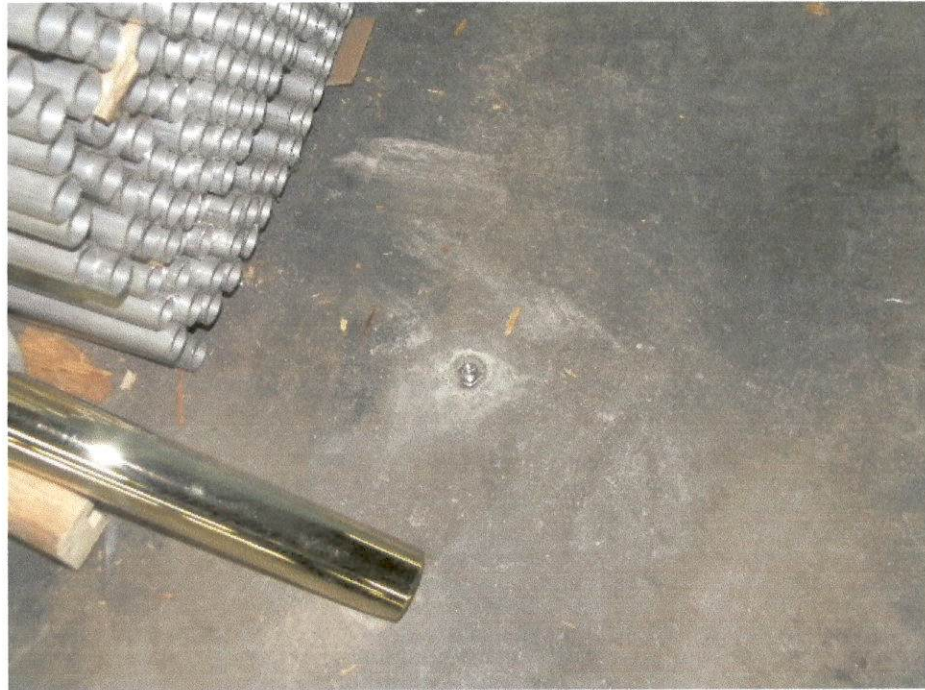
PERMANENT SOIL VAPOR POINT (TYPICAL)

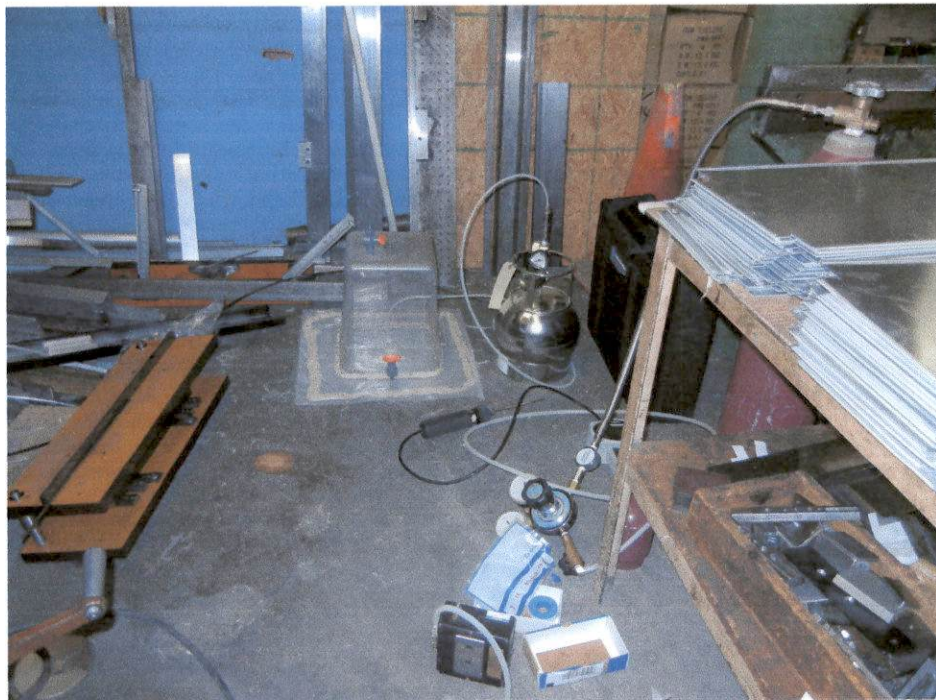
SUB-SLAB INTERIOR SAMPLING (TYPICAL)

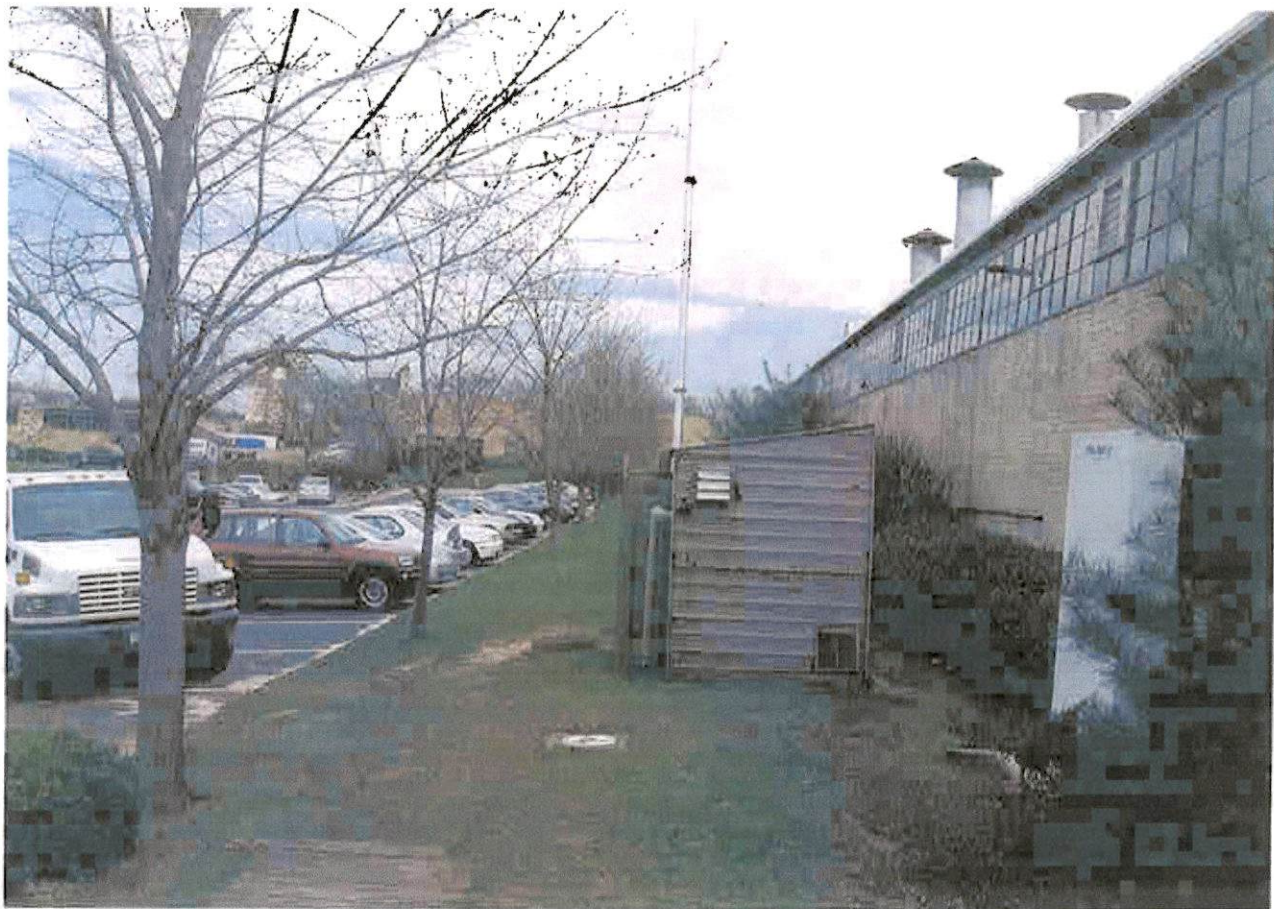
RECOVERY SYSTEM NORTH
