QUARTERLY OPERATION AND MAINTENANCE REPORT – FIRST QUARTER 2021

Active Industrial Uniform Superfund Site

63 West Merrick Road
Lindenhurst, New York

NYSDEC Site Number: 152125

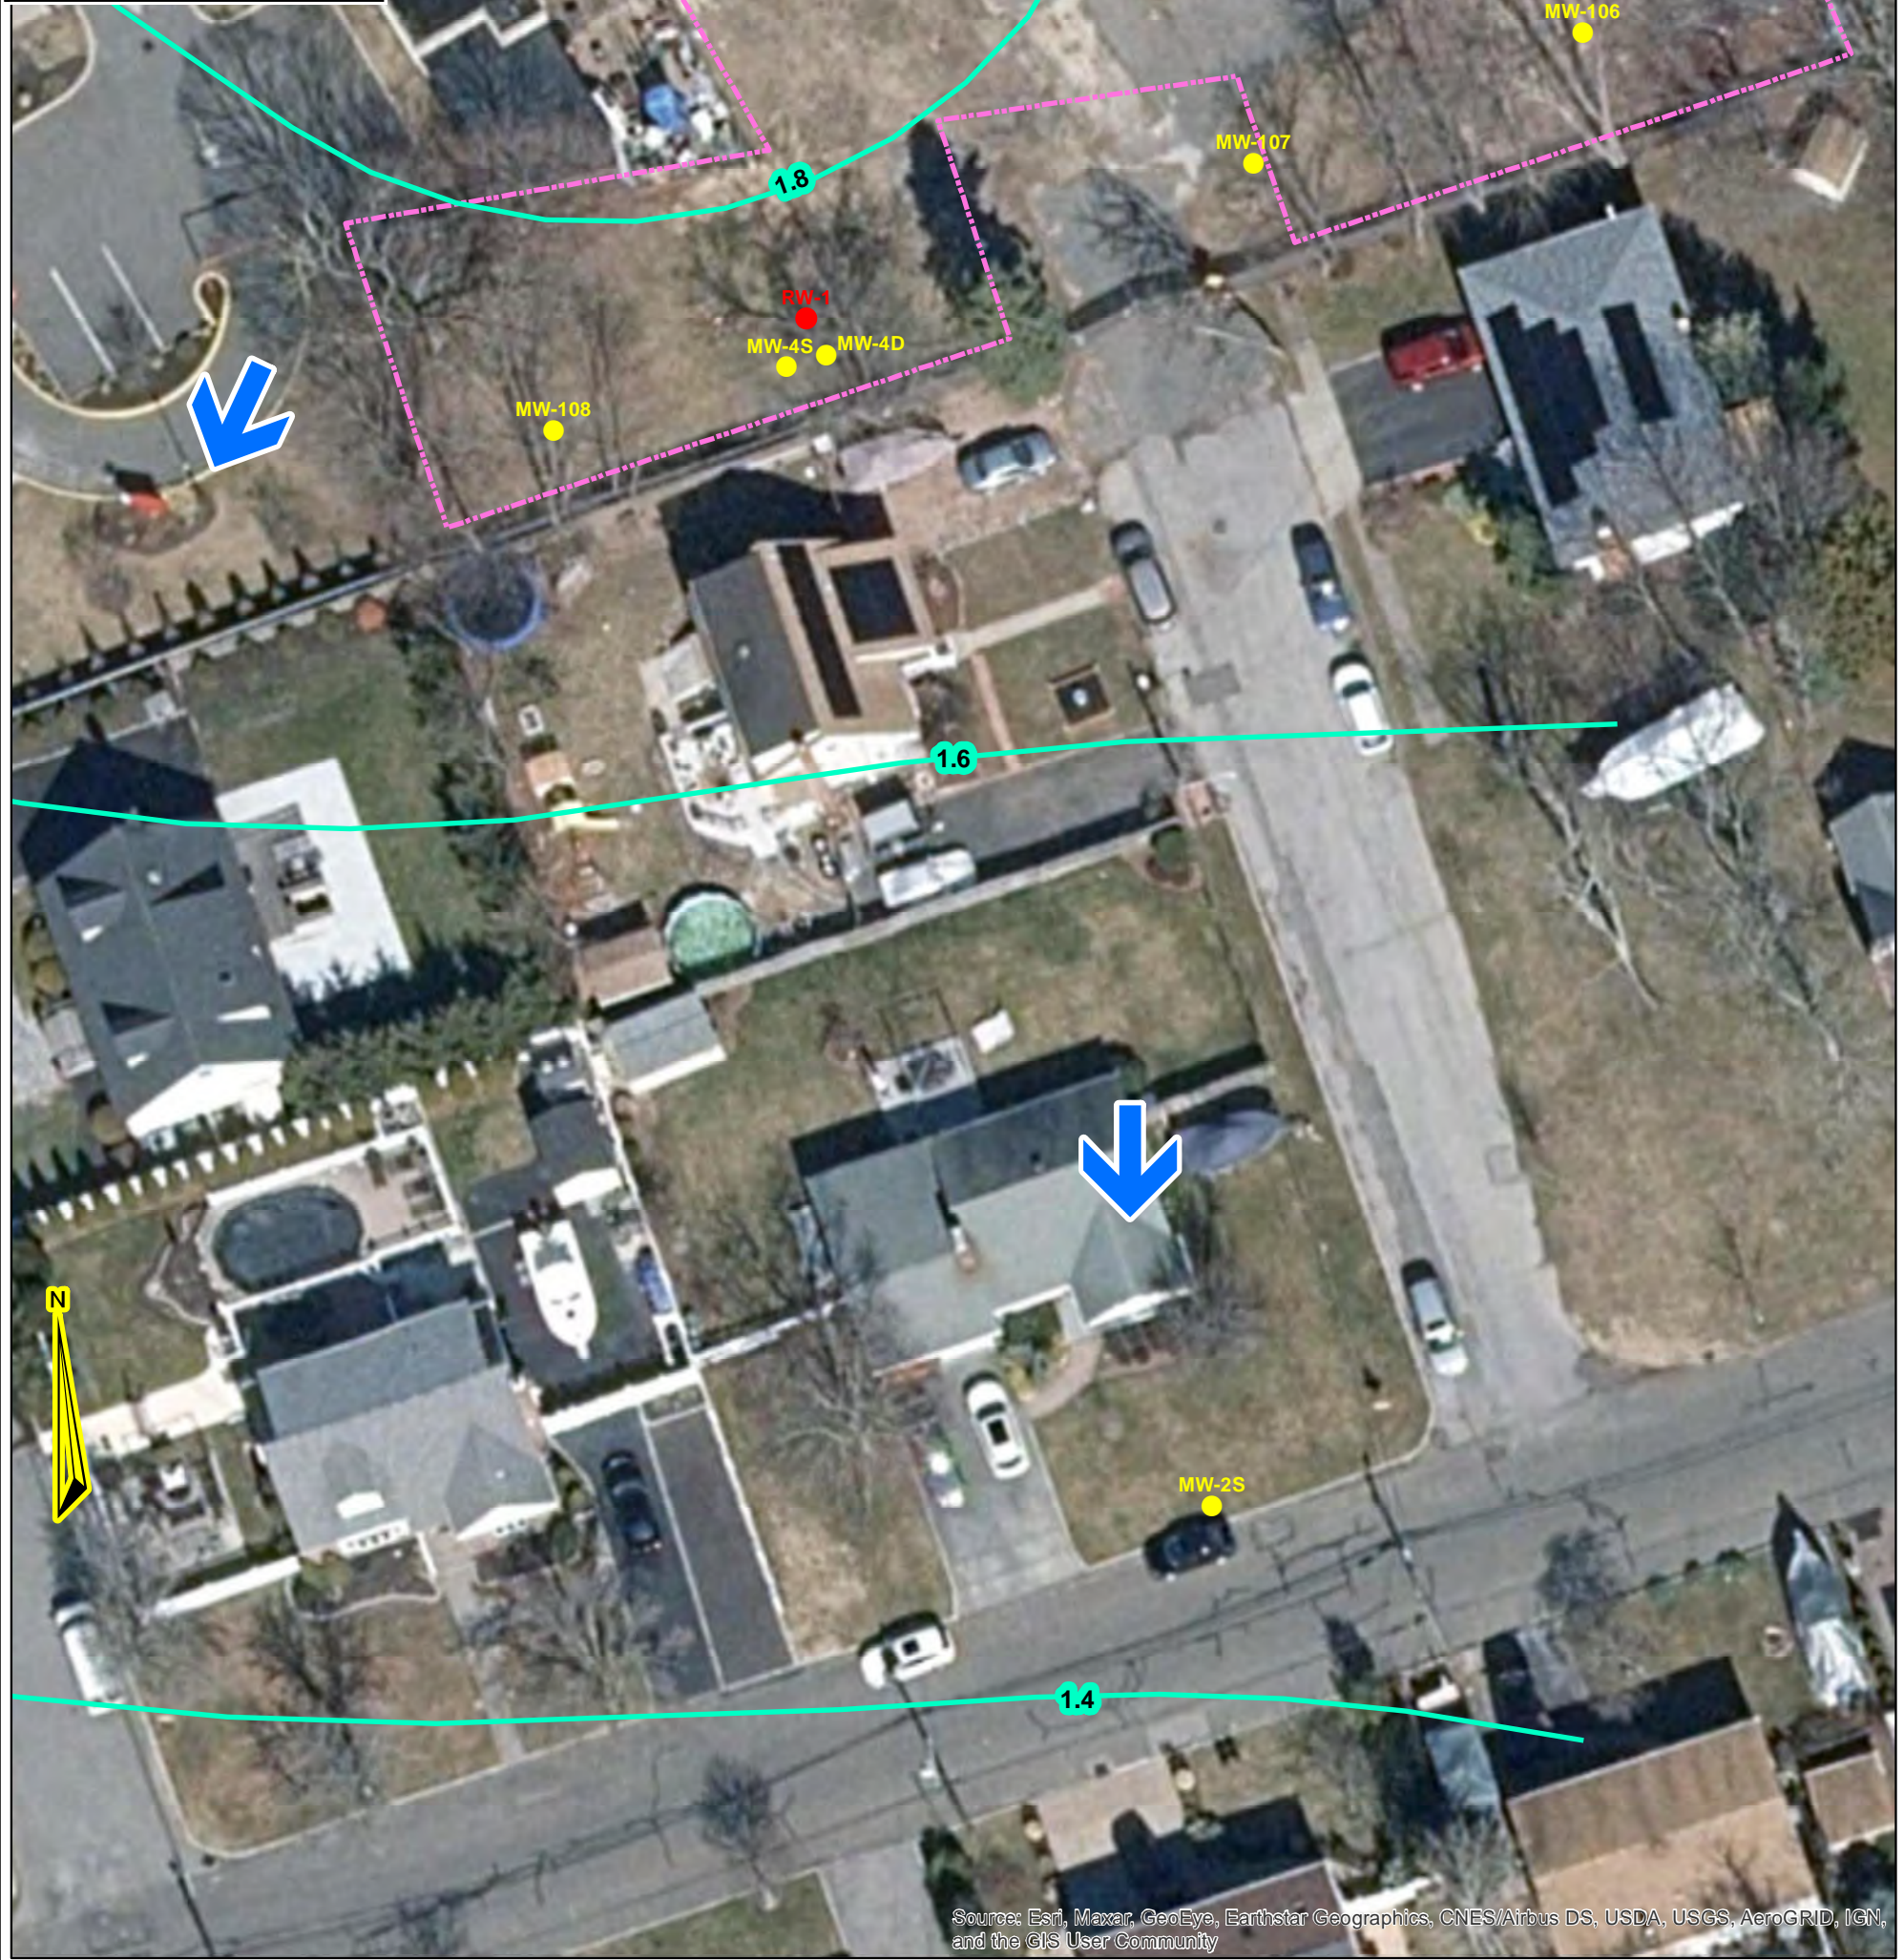
Depth to groundwater ranged from 0.71 (in MW-109) to 9.76 (in RW-1) feet below ground surface, as measured during the January 2021 groundwater sampling event. Groundwater flows predominantly to the south. Groundwater contours and interpreted flow direction are shown on **Figure 4**.

Monitoring Well ID	Groundwater Elevation, feet
MW-101	1.9
MW-102	1.89
MW-103	1.86
MW-104	1.97
MW-105	1.79
MW-106	1.76
MW-107	1.73
MW-108	1.71
MW-109	0.5
MW-111	1.15
MW-2S	1.43
MW-4D	1.7
MW-4S	1.7
MW-5S	1.89
RW-1	1.71
RW-2	0.41

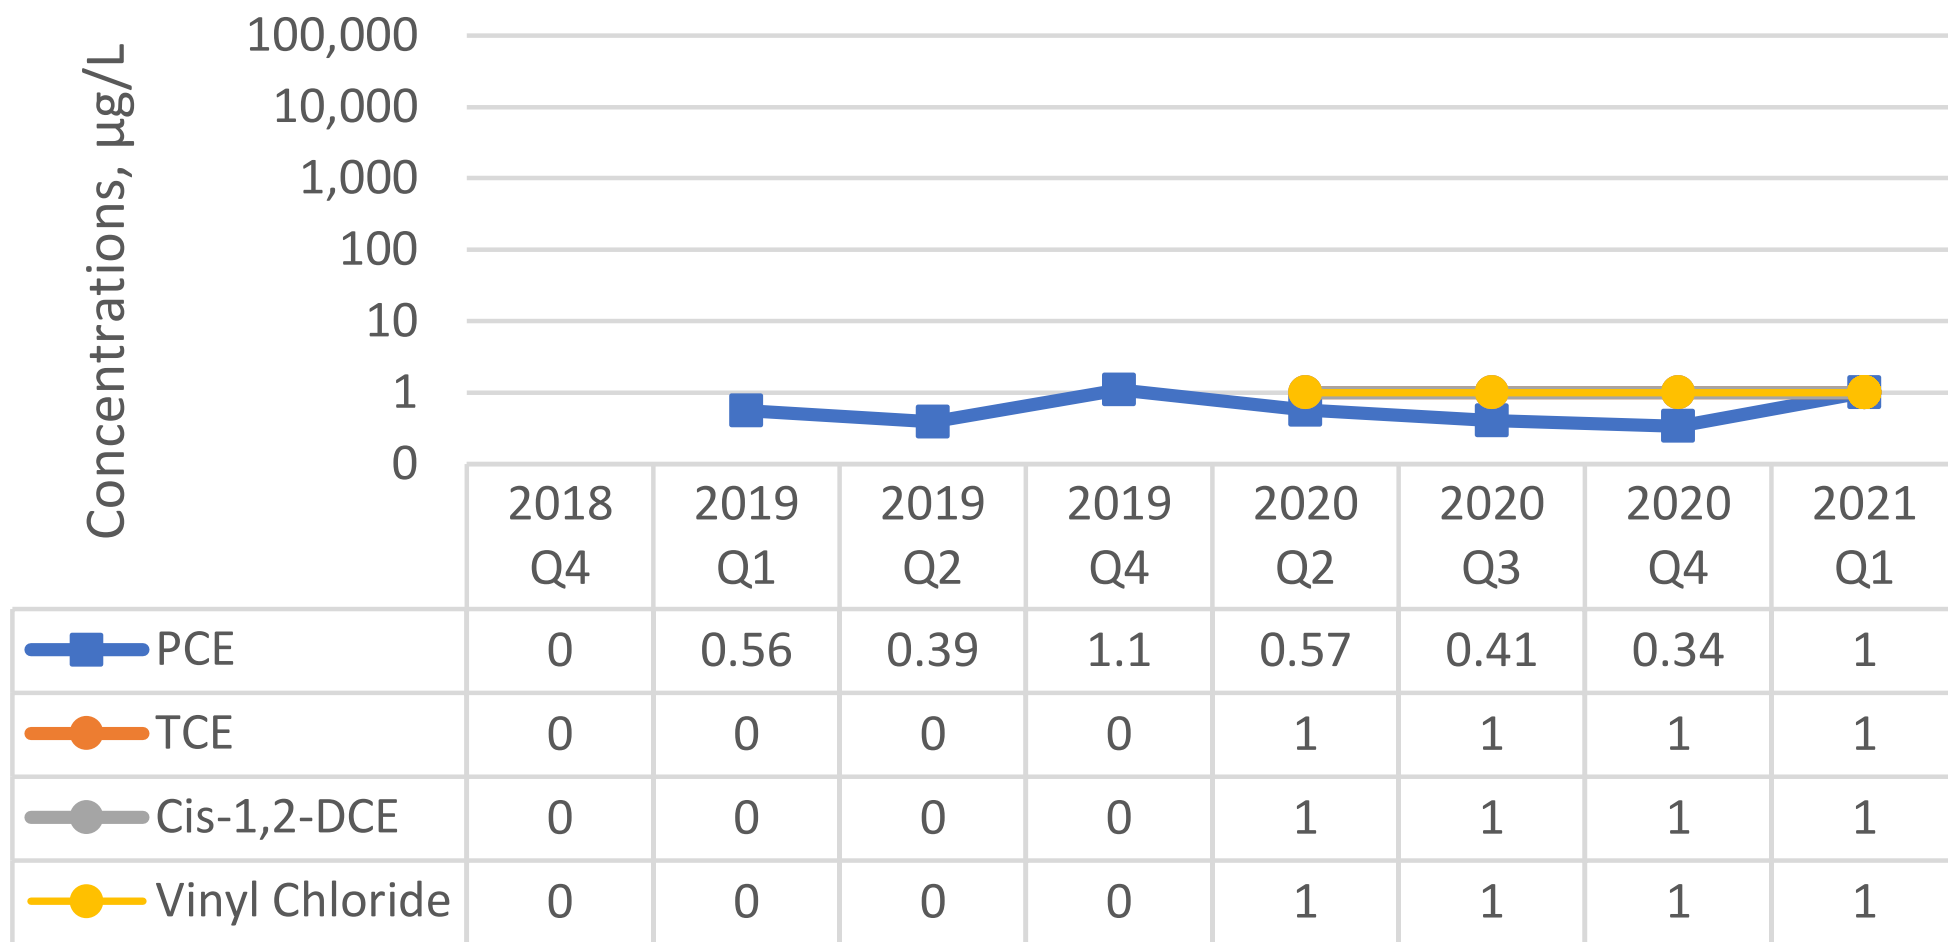
MW-5S

- MW-5S: The monitoring well is located in the western portion of the Site and screened at 14 to 24 fbg. None of the contaminants of concern were detected above the laboratory detection limits.

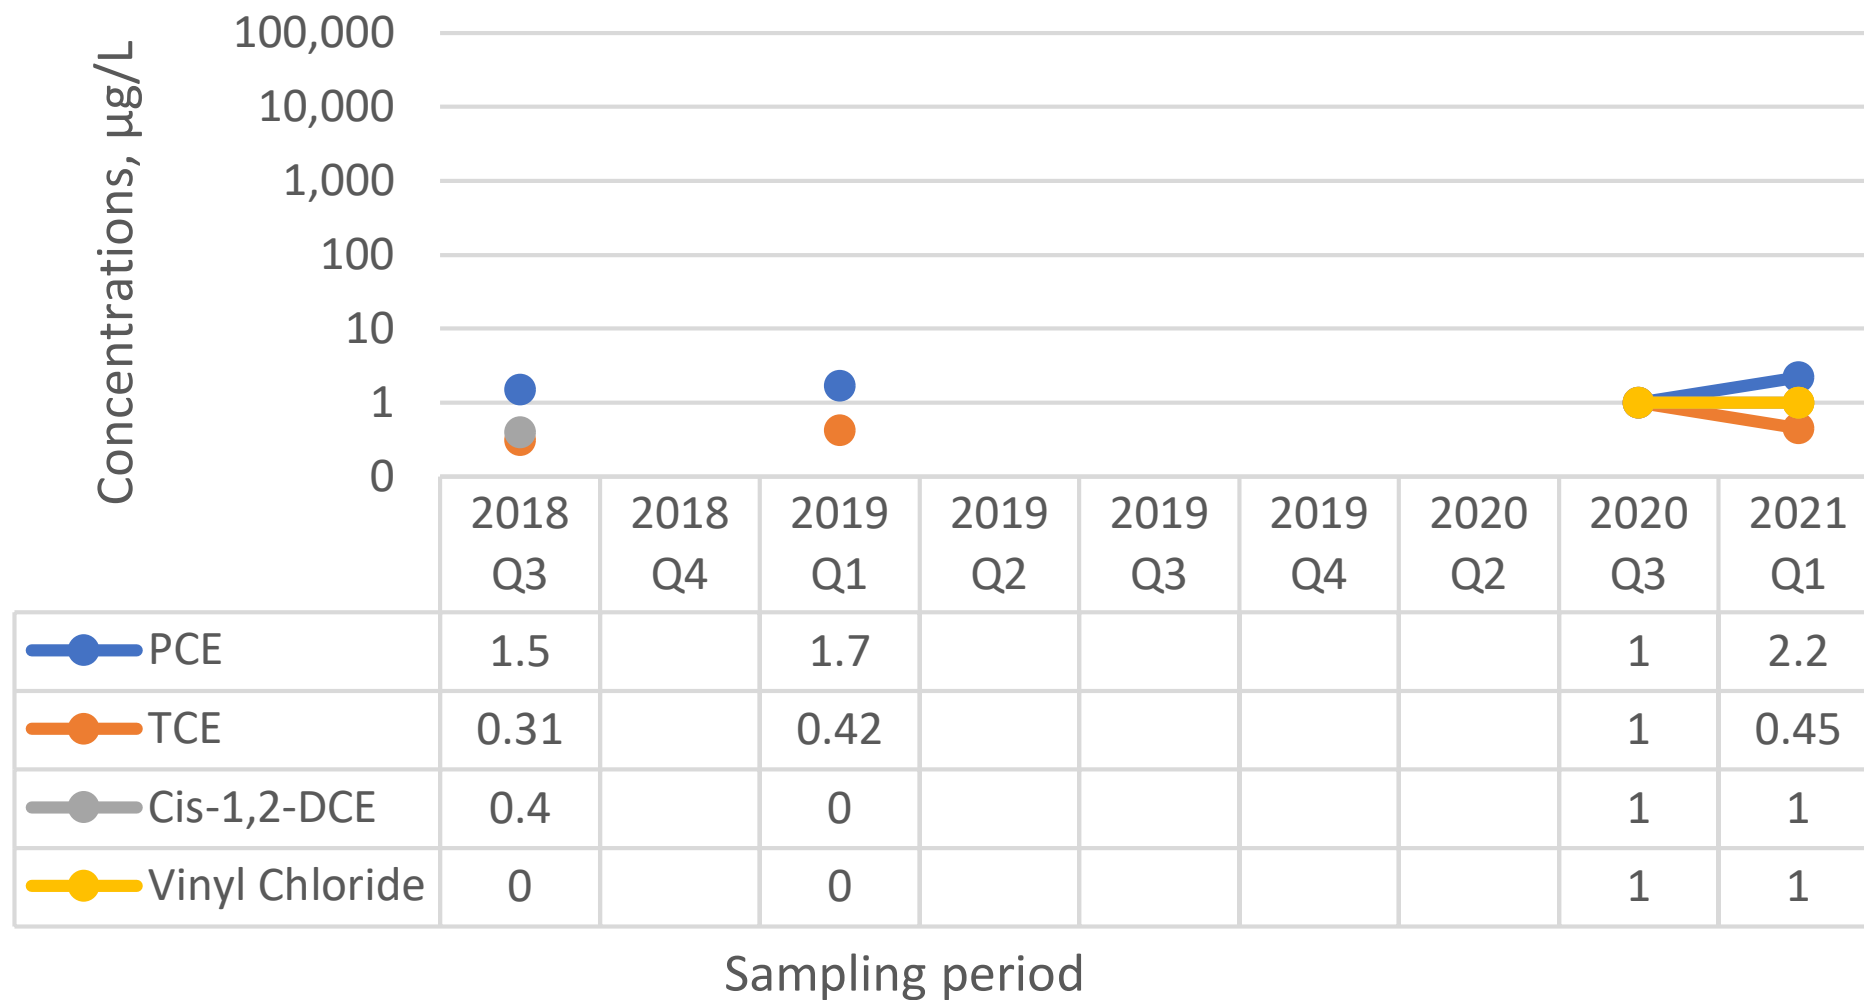
MW-102

- MW-102: The monitoring well is located on the north-central portion of the Site and screened at 5-15 feet bgs. PCE and TCE were detected at concentrations below the Class GA Standards. cis-1,2-DCE and vinyl chloride were not detected above the laboratory detection limits.

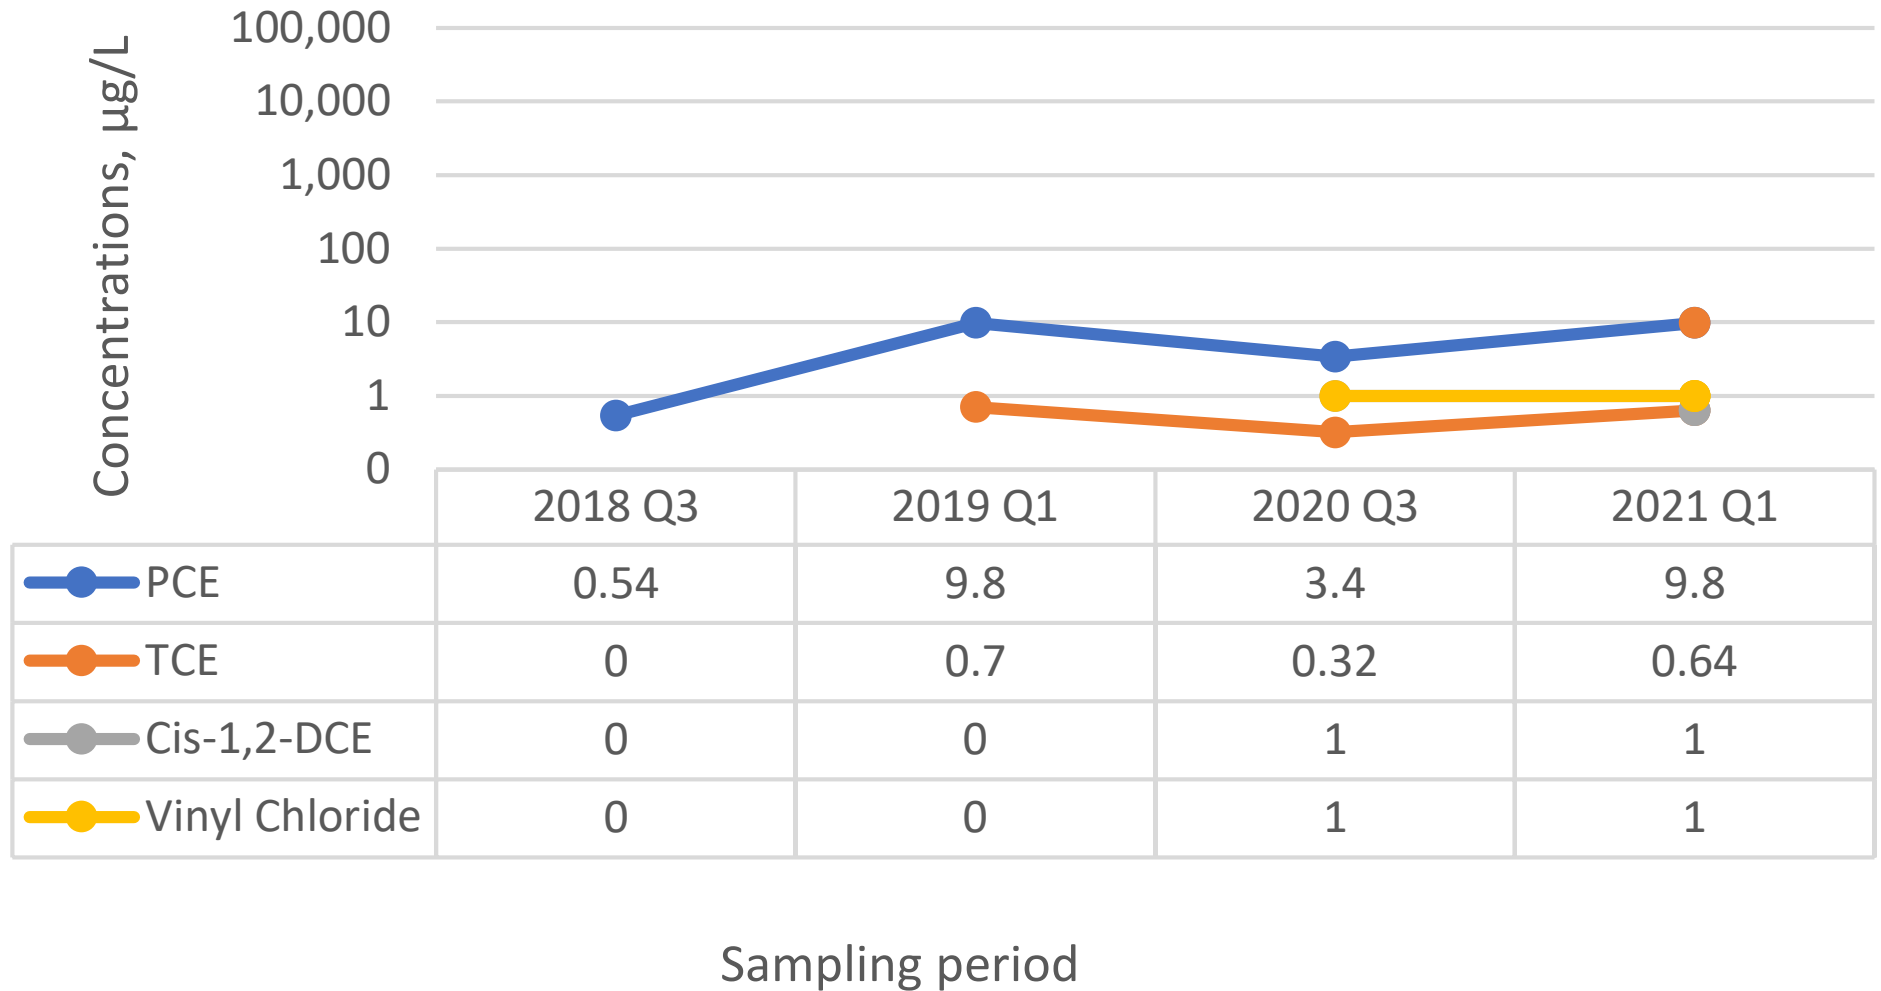
MW-108

- MW-108: The monitoring well is located in the southwestern corner of the Site and screened at 5 to 15 fbg. PCE exceeded the Class GA standards. TCE was detected at concentrations below the Class GA Standards. Cis-1,2-DCE and vinyl chloride were not detected above the laboratory detection limits.

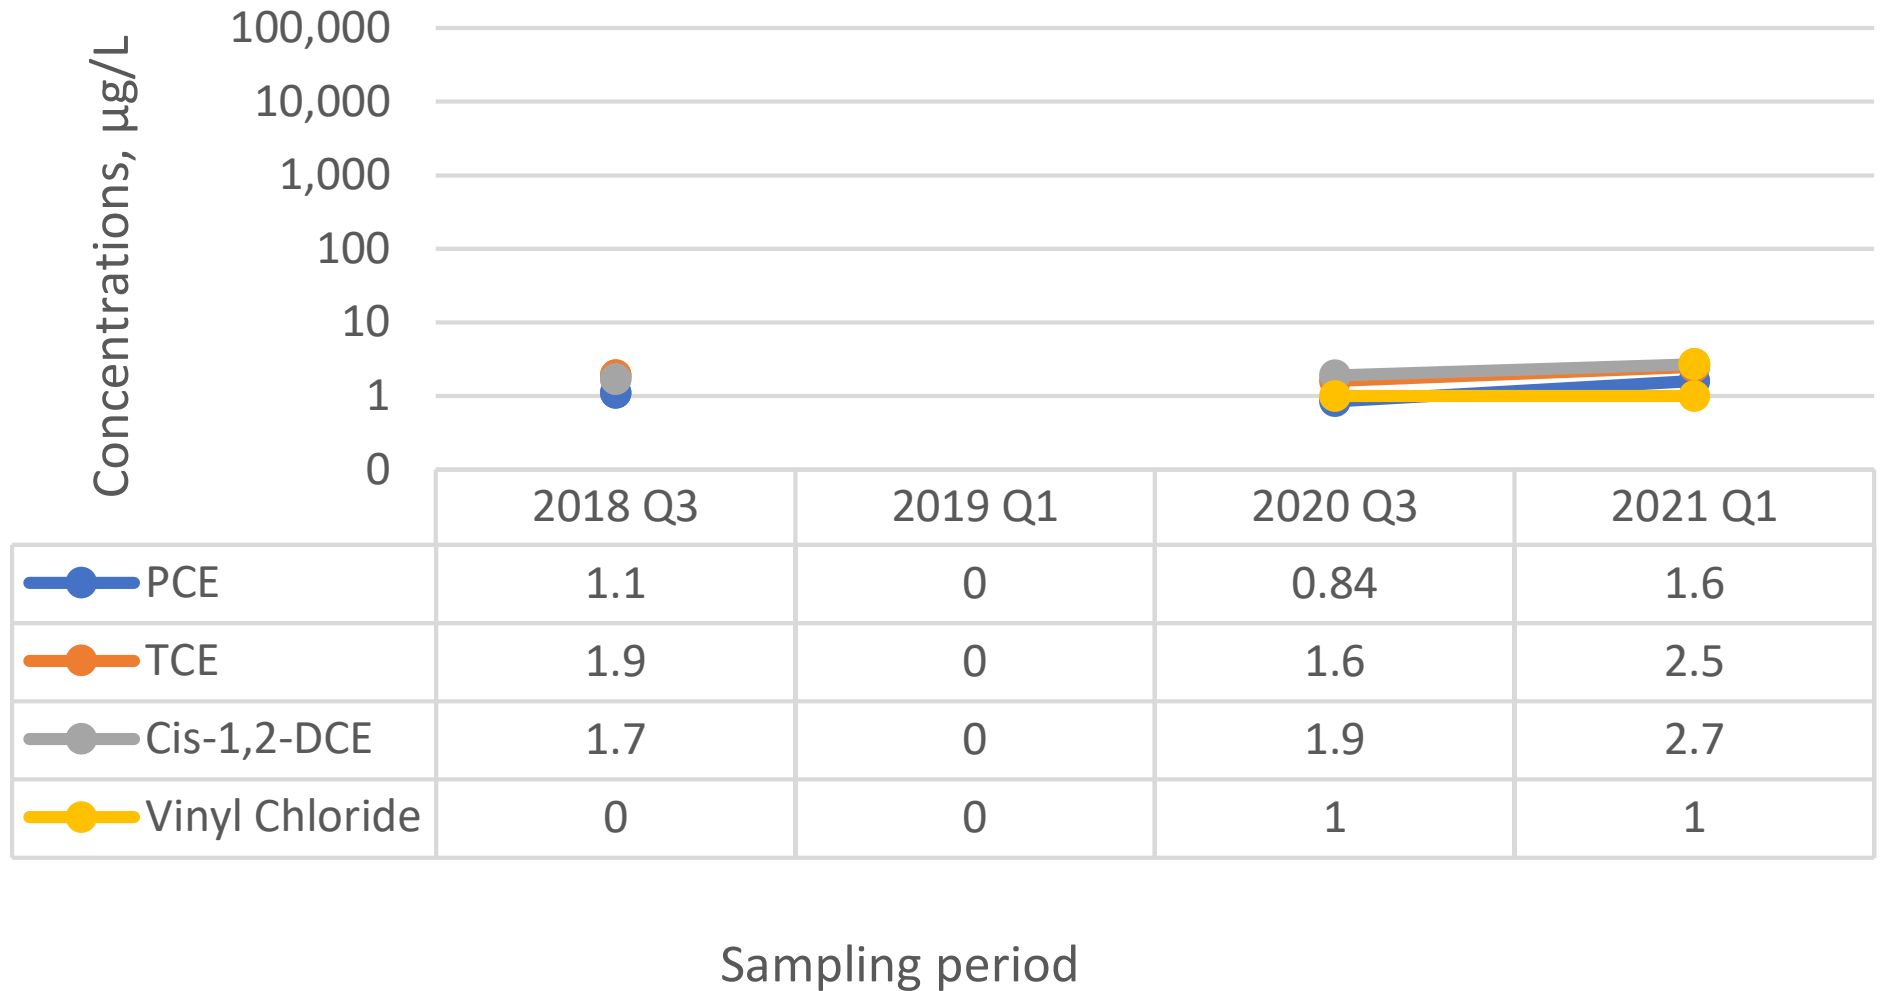
MW-109

- MW-109: The monitoring well is located on Orchard Street, approximately 1,700 feet to the southwest of the Site and screened at 25-35 feet bgs. PCE, TCE, and cis-1,2-DCE were detected below the Class GA Standards. Vinyl chloride was not detected above the laboratory detection limits.
