QUARTERLY OPERATION AND MAINTENANCE REPORT – SECOND QUARTER 2021

Active Industrial Uniform Superfund Site

63 West Merrick Road
Lindenhurst, New York

NYSDEC Site Number: 152125

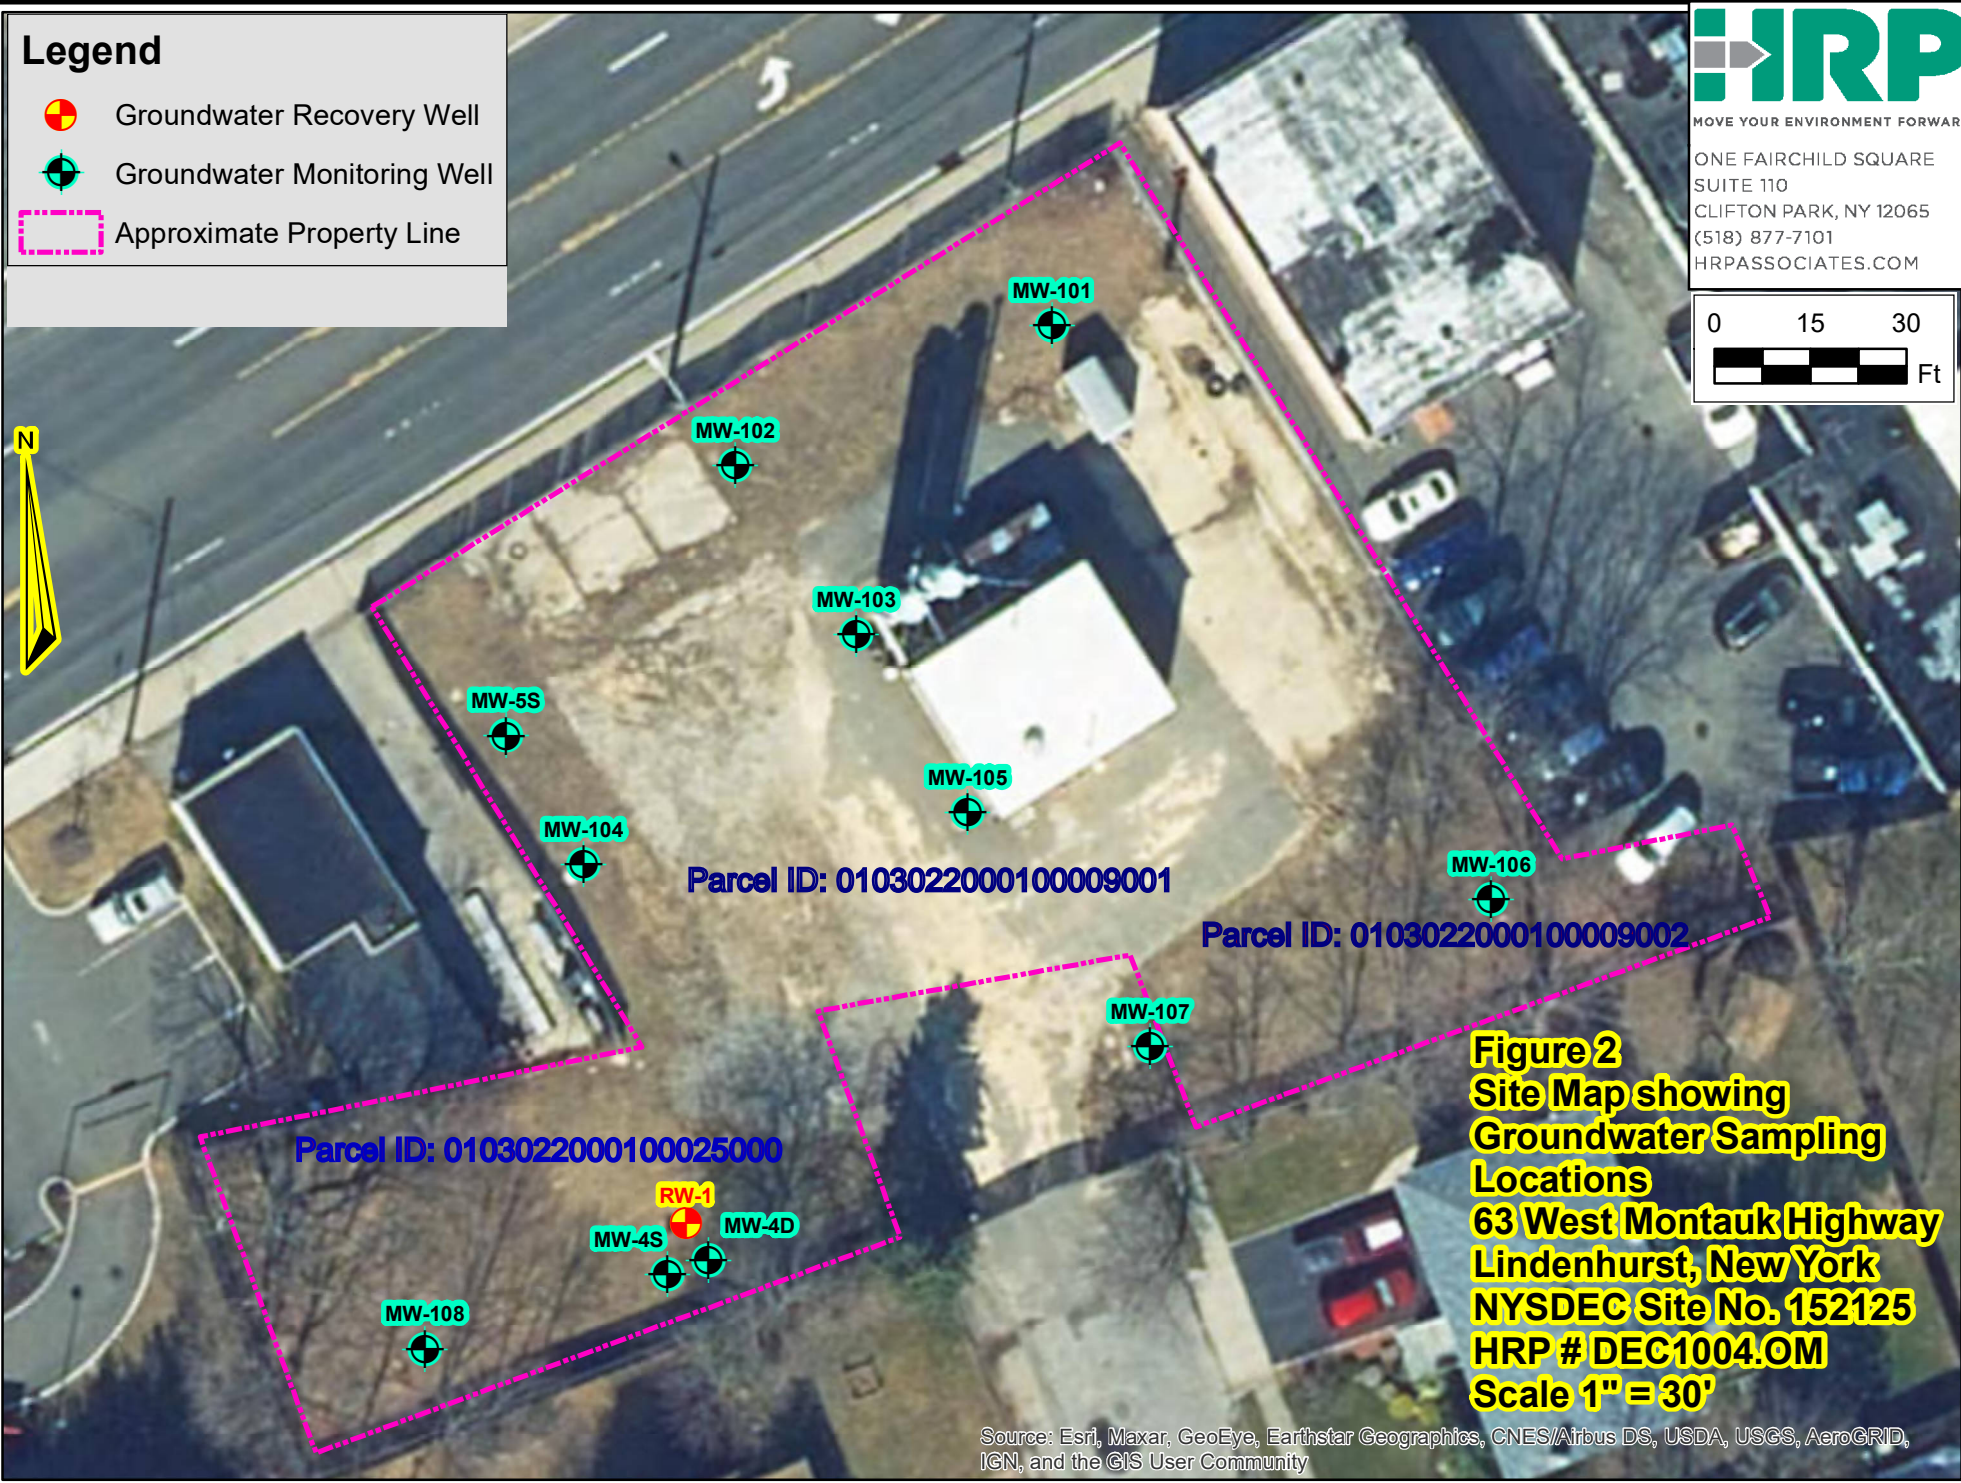
Figure 2
Site Map showing
Groundwater Sampling
Locations
63 West Montauk Highway
Lindenhurst, New York
NYSDEC Site No. 152125
HRP # DEC1004.OM
Scale 1" = 30'

Site features are depicted on **Figure 2**, and general Site area features are shown on **Figure 3**.

The GWE&T consists of two 4-inch diameter extraction wells, RW-1 and RW-2, designed to pump groundwater to the treatment system housed in the system remediation building. RW-1 is located in the southwestern portion of the Site. RW-2 is located off-site, approximately 1,500 feet southwest of the Site (see **Figures 2 and 3**).

The monitoring program for the Active Industrial Uniform Superfund Site includes periodic sampling of select groundwater monitoring wells and two extraction wells (see Table 1 below), including 11 on-site monitoring wells (MW-101 through MW-108, MW-4D, MW-5S, and RW-1) and four off-site monitoring wells (MW-109, MW-111, MW-2S, and RW-2). The locations of the wells are depicted on **Figures 2** and **3**.

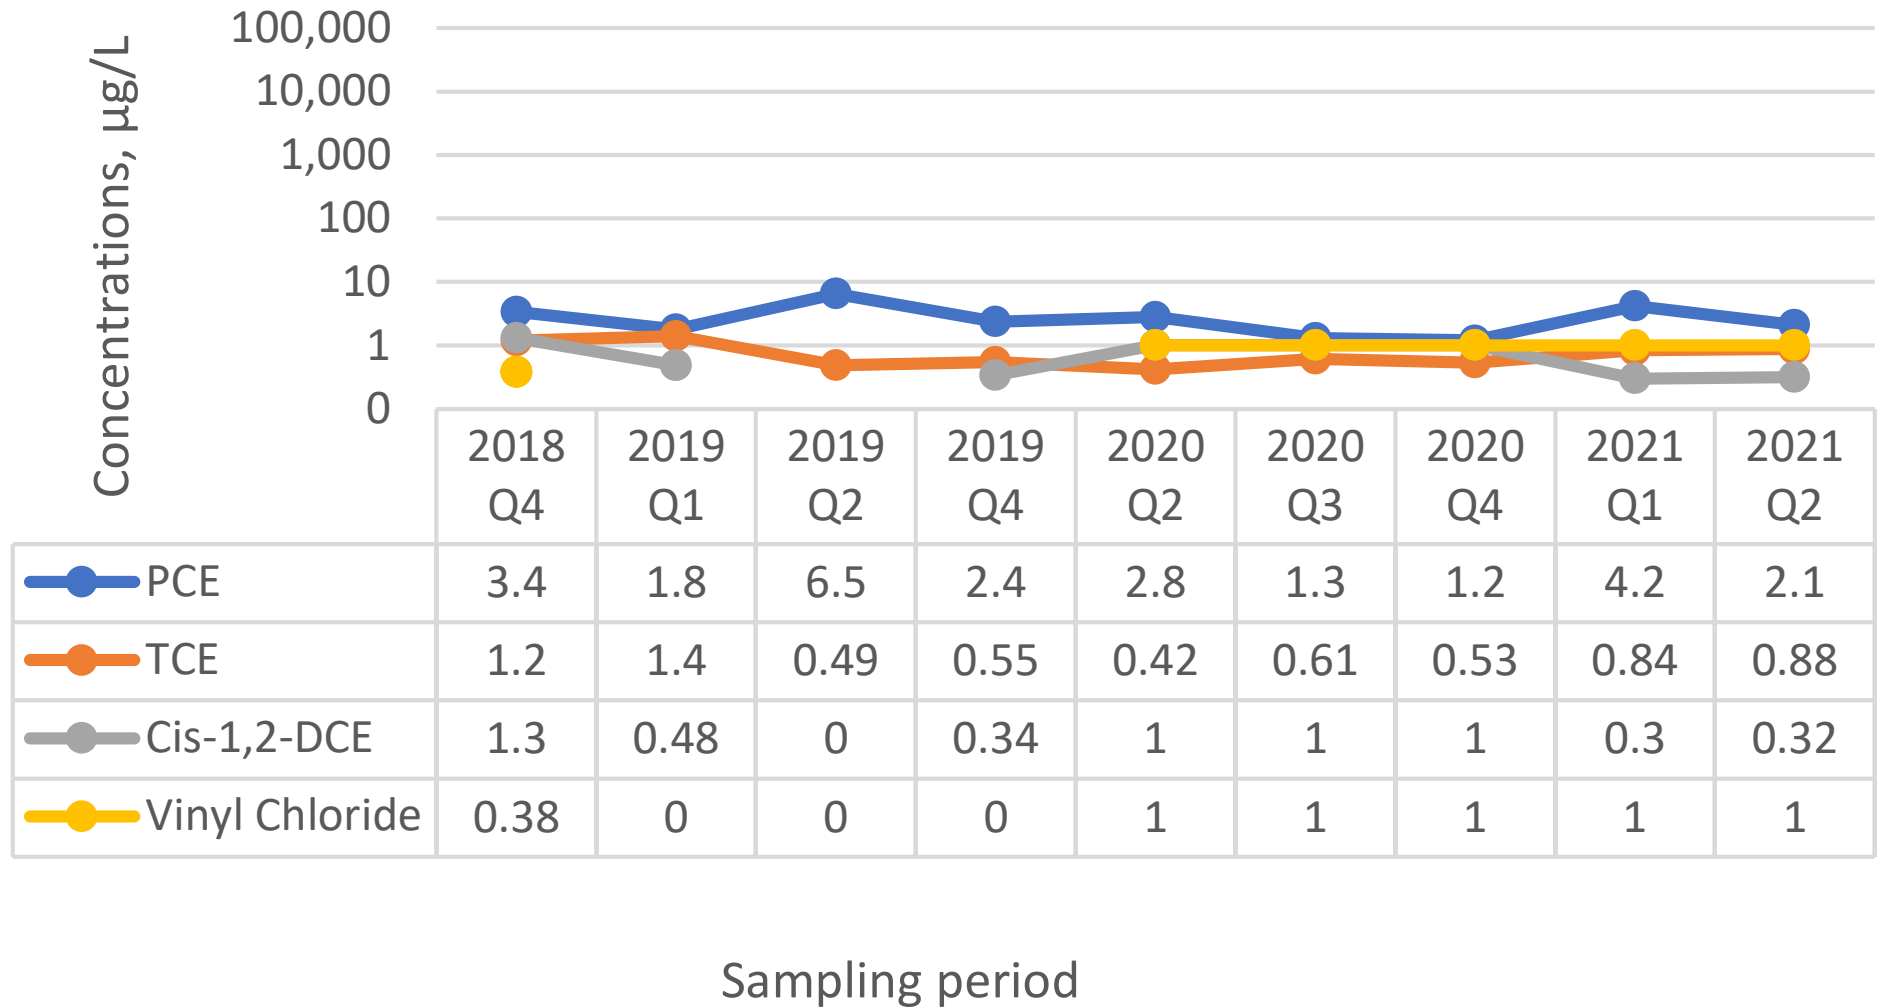
MW-107

Temporal Variations of VOCs Concentrations
Active Industrial Uniform Superfund Site #152125
63 West Merrick Road, Lindenhurst, New York
HRP# DEC1004.OM

- MW-107: The monitoring well is located in the southern portion of the Site and screened at 5 to 15 fbg. PCE, TCE, and cis-1,2-DCE were detected at concentrations below the Class GA Standards. Vinyl chloride was not detected above the laboratory detection limits.
