QUARTERLY OPERATION AND MAINTENANCE REPORT – THIRD QUARTER 2021

Active Industrial Uniform Superfund Site

63 West Merrick Road
Lindenhurst, New York

NYSDEC Site Number: 152125

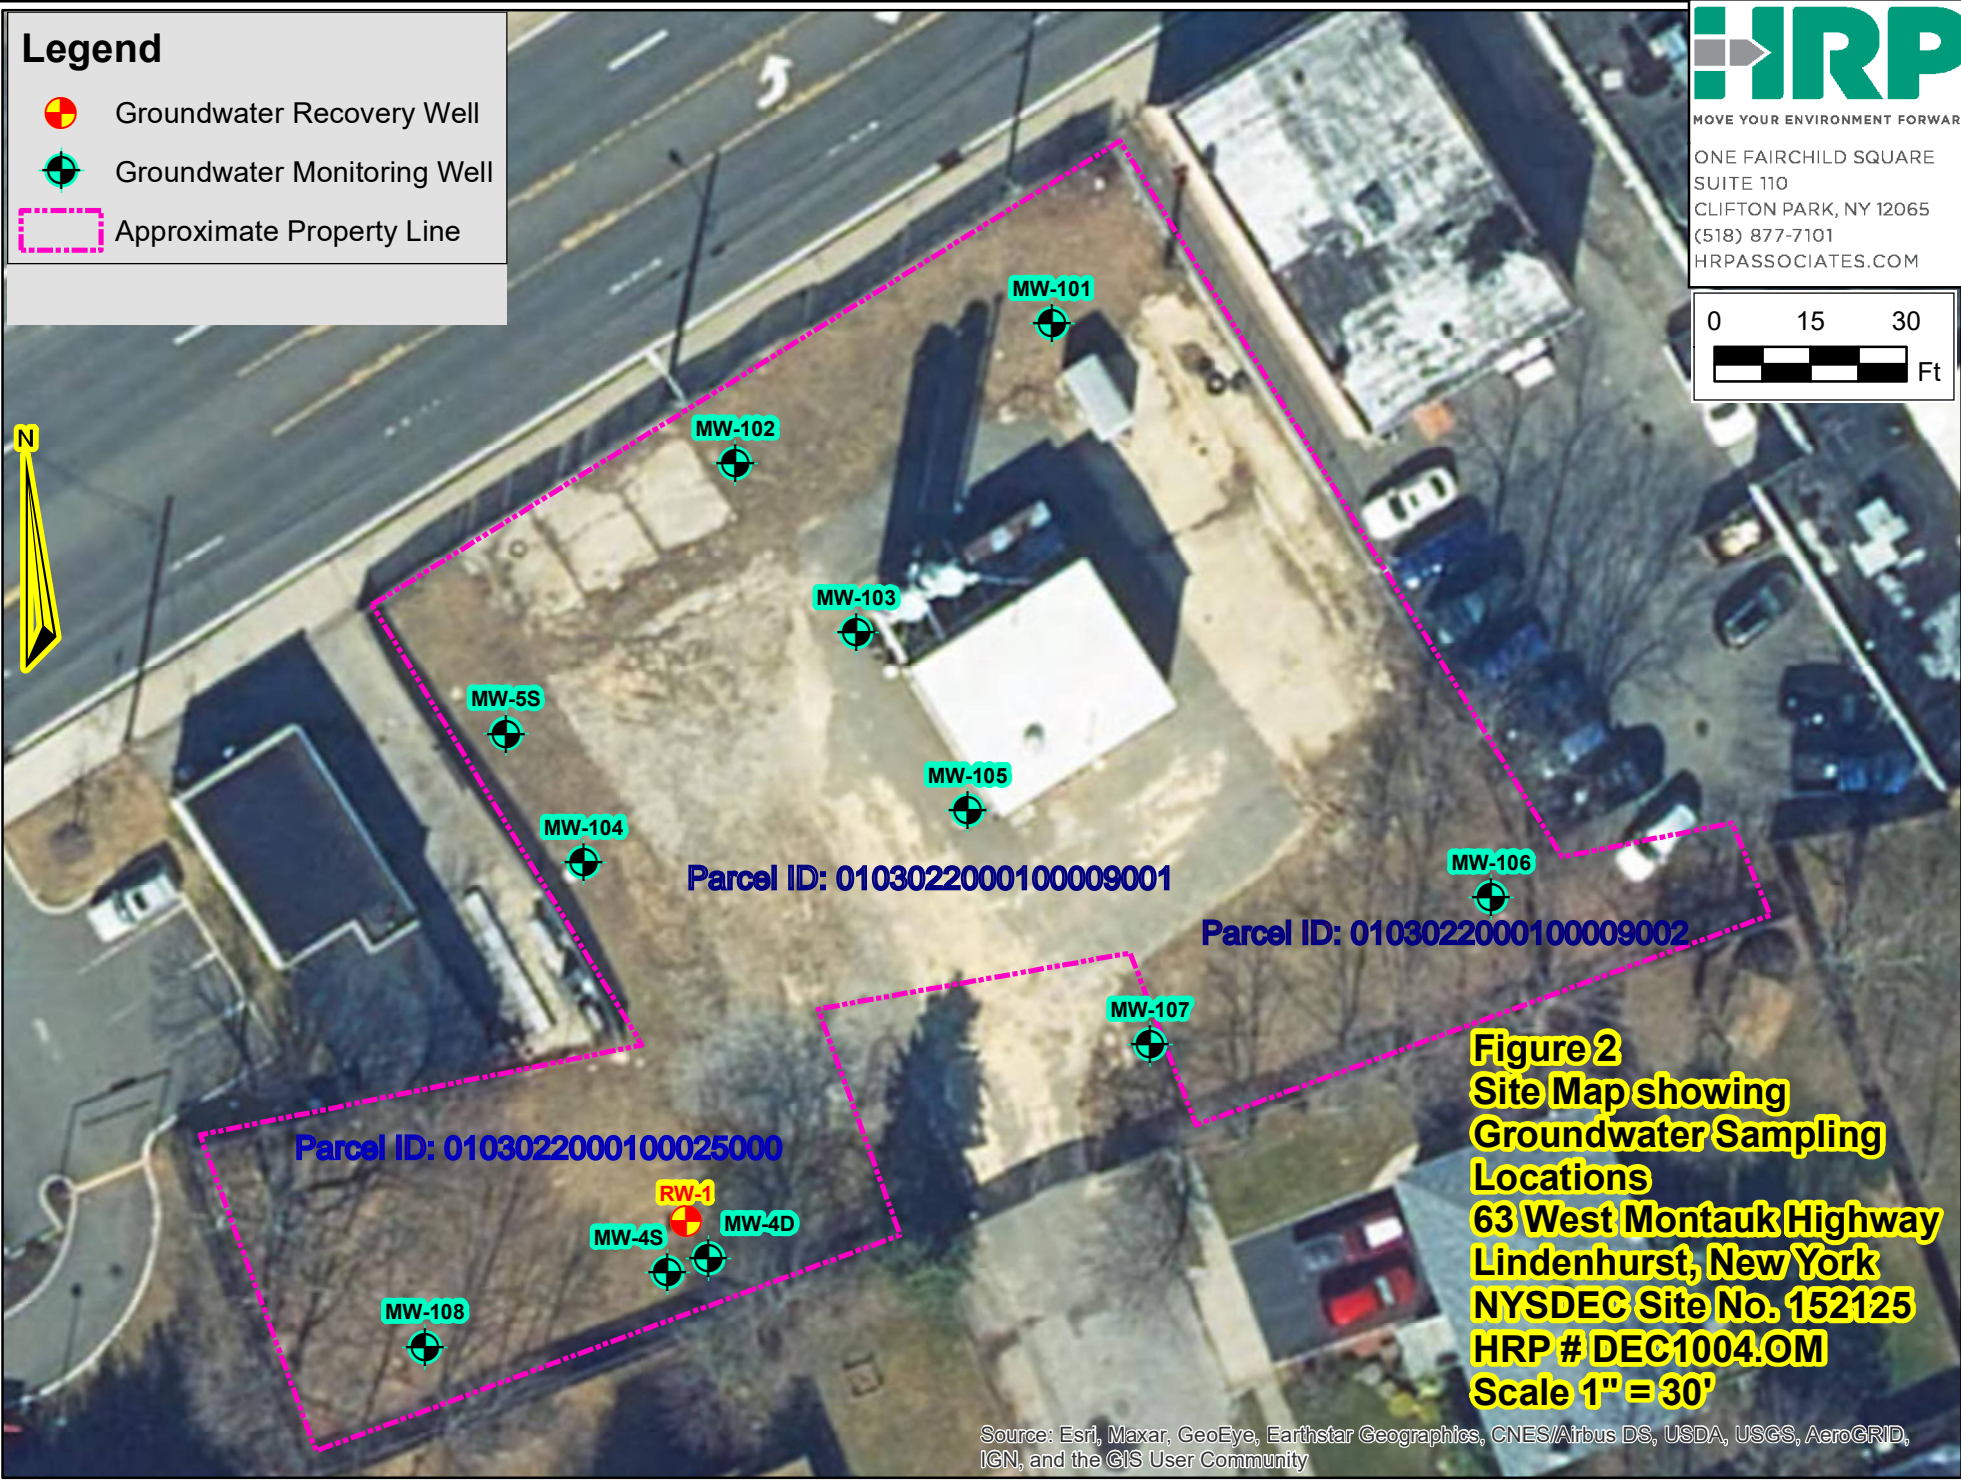
Figure 2
Site Map showing
Groundwater Sampling
Locations
63 West Montauk Highway
Lindenhurst, New York
NYSDEC Site No. 152125
HRP # DEC1004.OM
Scale 1" = 30'

Site features are depicted on **Figure 2**, and general Site area features are shown on **Figure 3**.

The GWE&T consists of two 4-inch diameter extraction wells, RW-1 and RW-2, designed to pump groundwater to the treatment system housed in the system remediation building. RW-1 is located in the southwestern portion of the Site. RW-2 is located off-site, approximately 1,500 feet southwest of the Site (see **Figures 2 and 3**).

The monitoring program for the Active Industrial Uniform Superfund Site includes periodic sampling of select groundwater monitoring wells and two extraction wells (see Table 1 below), including 11 on-site monitoring wells (MW-101 through MW-108, MW-4D, MW-5S, and RW-1) and four off-site monitoring wells (MW-109, MW-111, MW-2S, and RW-2). The locations of the wells are depicted on **Figures 2** and **3**.

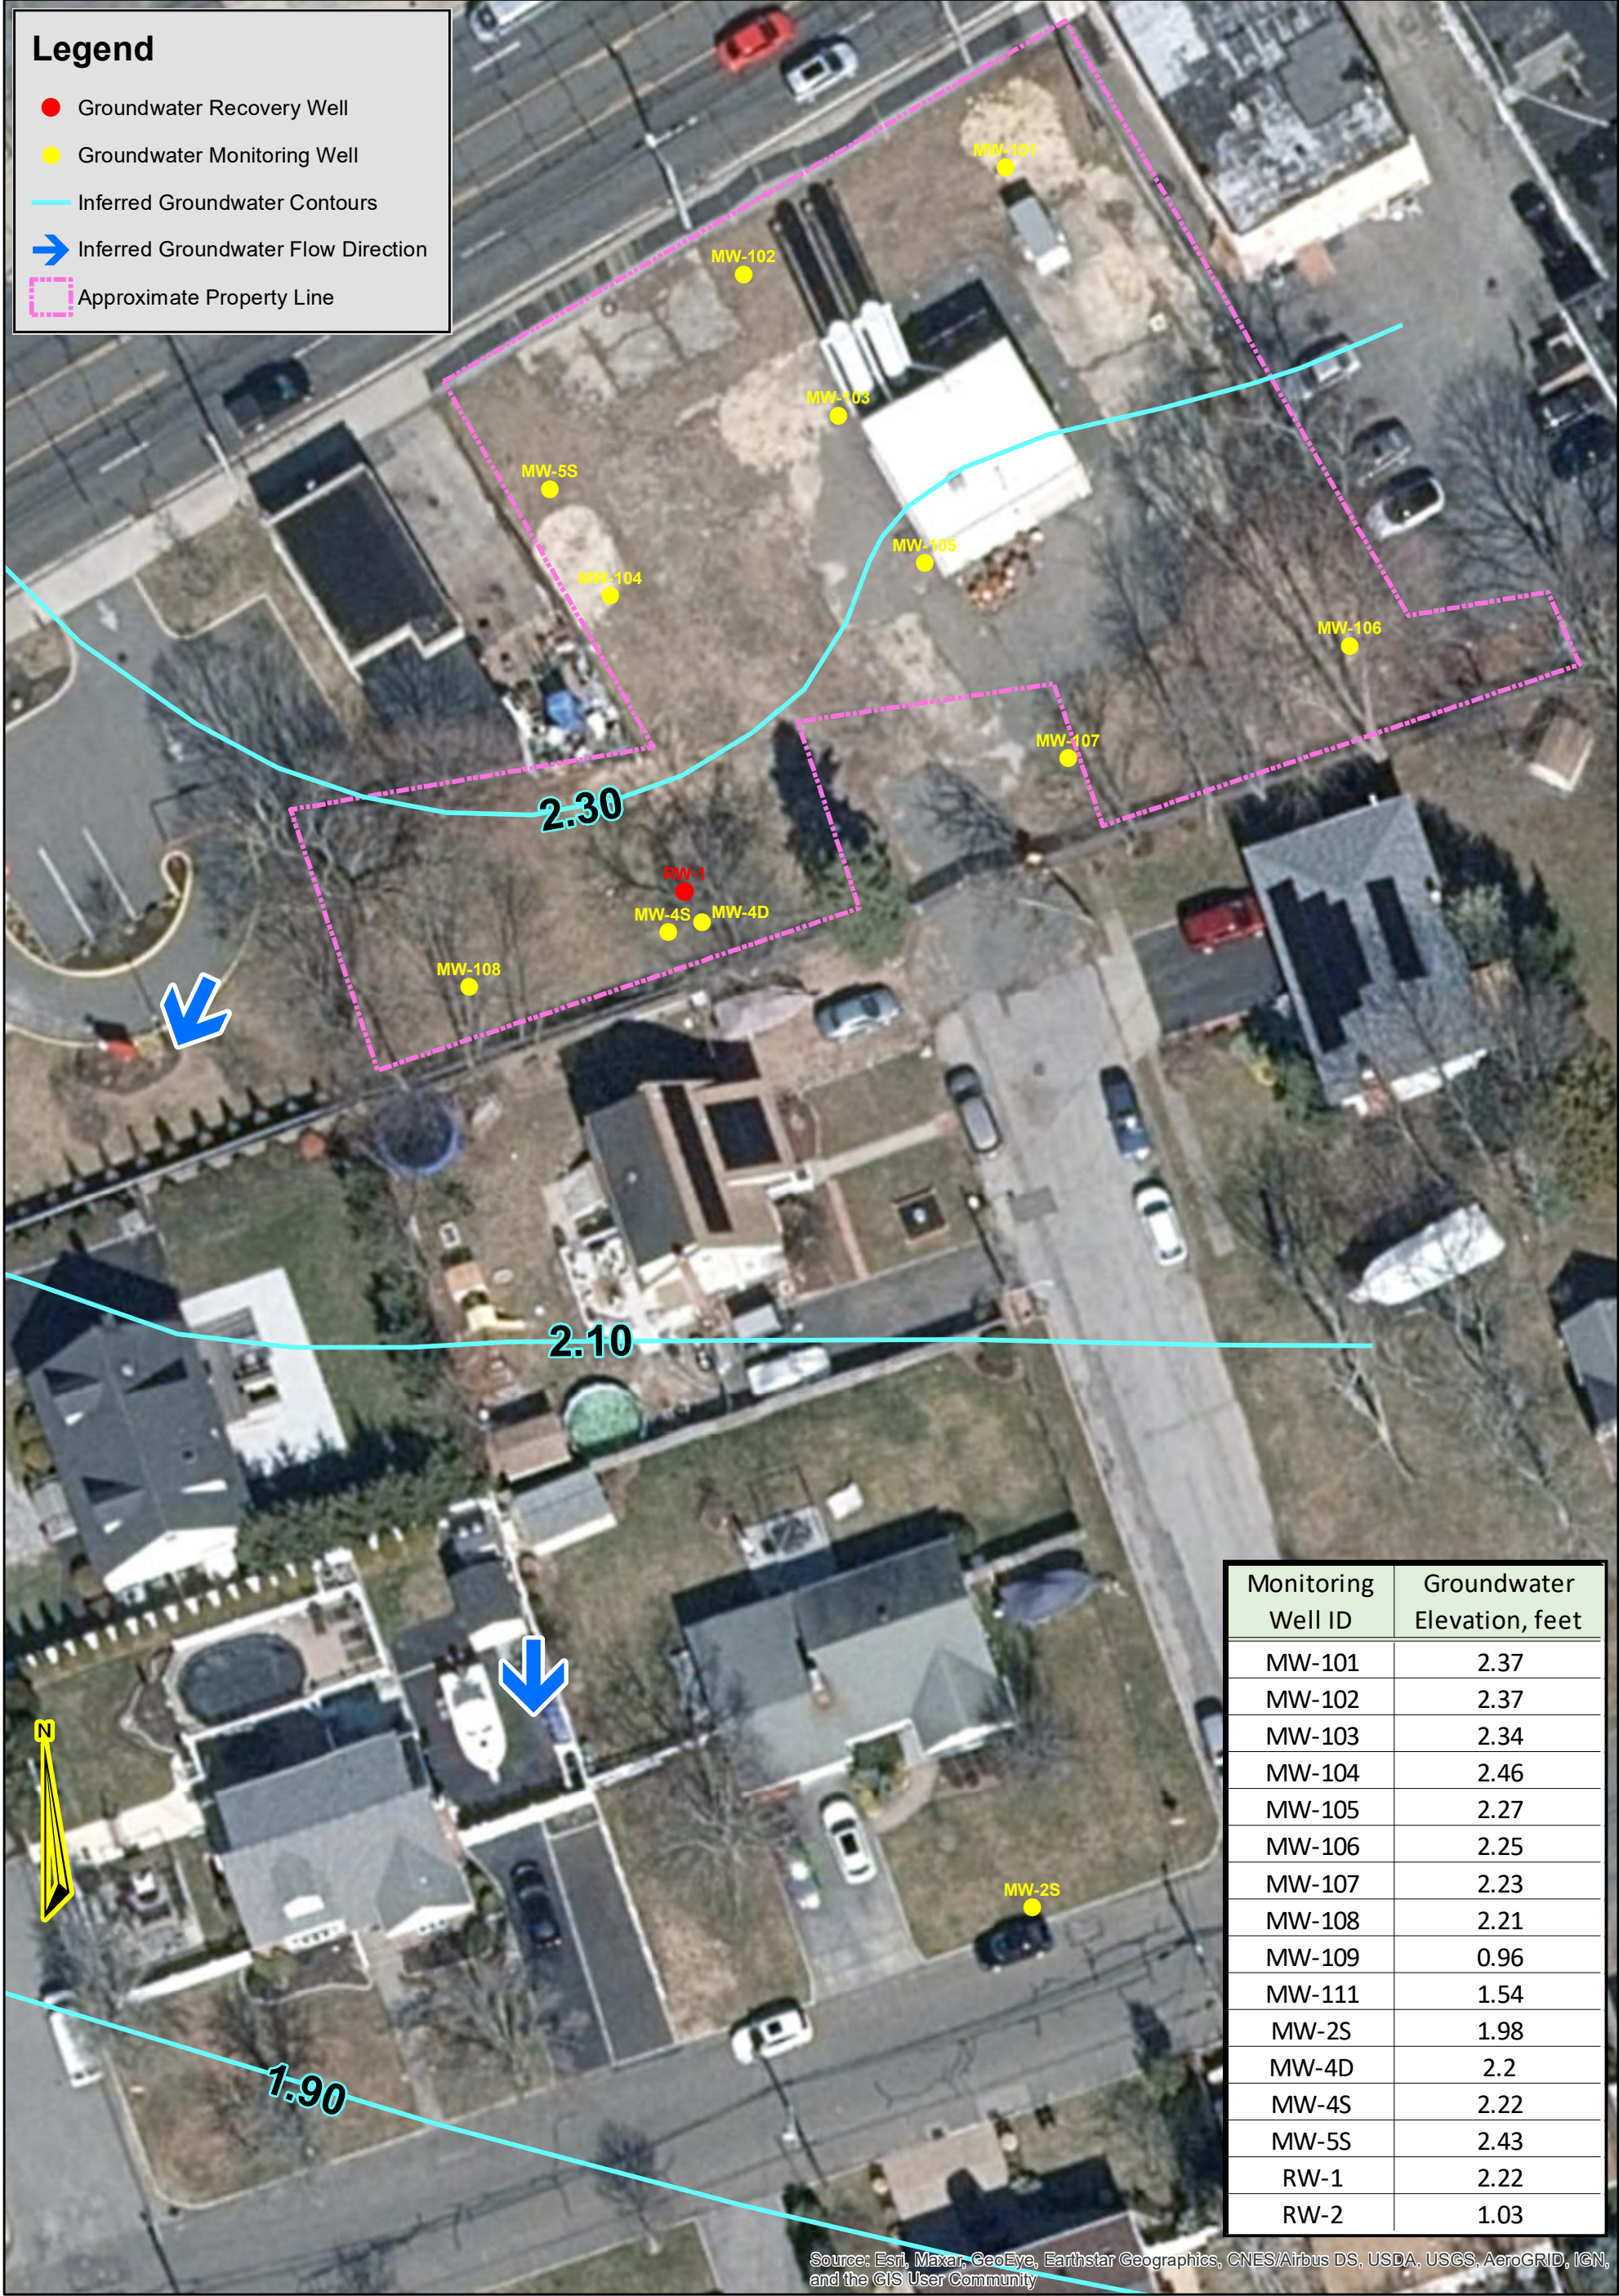
Inferred Groundwater
Contour Map
July 2021

Depth to groundwater ranged from 0.25 (in MW-109) to 9.25 (in RW-1) feet below ground surface, as measured during the July 2021 groundwater sampling event. Groundwater flows predominantly to the south.

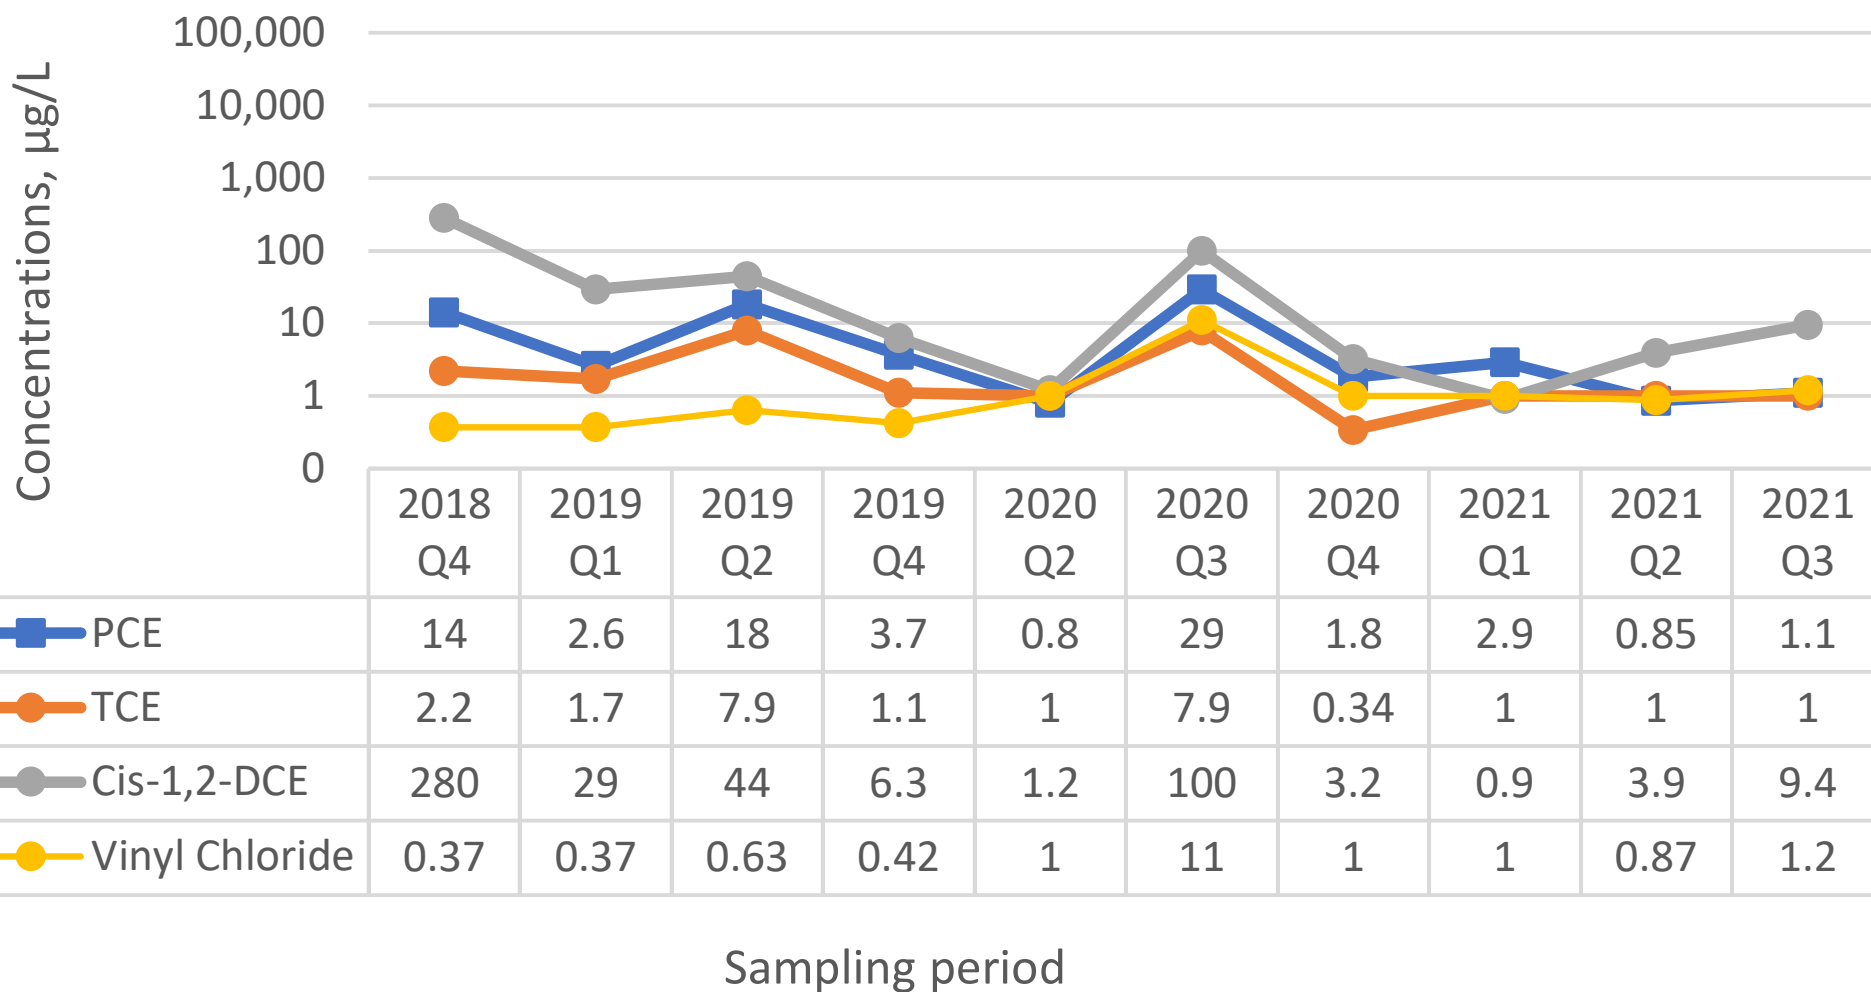
MW-2S

- MW-2S: The monitoring well is located on Tompkins Street, approximately 200 feet to the south of the Site and screened at 12 to 22 fbg. Cis-1,2-DCE was detected in exceedance of the Class GA Standards. PCE and vinyl chloride were detected below the Class GA Standards. TCE was not detected above the laboratory reporting limit.

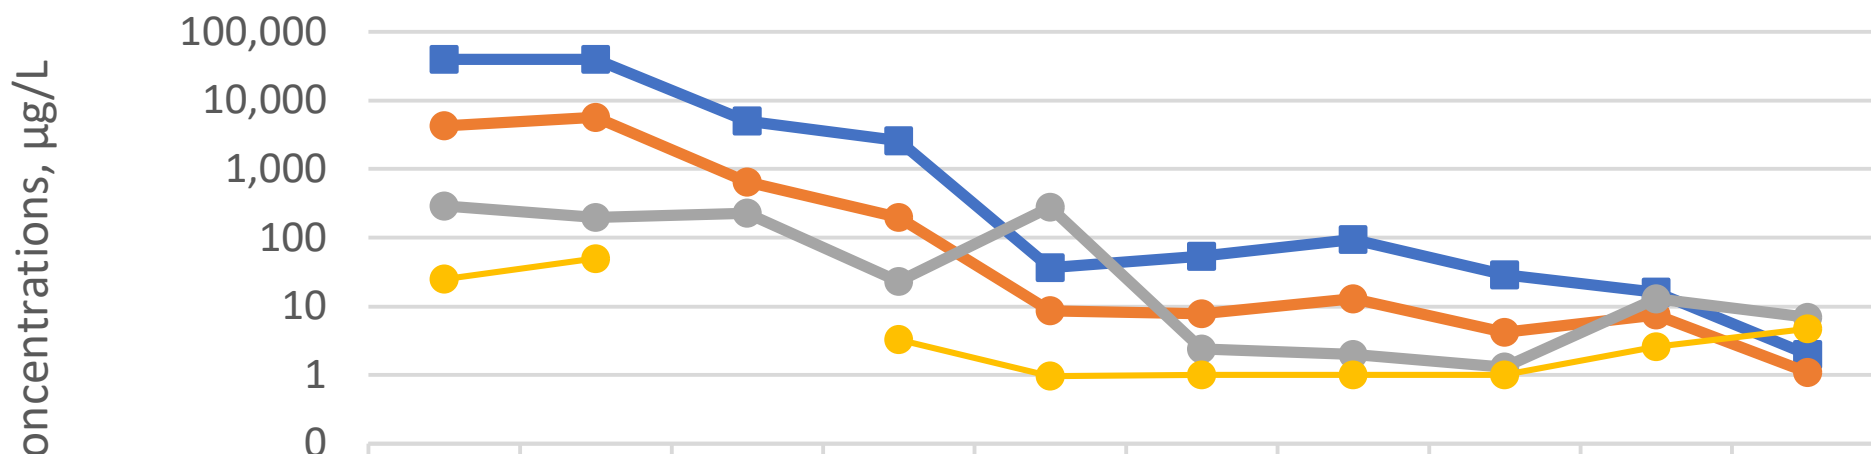
MW-4D

- **MW-4D:** The monitoring well is located in the southwestern portion of the Site and downgradient of the historical dry-cleaning activities. The well is screened at 60 to 70 feet below grade (fbg). Cis-1,2-DCE and vinyl chloride were detected in this monitoring well at concentrations exceeding the Class GA Groundwater Standards.
- **MW-5S:** The monitoring well is located in the western portion of the Site and screened at 14 to 24 fbg. None of the contaminants of concern were detected above the laboratory reporting limits.

2018 Q4	2019 Q1	2019 Q2	2019 Q4	2020 Q2	2020 Q3	2020 Q4	2021 Q1	2021 Q2	2021 Q3
■ PCE	40,00	40,00	5,000	2,600	37	54	95	29	16	2
● TCE	4,300	5,700	650	200	8.7	7.8	13	4.2	7.5	1.1
● Cis-1,2-DCE	290	200	230	23	280	2.4	2	1.3	13	6.9
● Vinyl Chloride	25	50	0	3.3	0.96	1	1	1	2.6	4.7

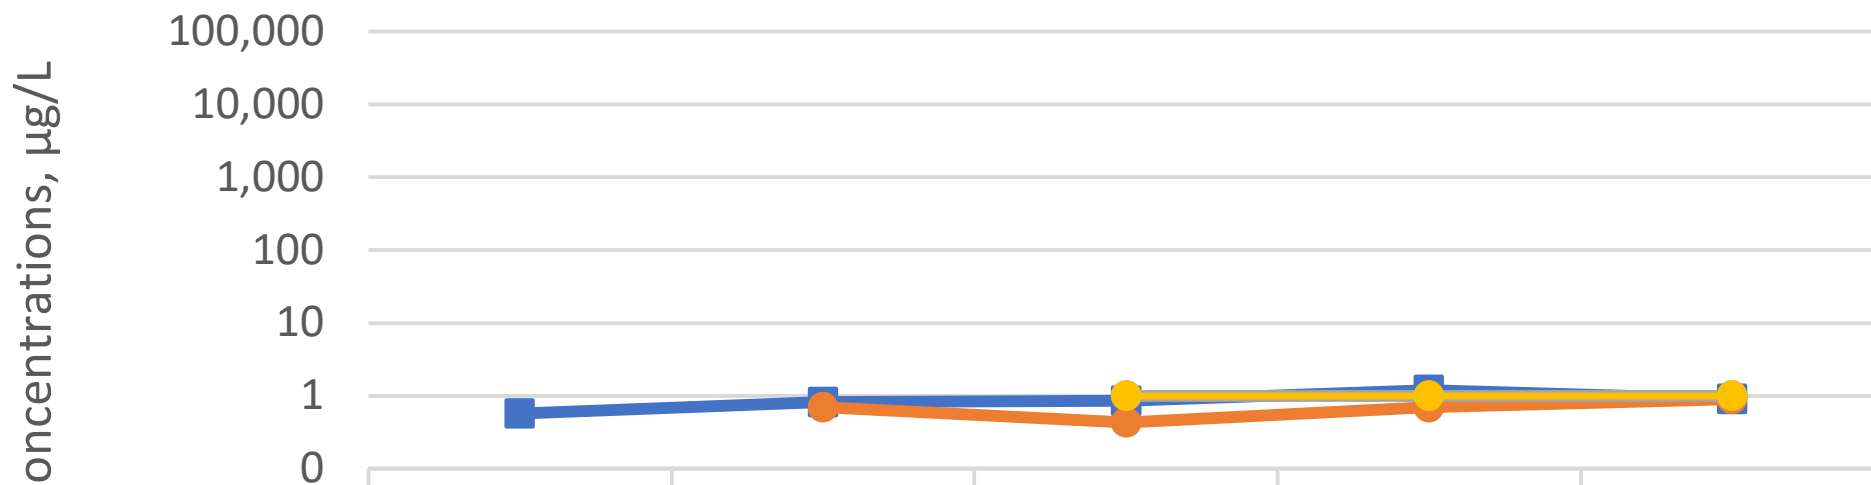
MW-101

- MW-101: The monitoring well is located on the northeastern portion of the Site and screened at 5-15 feet bgs. PCE and TCE were detected at concentrations below the Class GA Standards; cis-1,2-DCE and vinyl chloride were not detected above the laboratory detection limits.

2018 Q3	2019 Q1	2020 Q3	2021 Q1	2021 Q3
■ PCE	0.57	0.83	0.85	1.2	0.9
● TCE	0	0.7	0.43	0.7	0.71
● Cis-1,2-DCE	0	0	1	1	1
● Vinyl Chloride	0	0	1	1	1

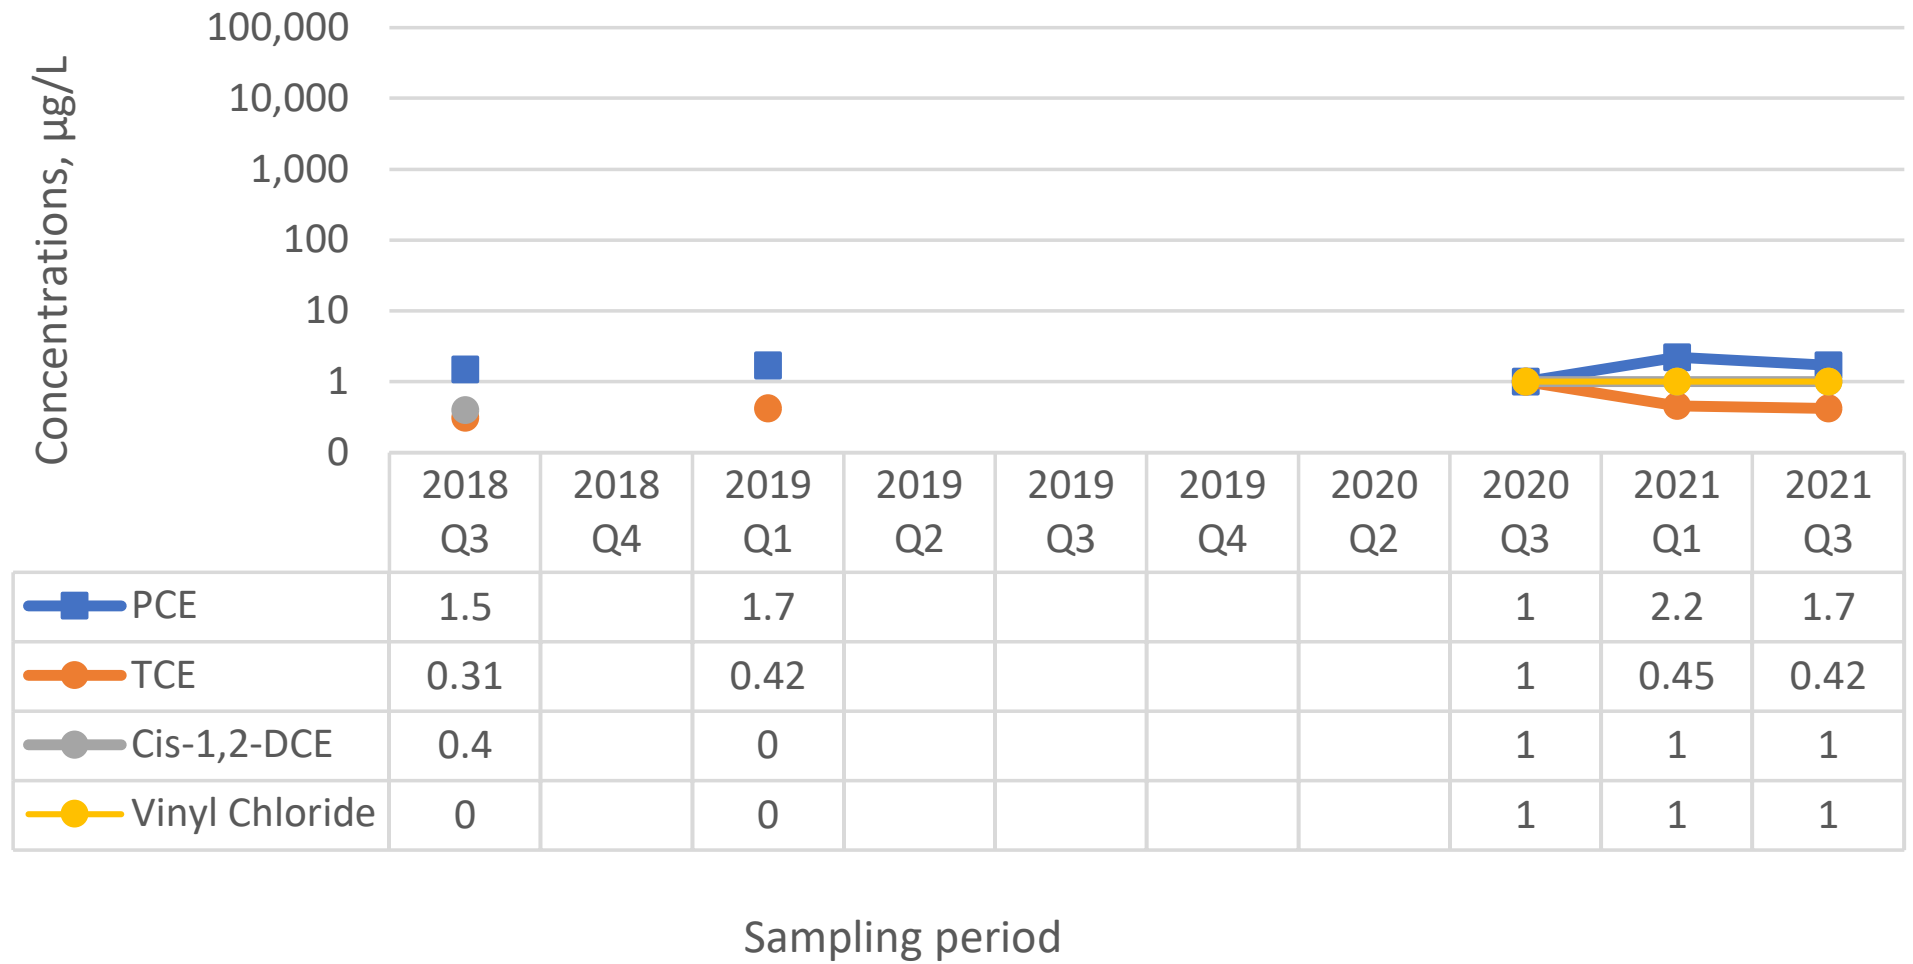
MW-102

- MW-102: The monitoring well is located on the north-central portion of the Site and screened at 5-15 feet bgs. PCE and TCE were detected at concentrations below the Class GA Standards; cis-1,2-DCE and vinyl chloride were not detected above the laboratory detection limits.

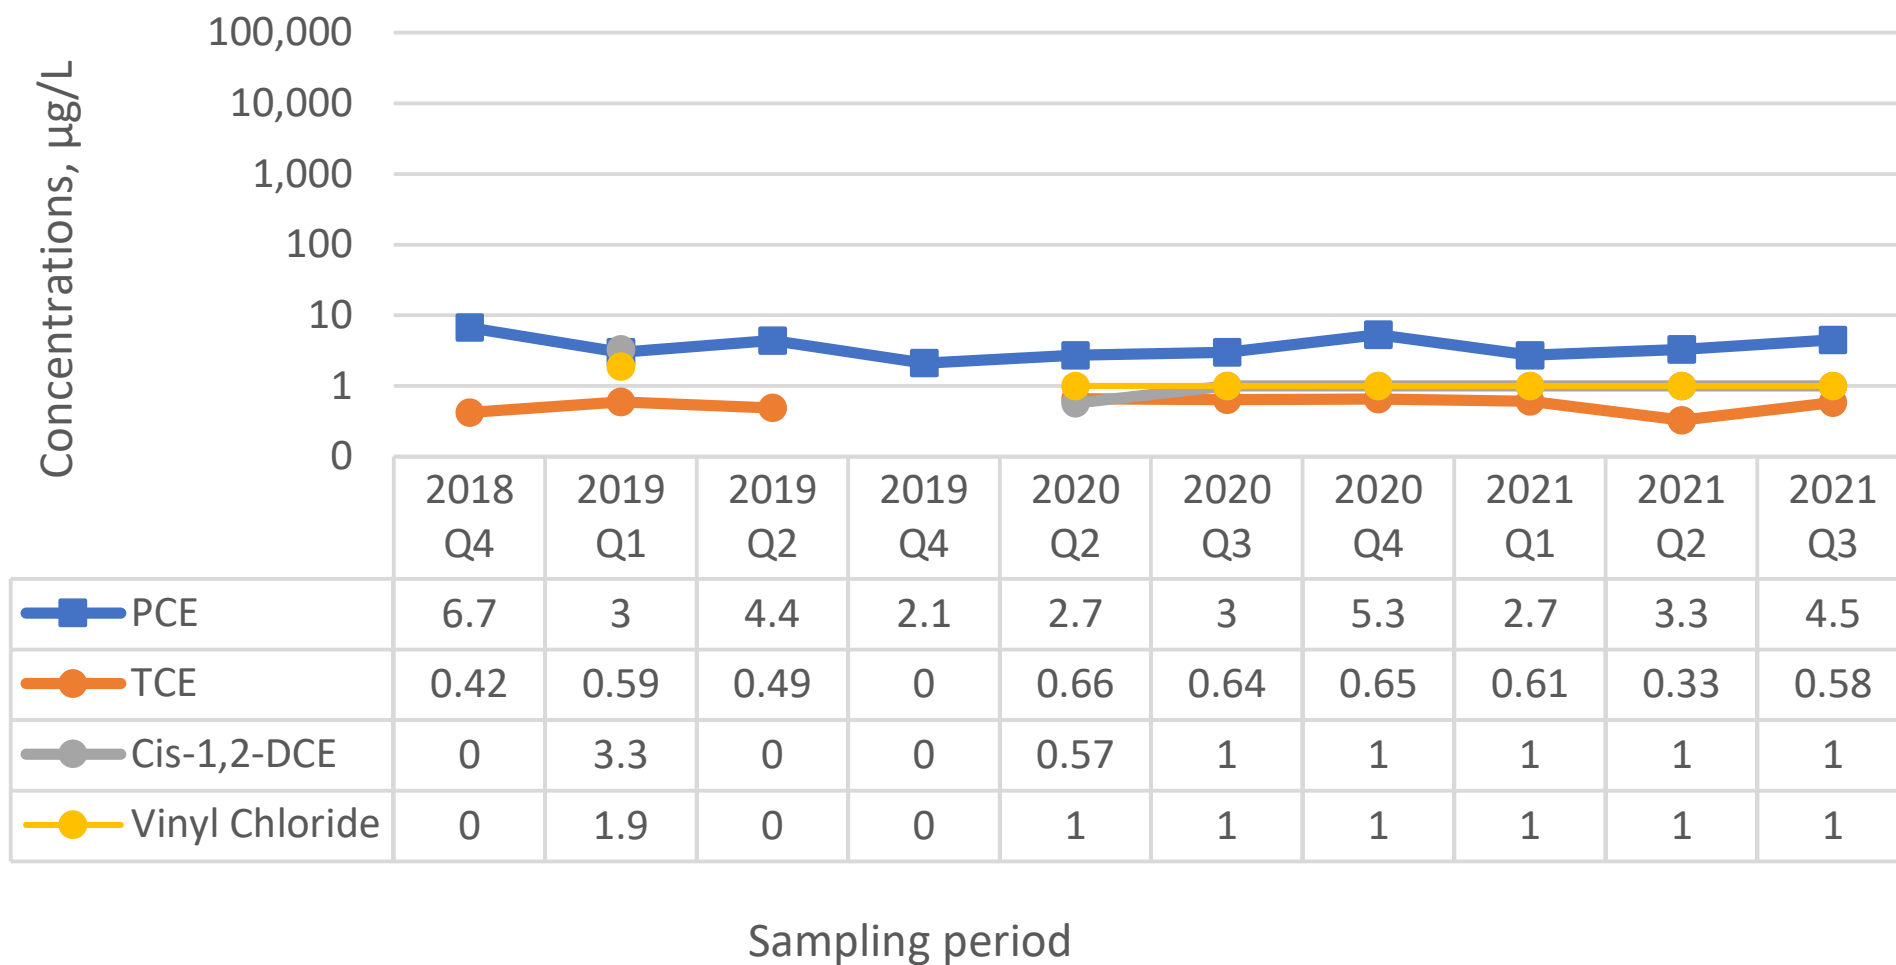
MW-103

- MW-103: The monitoring well is located in the northern portion of the Site and screened at 5 to 15 fbg. PCE and TCE were detected at concentrations below the applicable Class GA Standards. Cis-1,2-DCE and vinyl chloride were not detected above the laboratory reporting limit.

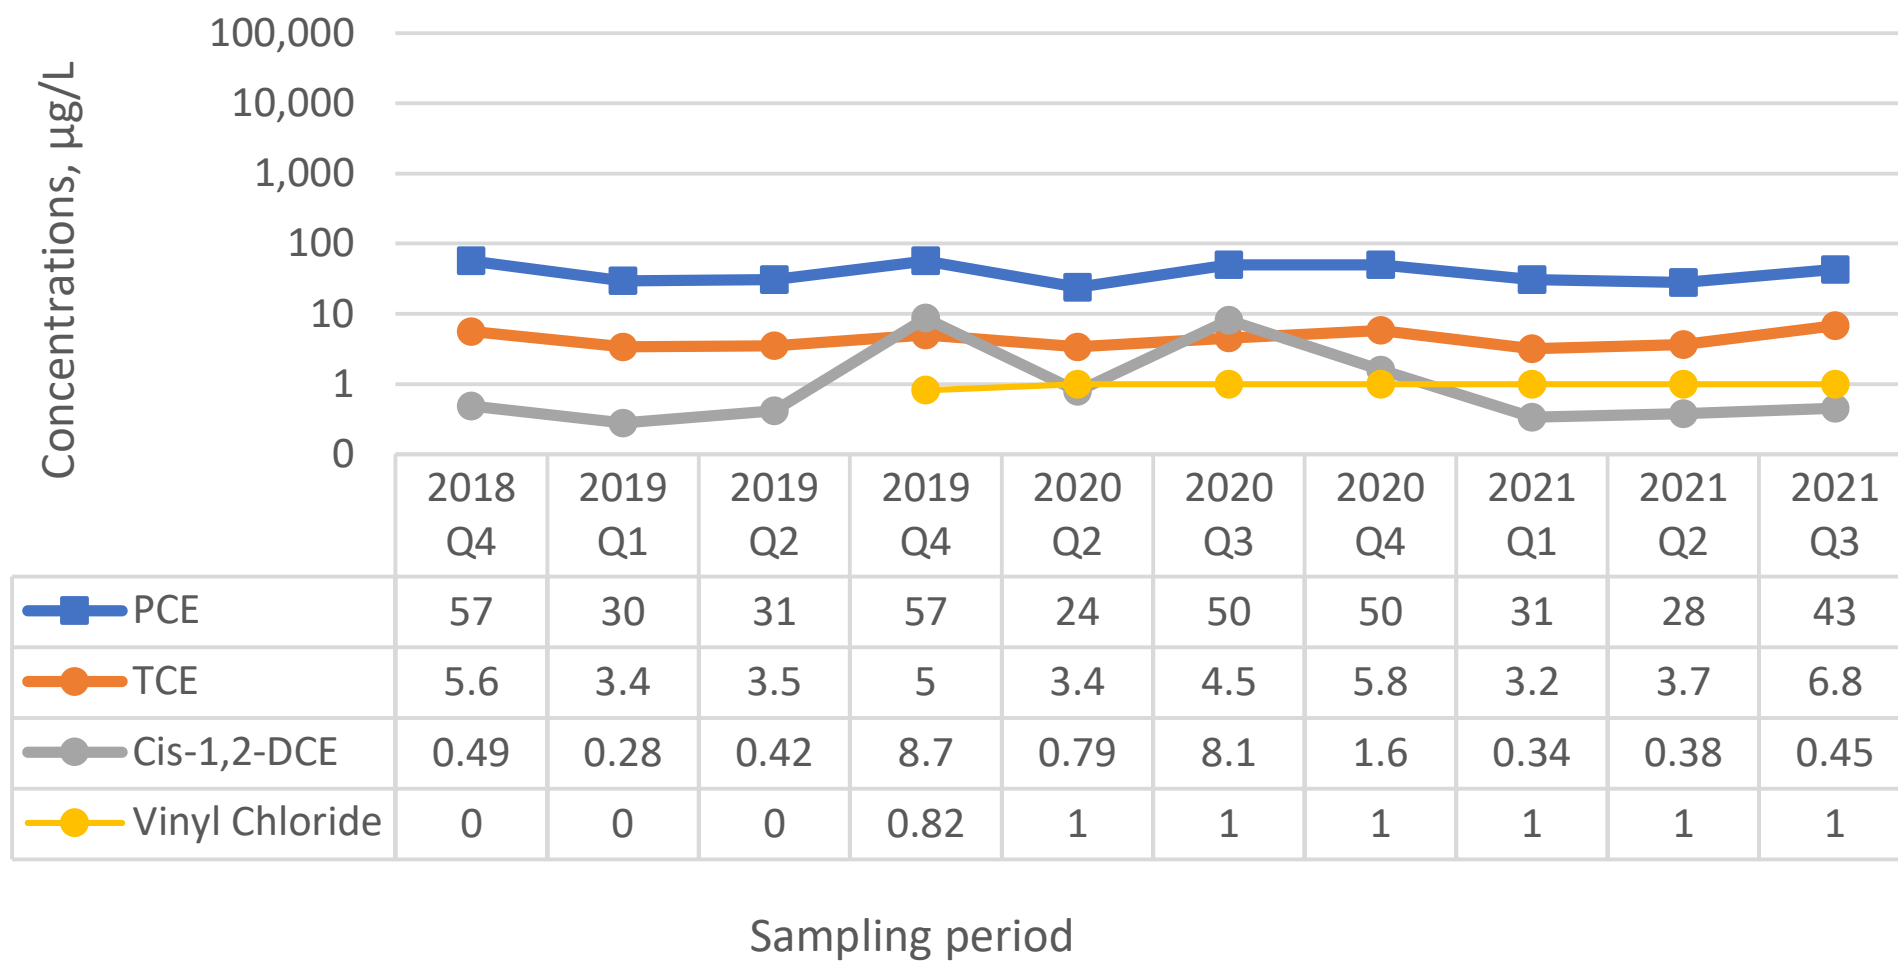
MW-104

- MW-104: The monitoring well is located on the western portion of the Site and screened at 5 to 15 fbg. PCE and TCE were detected in exceedance of the Class GA Standards. Cis-1,2-DCE was detected at a concentration below the Class GA Standards. Vinyl chloride was not detected above the laboratory reporting limit.

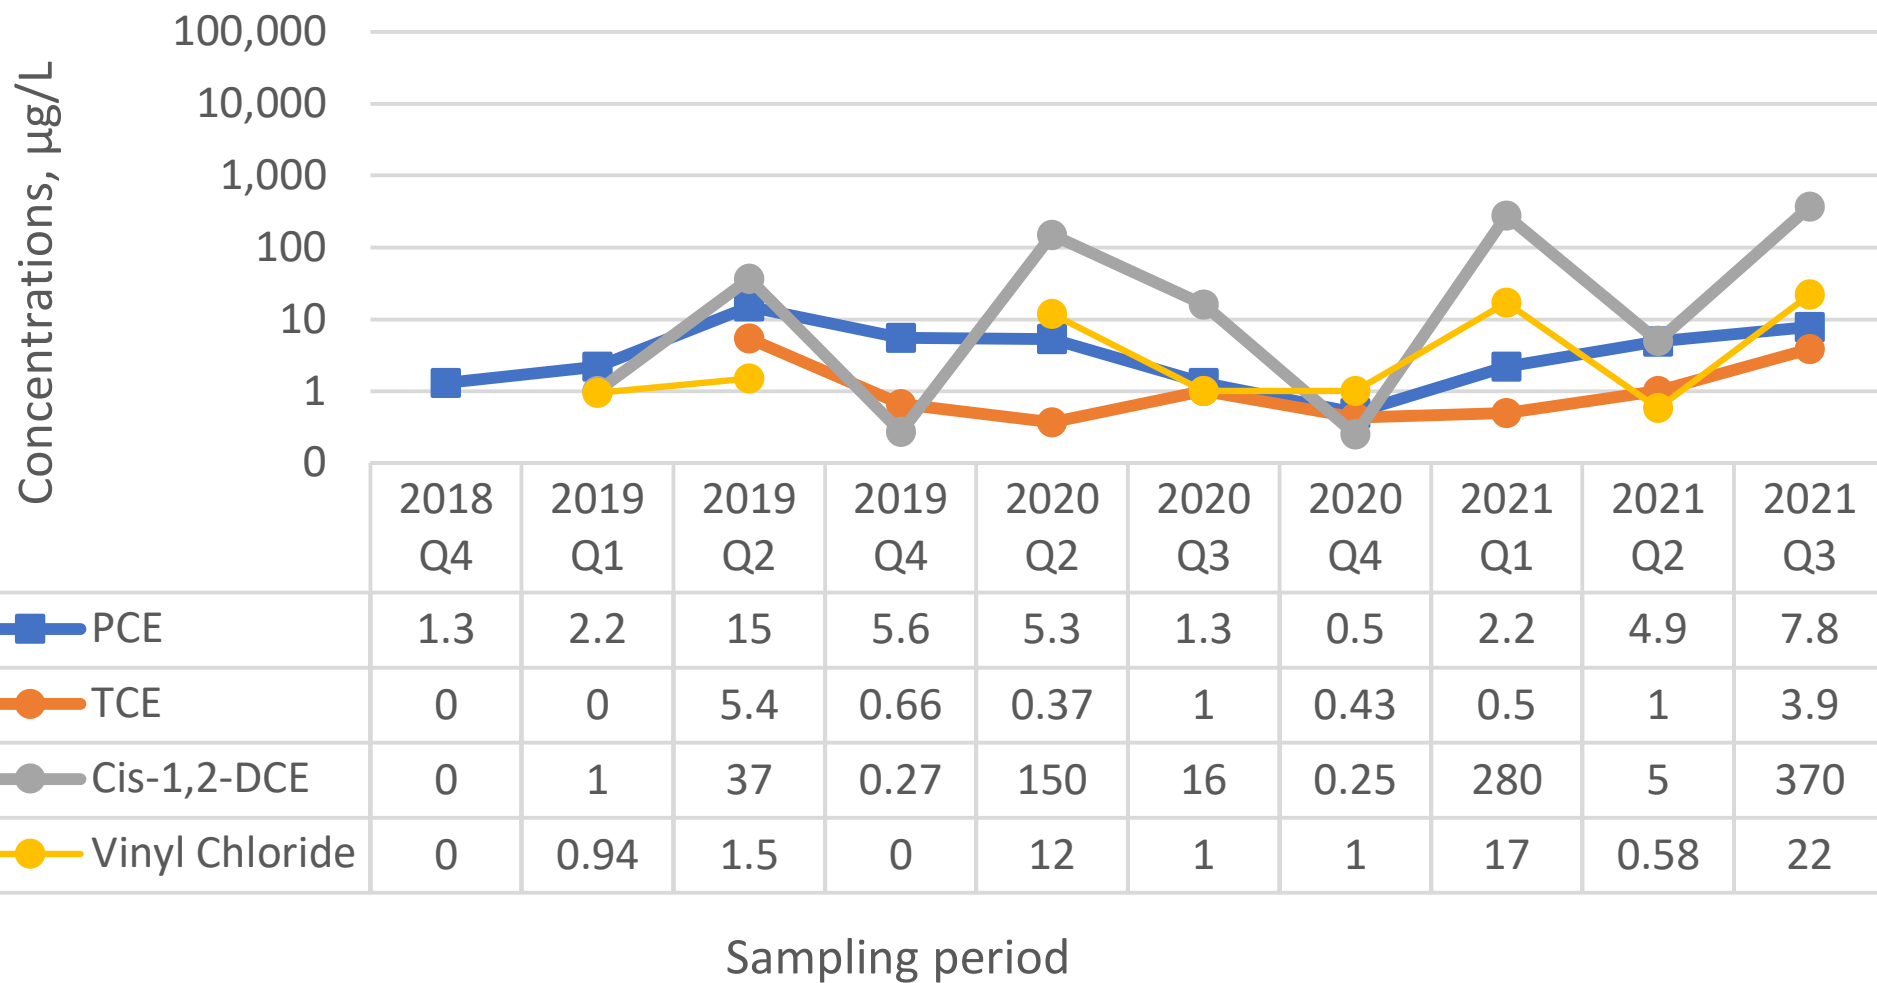
MW-105

- MW-105: The monitoring well is located near the southwestern corner of the treatment building and screened at 5 to 15 fbg. PCE, cis-1,2-DCE, and vinyl chloride were detected in exceedance of the Class GA Standards. TCE was detected at a concentration below the Class GA Standards. Sample MW-B was collected as a duplicate of sample MW-105. Detected concentrations of PCE, TCE, cis-1,2-DCE, and vinyl chloride were similar between the two samples.

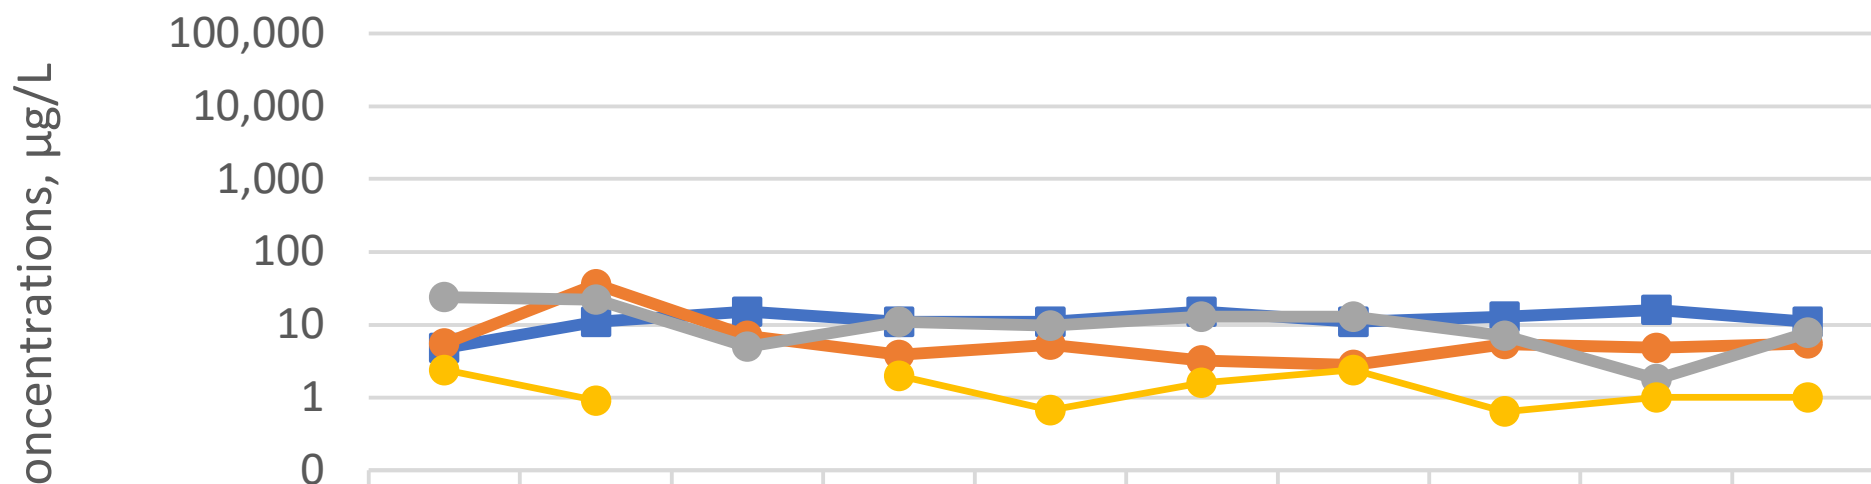
MW-106

- MW-106: The monitoring well is located in the southeastern corner of the Site and screened at 5 to 15 fbg. PCE, TCE, and cis-1,2-DCE were detected in exceedance of the Class GA Standards. Vinyl chloride was not detected above the laboratory reporting limits.

2018 Q4	2019 Q1	2019 Q2	2019 Q4	2020 Q2	2020 Q3	2020 Q4	2021 Q1	2021 Q2	2021 Q3
■ PCE	4.8	11	15	11	11	15	11	13	16	11
● TCE	5.6	36	7.1	3.9	5.3	3.2	2.8	5.4	4.8	5.5
● Cis-1,2-DCE	24	22	5	11	9.8	13	13	7	1.8	7.8
● Vinyl Chloride	2.4	0.9	0	2	0.67	1.6	2.4	0.64	1	1

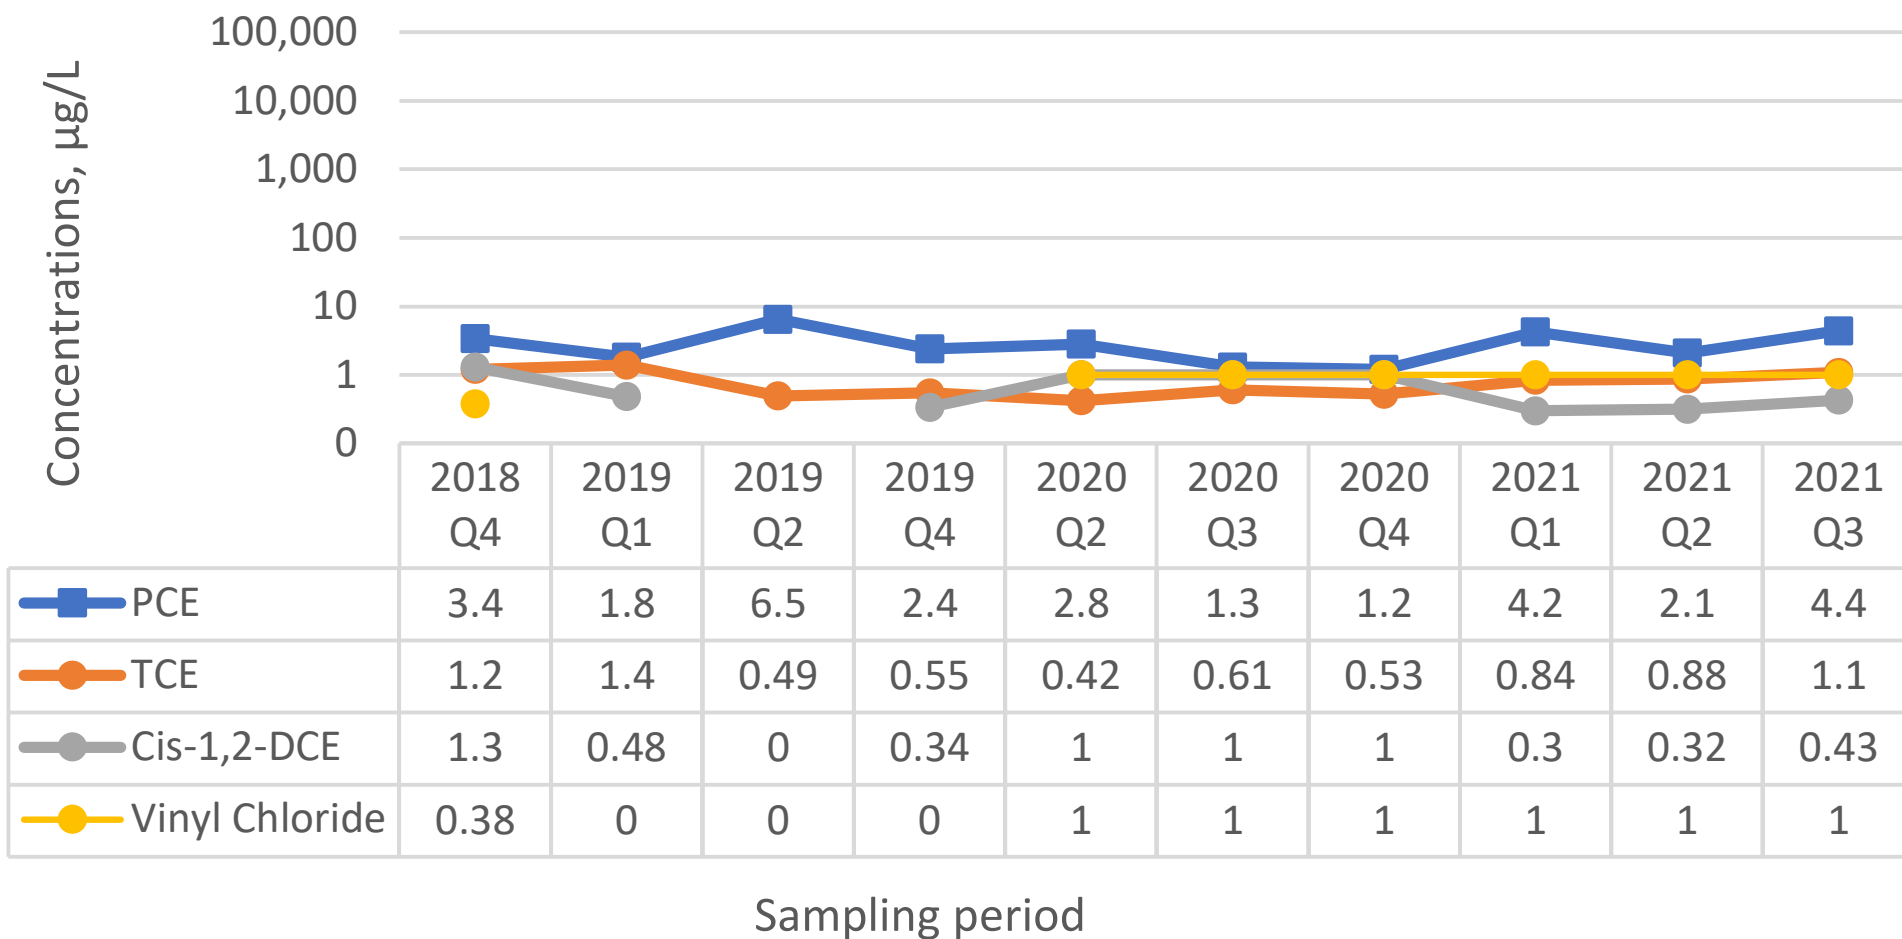
MW-107

- MW-107: The monitoring well is located in the southern portion of the Site and screened at 5 to 15 fbg. PCE, TCE, and cis-1,2-DCE were detected at concentrations below the Class GA Standards. Vinyl chloride was not detected above the laboratory reporting limits.

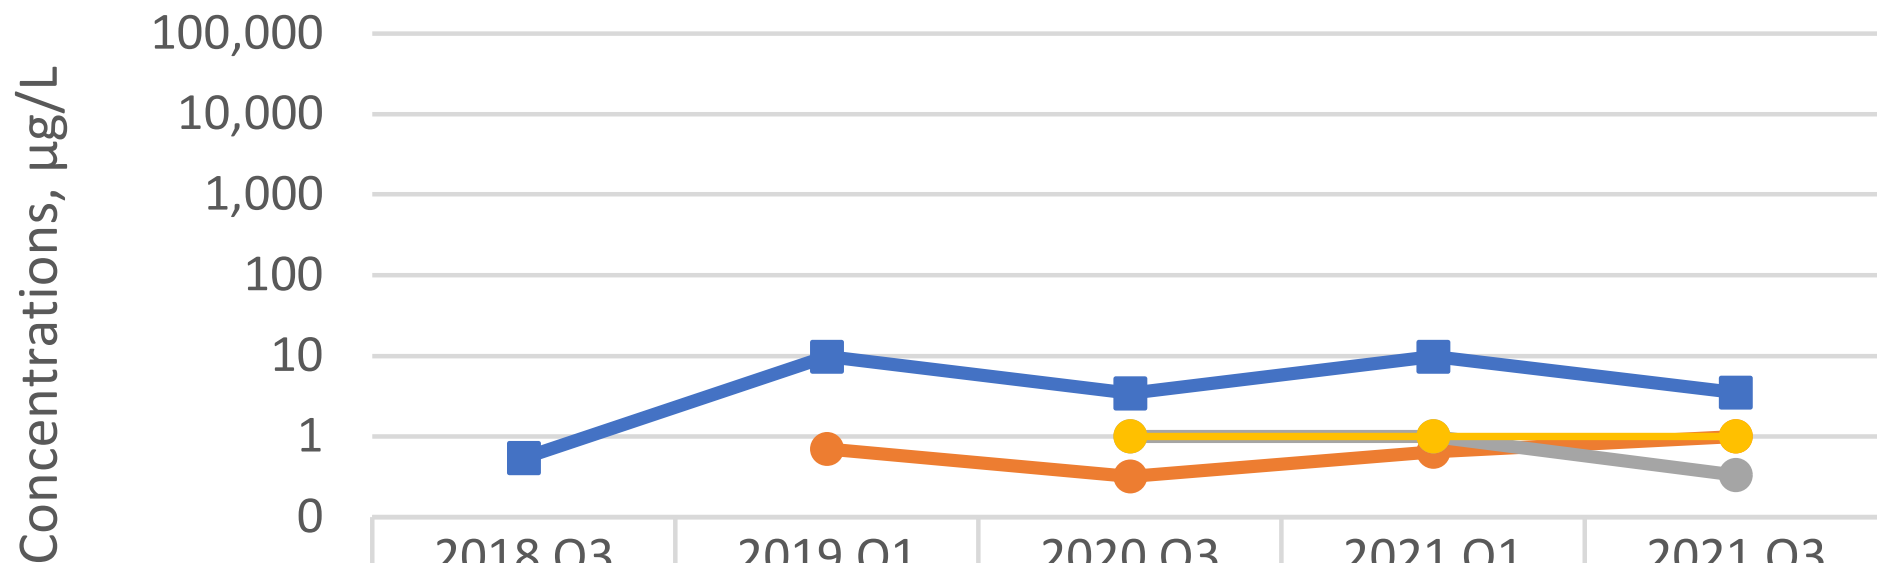
MW-108

- MW-108: The monitoring well is located in the southwestern corner of the Site and screened at 5 to 15 fbg. PCE and cis-1,2-DCE were detected at concentrations below the Class GA Standards. TCE and vinyl chloride were not detected above the laboratory reporting limits.

■ PCE	0.54	9.8	3.4	9.8	3.5
● TCE	0	0.7	0.32	0.64	1
● Cis-1,2-DCE	0	0	1	1	0.33
● Vinyl Chloride	0	0	1	1	1
