QUARTERLY OPERATION AND MAINTENANCE REPORT – THIRD QUARTER 2021

Active Industrial Uniform Superfund Site

63 West Merrick Road
Lindenhurst, New York

NYSDEC Site Number: 152125

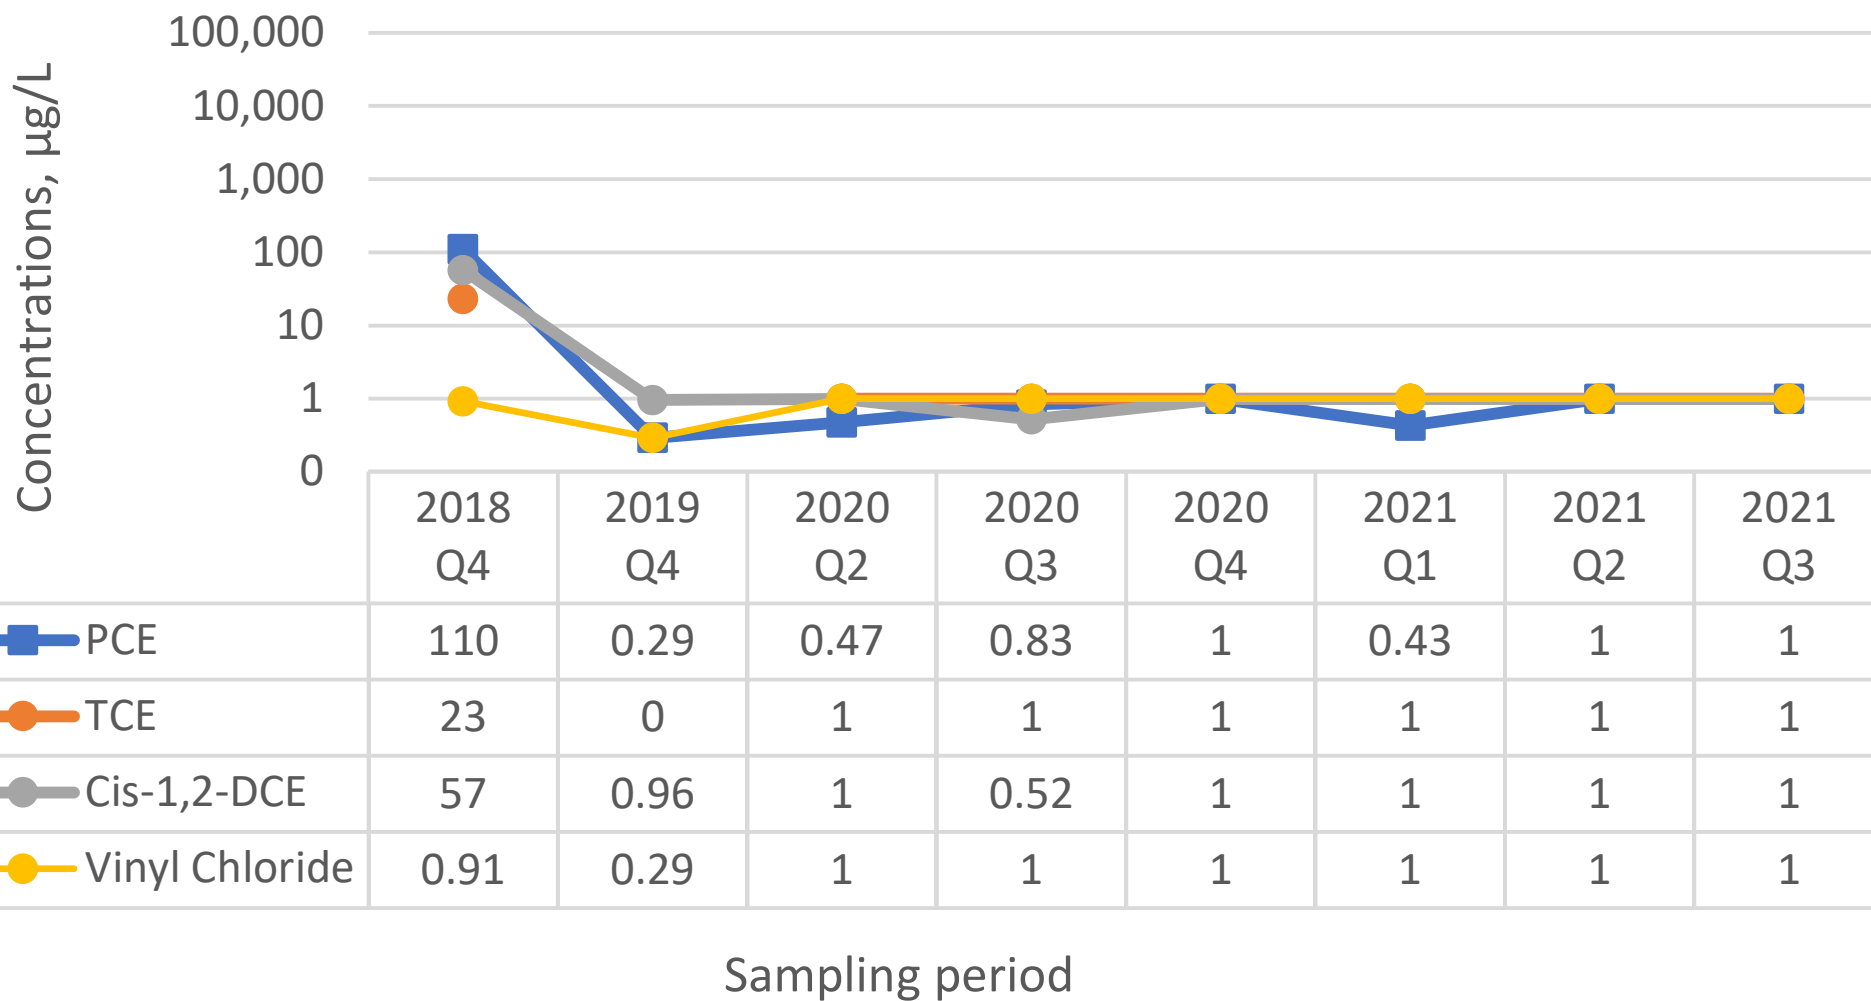
RW-1

- RW-1: The 4-inch extraction well is located in the southwestern portion of the Site and screened at 10-35 feet bgs. None of the contaminants of concern were detected above the laboratory reporting limits.

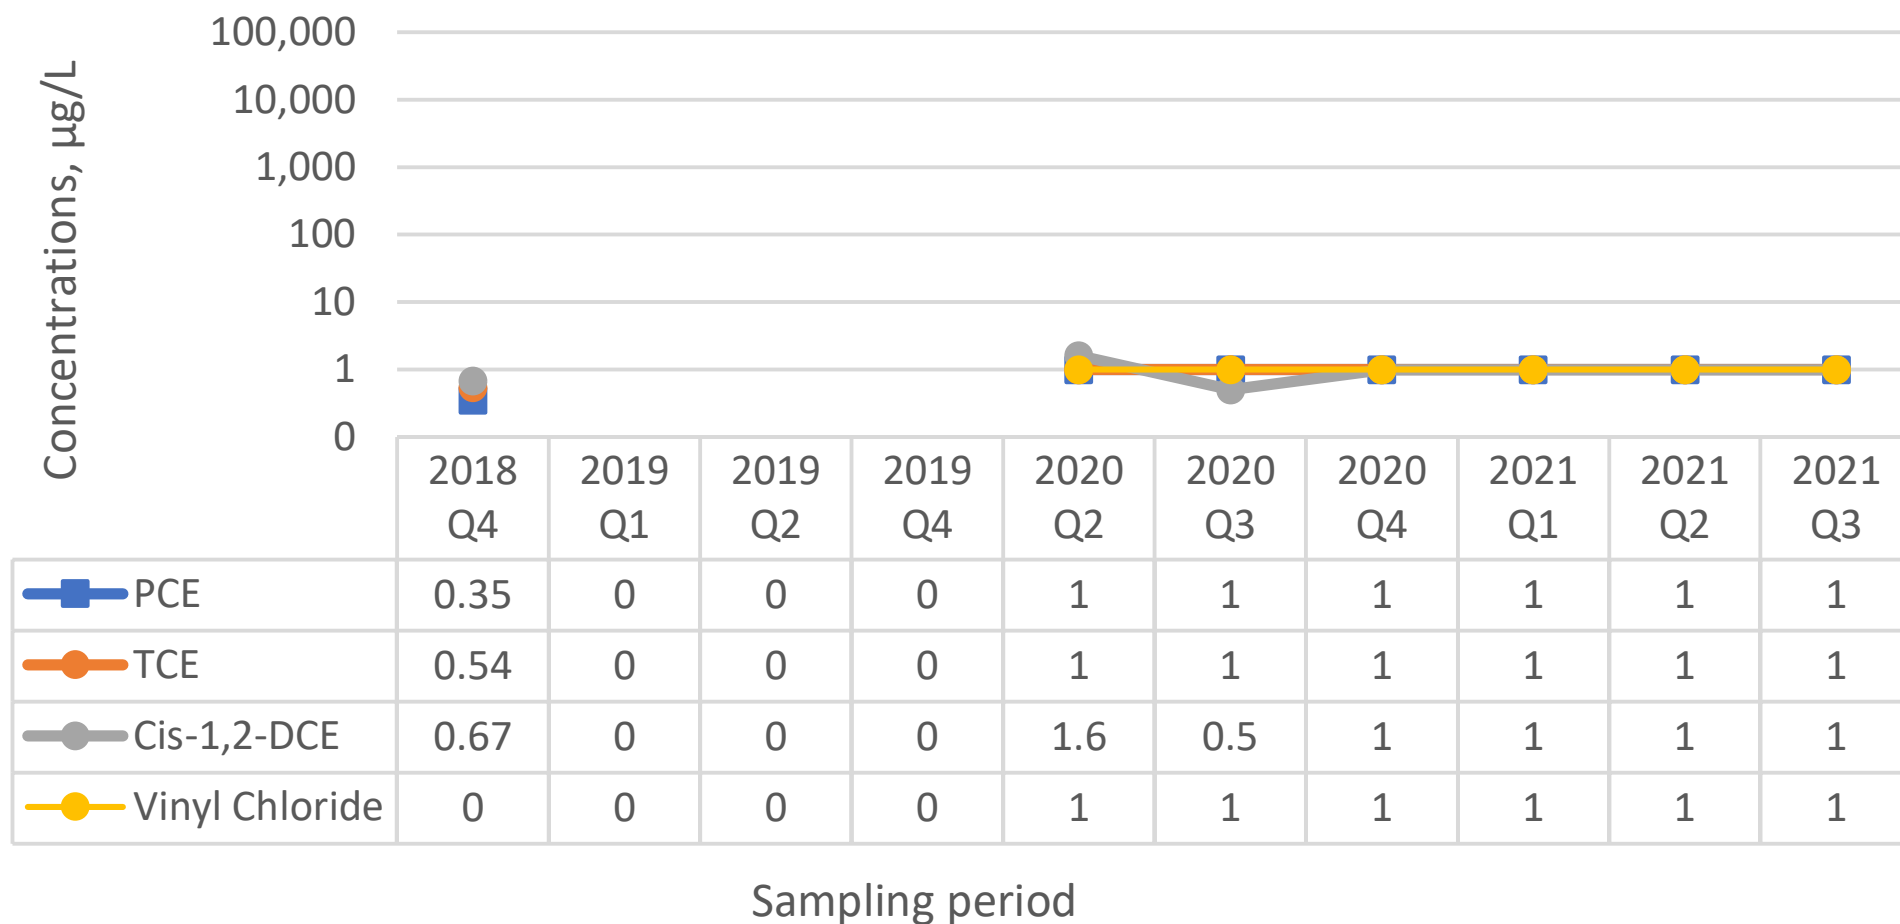
RW-2

Temporal Variations of VOCs Concentrations
Active Industrial Uniform Superfund Site #152125
63 West Merrick Road, Lindenhurst, New York
HRP# DEC1004.OM
