QUARTERLY OPERATION AND MAINTENANCE REPORT – FOURTH QUARTER 2021

Active Industrial Uniform Superfund Site

63 West Merrick Road
Lindenhurst, New York

NYSDEC Site Number: 152125

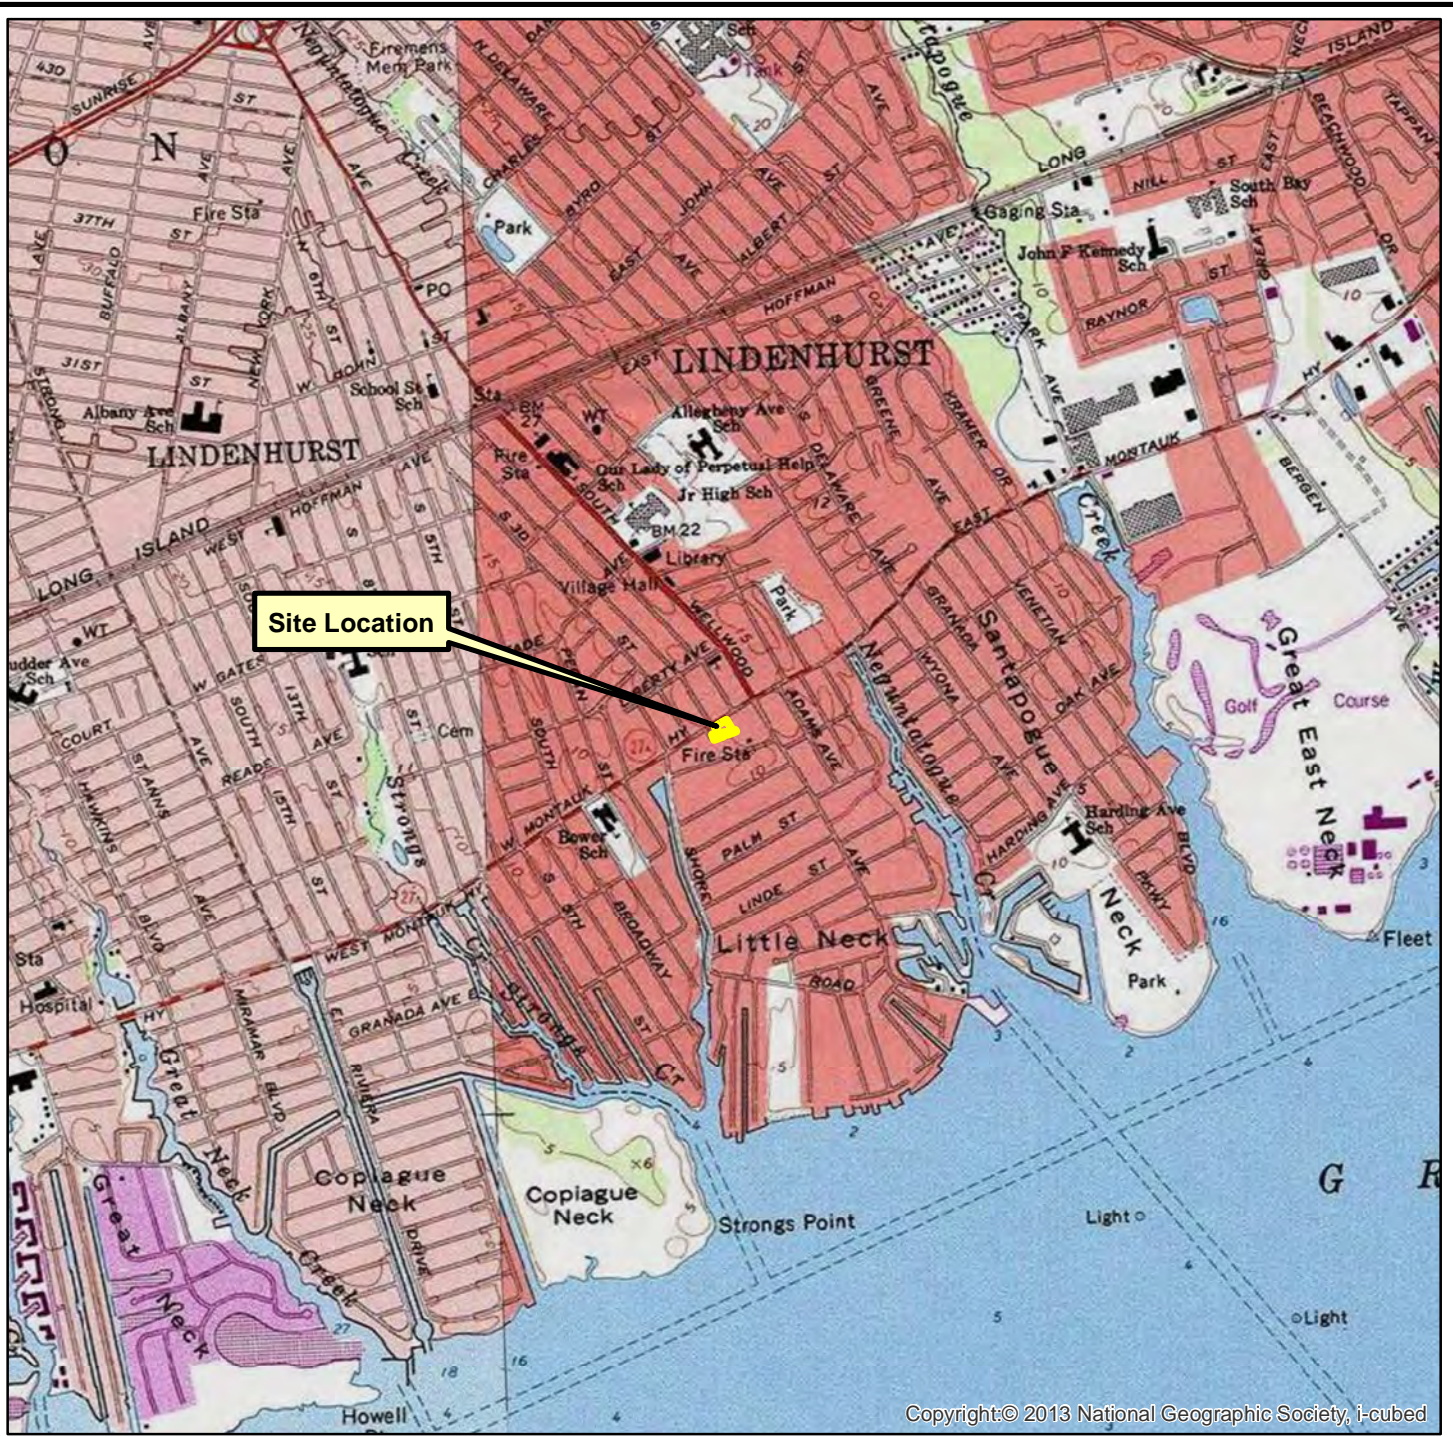
The Active Industrial Uniform Site is a 0.5-acre parcel of land located at 63 West Merrick Road (a.k.a. West Montauk Highway, or State Route 27A). The Site is accessed via a driveway from Tompkins Lane. A fence with locked gate completely surrounds the property. The Site location is shown on **Figure 1**.

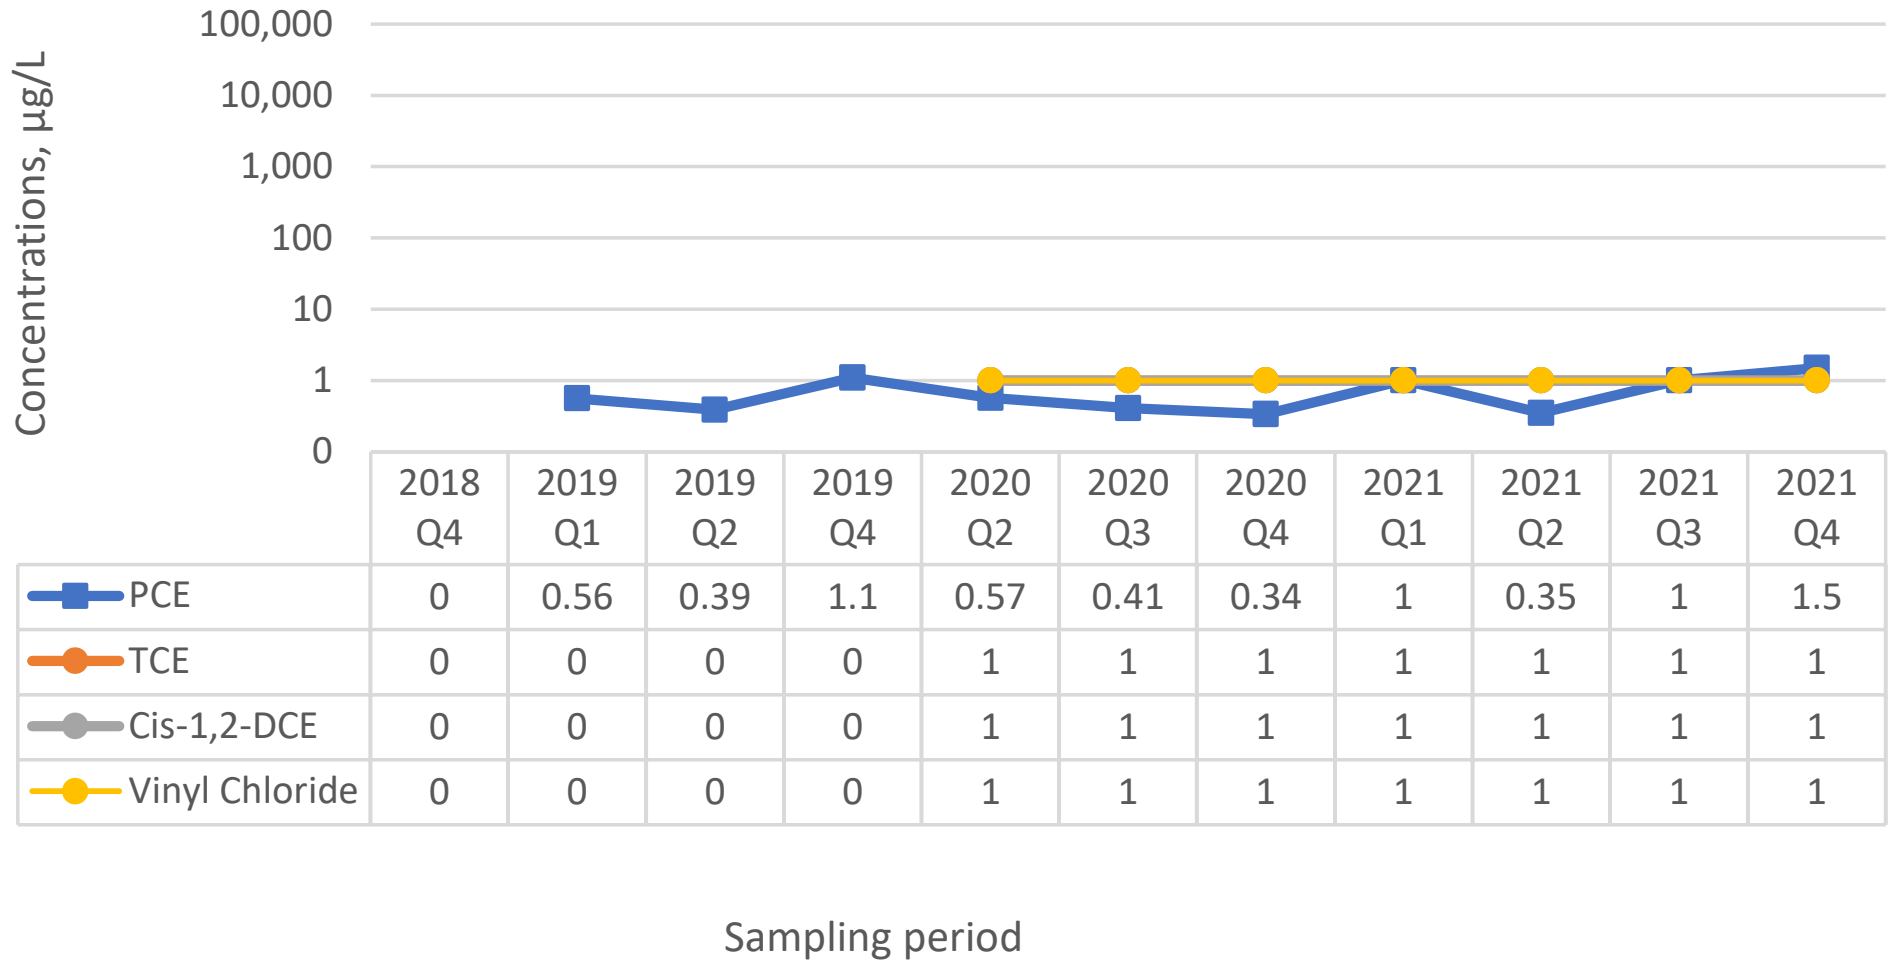
MW-5S

- **MW-5S:** The monitoring well is located in the western portion of the Site and screened at 14 to 24 fbg. None of the contaminants of concern were detected above the laboratory reporting limits, except for PCE, which was detected below the applicable standards.

Temporal Variations of VOCs Concentrations
 Active Industrial Uniform Superfund Site #152125
 63 West Merrick Road, Lindenhurst, New York
 HRP# DEC1004.OM

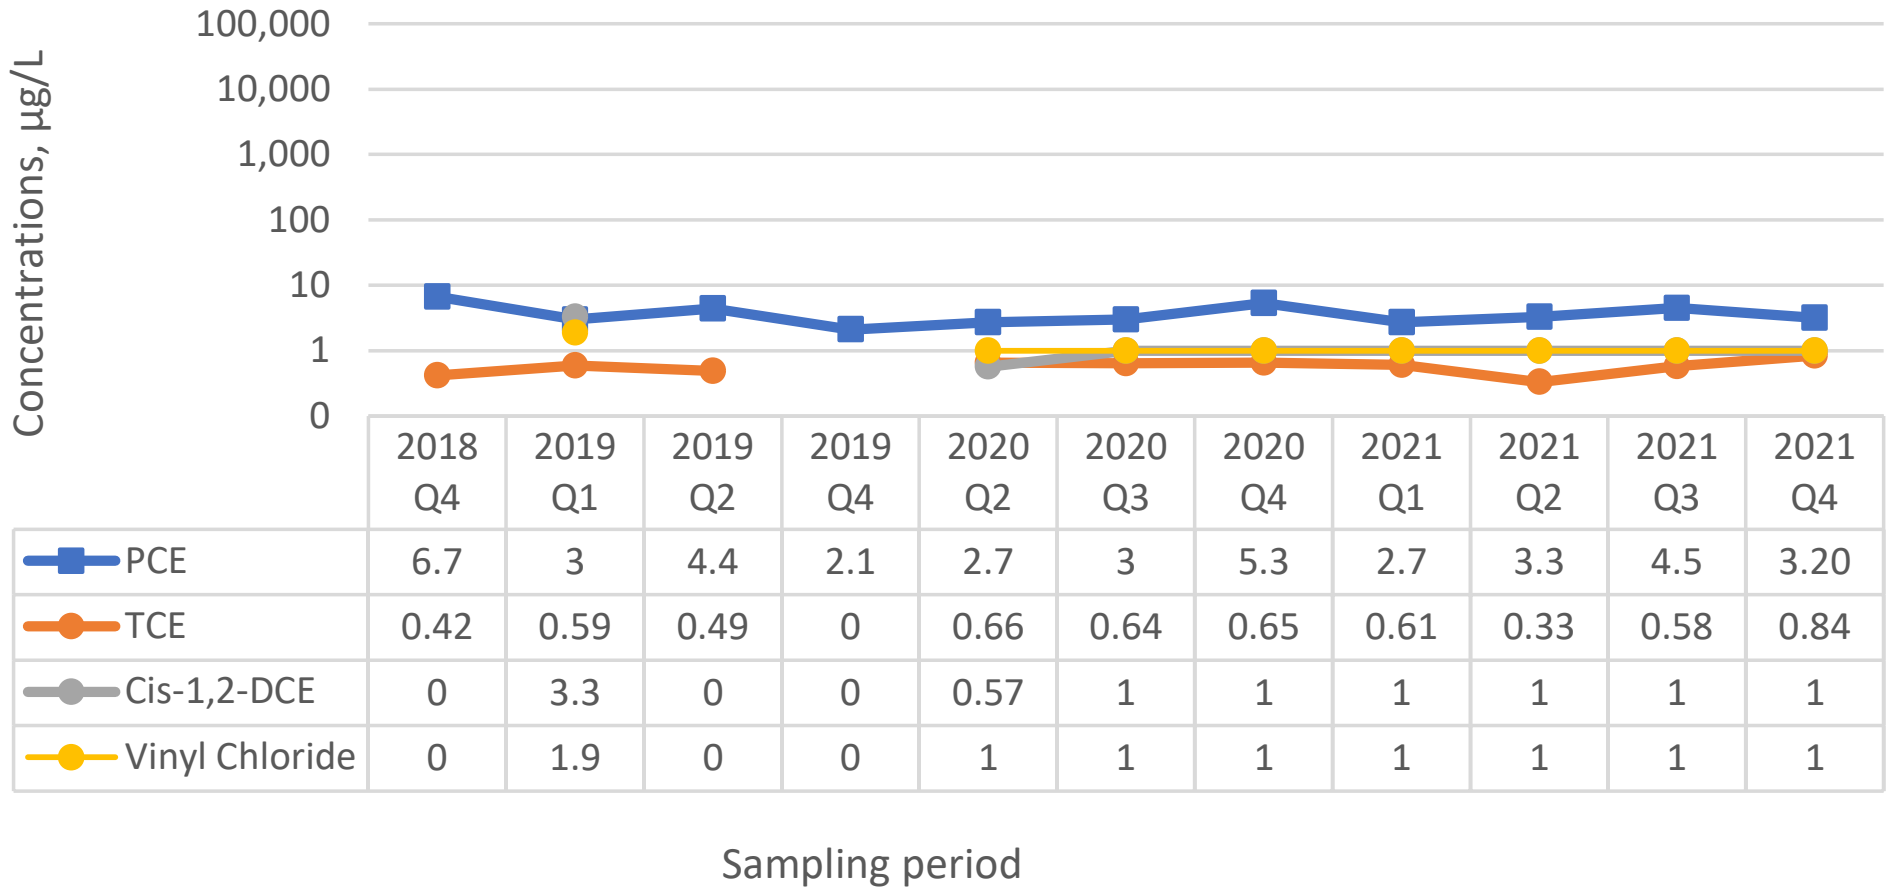
MW-103

- **MW-103:** The monitoring well is located in the northern portion of the Site and screened at 5 to 15 fbg. PCE and TCE were detected at concentrations below the applicable Class GA

Standards. Cis-1,2-DCE and vinyl chloride were not detected above the laboratory reporting limit.

Temporal Variations of VOCs Concentrations
 Active Industrial Uniform Superfund Site #152125
 63 West Merrick Road, Lindenhurst, New York
 HRP# DEC1004.OM

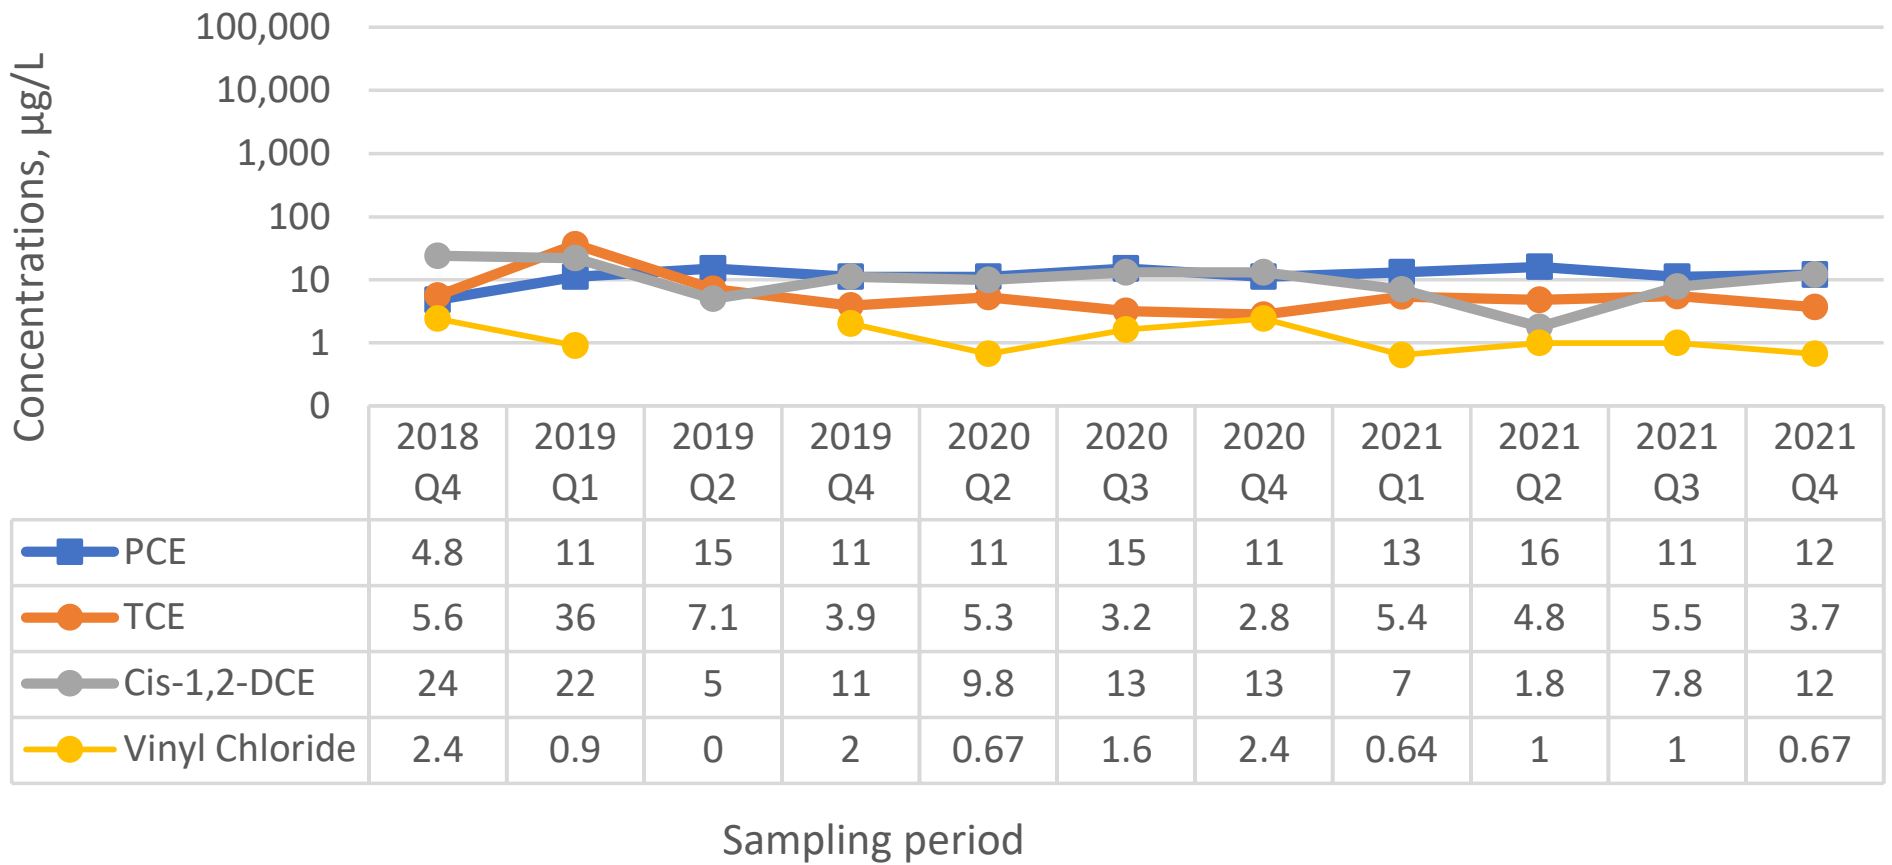
MW-106

- MW-106: The monitoring well is located in the southeastern corner of the Site and screened at 5 to 15 fbg. PCE and cis-1,2-DCE were detected in exceedance of the Class GA Standards. TCE and vinyl chloride were detected at concentrations below the Class GA Standards.

Temporal Variations of VOCs Concentrations
 Active Industrial Uniform Superfund Site #152125
 63 West Merrick Road, Lindenhurst, New York
 HRP# DEC1004.OM

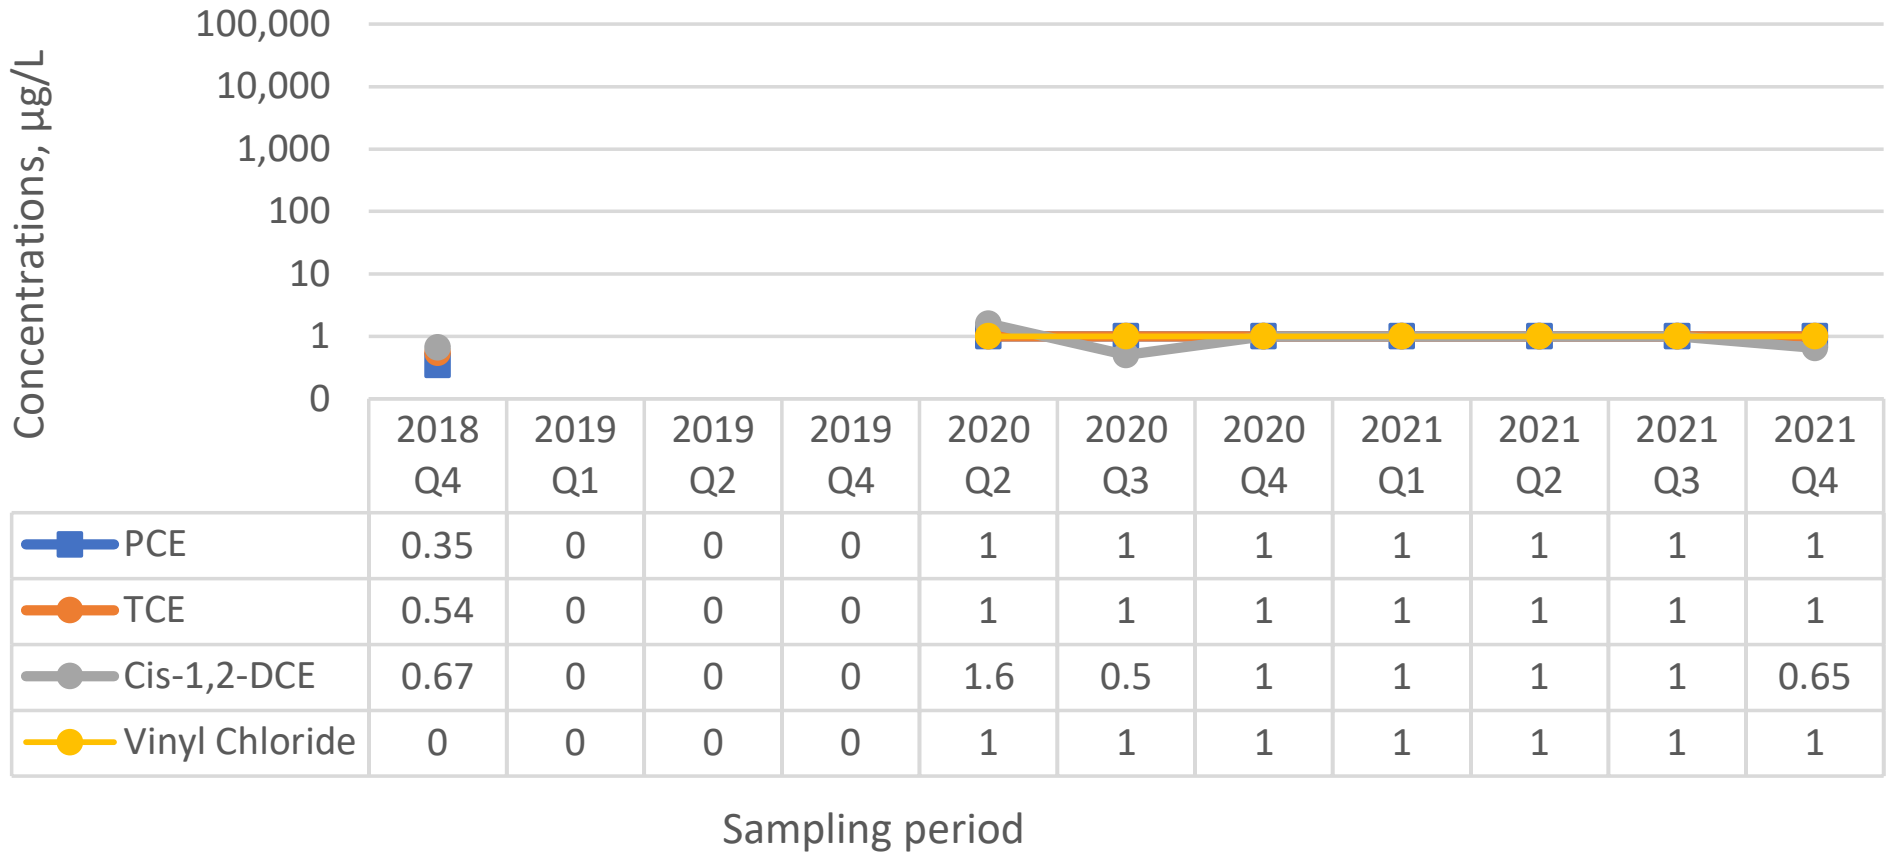
RW-2

- RW-2: The 4-inch extraction well is located on Orchard Street, approximately 1,500 feet to the southwest of the Site, and screened at 12-37 feet bgs. Sample MW-A was collected as a duplicate of sample RW-2. PCE, TCE, and vinyl chloride were not detected above the laboratory reporting limits in either of the sample. Cis-1,2-DCE was detected below the Class GA Standards.

Temporal Variations of VOCs Concentrations
 Active Industrial Uniform Superfund Site #152125
 63 West Merrick Road, Lindenhurst, New York
 HRP# DEC1004.OM
