QUARTERLY OPERATION AND MAINTENANCE REPORT – FIRST QUARTER 2022

Active Industrial Uniform Superfund Site

63 West Merrick Road
Lindenhurst, New York

NYSDEC Site Number: 152125

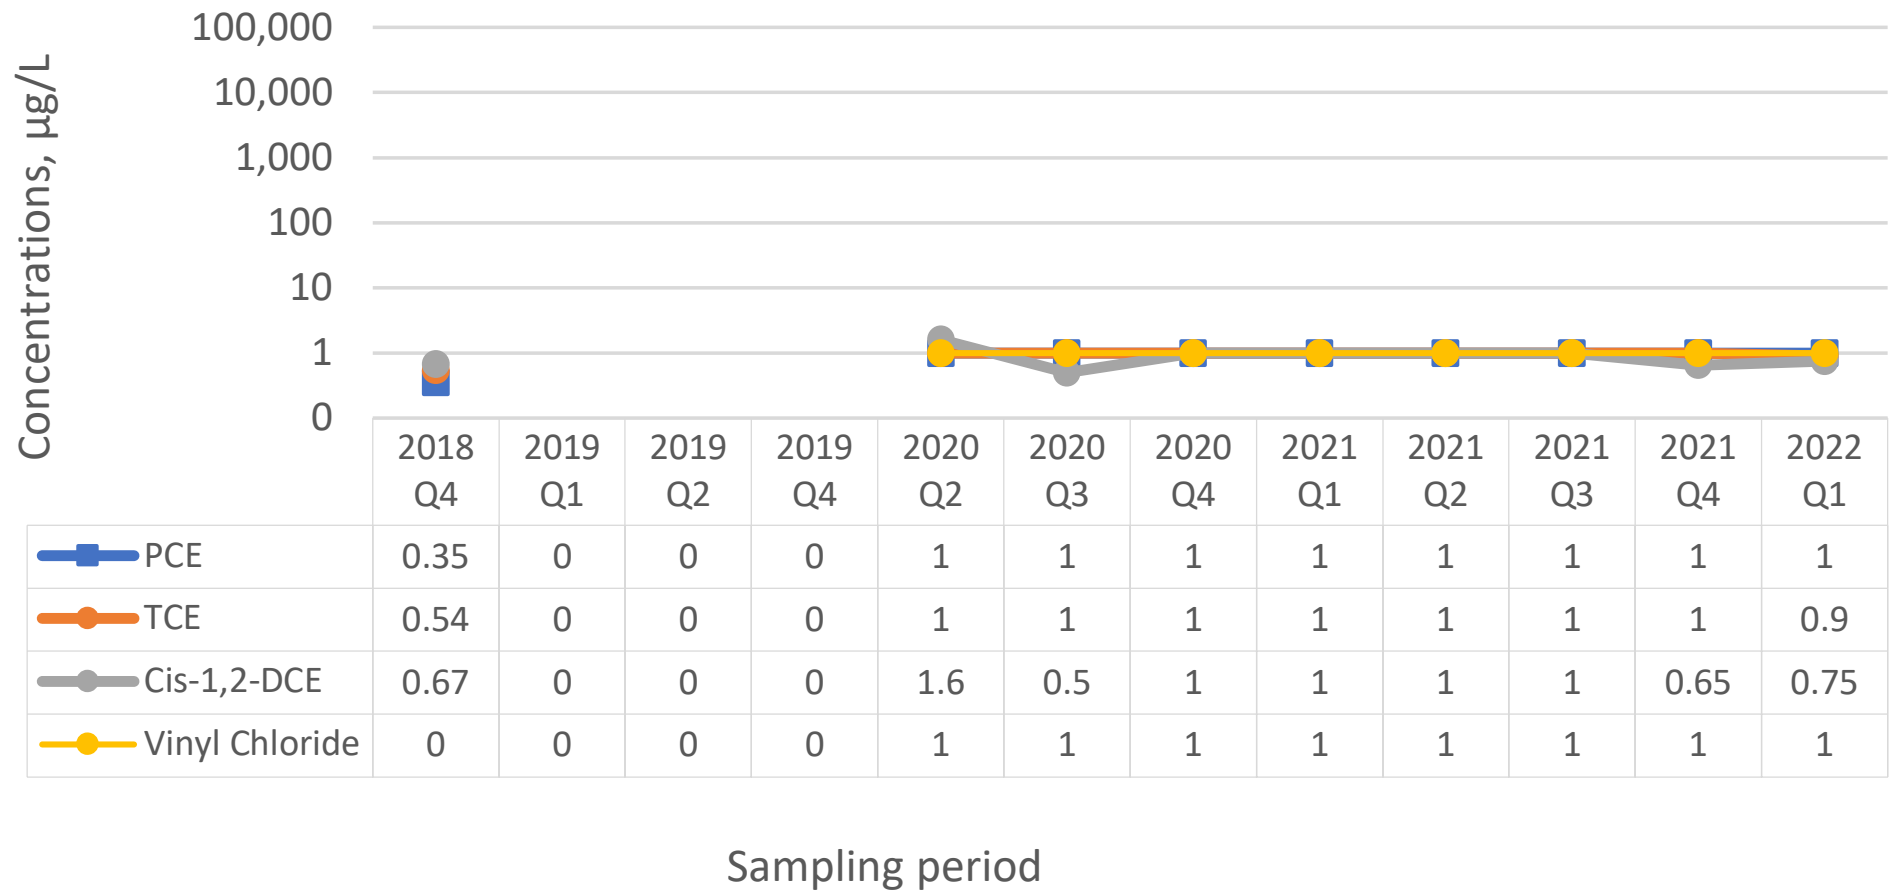
RW-2

- **RW-2:** The 4-inch extraction well is located on Orchard Street, approximately 1,500 feet to the southwest of the Site, and screened at 12-37 fbg. Sample MW-A was collected as a duplicate of sample RW-2. None of the contaminants of concern were detected above the laboratory reporting limits.

Temporal Variations of VOCs Concentrations
Active Industrial Uniform Superfund Site #152125
63 West Merrick Road, Lindenhurst, New York
HRP# DEC1004.OM
