# O&M DATA SHEET - NATIONAL HEATSET - OFF-SITE SYSTEM

Date: 12/27/2012

**PHOTOGRAPHIC LOG**  
**Date: 12-27-12**  
**AECOM Job No.**  
**National Heatset Printing Site - Off-Site**

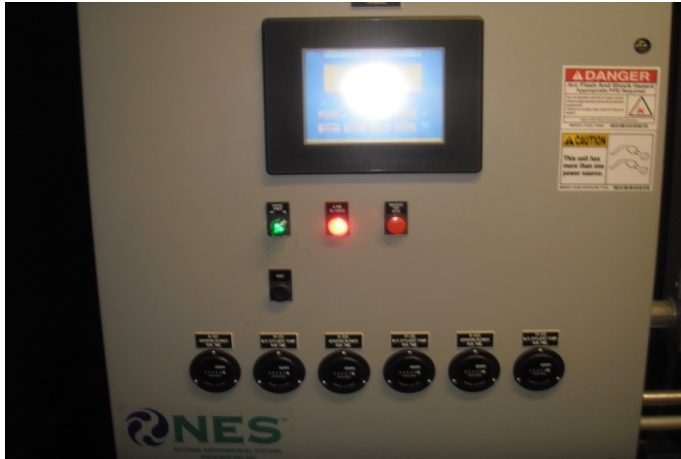
**Picture 348-** Both blowers were up and two (2) alarms were triggered upon arrival.

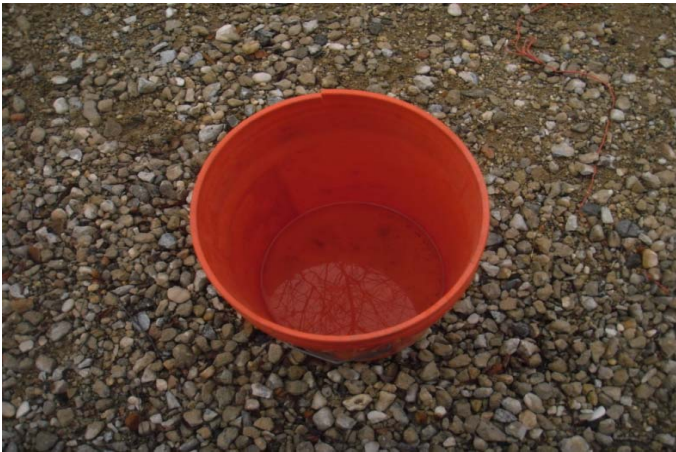
Set Temp. (°F)	75	1 - DDC-5's condensate valve was drained for 5 minutes, from which less than a half of a gal. of water was produced.
Actual Temp. (°F)	78	
Pump Pressure (PSI)	25	2 - DDC-6's condensate valve was drained for 1 minute, from which a less than a quarter gallon of water was produced. DDC-6 produced mostly air from the initial release of the valve.
Freon High Pres. (PSI)	200	
Freon Low Pres. (PSI)	74

**Picture 353-** Water drained from DDC-6 condensate valve.
