Project: National Heatsheet Printing Site - Off-Site - Site Management
Contractors: AECOM and Preferred Environmental Services
AECOM Job No: 60135649
Site No: 1-52-140
AECOM Project Manager: Walt Howard

DAILY REPORT

O&M DATA SHEET - NATIONAL HEATSET - OFF-SITE SYSTEM

PHOTOGRAPHIC LOG
Date: 1-23-13
AECOM Job No.
National Heatset Printing Site - Off-Site

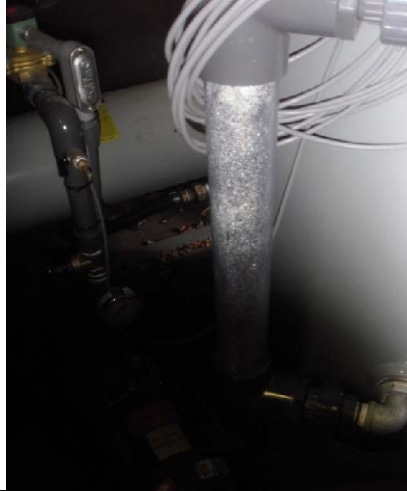
Picture 390- No measurable water was seen on the site glasses associated with the knock-out tanks.

PHOTO	DATE	TIME	DESCRIPTION	COMMENTS
Picture 390	1/23/2013	11:15	No measurable water was seen on the site glasses associated with the knock-out tanks.	
Picture 396	1/23/2013	12:30	The differential pressure gauges associated with the four (4)-inch injection lines were observed to read elevated compared to prior readings.

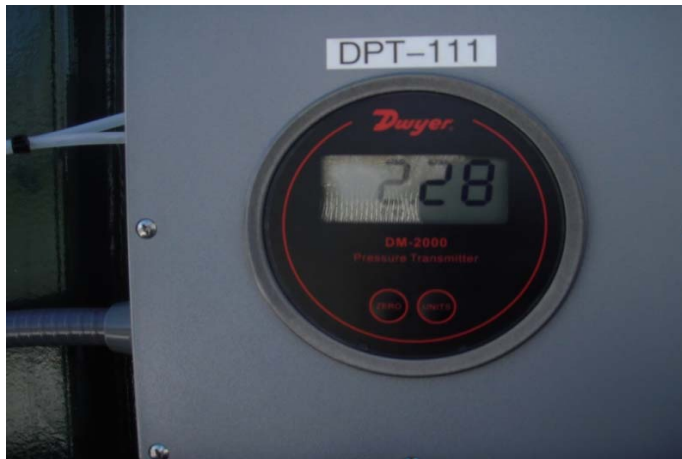
Picture 396- The differential pressure gauges associated with the four (4)-inch injection lines were observed to read elevated compared to prior readings.

13:33 - Preferred locked both sheds and all parties off-site. All alarms were reset, with blowers B-501 & B-502 up upon departure. Preferred discussed elevated pressure readings on the DDC wells with AECOM. System left running as per AECOM direction.
