Project: National Heatsheet Printing Site - Off-Site - Site Management
 Contractors: AECOM and Preferred Environmental Services
 AECOM Job No: 60135649
 Site No: 1-52-140
 AECOM Project Manager: Walt Howard

DAILY REPORT

O&M DATA SHEET - NATIONAL HEATSET - OFF-SITE SYSTEM

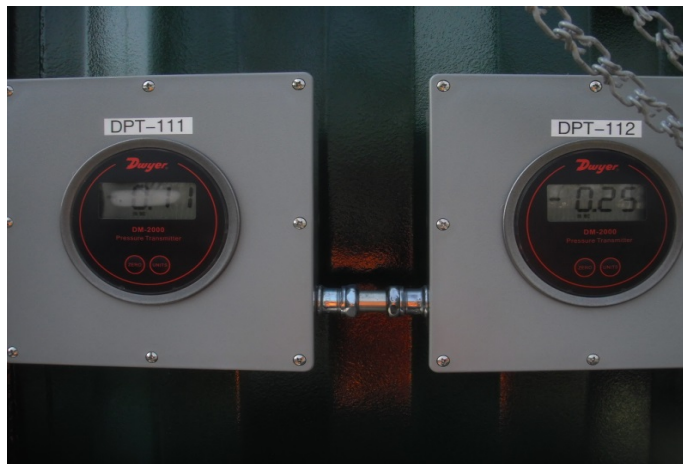
Picture 0035- Three (3) of the digital differential pressure gauges on the four (4)-inch injection lines were observed to be negative.

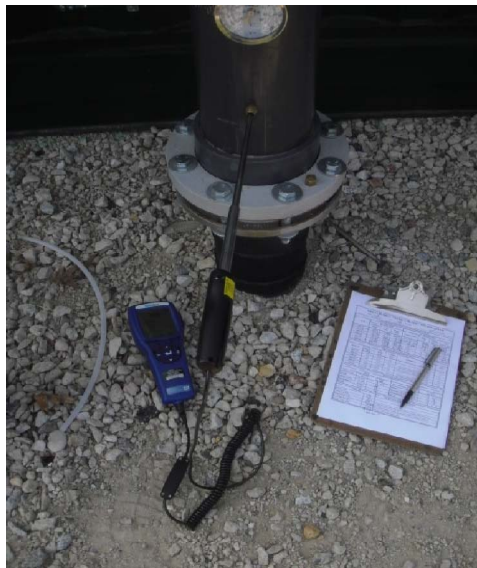
Picture 0037- Air velocity readings were taken from the six (6)-inch extraction lines returning to the treatment shed.
