**Periodic Review Report No. 3
January 1, 2016 – December 31, 2016
National Heatset Printing Co. Site (152140)**

**Town of Babylon
Suffolk County, New York**

December 2017
Version: FINAL
EA Project No. 14907.16

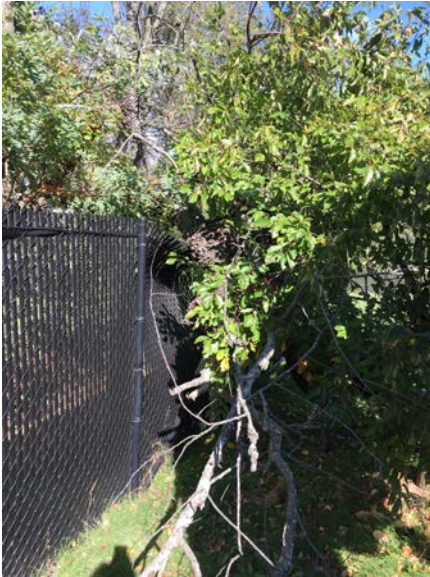
Minor damage was observed at the offsite DDC system enclosure during the October 2016 quarterly event. Upon arrival, it was observed that a tree branch from the SCWA – Albany Avenue Well Field property had fallen onto the west fence line of the equipment trailer compound. The branch was removed and placed back on SCWA property. A portion of the west fence line is bent slightly as a result, but still retains its functionality.

Tree from SCWA property on off-site system fence line (1 of 2)

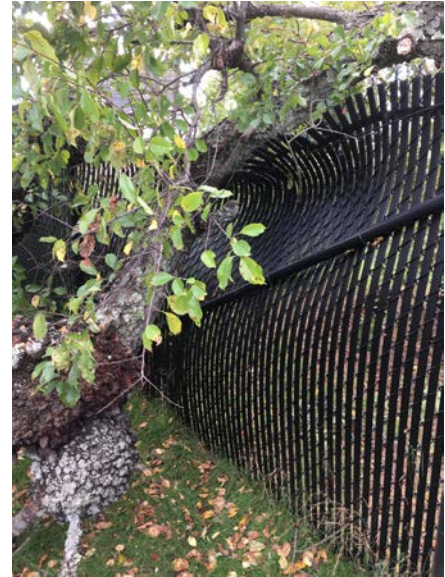
Tree from SCWA property on off-site system fence line (2 of 2)

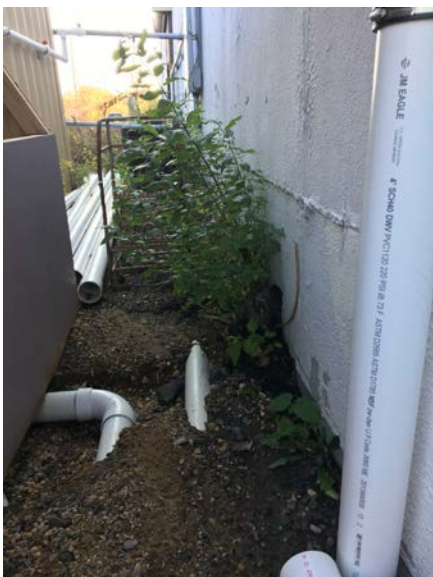
The SVE system and surrounding areas were generally observed to be in good condition during the annual inspection (**Appendix B**). There was no evidence of vandalism to the SVE treatment system and new outdoor manifold. Additionally, a roof drain from the 1 Adams Boulevard building (located near the horizontal well manifold) was observed to be eroding the soil cover for the well lines and entering the system during heavy rain events. Modifications will be made in early 2017 to divert flow away from the SVE treatment trailer. Inside the building, vapor-monitoring points sustain continual wear and tear due to the daily operations of the tenant. At the time of inspection, it was noted that one of the well covers for MW-G was broken. The cap will be replaced in early 2017.

Erosion near SVE manifold

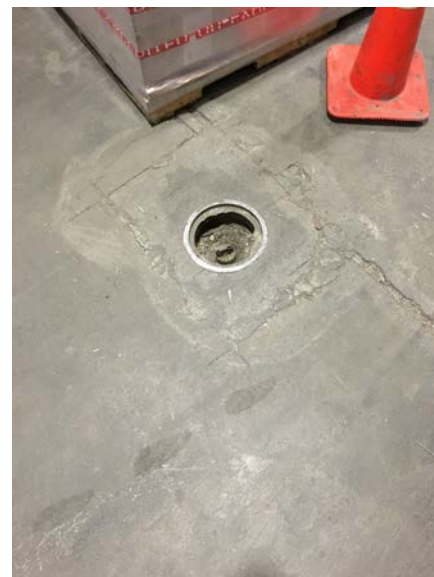
Missing well cap inside 1 Adams Blvd.

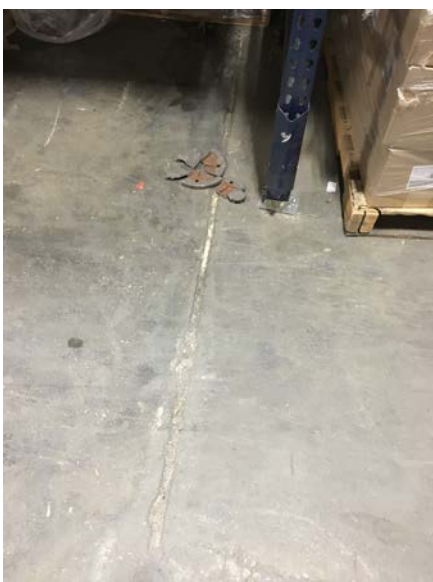
Well cap for MW-H

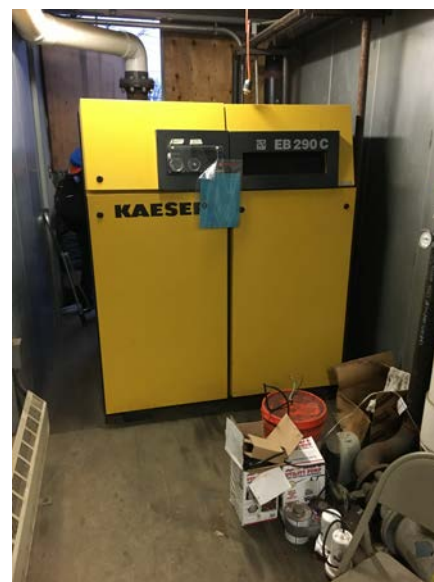
On December 22, 2016, it was noted that the BP-01 pressure gauge on the blower in onsite DDC system #2 might be faulty. A replacement was ordered though D&D and repairs are scheduled for early 2017; in the interim, the system will remain operational.

Blower in System #2 with faulty pressure gauge.
