**Periodic Review Report No. 4
30 January 2017 – 30 January 2020
National Heatset Printing Co. Site (152140)**

**Town of Babylon
Suffolk County, New York**

April 2021
Version: DRAFT
EA Project No. 1602518

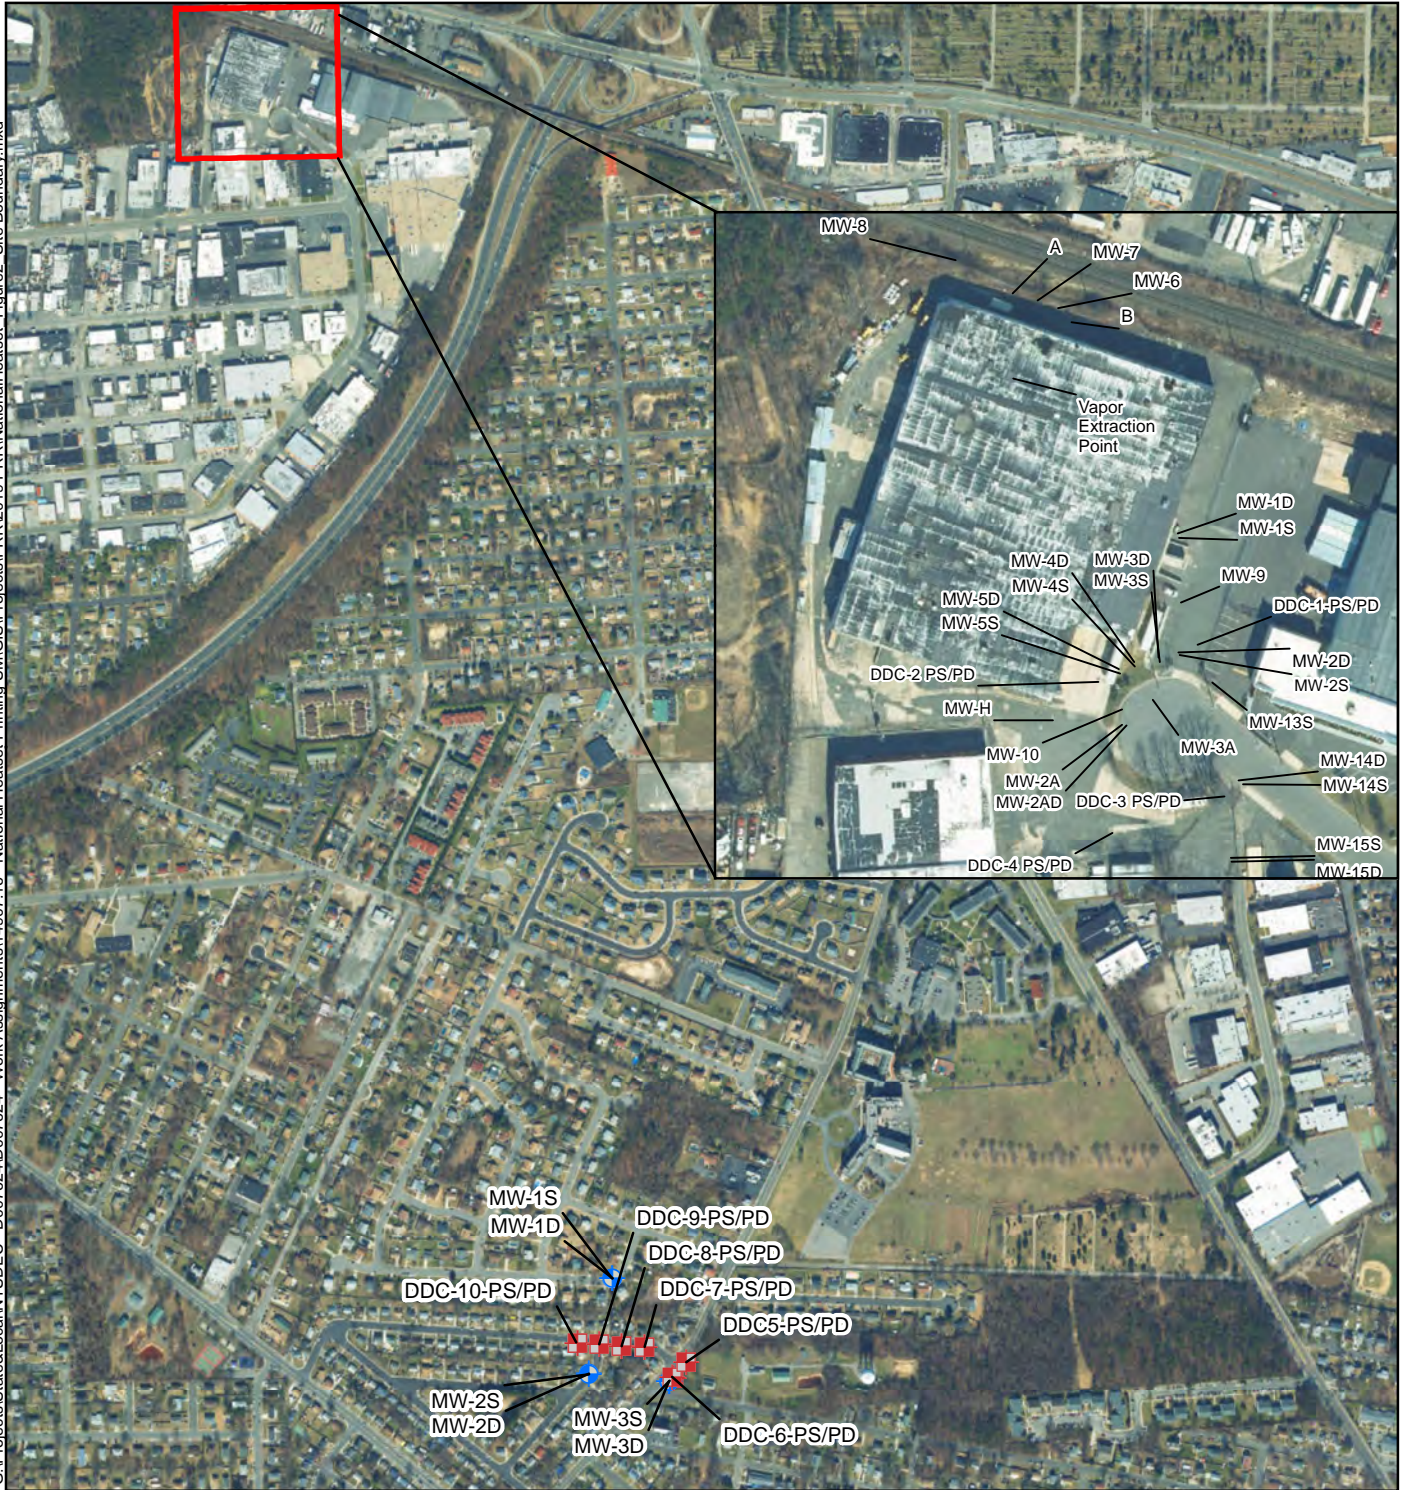
Figure 2
SITE, SURROUNDING AREA, AND
MONITORING WELL NETWORK
NATIONAL HEATSET SITE (152140)
BABYLON, NEW YORK
SUFFOLK COUNTY

The National Heatset Printing Co. (NHP) site is currently a Class 4 site listed on the New York State Department of Environmental Conservation (NYSDEC) Registry of Inactive Hazardous Waste Sites (Number [No.] 152140). The site is located at 1 Adams Boulevard in the Hamlet of Farmingdale, Town of Babylon, Suffolk County, New York, and is identified as Block 1.00 and Lot 20.001 on the Town of Babylon Tax Map No. 132.20-1-3.2. A site location map is presented in **Figure 1**. The site is currently owned by 1 Adams Boulevard Realty Corporation, managed by Finkelstein Realty, and leased by a tenant. The site contains one industrial building and is 4.5 acres in size. The site is located in an industrial area and is bounded by railroad tracks to the north, Adams Boulevard and an industrial property to the south, an industrial property to the east, and an industrial property to the west (**Figure 2**).

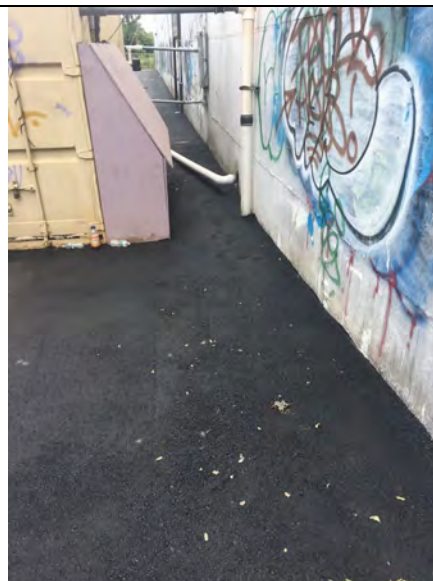
Paving completed behind 1 Adams boulevard building

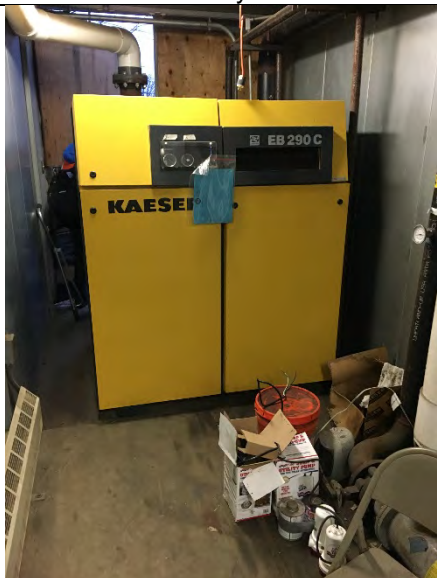
The DDC treatment systems were observed to be in good condition during the annual inspections; no additional damage to the system enclosures or wellheads in either location was noted during the inspections. At the time of the annual inspections, all gauges and meters read within acceptable levels on the operating systems. Remote communication equipment was functional for onsite DDC System #2 and the offsite system, except for the blower pressure gauge for onsite DDC System #2, which was malfunctioning.

Blower in onsite DDC system #2 with faulty pressure gauge

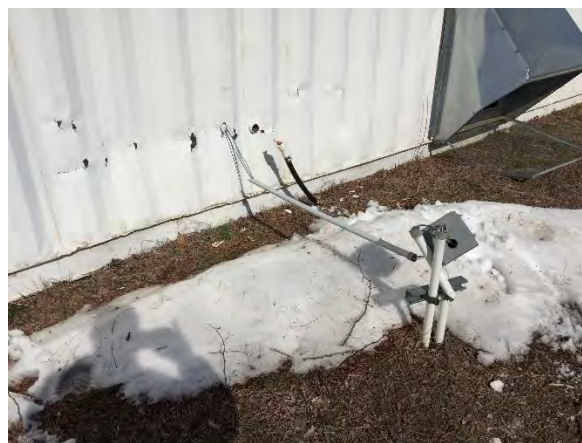
During the October 2017 inspection, it was noted that damage had occurred to the onsite DDC System #2 trailer in February 2017. A snowplow hit the side of the trailer and damaged the exterior electrical conduit. Damage to the electrical conduit was repaired on 14-17 February 2017.

Damage was observed at the onsite DDC System #2 trailer during the February 2017 monthly event. The trailer was damaged by a snowplow during snow removal activities. An exterior electrical conduit was also damaged during this event. Electrical conduit associated with onsite DDC System #2 was repaired the week after damage was noted.

Damage to exterior of onsite DDC system #2 incurred in winter 2017. Snowplow collided with system trailer and damaged exterior electrical conduit.

Onsite DDC System #2 was shut down for brief periods during the reporting period for repairs. Repairs were performed to address the damaged exterior electrical conduit in 2017 when the system was struck by a snowplow, replacement of switches on the control panel, and to repair the transfer pump. In February 2019, onsite DDC System #2 was shut down due to high local groundwater elevations and associated operational issues. Local groundwater elevations were continuously monitored but did not return to a level that would allow system operation during the reporting period.

2/17/2017	Onsite	PES and D&D onsite to repair conduit damaged earlier in week.
3/27/2017	Onsite and offsite	Monthly visit. Transfer pump for KO tank in onsite DDC System #2 leaking. System was shut down and a replacement was ordered to be installed following month.
4/17/17 – 4/20/17	Onsite and offsite	Quarterly visit and sampling. Collected groundwater and offsite and SVE system air samples. Onsite systems off upon arrival due to broken blower belts (System #1) and damaged transfer pump (System #2). System #2 pump repaired but would not restart due to error with VFD. Systems remained off until repairs could be completed; air samples to be collected from on-site systems during next monthly visit after repairs are complete.
5/16/2017	Onsite	PES and D&D onsite to replace belts on onsite System #1 and VFD for onsite System #2. Also preventatively replaced belts on onsite System #2.
5/23/2017	Onsite and offsite	Monthly visit. Conducted monthly O&M and collected samples of system air at all onsite systems.

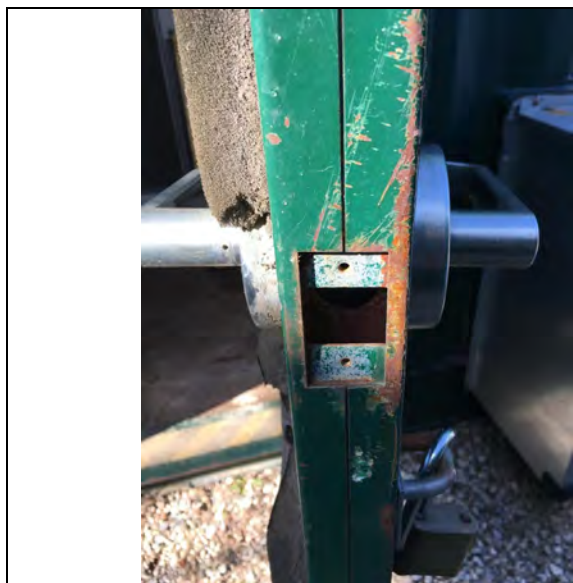
Removed door latches at offsite system trailer to prevent lock-outs.

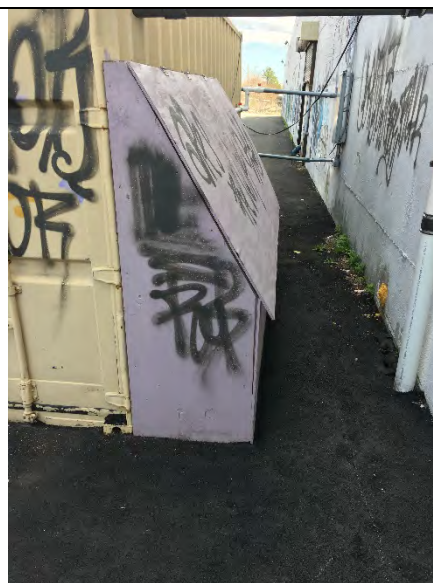
The SVE system and surrounding areas were generally observed to be in good condition during each annual inspection. There was no evidence of vandalism to the SVE treatment system and new outdoor manifold, however, graffiti was found on the SVE system enclosure during the April 2018 inspection. Also, during the same inspection the SVE blower was not operational and was offsite for repairs.

The SVE system and surrounding areas were generally observed to be in good condition during the annual inspections (**Appendix B**). There was no evidence of vandalism to the SVE treatment system and new outdoor manifold; however, additional graffiti was noted on the enclosure. Inside the building, vapor-monitoring points sustain continual wear and tear due to the daily operations of the tenant.

Graffiti on SVE system enclosure

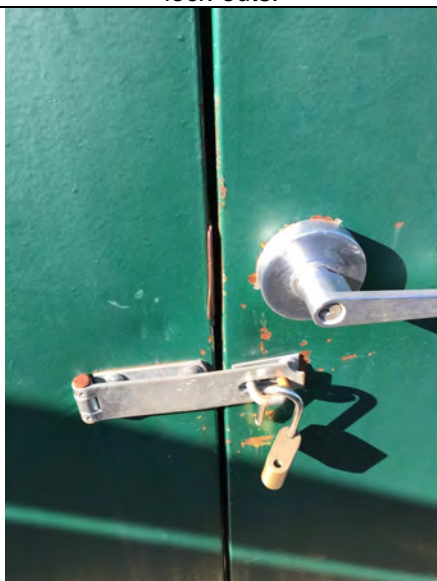
Door locked with exterior latch only – interior door latches removed.

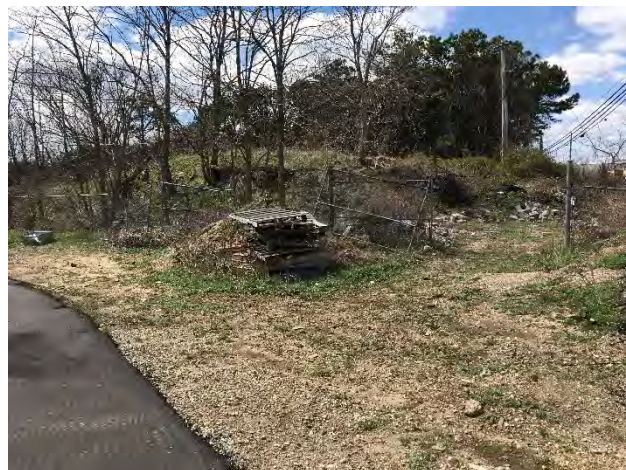
Fence panels removed on northwest corner of 1 Adams Blvd property

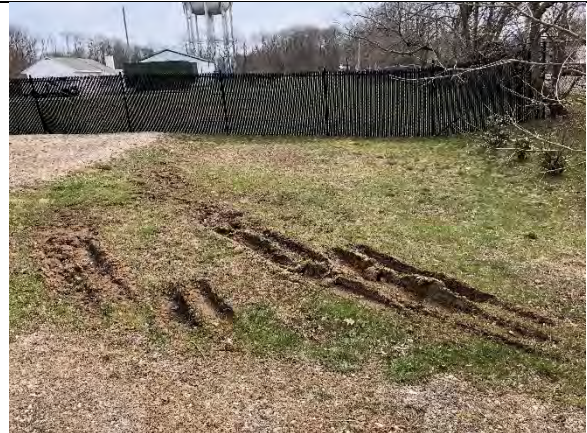
Wheel tracks noted in enclosure of offsite system.
Tracked caused by D&D support van during removal of B502

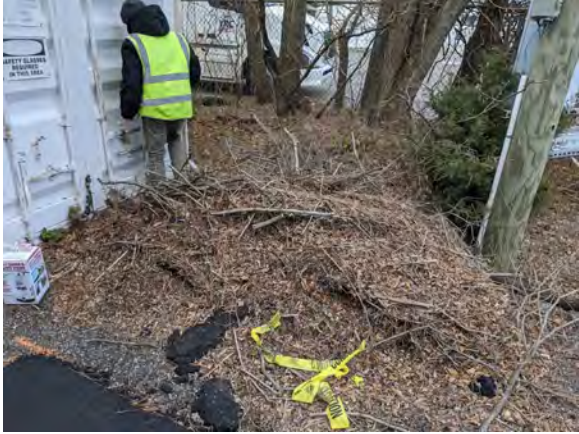
<p>Tree fallen on fence at offsite fence.</p>	<p>Onsite DDC System #2 access door partially obstructed by branches & other organic debris</p>

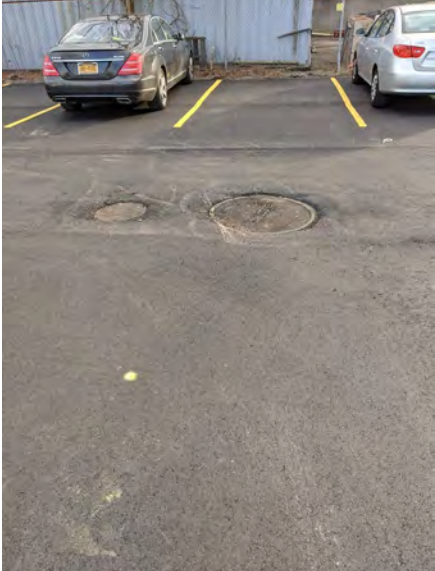
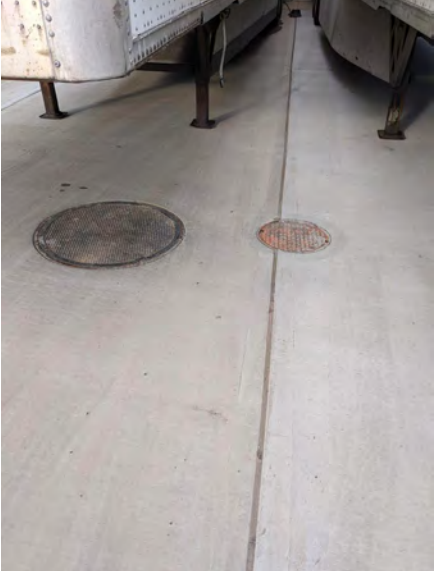
<p>DDC-4 well vault in freshly paved parking lot</p>	<p>DDC-2 well vault in loading dock; concrete recently repaired.</p>
