**Periodic Review Report No. 4  
30 January 2017 – 30 January 2020  
National Heatset Printing Co. Site (152140)**

**Town of Babylon  
Suffolk County, New York**

June 2021  
Version: FINAL  
EA Project No. 1602518

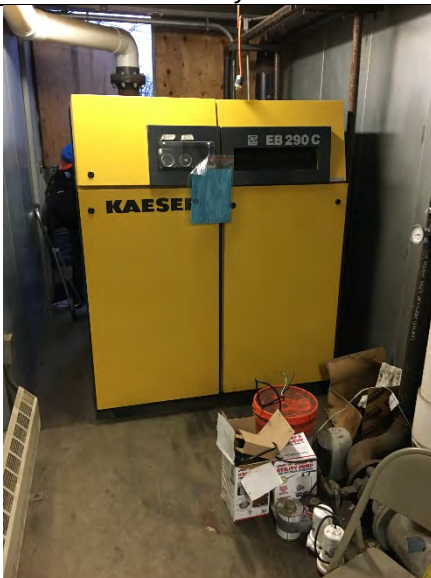
Blower in onsite DDC system #2 with faulty pressure gauge

The DDC treatment systems were observed to be in good condition during the annual inspections; no additional damage to the system enclosures or wellheads in either location was noted during the inspections. At the time of the annual inspections, all gauges and meters read within acceptable levels on the operating systems. Remote communication equipment was functional for onsite DDC System #2 and the offsite system, except for the blower pressure gauge for onsite DDC System #2, which was malfunctioning.

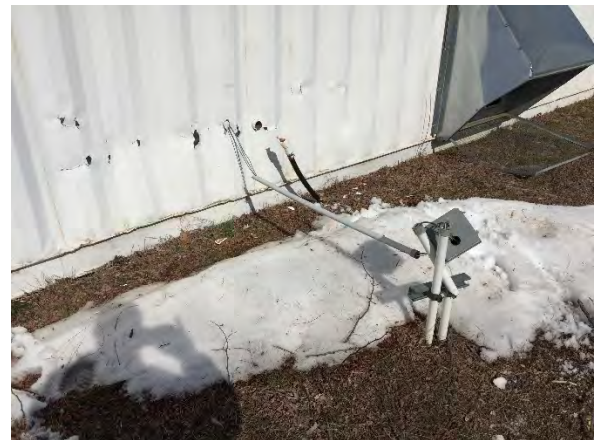
Damage to exterior of onsite DDC system #2 incurred in winter 2017. Snowplow collided with system trailer and damaged exterior electrical conduit.

Damage was observed at the onsite DDC System #2 trailer during the February 2017 monthly event. The trailer was damaged by a snowplow during snow removal activities. An exterior electrical conduit was also damaged during this event. Electrical conduit associated with onsite DDC System #2 was repaired the week after damage was noted.

| Date | System | Purpose |
|---|---|---|
| 2/13/17 – 2/14/17 | Onsite | EA and D&D Electric Motors & Compressors (D&D) onsite to replace selector switch at onsite DDC System #2. Damage to exterior of system trailer observed. Electrical conduit, pump for KO tank, and side of trailer damaged. Repaired polyvinyl (PVC) line for KO tank. |
| 2/17/2017 | Onsite | PES and D&D onsite to repair conduit damaged earlier in week. |

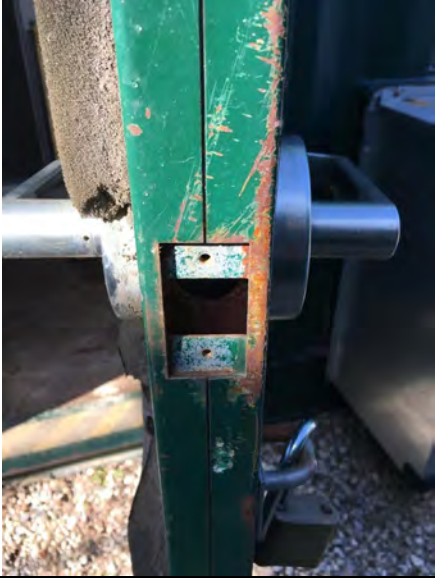
| <p>Removed door latches at offsite system trailer to prevent lock-outs.</p> | <p>Graffiti on SVE system enclosure</p> |

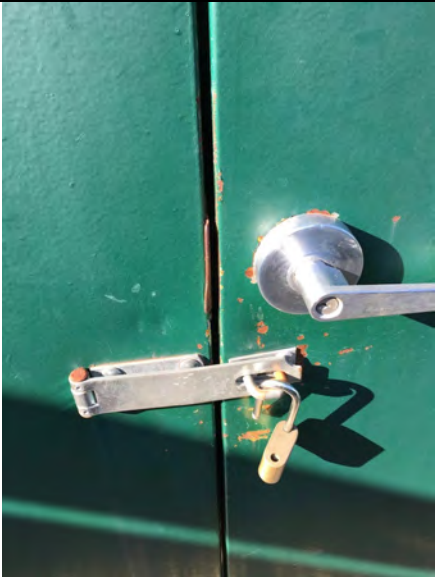
| <p>Door locked with exterior latch only – interior door latches removed.</p> | <p>Fence panels removed on northwest corner of 1 Adams Blvd property</p> |

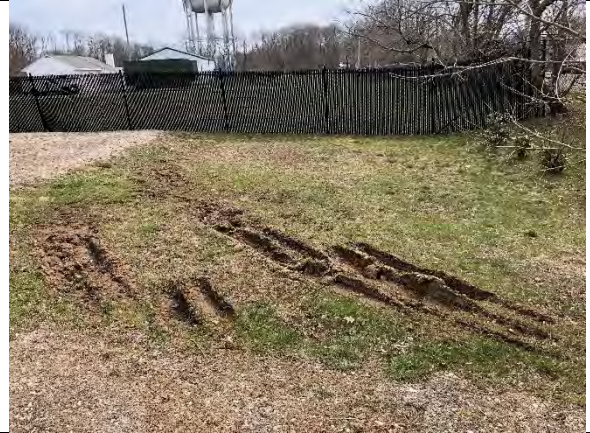
Wheel tracks noted in enclosure of offsite system. Tracked caused by D&D support van during removal of B502

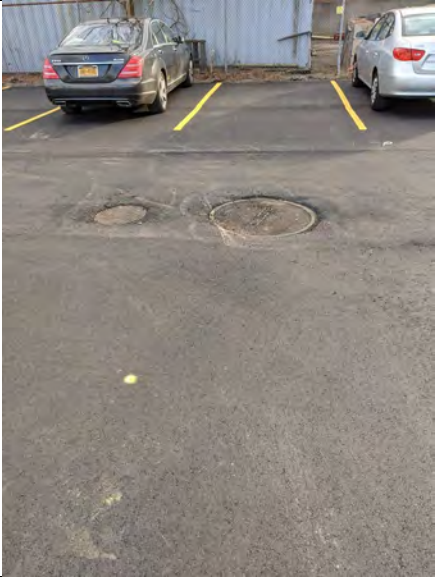
| <p>DDC-4 well vault in freshly paved parking lot</p> | <p>DDC-2 well vault in loading dock; concrete recently repaired.</p> |
