**Periodic Review Report No. 5
30 January 2020 – 30 January 2022
National Heatset Printing Co. Site (152140)**

**Town of Babylon
Suffolk County, New York**

March 2022
Version: DRAFT
EA Project No. 1602518

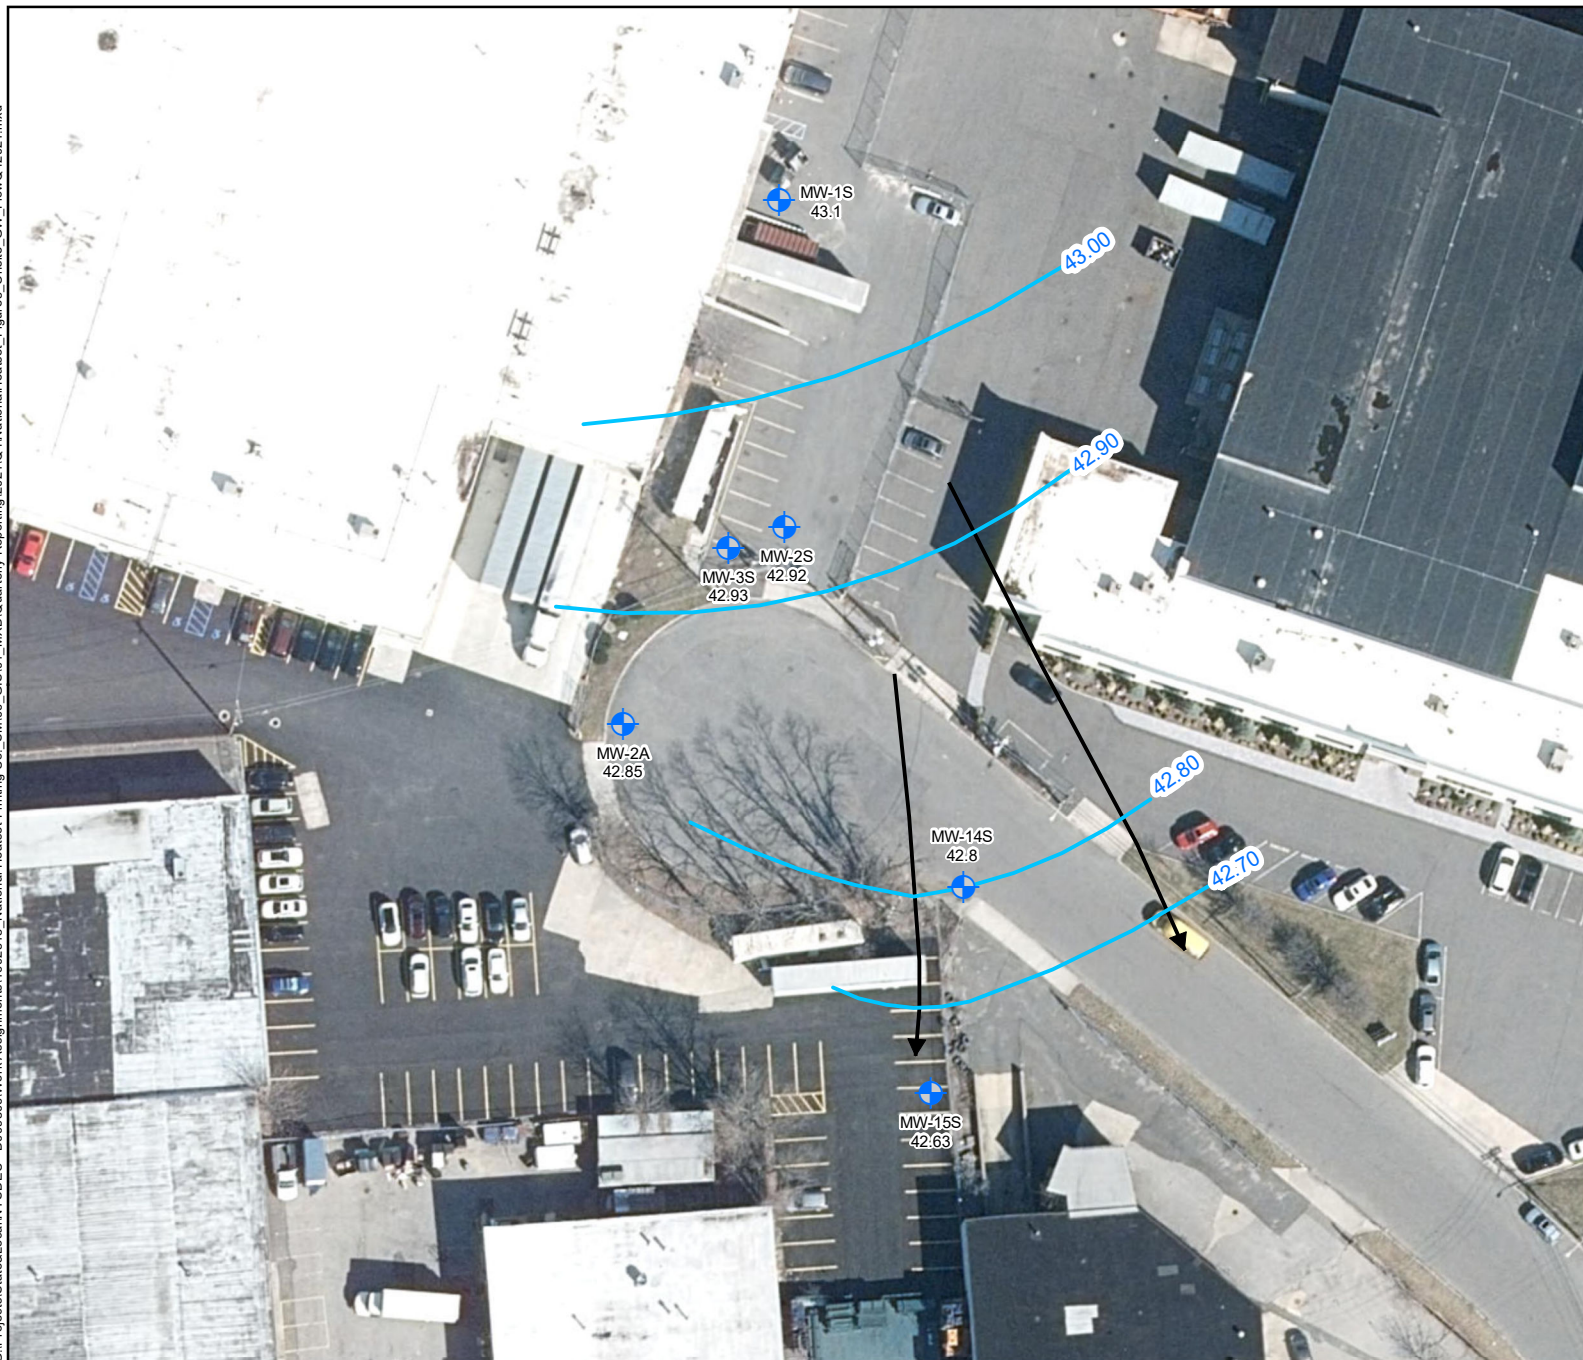
Figure 3
ON-SITE GROUNDWATER
FLOW DIRECTION
(OCTOBER 2021)
NATIONAL HEATSET
PRINTING CO. SITE (152140)
BABYLON, NEW YORK
SUFFOLK COUNTY

- Monitoring Wells
- Approximate Groundwater Flow Direction
- Approximate Groundwater Elevation (ft. AMSL)

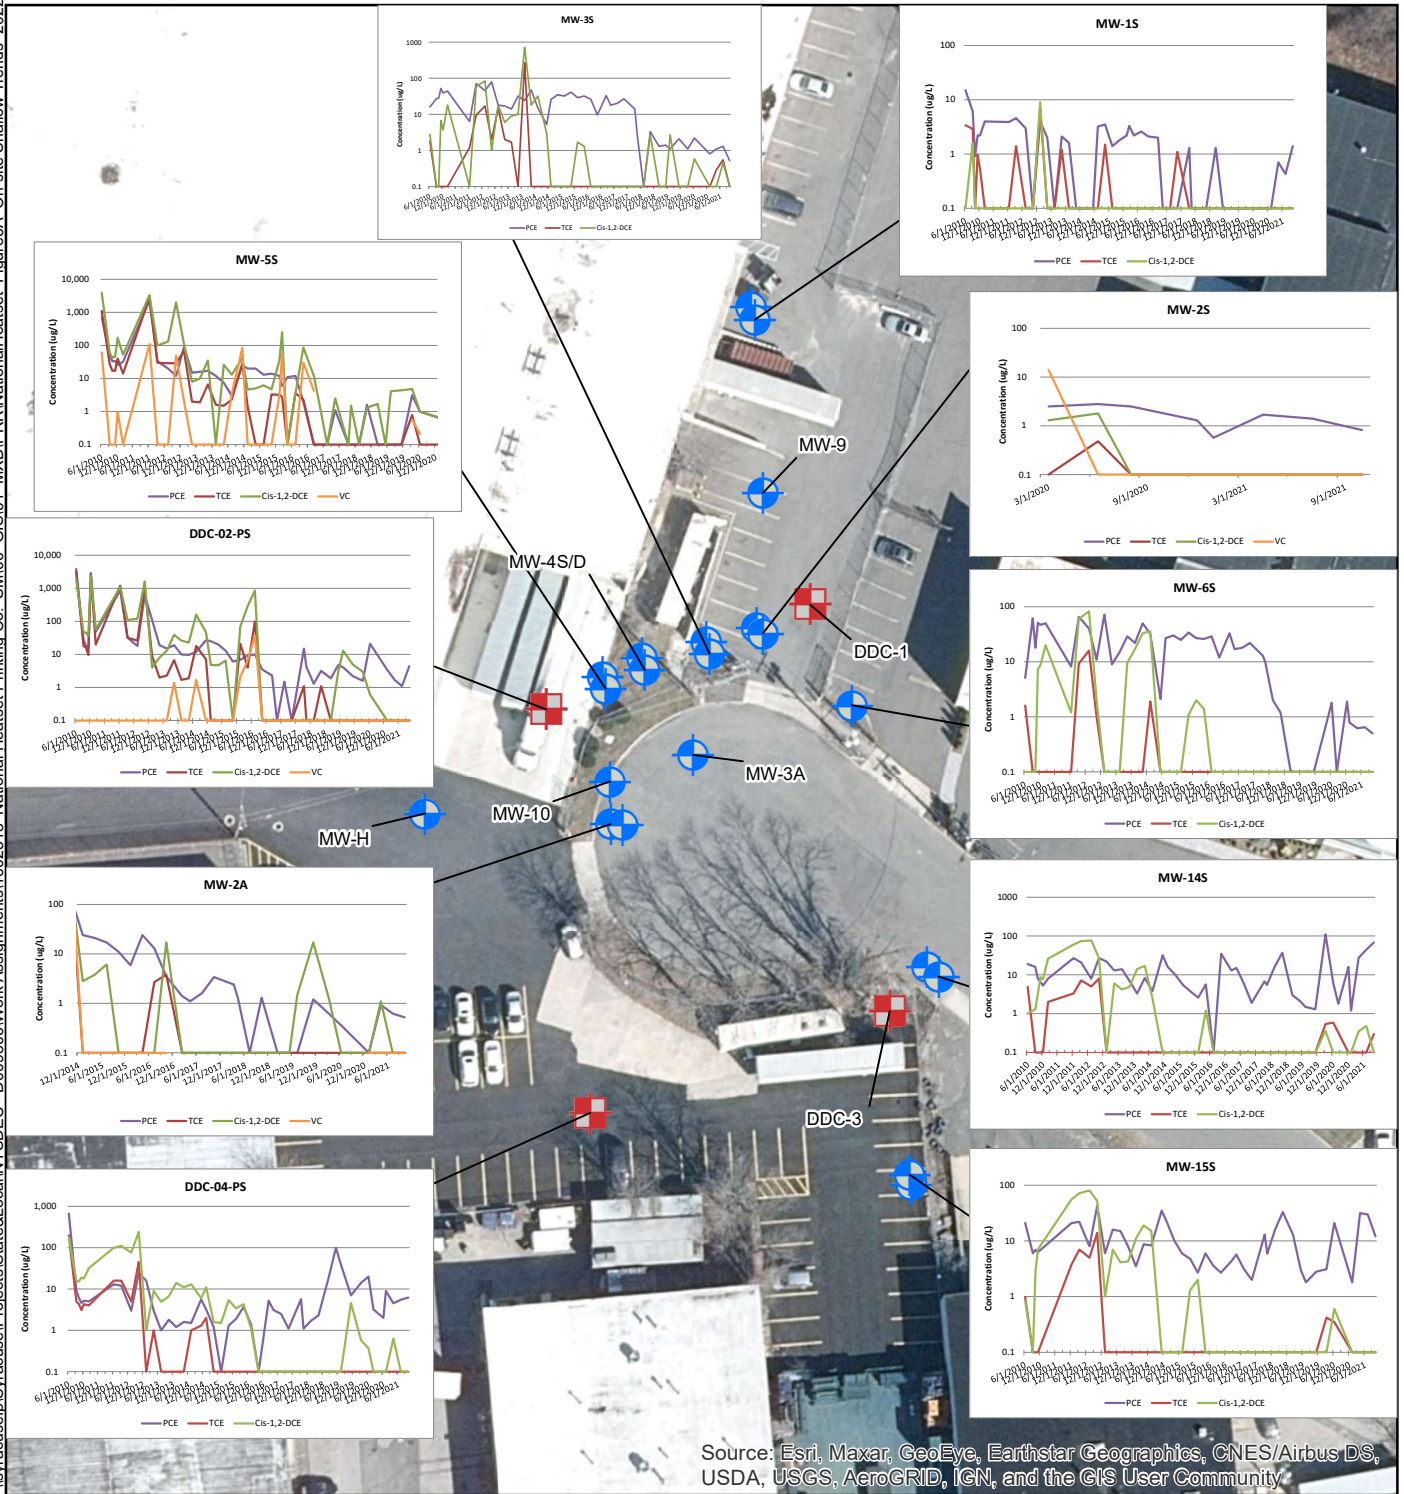
Figure 6A
ON-SITE SHALLOW WELLS
CVOC TREND GRAPHS
 June 2010 - October 2021 NATIONAL
 HEATSET PRINTING CO. SITE (152140)
 BABYLON, NEW YORK
 SUFFOLK COUNTY

- Legend**
- DDC Well Cluster
 - Groundwater Monitoring Well
 - PCE
 - TCE
 - cis-1,2-DCE
 - VC
 - Site Location

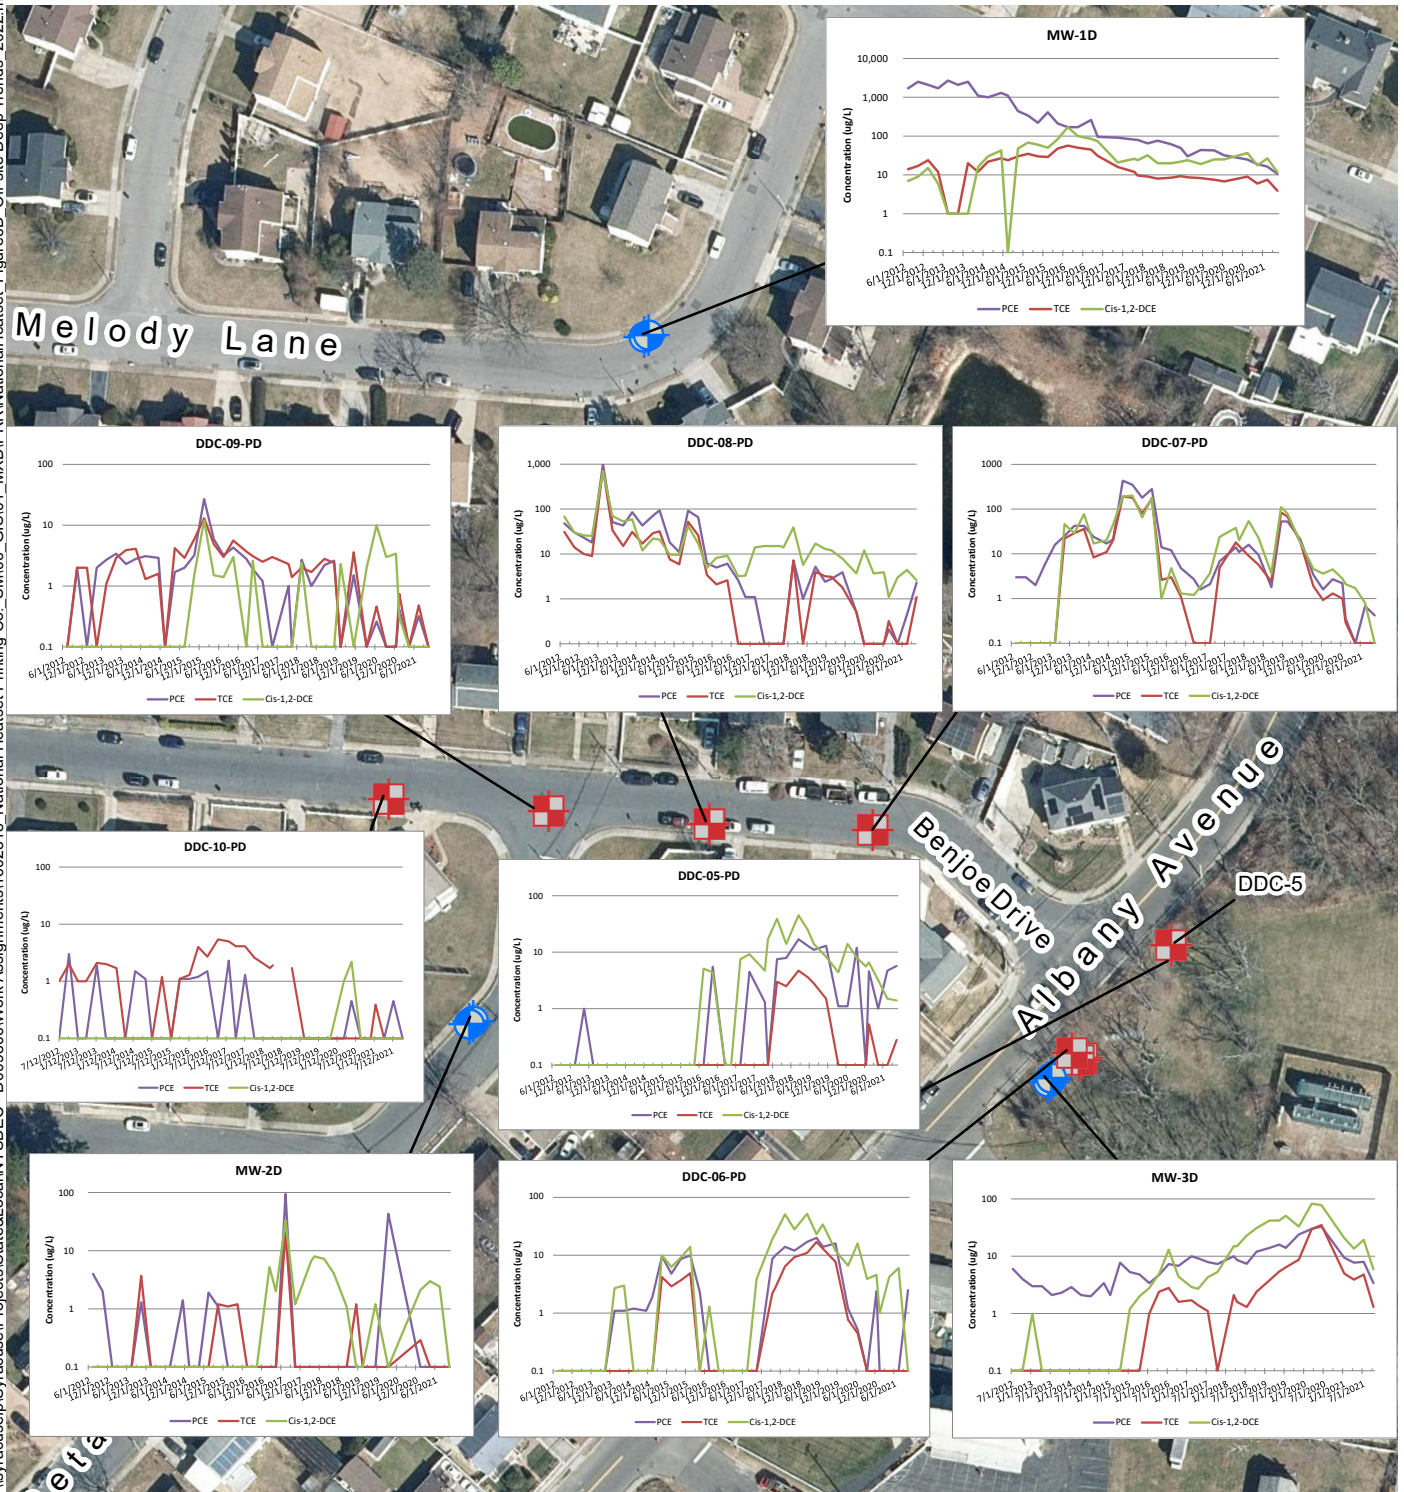
Figure 6D
OFF-SITE DEEP WELLS
CVOC TREND GRAPHS
June 2012 - October 2021
NATIONAL HEATSET PRINTING CO. SITE (152140)
BABYLON, NEW YORK
SUFFOLK COUNTY
Map Date: 2/11/2022
Source: ESRI, 2011

- Legend**
- DDC Well Cluster
 - Groundwater Monitoring Well
 - PCE
 - TCE
 - cis-1,2-DCE
 - VC
 - Site Location

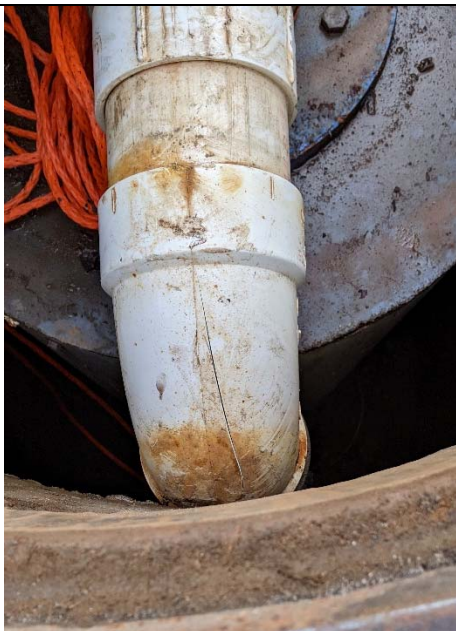
- A cracked polyvinyl chloride (PVC) fitting on the on-site DDC-2 well was observed during the January 2021 troubleshooting event. The PVC fitting was repaired in July 2021, but the system was still not able to run.

Cracked PVC fitting on DDC-2

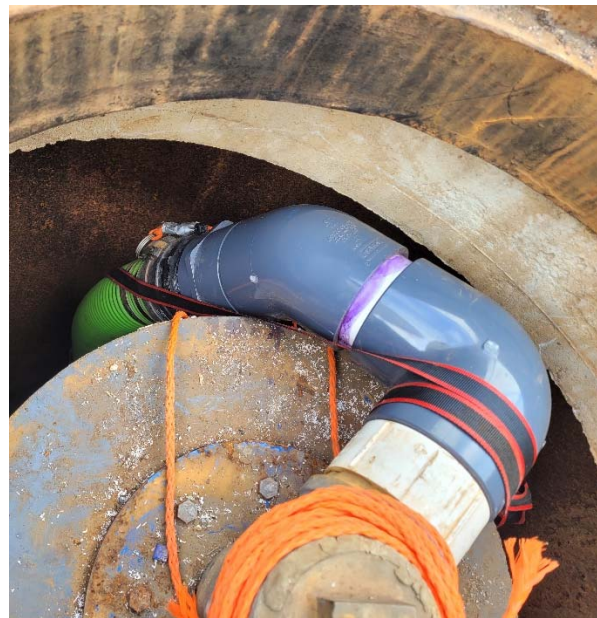
DDC-2 after replacing cracked PVC

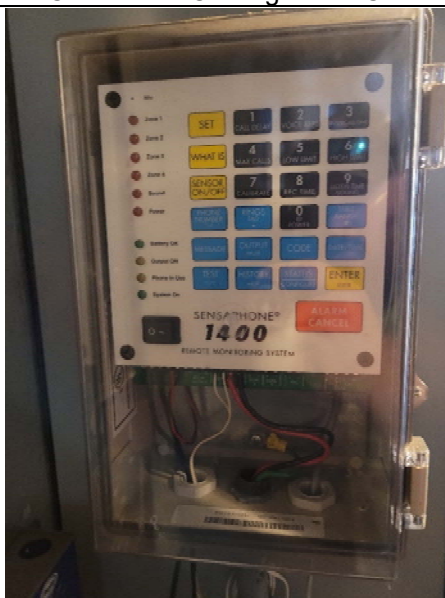
Sensaphone for DDC System #1 remains off

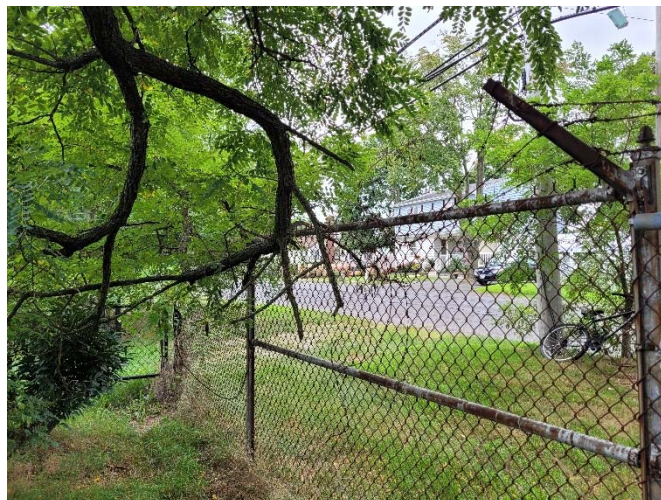
Tree branch bending fence at Off Site System
