**NO FURTHER RESPONSE ACTION PLANNED DECISION DOCUMENT
FOR
SITE 5 – SOUTHWEST STORM DRAINAGE DITCH**

**106TH RESCUE WING
FRANCIS S. GABRESKI AIRPORT
WESTHAMPTON BEACH, NEW YORK**

DECEMBER 2011

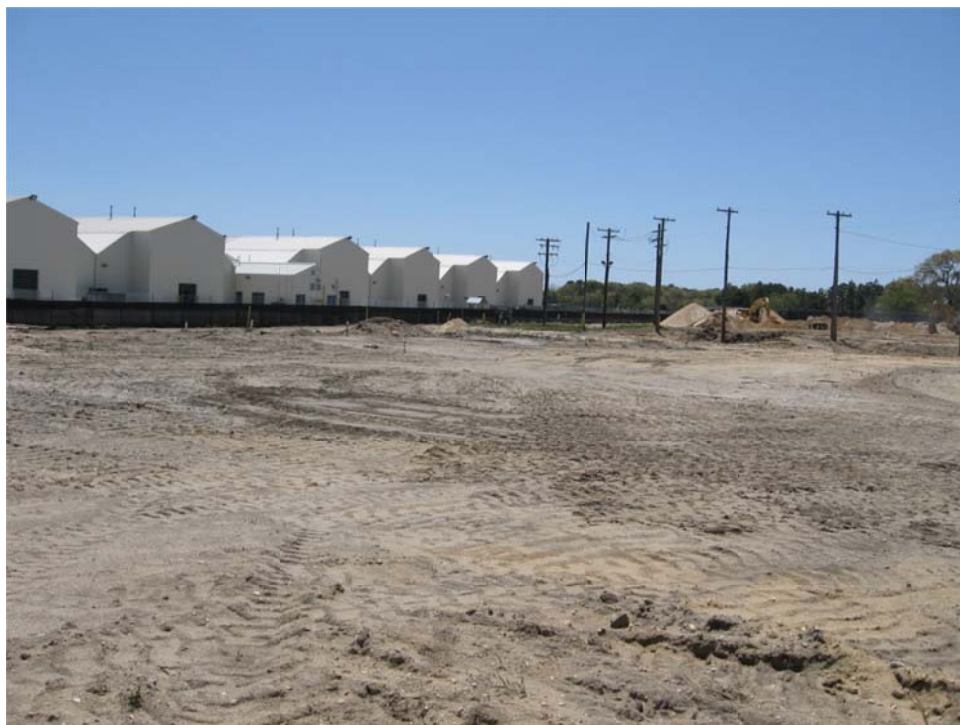
View of Site Looking Toward the Southwest Prior to Remedial Action

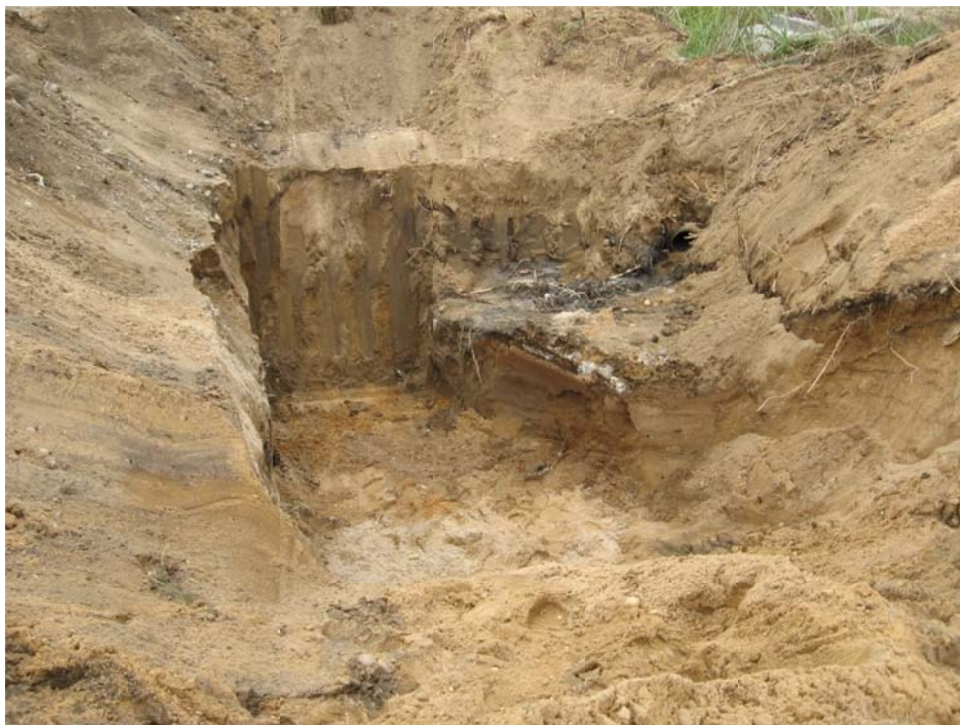
Area-1 Excavation

On May 20, 2009 an approximate 4 ft by 10 ft rectangle (4.4 yd³ or 8 tons) of soil was removed from the northern portion of the ditch approximately 18 ft east of former Building 374. The excavation extended to depths ranging from 3.0 to 3.5 ft bgs. No staining or odors were observed during the excavation activities and no photoionization detector (PID) readings greater than 0.0 ppmv were recorded. Photographs of Area-1 are provided in Appendix D.

One bottom and four sidewall confirmation soil samples (north, south, east and west walls) were collected and submitted to the laboratory for analysis of metals at expedited turnaround time (TAT). Confirmation soil samples GAB-A1-F1 (bottom sample) and GAB-A1-W1 (west wall sample) and GAB-A1-S1 (south wall sample) contained several metals (cadmium, chromium, copper, lead and mercury) at concentrations exceeding the SCOs (Table 1.6).

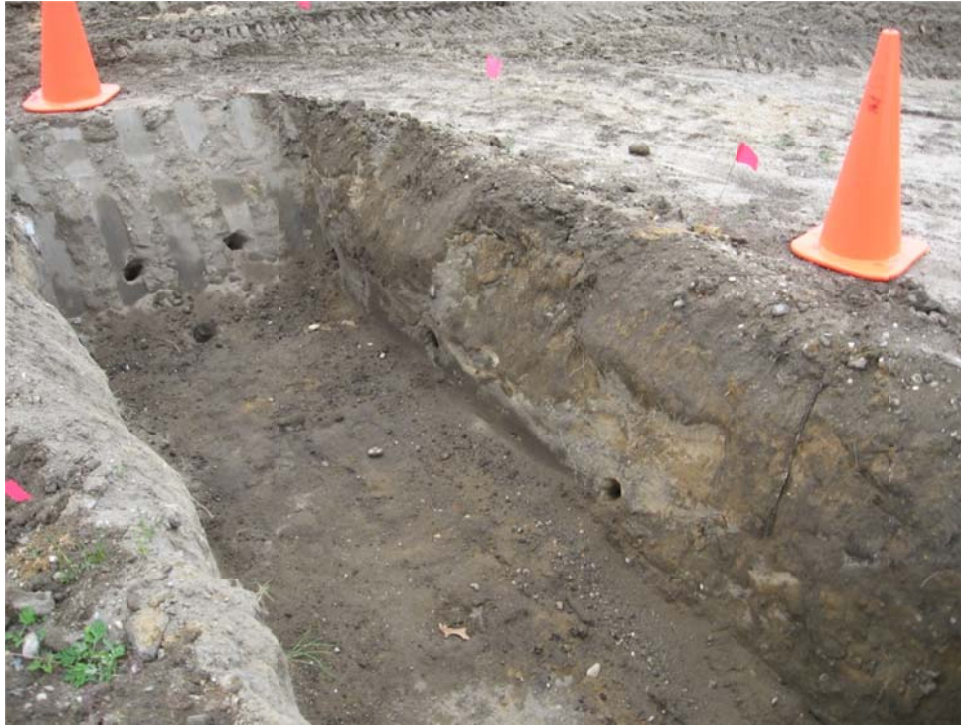
Area-2 Excavation

On May 20, 2009 an approximate 5 ft by 14 ft rectangle (5.2 yd³ or 9.5 tons) of soil was removed approximately 12 ft east of former Building 374 (southwest of Area-1) in the northern portion of the ditch. The excavation extended to approximately 2.0 ft bgs. No staining or odors were observed during the excavation activities and no PID readings greater than 0.0 ppmv were recorded. Photographs of Area-2 are provided in Appendix D.

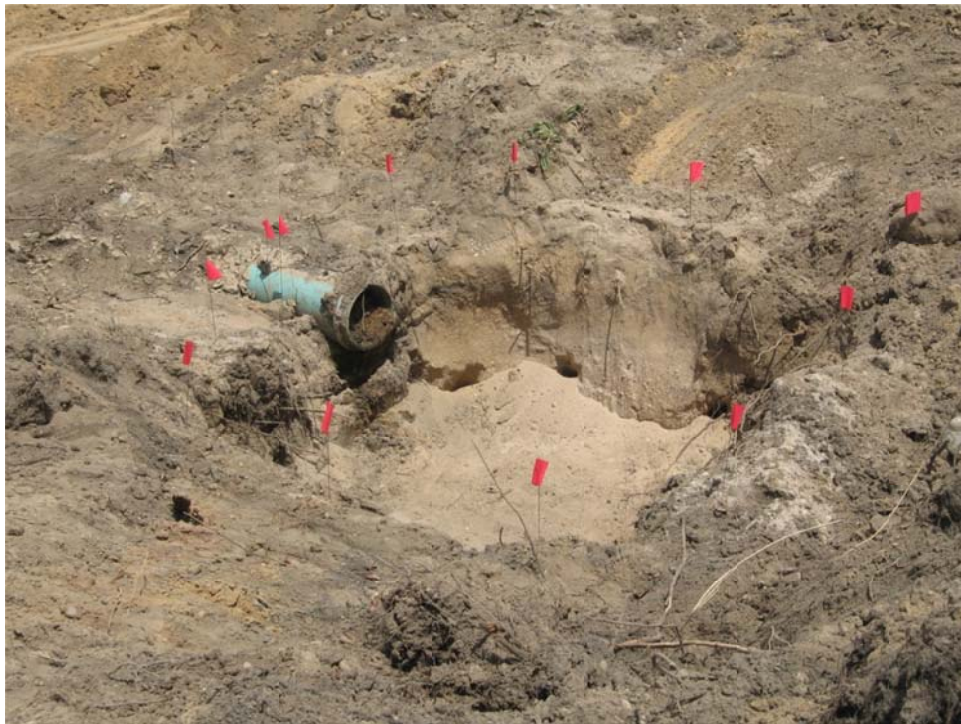
Area-3 Excavation

On May 20, 2009 an approximate 5 ft by 5 ft rectangle (1.9 yd³ or 3.4 tons) of soil was removed from the ditch approximately 36 ft southwest of former Building 378. The excavation extended to approximately 2.0 ft bgs. No staining or odors were observed during the excavation activities and no PID readings greater than 0.0 ppmv were recorded. Photographs of Area-3 are provided in Appendix D.

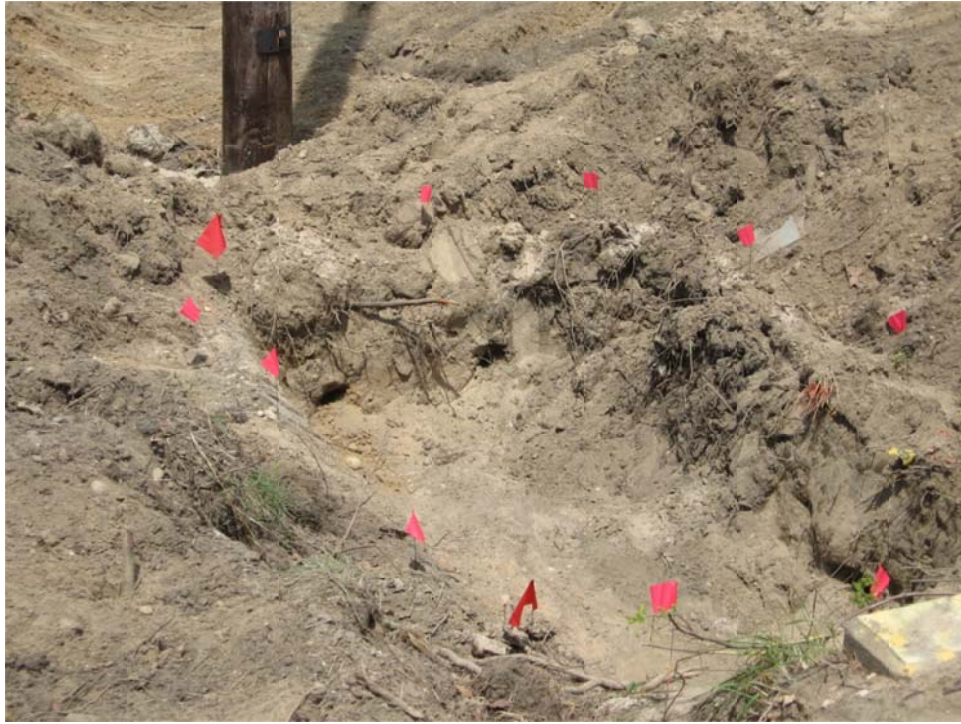
Area-4 Excavation

On May 20, 2009 an approximate 4 ft by 8 ft rectangle (2.4 yd³ or 4.3 tons) of soil was removed from the ditch approximately 100 ft southwest of former Building 378. The excavation extended to approximately 2.0 ft bgs. No staining or odors were observed during the excavation activities and no PID readings greater than 0.0 ppmv were recorded. Photographs of Area-4 are provided in Appendix D.

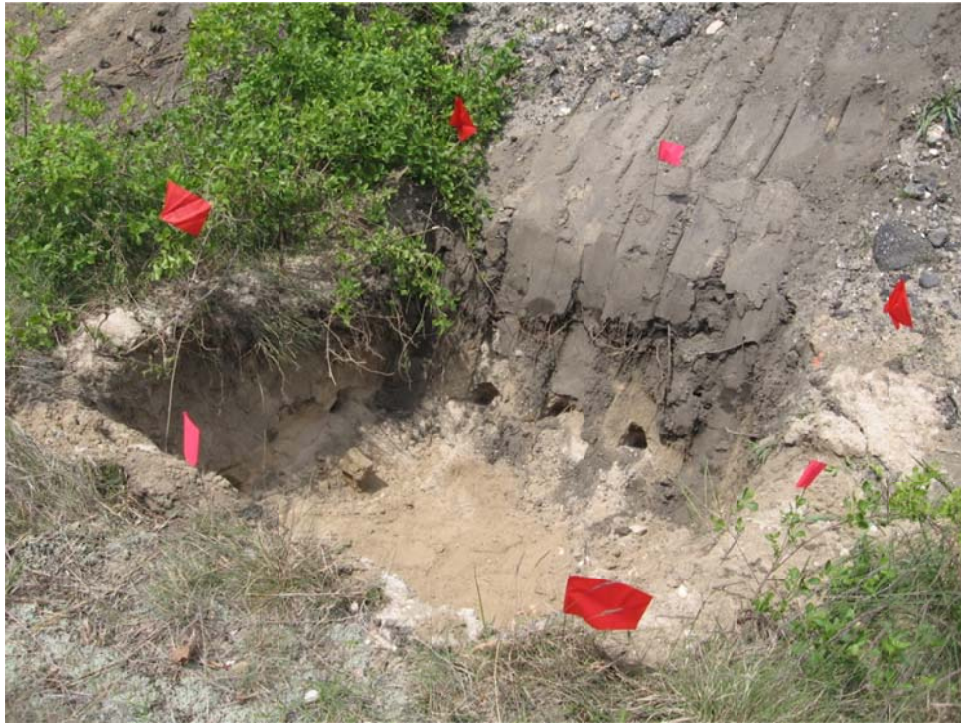
Area-5 Excavation

On May 20, 2009 an approximate 4 ft by 5 ft rectangle (1.9 yd³ or 3.4 tons) of soil was removed from the ditch approximately 38 ft south of former Building 378. The excavation extended to approximately 2.5 ft bgs. No staining or odors were observed during the excavation activities and no PID readings greater than 0.0 ppmv were recorded. Photographs of Area-5 are provided in Appendix D.
