PROJECT CLOSEOUT REPORT FOR SITE 2 – FORMER HAZARDOUS WASTE STORAGE AREA

106TH RESCUE WING FRANCIS S. GABRESKI AIRPORT WESTHAMPTON BEACH, NEW YORK

MARCH 2012

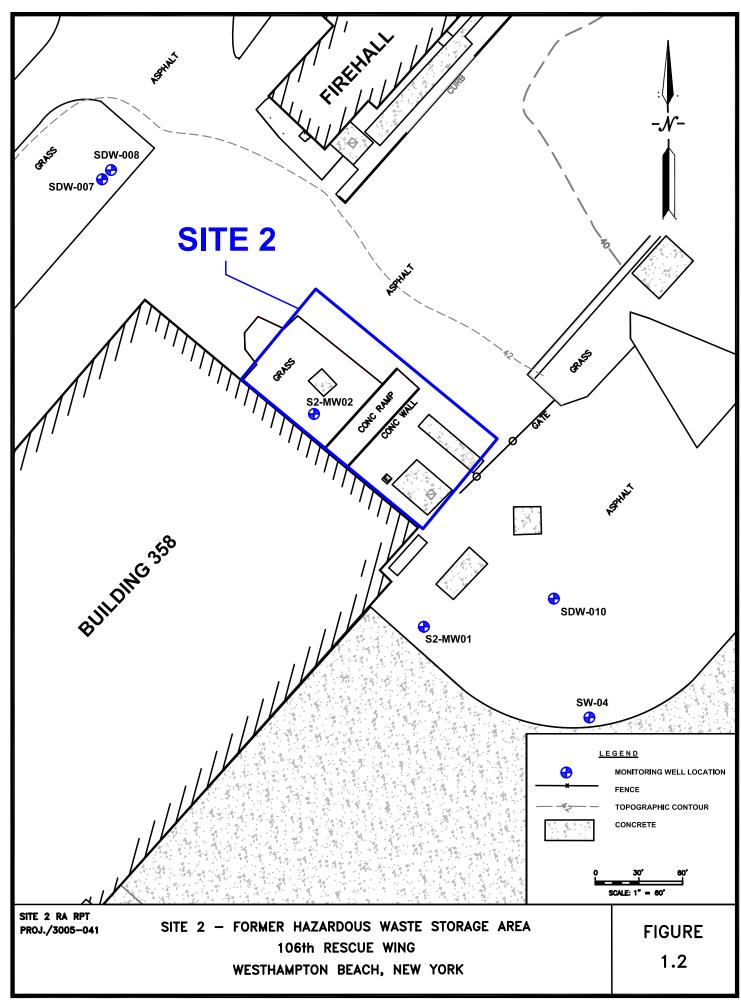
Site 2 – Former Hazardous Waste Storage Area is located in the northeast-central portion of the base. Site 2 is shown on Figure 1.2. Site 2 and the previous investigations conducted at the site are briefly described in the following subsections.

Site 2 - Former Hazardous Waste Storage Area is located adjacent to a loading ramp along the northeast wall of Building 358 (Hanger 2). The site includes grass-covered areas and areas paved with concrete, bricks and asphalt. The site was used from 1970 until 1982 to store shop solvent wastes, including PD-680 (a parts cleaner), and drums containing recovered fuels and oils. The site was formerly an open gravel space with no containment structures and has recently been paved with asphalt on the southeast side of the loading ramp. Previous investigations estimated that less than 500-gallons of liquids from minor spills may have been released at the site during its 12-year operation. No spills were reported at the site; however, stained surface soils were observed during a site visit in 1986 (PEER 2011b).

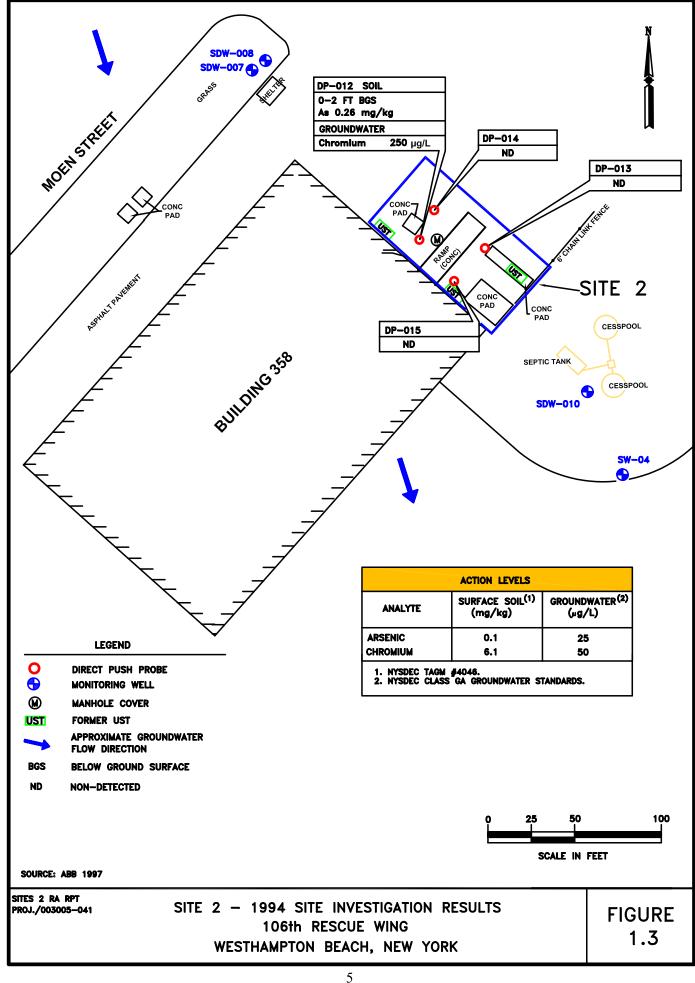
Chromium was the only analyte detected above NYSDEC action levels or reporting limits in one of the two groundwater samples collected from 35 to 57 ft below ground surface (bgs). However, since the sample was collected from a direct-push boring, the level of chromium was attributed to the high levels of suspended solids due to the direct-push sampling methodology (ABB-ES 1997). Tables 1.1 and 1.2 summarize the analytes detected above previous action levels at Site 2 (ABB-ES 1977). These results are shown on Figure 1.3.

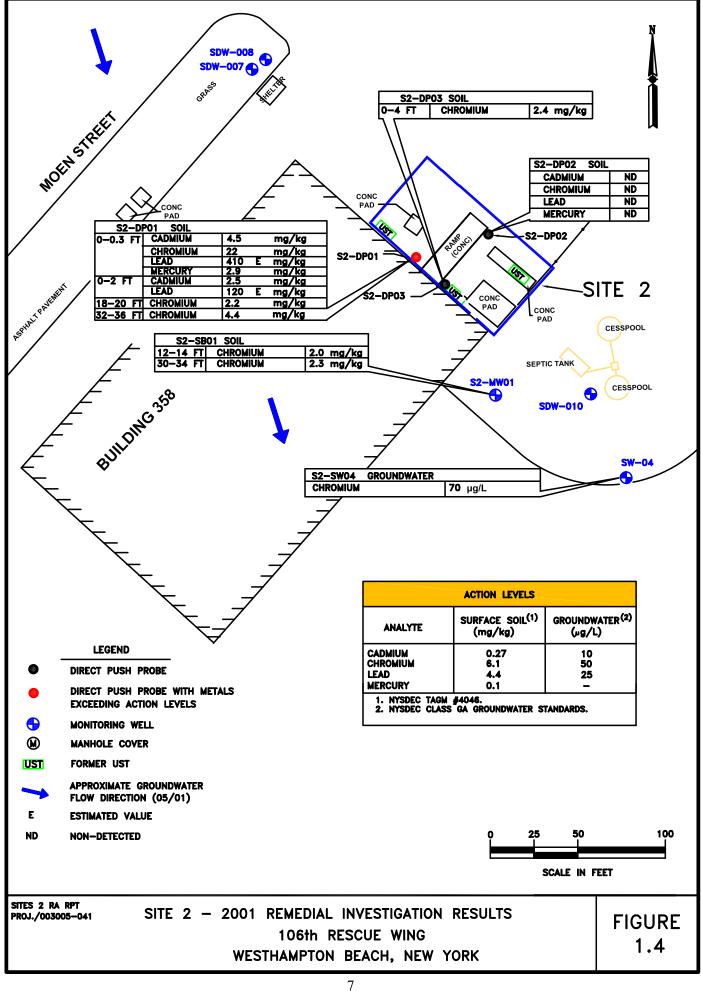
biphenyls (PCBs). The results of the VOC and SVOC confirmatory soil analyses and the metals confirmatory soil analyses are summarized on Tables 1.3 and 1.4, respectively. The results for the 2001 RI are shown on Figure 1.4.

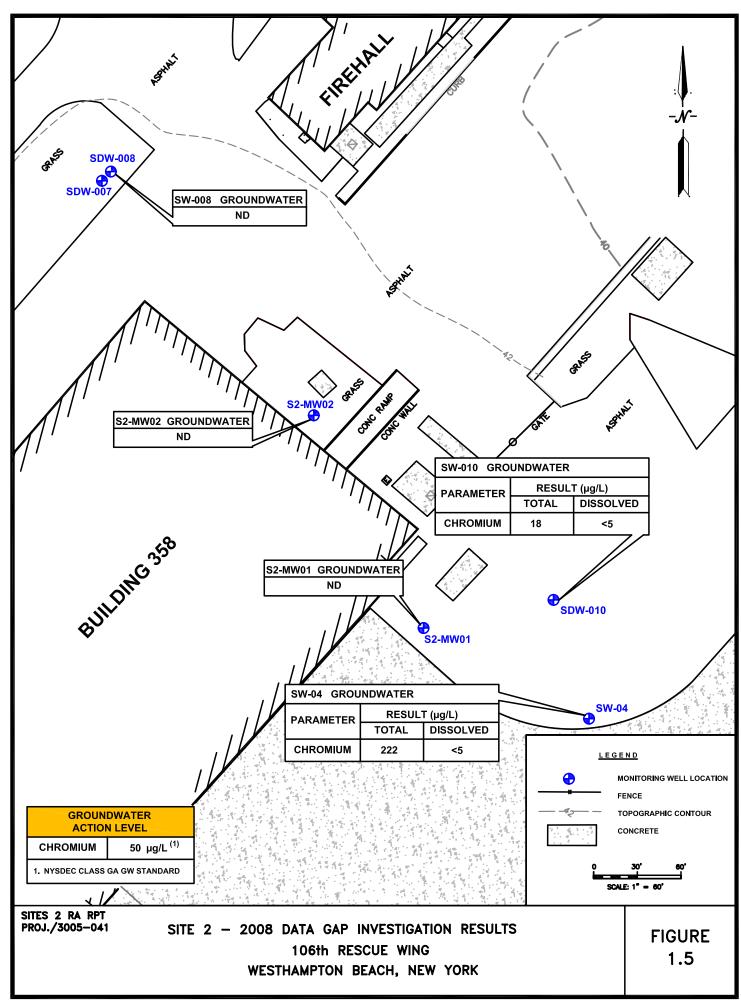
Table 1.8 summarizes the analytical results for the groundwater sampling activities. The results are shown on Figure 1.5. The analytical results for the groundwater samples are discussed in the following paragraph.

Chromium was not detected in the new well (S2-MW02) that was installed at the former location of direct-push boring DP-012. Chromium (unfiltered sample) was detected at a concentration of 222 μ g/L in well SW-04 which exceeded the NYSDEC Class GA groundwater standard of 50 μ g/L. However, chromium was not detected in the dissolved (filtered) sample from the same well, and no other metals were detected at concentrations exceeding the NYSDEC Class GA groundwater standards.

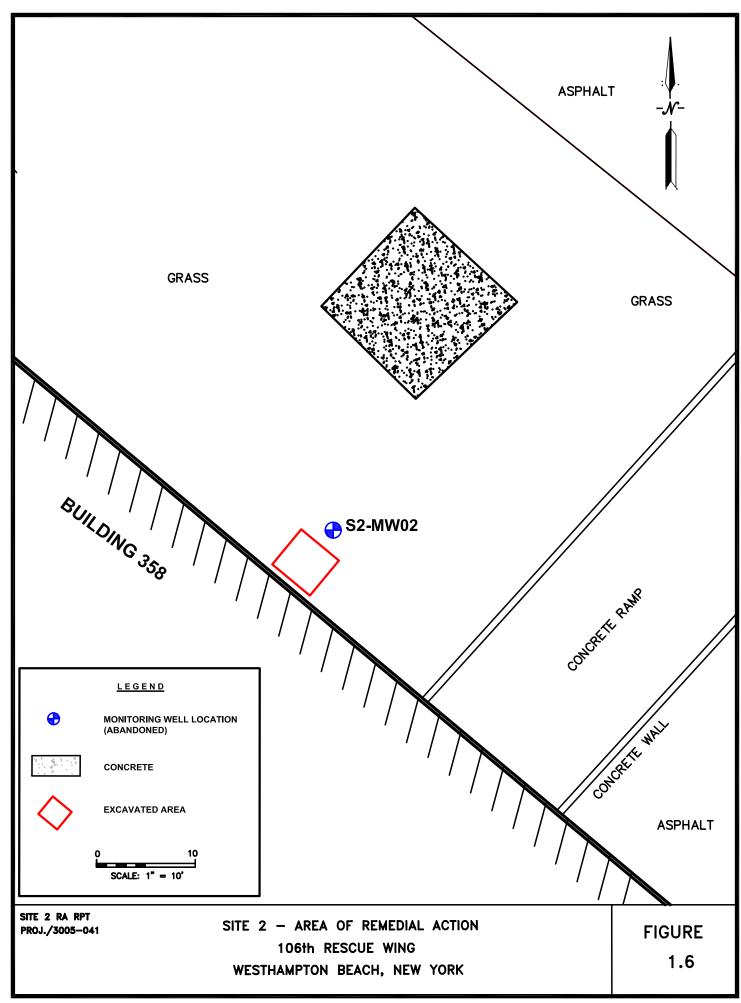
Remedial action began at Site 2 on November 4, 2011 and consisted of excavating metals-impacted soil adjacent to the northern end of Building 358. The soil was excavated from an area of 4 ft by 5 ft in size to a depth of approximately 3 ft in accordance with the *Work Plan* (PEER 2011b). The extent of the excavated area is shown on Figure 1.6.

The soils were removed using a small backhoe with the overall excavation extending to a depth of 3.2 ft bgs. In all, 2.4 yd³ (4.3 tons) of metals-impacted soil were excavated and removed from Site 2. No staining or odors were observed in site soils during the excavation activities and no photoionization detector (PID) readings greater than 0.0 ppmv were observed or recorded. Photographs of the area are provided in Appendix E.

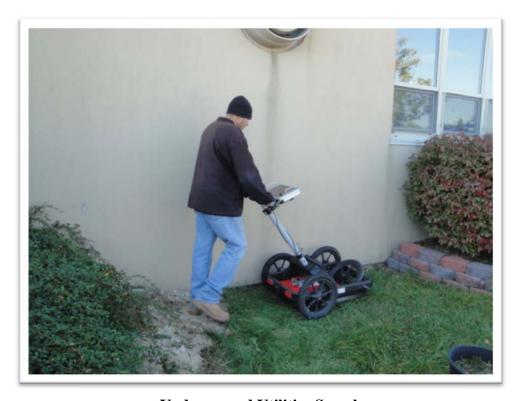
Underground Utilities Search

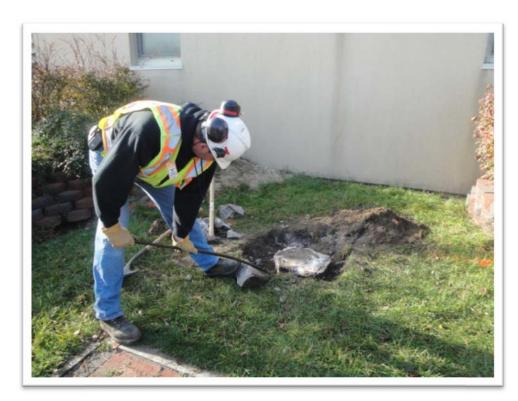
Digging up the Concrete Pad for Well S2-MW02

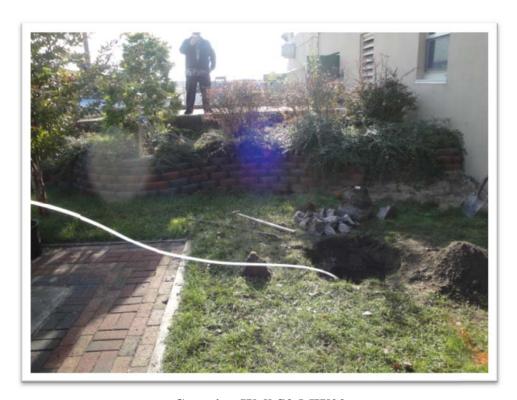
Grouting Well S2-MW02

One monitoring well (S2-MW-02) was abandoned at Site 2 (Figure 1.4) on November 3, 2011. The well was abandoned in accordance with NYSDEC policy by removing the surface completion (e.g., concrete pad, manhole), and then grouting in-place. In order to grout in-place, the well casing was filled with grout to a level of approximately 5 ft bgs and the casing was cut at the 5 ft depth. The top portion of the casing was removed and the upper 5 ft of the hole was backfilled with native soils to the land surface. The area was later reseeded in conjunction with the restoration of the excavated area. An NYSDEC Well Decommissioning Record form was prepared and is included in Appendix C.

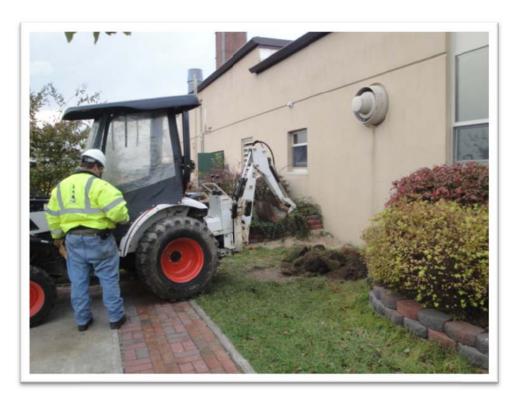
Beginning the Excavation Activities

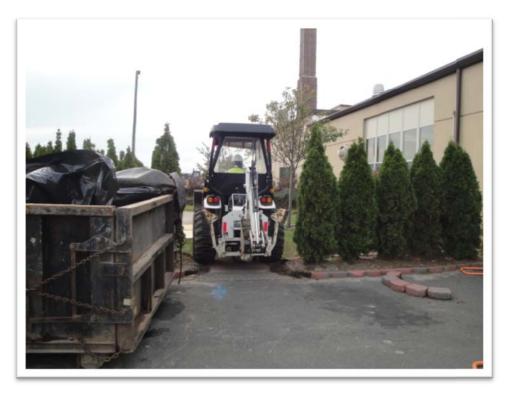
Excavation Activities Continue

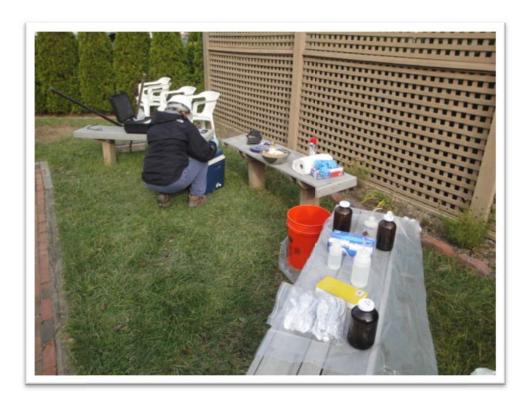
Preparation for Confirmation Sampling

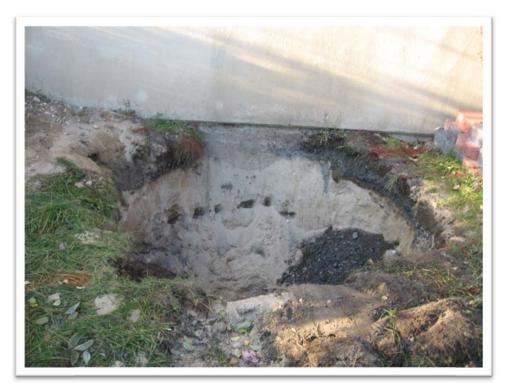
Open Excavation After Confirmation Sampling

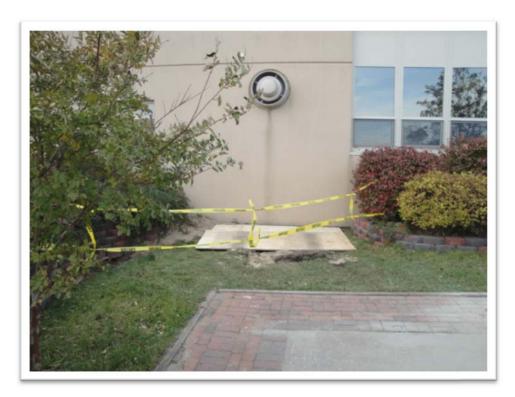
Securing the Excavation

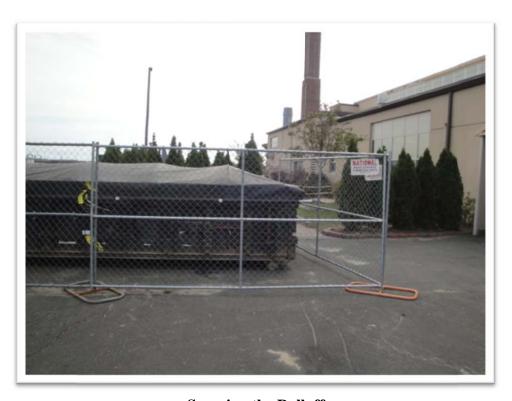
Securing the Rolloff

In all, 4.3 tons of soils were excavated from the excavation at Site 2. The excavated soil was placed in a lined roll-off and covered with a tarp. Excavated soil was transported to Clean Earth, Carteret, New Jersey for recycling on November 16, 2011. Non-Hazardous Waste Manifests and weight tickets are provided in Appendix F. Characterization samples were collected for the recycling facility prior to transporting the soil. The characterization sample results are provided in Appendix D.

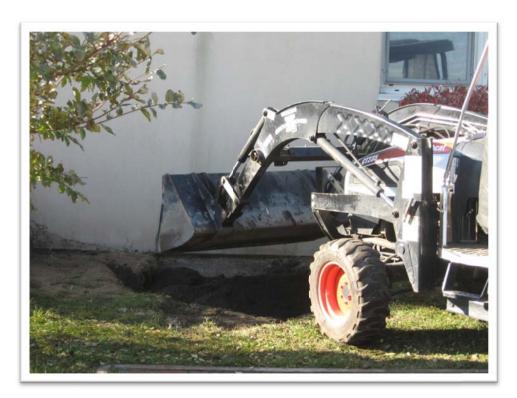
Backfilling the Excavation

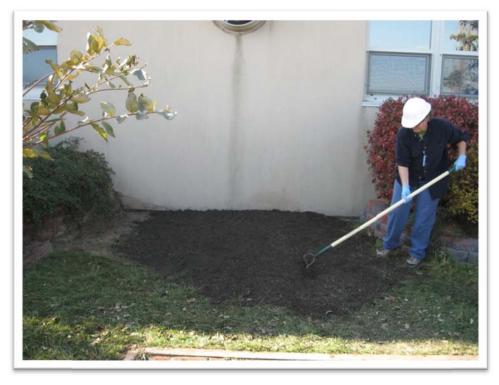
Re-Seeding and Restoring the Site
