**REMEDIAL INVESTIGATION / FEASIBILITY STUDY (RI/FS)
WORK PLAN**

**PRECISION CONCEPTS
26 PRECISION DRIVE
SHIRLEY, NEW YORK 11967**

NYSDEC SHWS I.D. No. 1-52158

MAY 1998

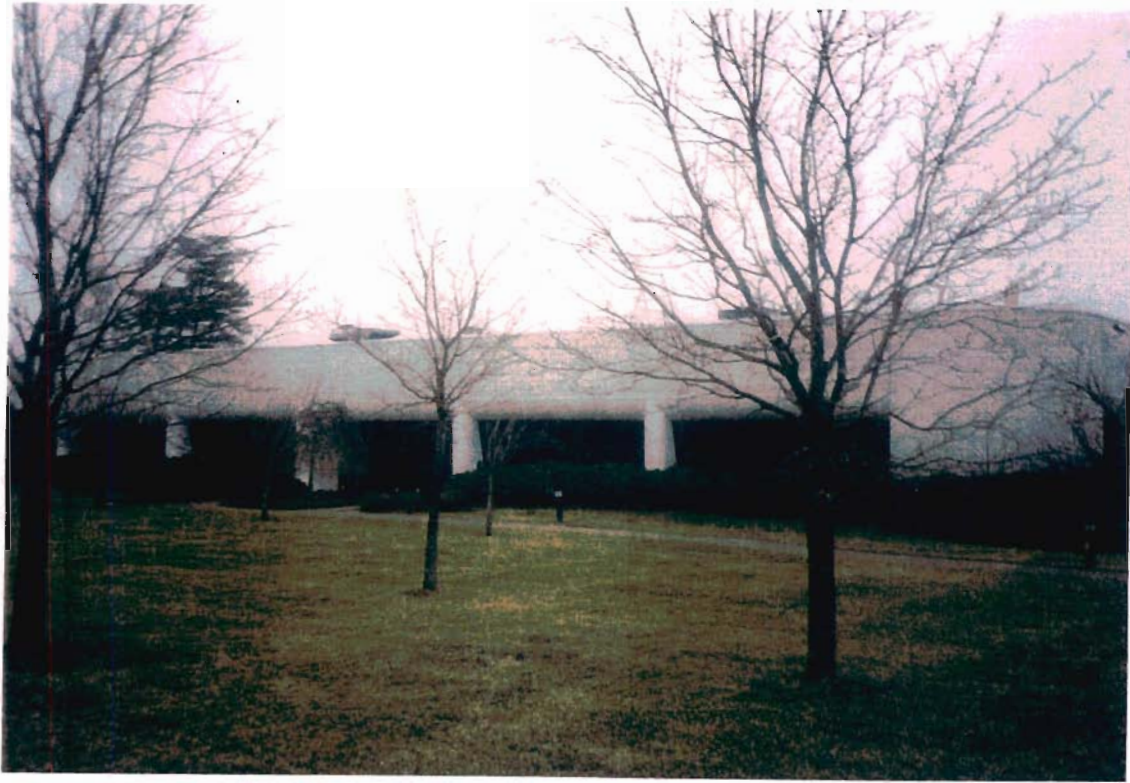
5. View of the front (north) side of the subject building.

The subject building is constructed of concrete block with brick veneer. The building rests on a poured concrete slab foundation. Windows are comprised primarily of bronze plate glass in aluminum frames.

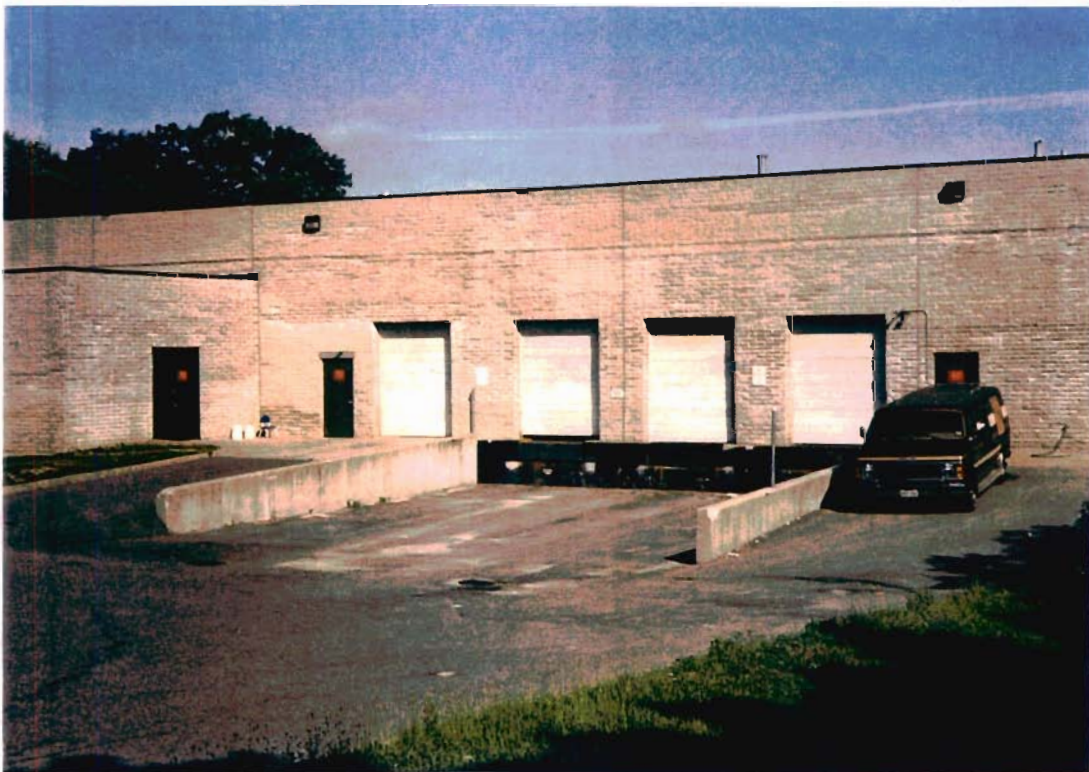
6. View of the rear (south) side of the subject building.

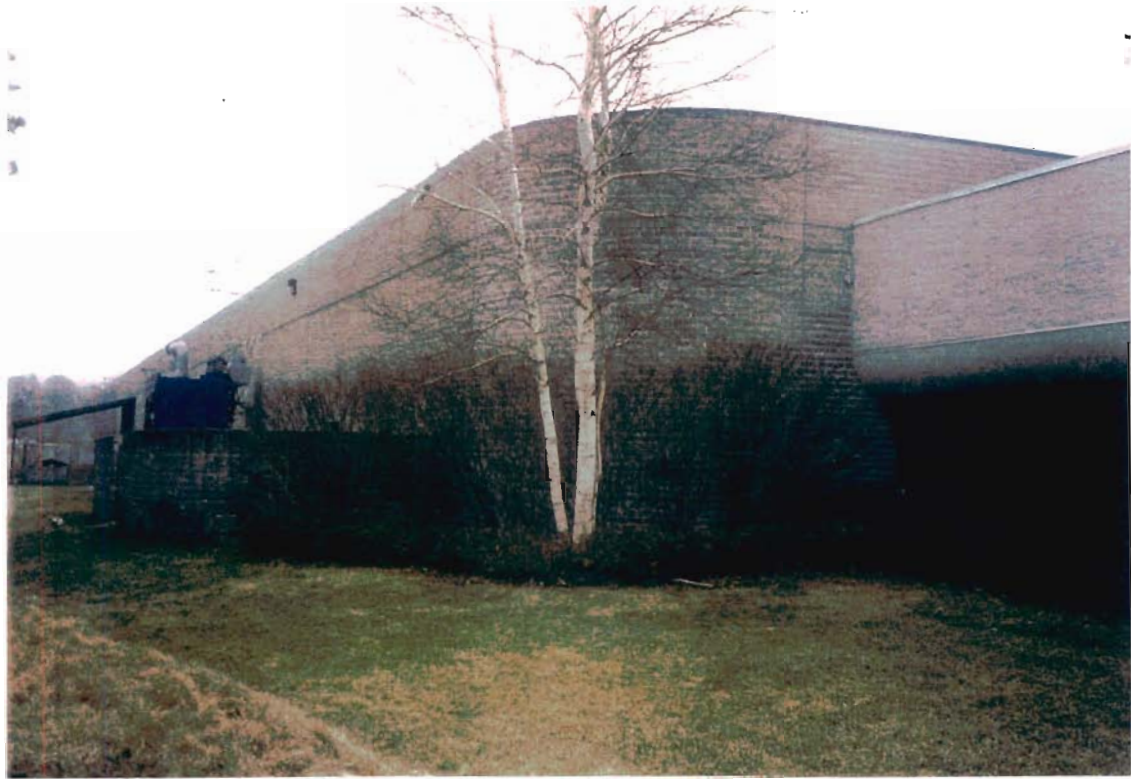
7. View of the east side of the subject building.

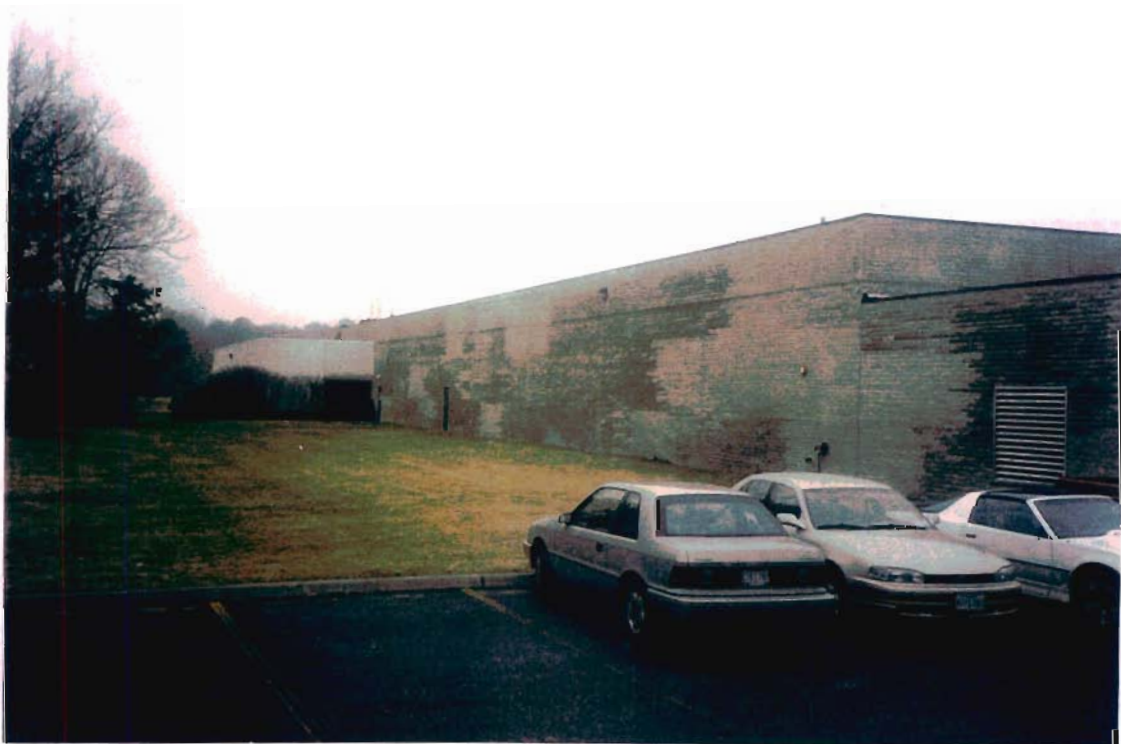
8. View of the west side of the subject building.
