FOCUSED REMEDIAL INVESTIGATION WORK PLAN

**PRECISION CONCEPTS
26 PRECISION DRIVE
SHIRLEY, NEW YORK 11967**
9/98
NYSDEC IHWDS I.D. No. 1-52-158

SEPTEMBER 1998

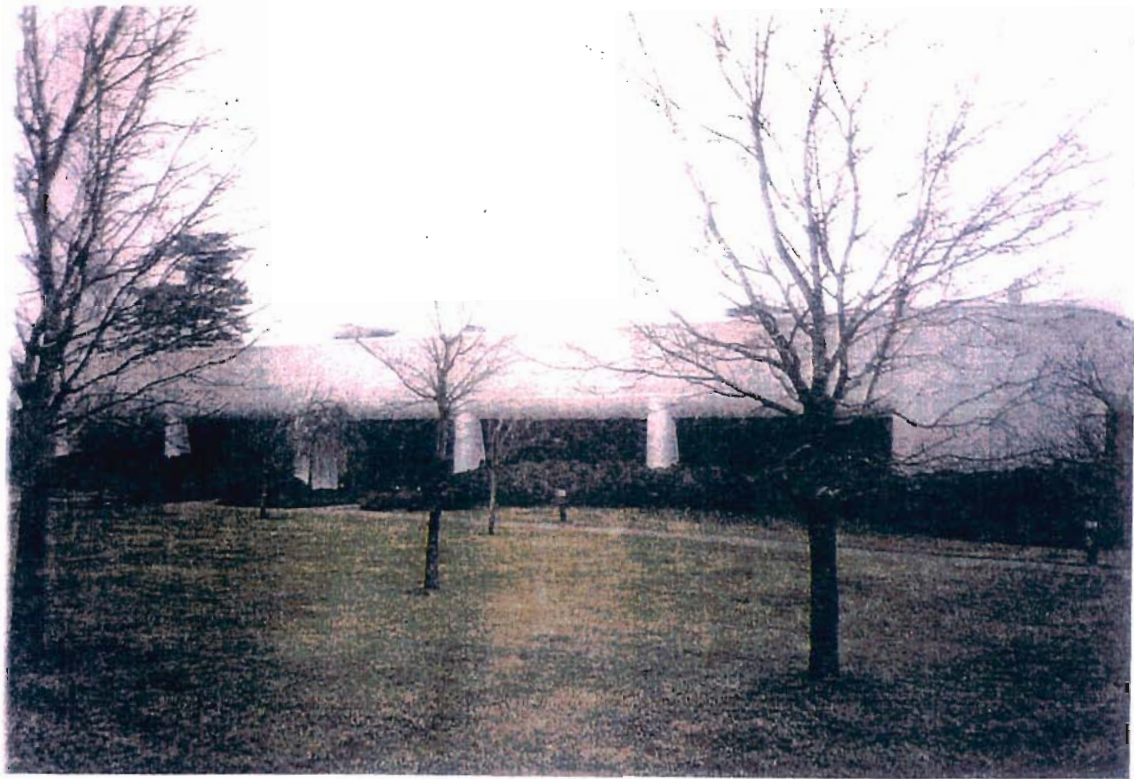
5. View of the front (north) side of the subject building.

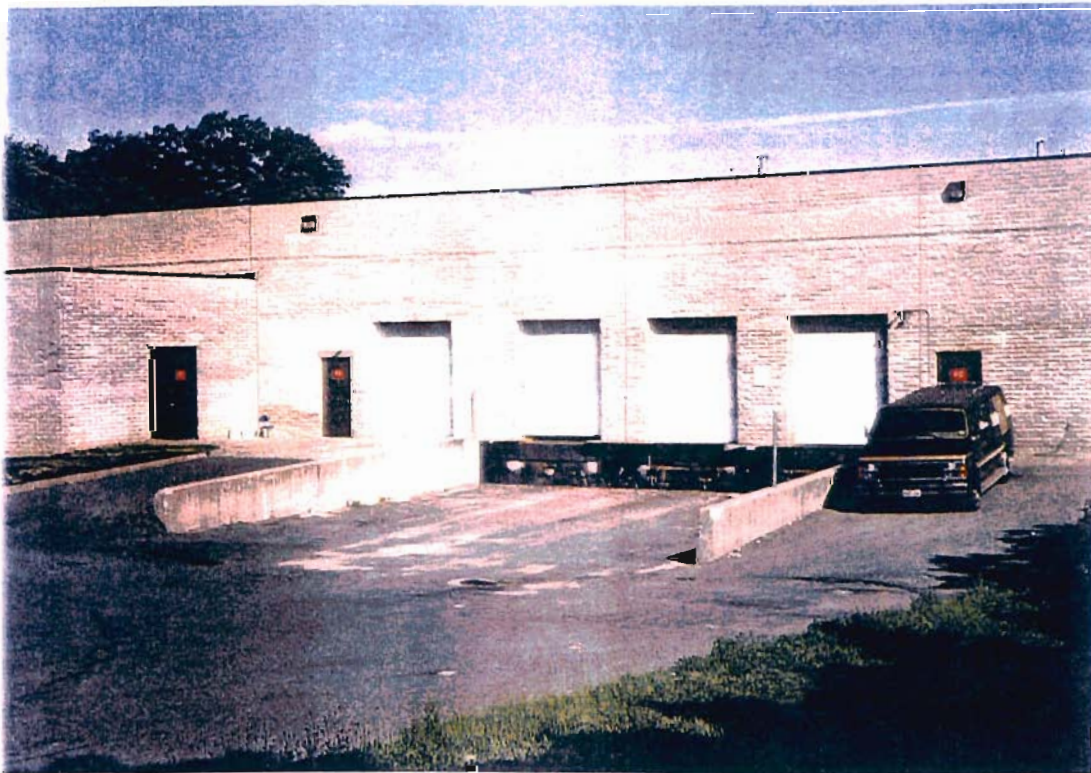
6. View of the rear (south) side of the subject building.

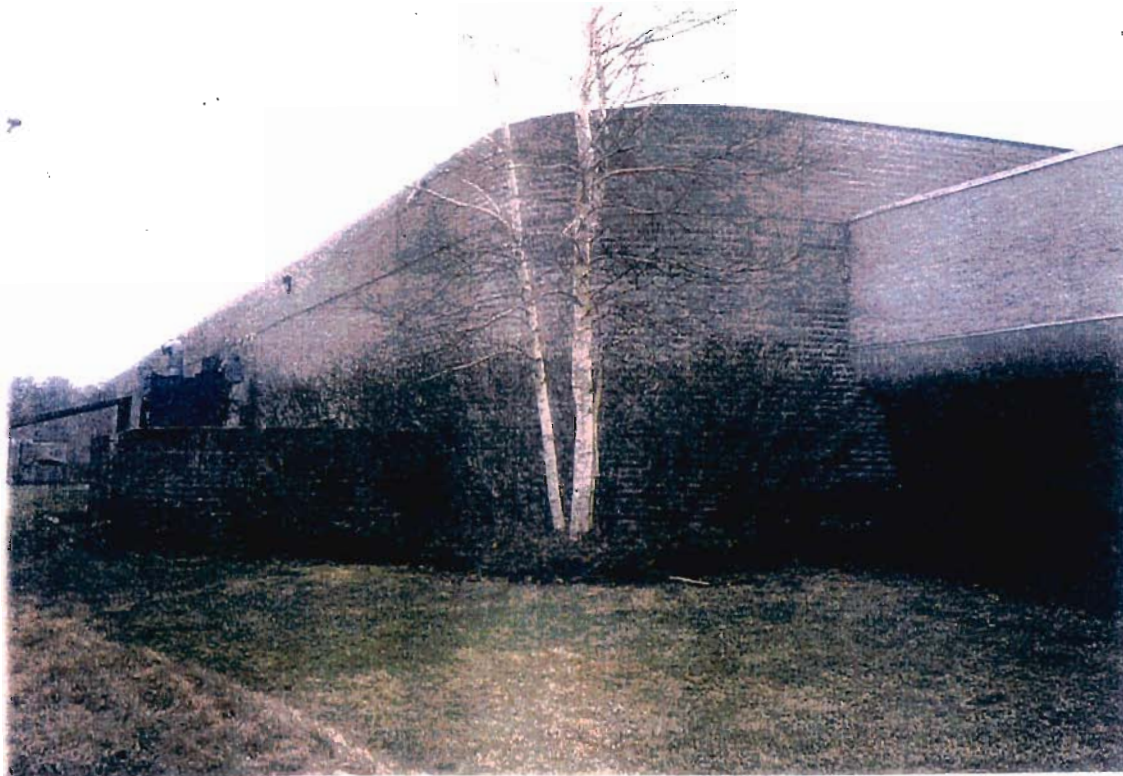
7. View of the east side of the subject building.

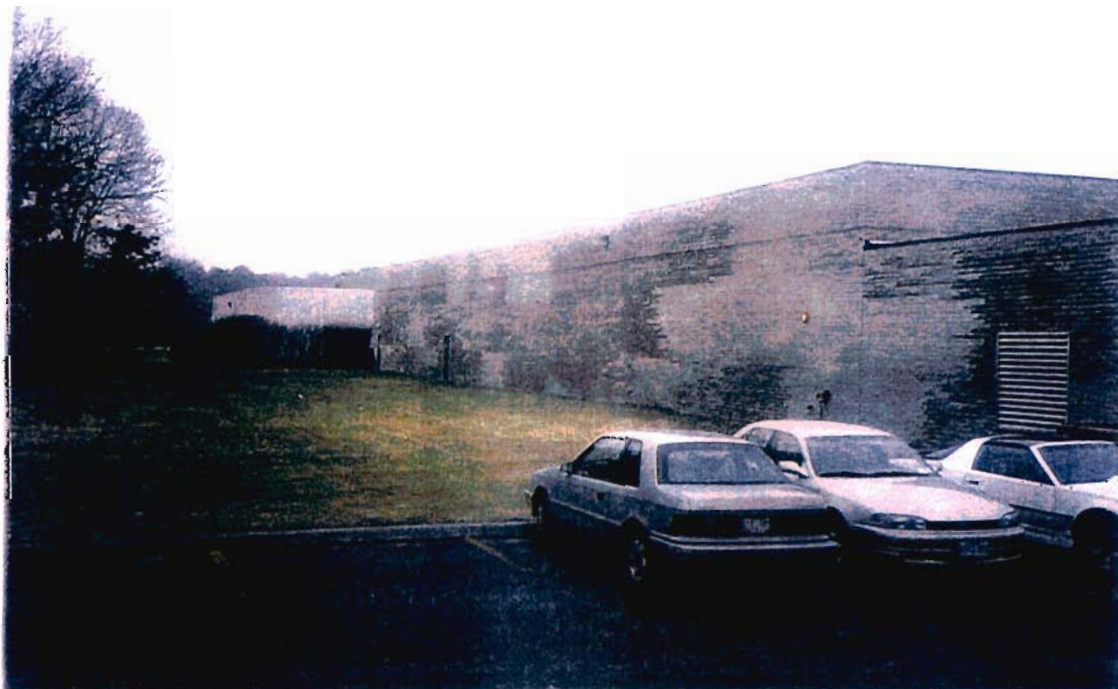
8. View of the west side of the subject building.
