**SAG HARBOR
FORMER MANUFACTURED GAS PLANT SITE**

REMEDIAL INVESTIGATION REPORT

**KEYSPAN ENERGY
One MetroTech Center
Brooklyn, New York**

**DVIRKA AND BARTILUCCI CONSULTING ENGINEERS
330 Crossways Park Drive
Woodbury, New York**

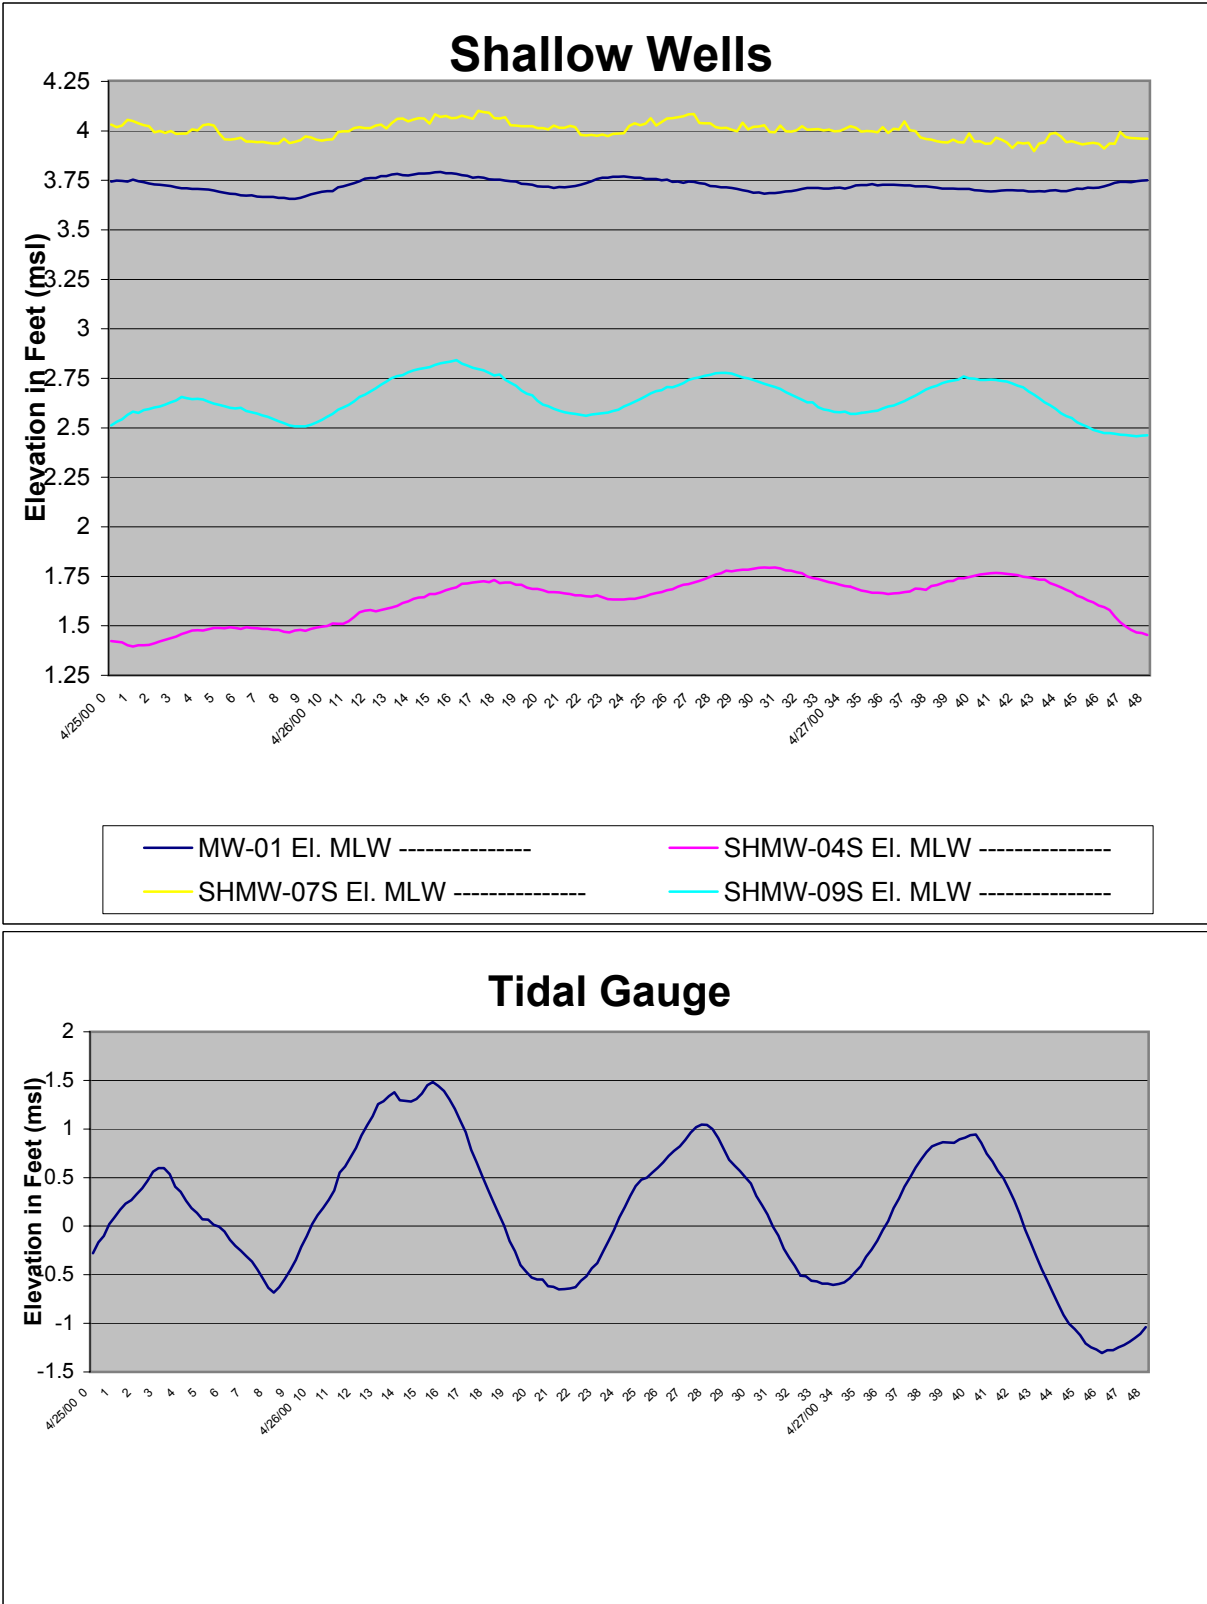
FIGURE 3-3
SAG HARBOR FORMER MGP SITE INVESTIGATION
TIDAL FLUCTUATIONS OBSERVED IN SHALLOW MONITORING WELLS

within the site. As illustrated by **Figures 3-3** and **3-4**, tidal influences appear to be greatest in intermediate and deep monitoring wells screened below the peat/silt/clay unit, including SHMW-04I, SHMW-07I, SHMW-09I and the one deep well, SHMW-02D. Shallow monitoring wells screened at the water table and above the peat/silt/clay unit, including MW-01, SHMW-04S, SHMW-07S and SHMW-09S, exhibited the least tidal influence.

Comparison of the tidal data for shallow wells as presented on **Figure 3-3** indicates the greatest tidal influence in shallow groundwater was observed at wells SHMW-04S and SHMW-09S, with an observed fluctuation of between 0.5 and 0.3 feet, respectively. Of the four shallow wells utilized in the tidal survey, SHMW-04S is located closest to Sag Harbor Cove at approximately 150 feet from the shoreline. In addition, this well is located in an area where the peat/silt/clay unit appears to be absent. Shallow well SHMW-09S is located approximately 310 feet south of Sag Harbor Cove, in an area where the peat/silt/clay unit is present. Both wells exhibit a slight delay or lag of about 1/2 to 1 hour in their cyclic fluctuation when compared to the observed tidal cycle. Shallow monitoring wells MW-01 and SHMW-07S, located further inland, exhibit very little tidal influence and are both screened within the fill deposits and above the peat/silt/clay unit. The tidal data from the four shallow wells indicate the following:

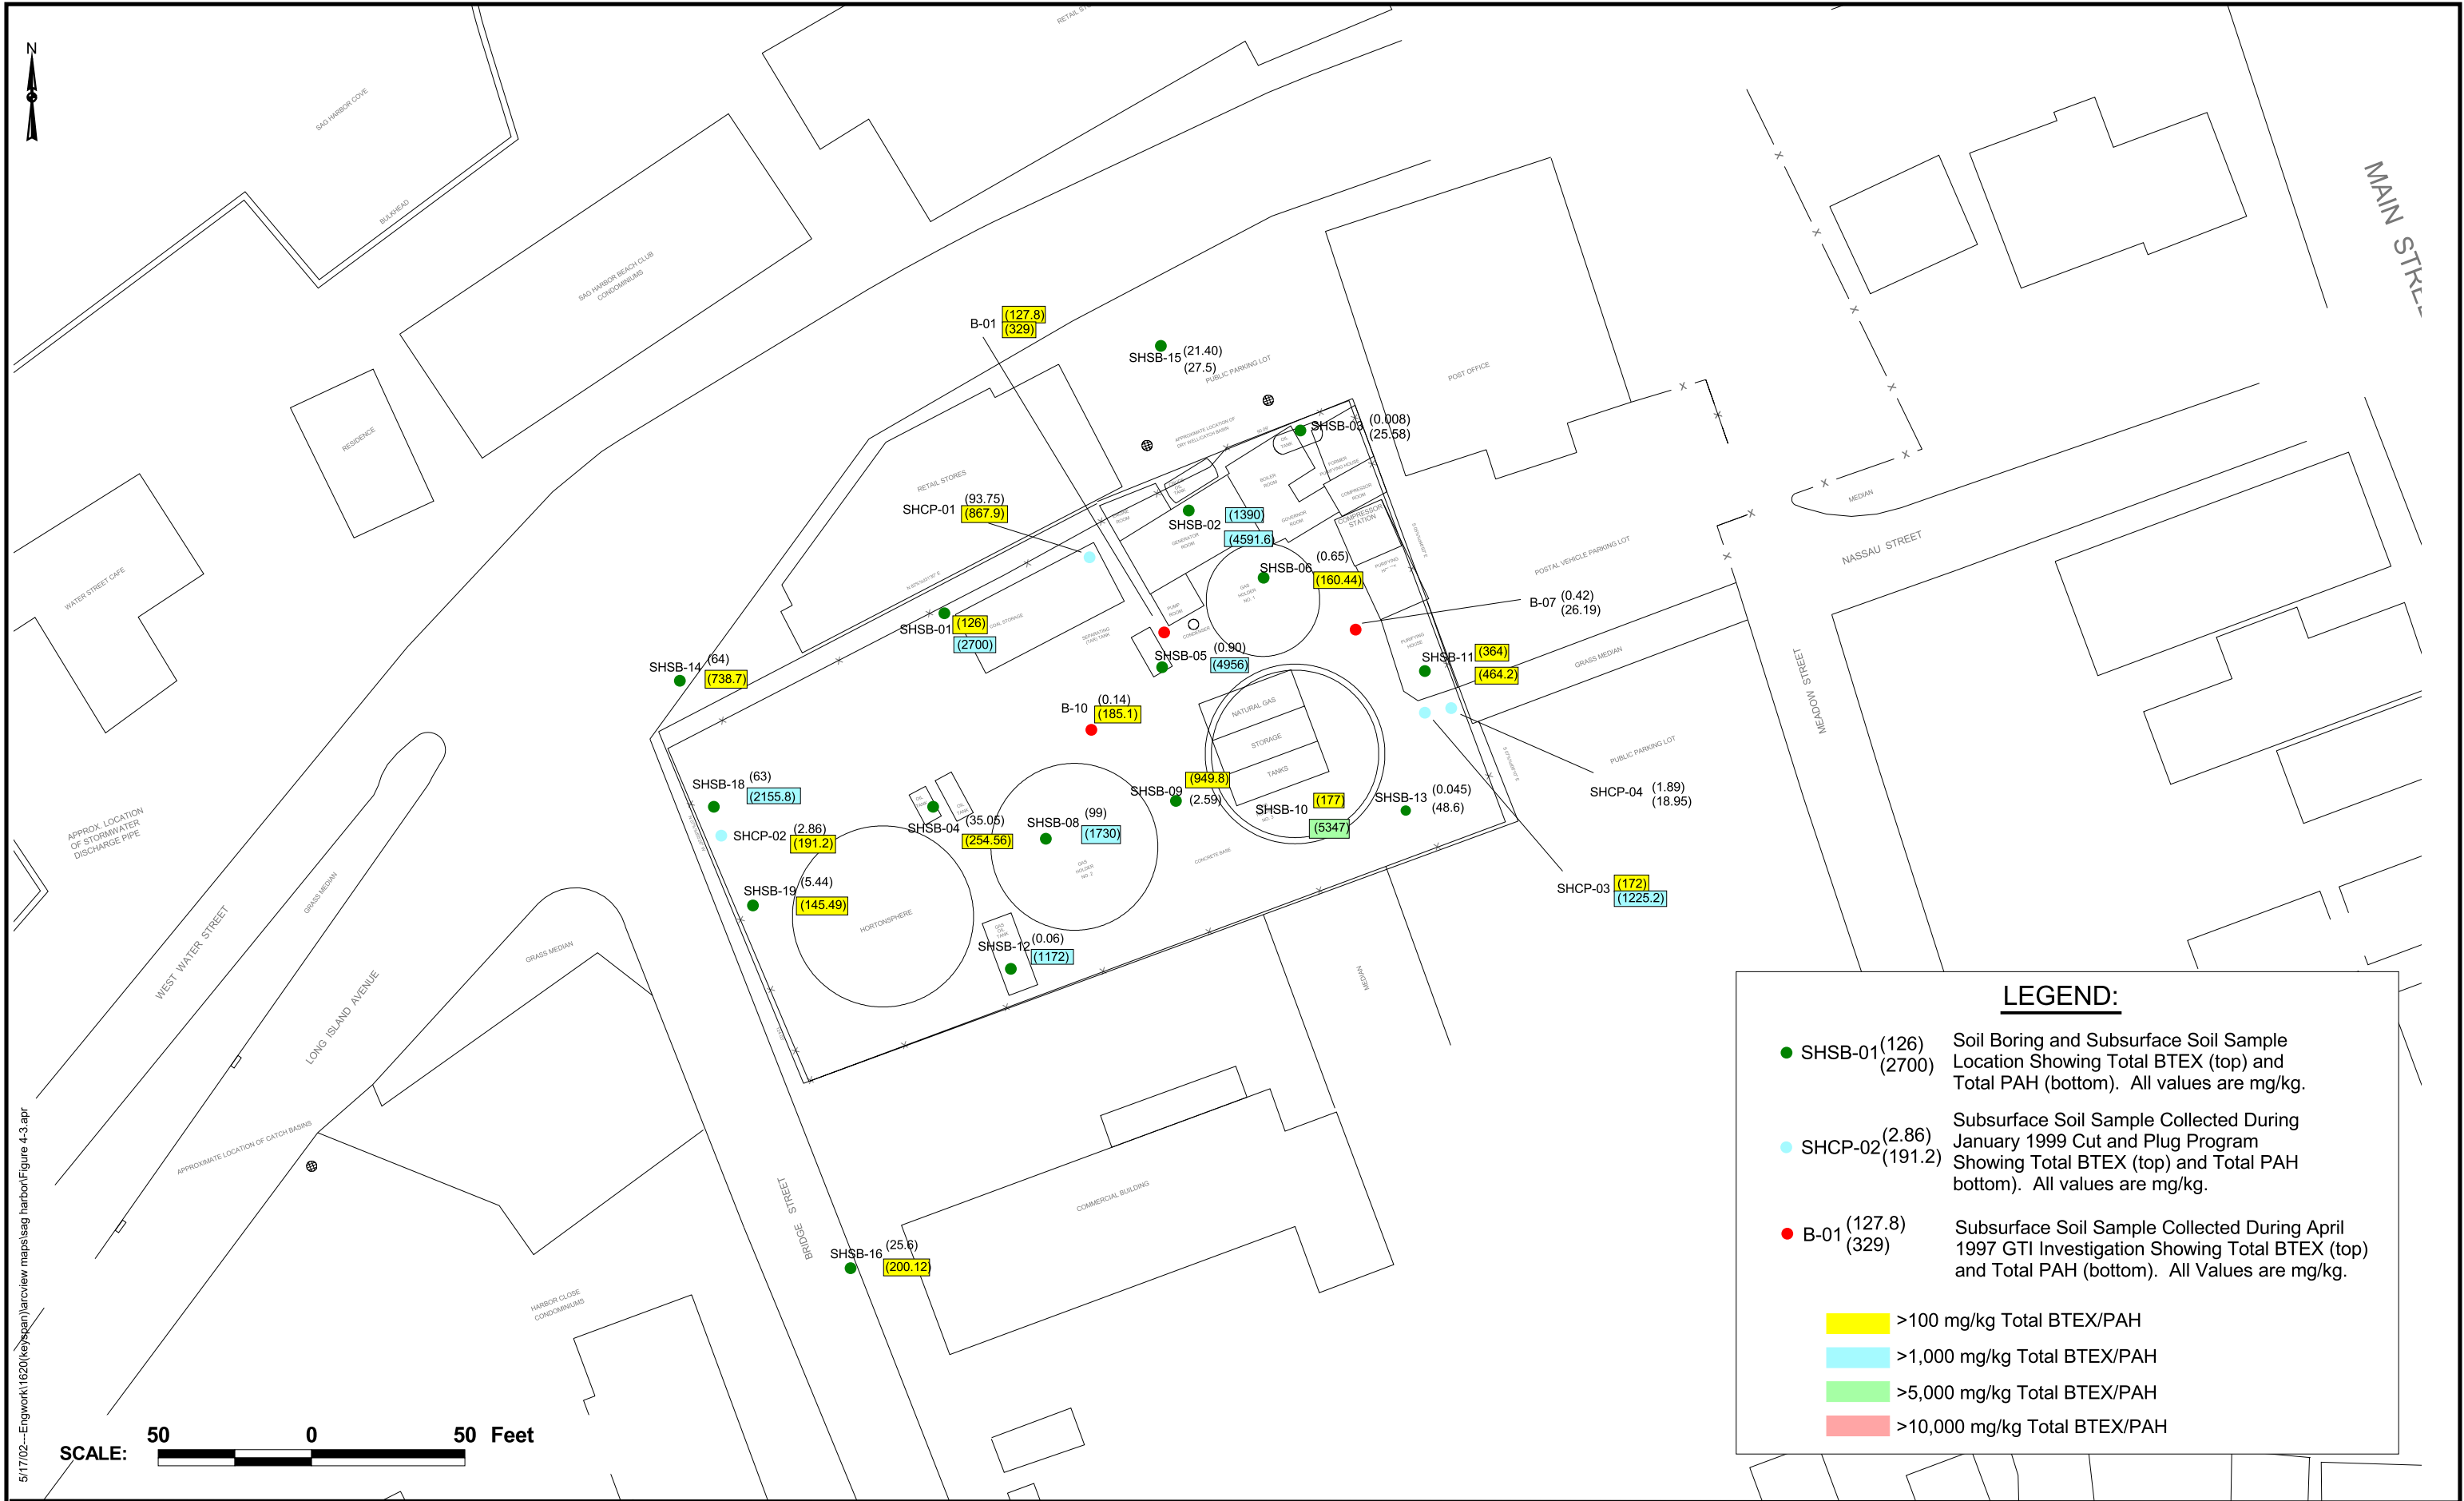
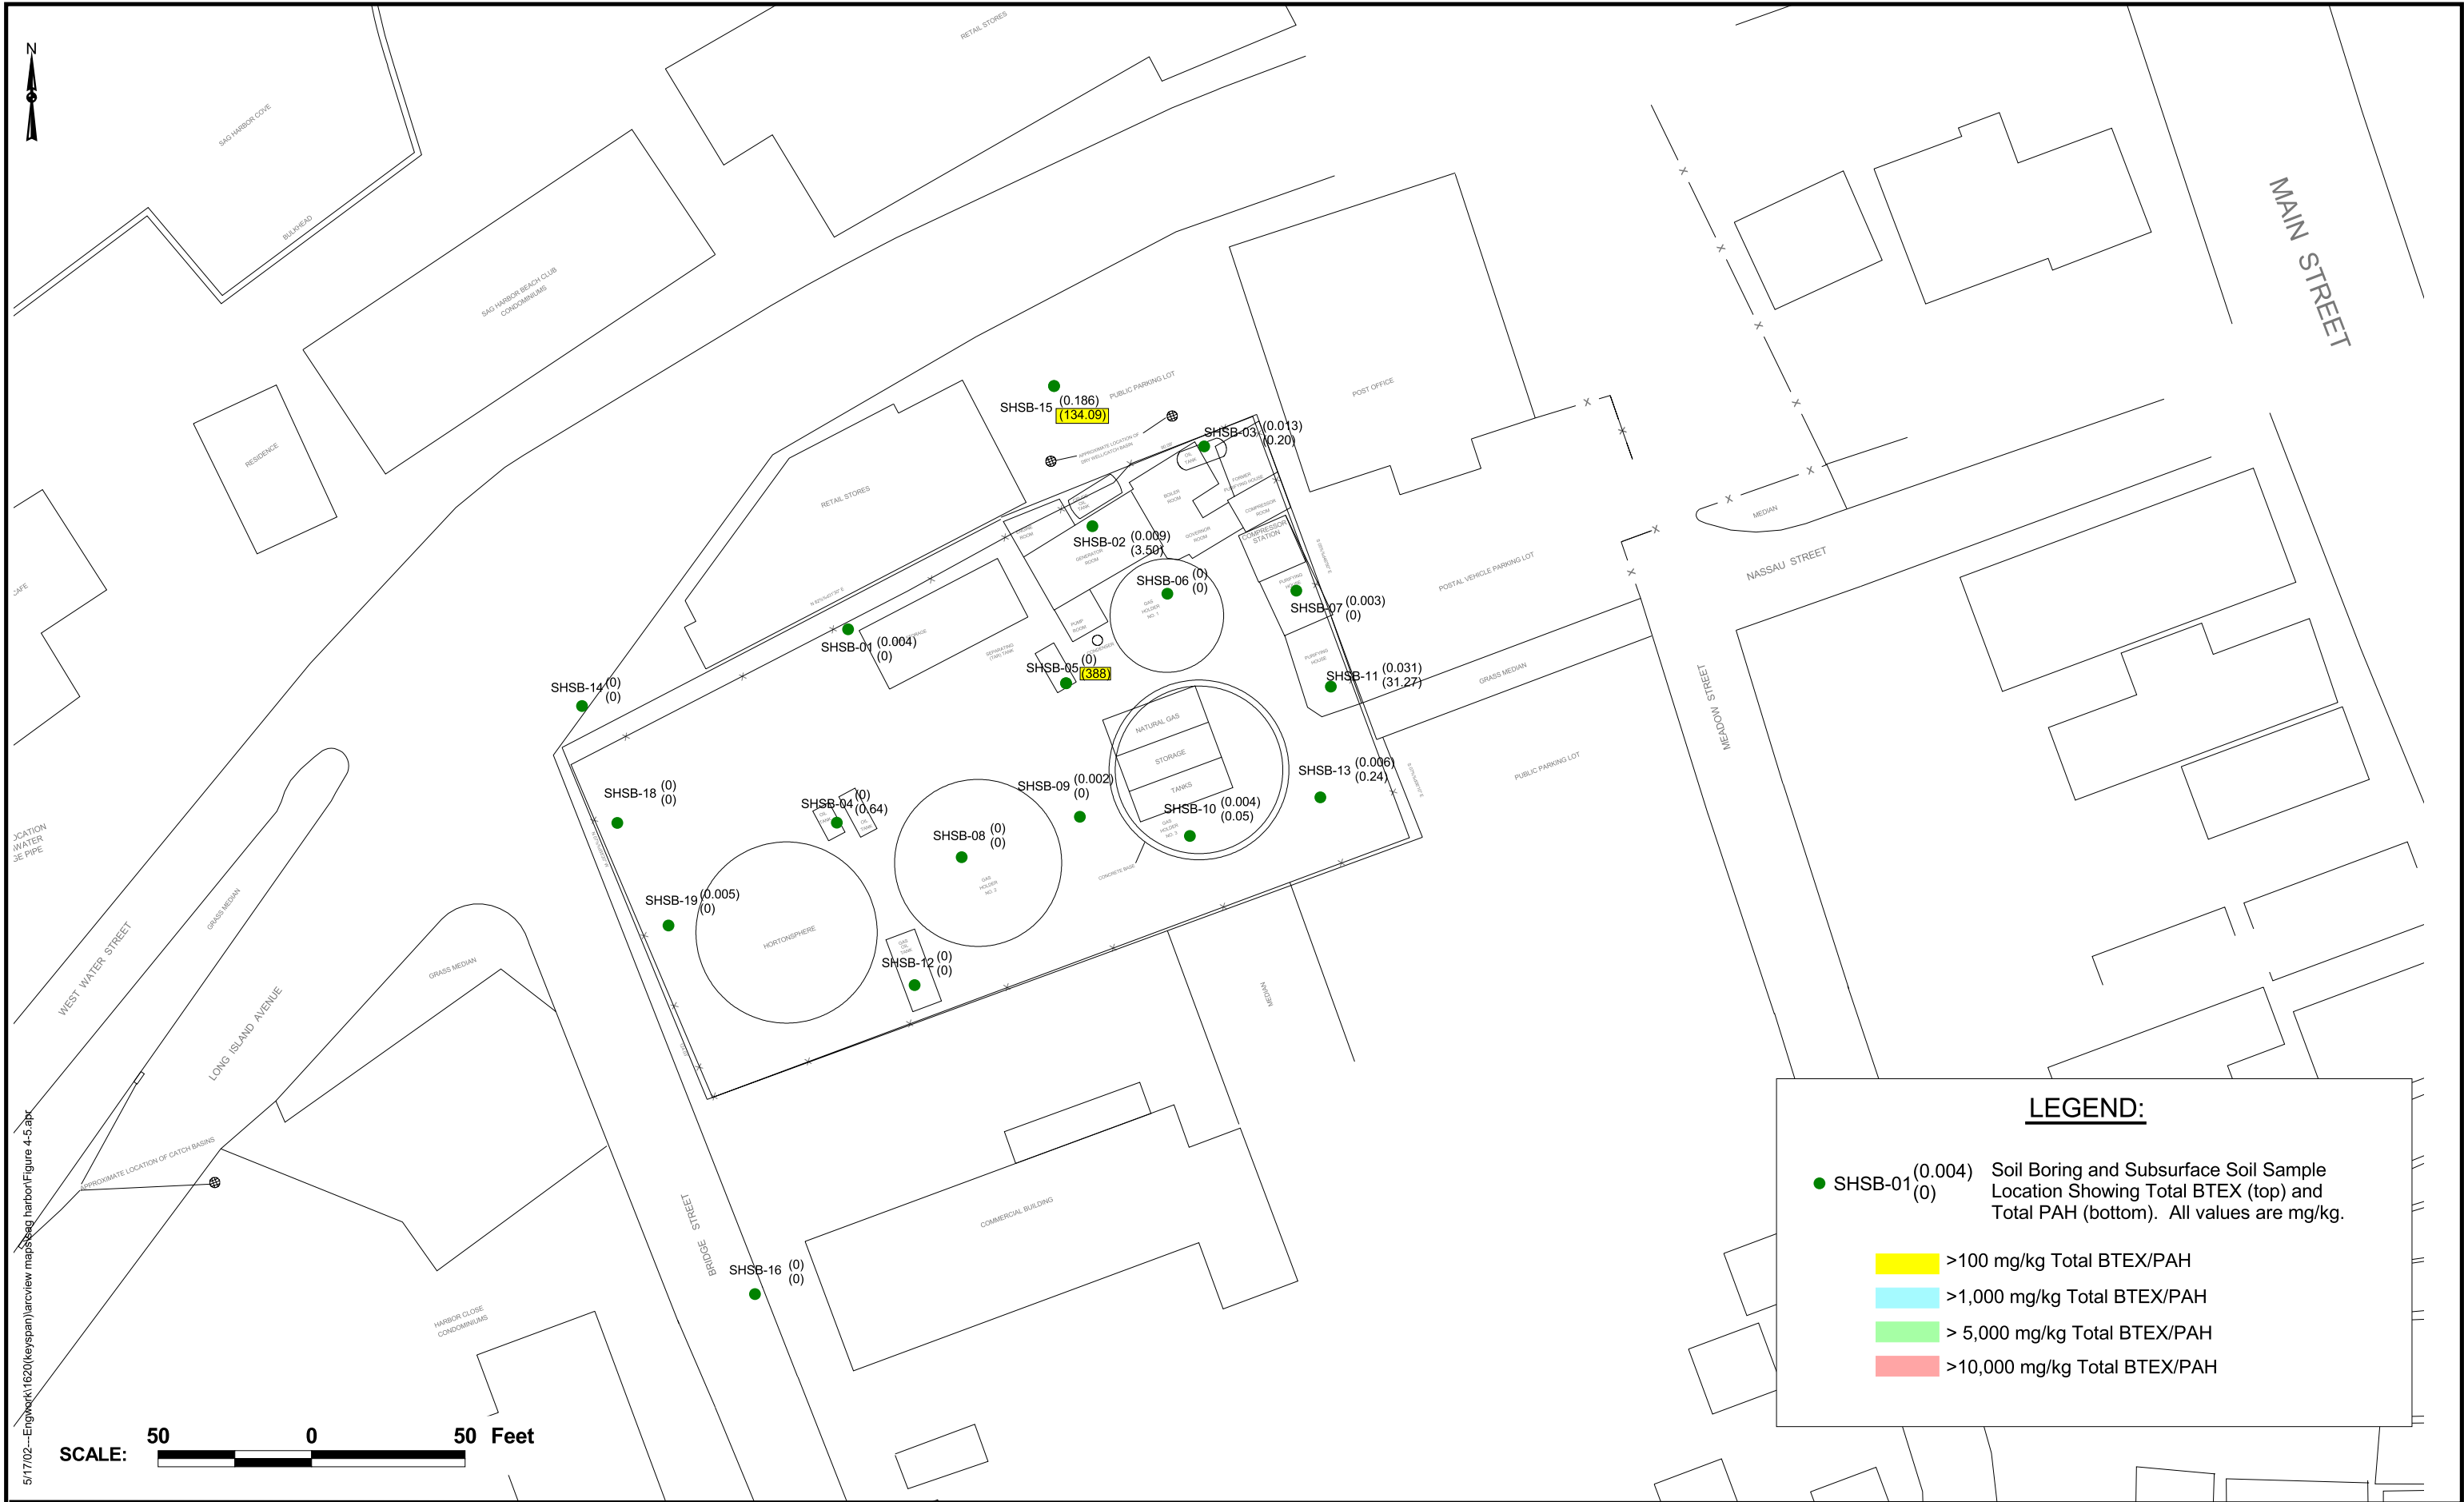
Figures 4-2 through 4-5 depict total BTEX concentrations along with total PAH concentrations in subsurface soil at on-site and off-site sample locations. The maps include soil data generated as part of this investigation, as well as data generated under the Cut and Plug IRM (see **Section 2.8**) and the 1997 Phase I Site Investigation report (see **Section 1.7**). The data used for **Figure 4-2** is based on subsurface data collected at depths ranging from 0 to 2 feet bgs. The data used for **Figure 4-3** is based on subsurface soil data collected at depths ranging from 2-8 feet bgs. The data used for **Figure 4-4** is based on subsurface soil data collected at depths

ranging from 8-18 feet bgs. The data used for **Figure 4-5** is based on subsurface soil data collected at depths greater than 18 feet bgs. At sample locations where more than one sample was analyzed for BTEX within a given depth range, the highest concentration detected was utilized in developing these maps. Based on the review of the maps, the following is observed:

1. Shallow subsurface soil to a depth of 2 feet bgs did not exhibit total BTEX concentrations exceeding 22 mg/kg.
2. The highest BTEX concentrations were observed between 2 and 8 feet bgs, i.e., above the peat/silt/clay unit and primarily within the eastern half of the site. Off-site probe data from SHSB-14, 15 and 16 suggests some off-site migration of BTEX in subsurface soil above the peat silt/clay unit, to the north, northwest and southwest.
3. While evidence of NAPL such as staining, odors and tar blebs was observed at a number of soil probes below the peat/silt/clay unit, total BTEX soil concentrations do not exceed 0.186 mg/kg in any sample analyzed from a depth of 18 feet bgs or greater.
