**Site Address: Brandt-Airflex Corp.
937 & 965 Conklin St
East Farmingdale, NY
NYSDEC Site No: 152183
Progress Report – November 2025**

Daily Field Report

**Sub-Slab
Depressurization
Systems**

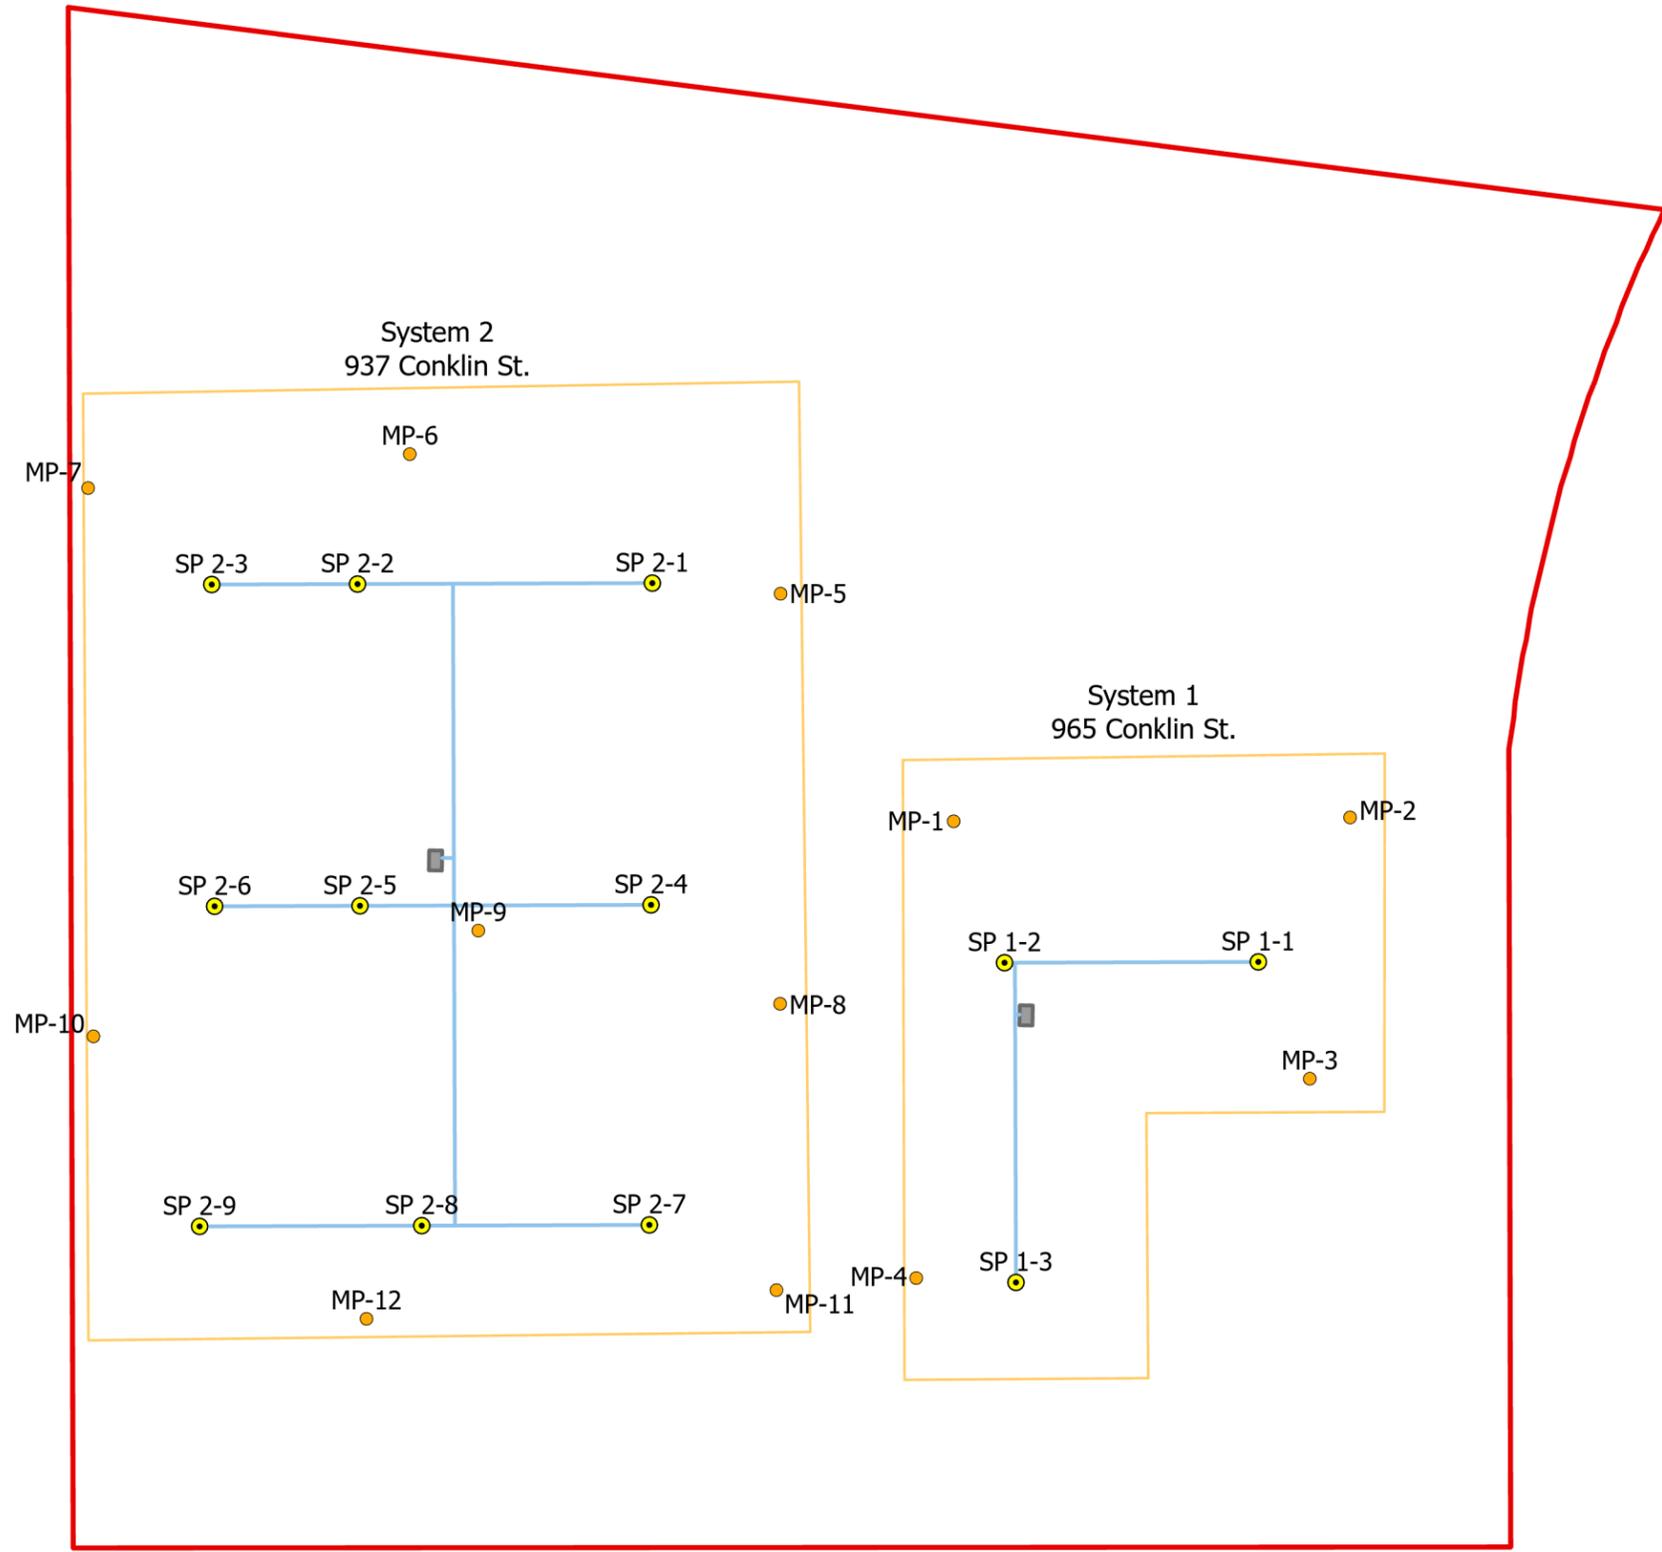
FIGURE:

Each of the SSD systems, including suction points, monitoring points, system piping, and blower locations are shown on Figure 2.

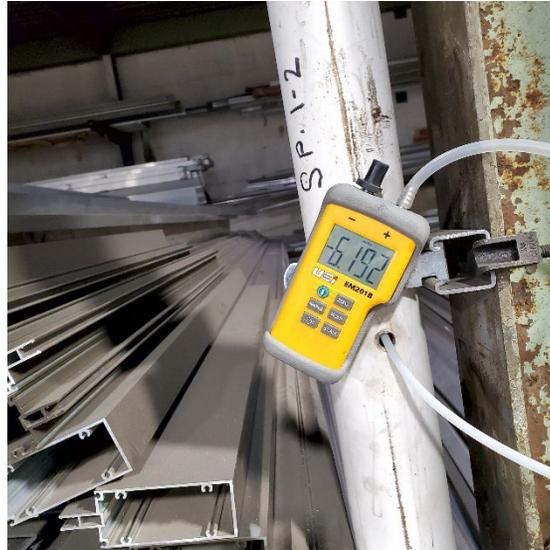
<u>System-1 - 965 Conklin Street</u>			
Blower: GBR 89	Vac @ gauge: 6.093 “w.c.	Status: ON	Condition: Good
<u>Measuring Point</u>	<u>Vacuum (“w.c.)</u>	<u>PID (ppm)</u>	<u>Ball Valve Pos. (%)</u>
SP 1-1	-5.840	0.0	100
SP 1-2	-6.192	0.0	100
SP 1-3	-6.055	0.0	100
MP-1	-0.019	NA	NA
MP-2	-0.010	NA	NA
MP-3	-0.008	NA	NA
MP-4	NA	NA	NA

View of suction point, SP 1-2 and associated vacuum gauge with manometer reading.

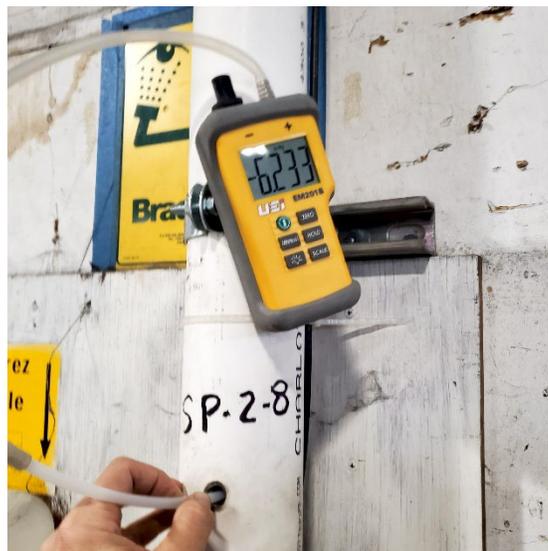
System-2 – 937 Conklin Street			
Blower: GBR 89	Vac @ gauge: 6.502 “w.c.	Status: ON	Condition: Good
Measuring Point	Vacuum (“w.c.)	PID (ppm)	Ball Valve Pos. (%)
SP 2-1	-7.435	0.0	100
SP 2-2	-6.285	0.0	100
SP 2-3	-6.818	0.0	100
SP 2-4	-7.082	0.0	100
SP 2-5	-7.012	0.0	100
SP 2-6	-7.106	0.0	100
SP 2-7	-5.484	0.0	100
SP 2-8	-6.233	0.0	100
SP 2-9	-7.426	0.0	100
MP-5	-0.034	NA	NA
MP-6	-0.006	NA	NA
MP-7	-0.018	NA	NA
MP-8	-0.045	NA	NA
MP-9	-0.045	NA	NA
MP-10	-0.080	NA	NA
MP-11	-0.000	NA	NA
MP-12	-0.030	NA	NA

Background PID near SP 2-8: 0.6 ppm; SP 2-9: 0.8 ppm

View of suction point, SP 2-8 and associated vacuum gauge with manometer reading.
