**Re: Supplemental Site Characterization and Investigation Work Plan**  
Former CAMCO Site Characterization and Investigation  
2125 Smithtown Avenue, Ronkonkoma, New York  
Index # A1-0627-12-09 Site # 152206

This **Supplemental Site Characterization and Investigation Work Plan** presents proposed work elements to address these requests and was developed to include results of discussions with, and correspondence received from, the NYSDEC during its preparation.

**ATTACHMENT A  
PHOTOGRAPHIC DOCUMENTATION – PARCEL A FOUNDATION  
SLAB DEMOLITION**

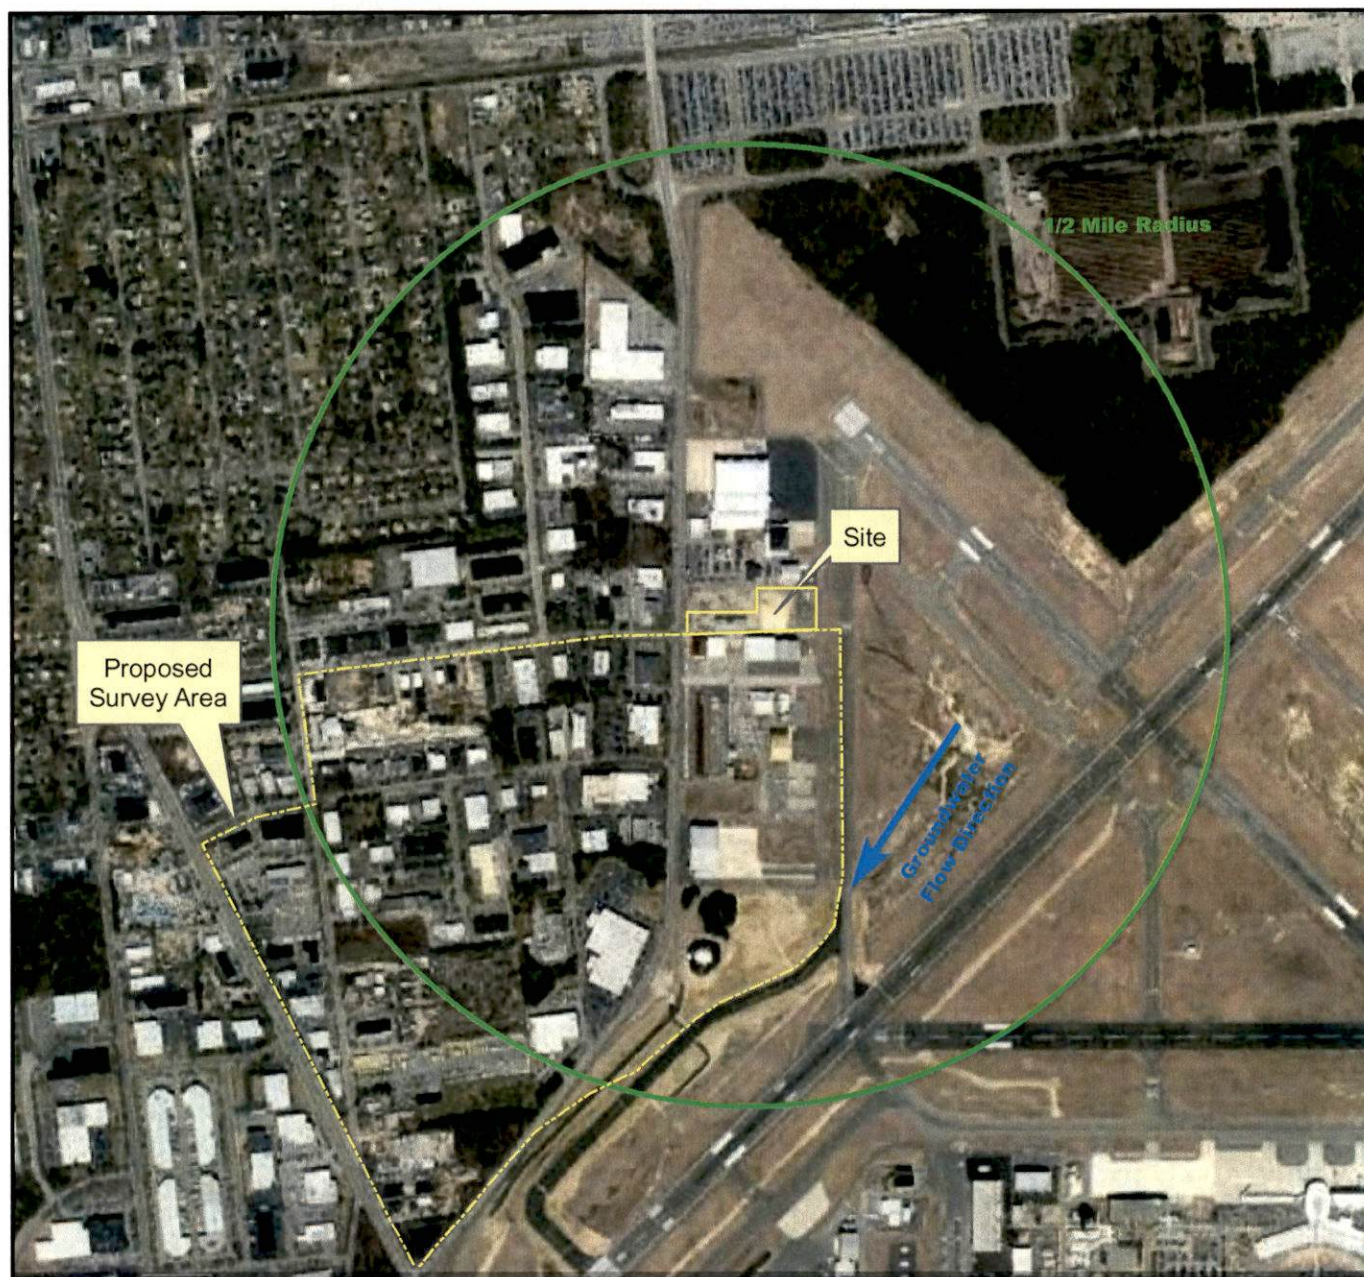
### Figure 1 Proposed Private Well Survey Area

Documentation regarding the existence and location of public/industrial water wells in the vicinity of the Site was obtained from Environmental Data Resources Inc (EDR) and presented in the NYSDEC approved October 2011 Work Plan. No records regarding private wells were

identified through that search. To follow up on the request from the NYSDEC regarding information pertaining to private wells in the vicinity of the Site, EnviroTrac will contact the Suffolk County Water Authority (SCWA) to obtain documentation showing the extent of municipal water service to the vicinity of the Site within the area shown on Figure 1 (attached). This area extends in the downgradient direction beyond a one-half mile search radius that was requested by the NYSDEC in communications held during preparation of this work scope. In addition, the Suffolk County Department of Health Services (SCDHS) will be contacted to further evaluate the possible presence of private wells within the area of interest. The presence and use of private wells is highly unlikely as there are no residences located within the proposed search area.

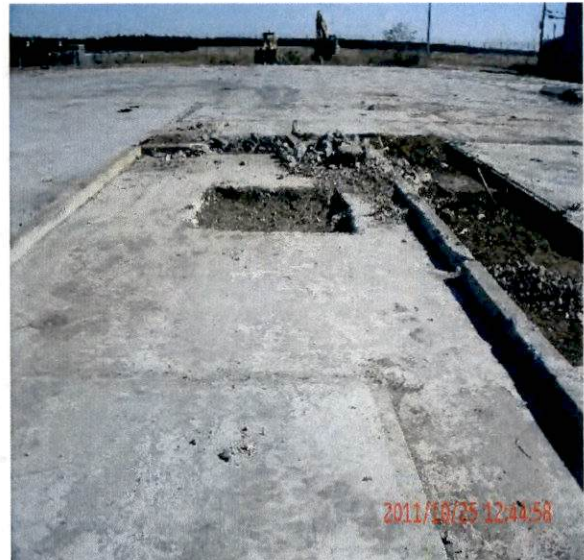
4. View looking East from the former drum storage area. (SG-7)

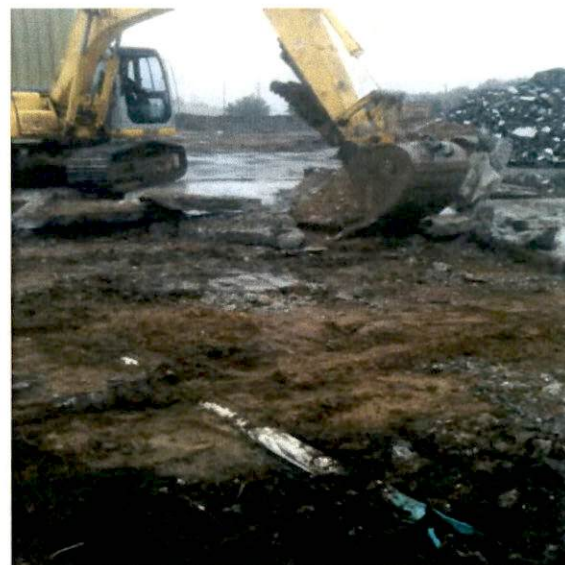
8. Concrete removal activities at the former drum storage area, looking northwest. (SG-7)

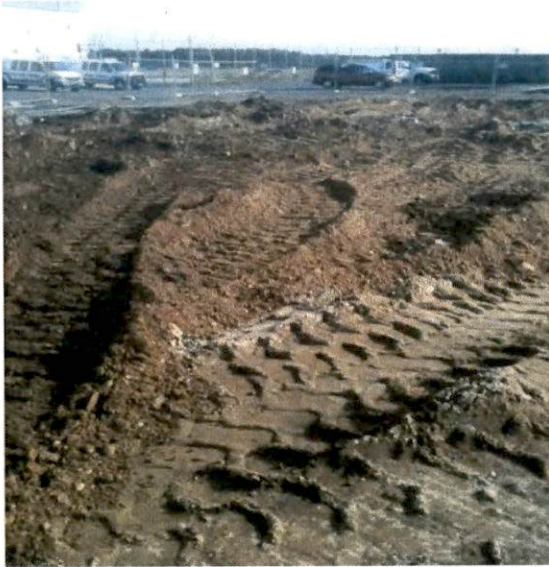
On October 28 and 31, 2011 Concrete removal activities continued at the Site. The soil beneath the former slab showed no apparent signs of staining or of previous discharges.

9.) View of the soil on the northern portion of the Site after excavation activities.

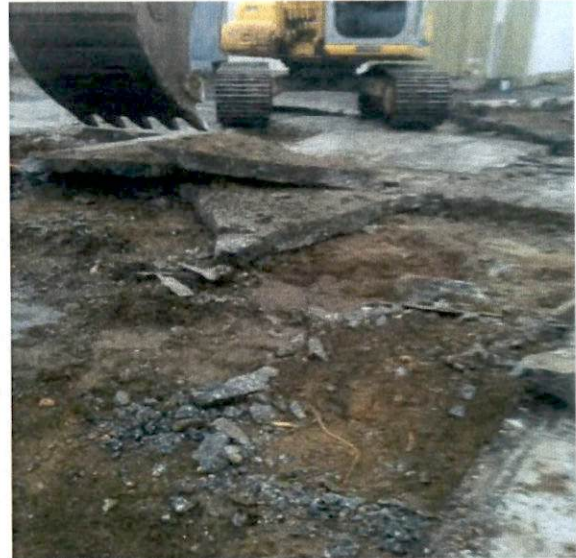
11. Concrete removal activities at the former drum storage area. (SG-7)

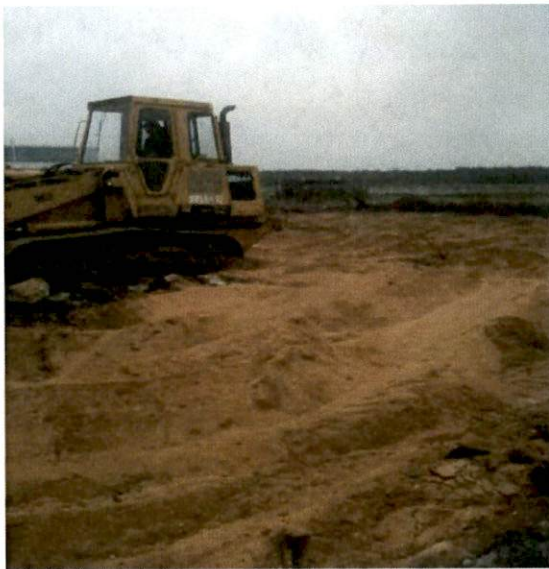
10.) View of the sand across the central portion of the site post concrete removal.

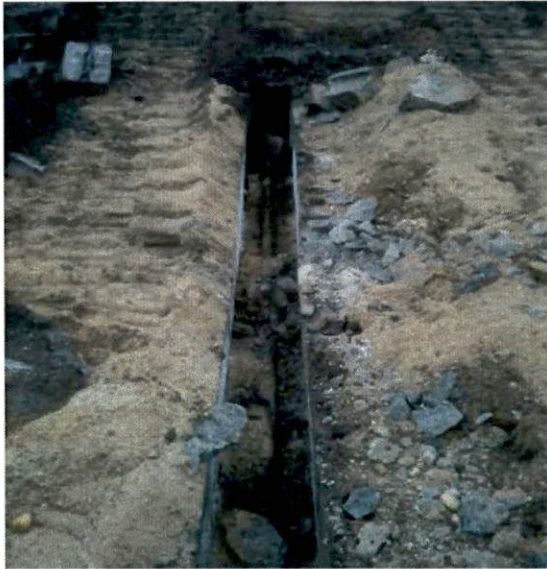
17.) Old abandoned gas line trench on the southern portion of the Site.
