# PERIODIC REVIEW REPORT JANUARY 2021 – DECEMBER 2023

**BIANCHI/WEISS GREENHOUSES SITE  
EAST PATCHOGUE, NEW YORK 11772**

**NYSDEC Site No. 152209**

**Work Assignment No. D00982-04.1**

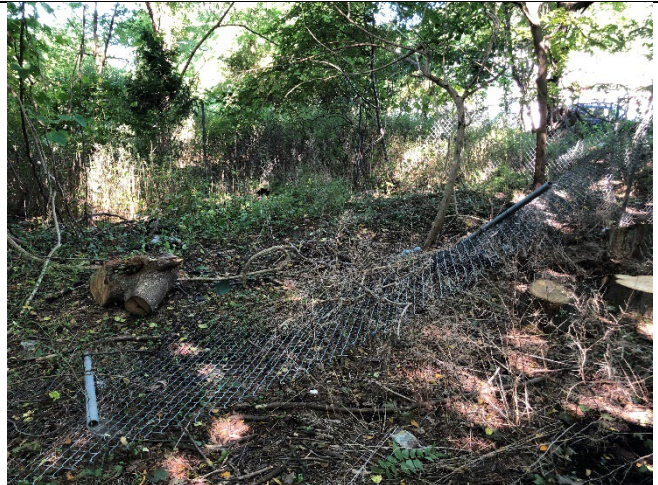
**Photo 4:** Damage fencing located on the eastern perimeter of the Site.

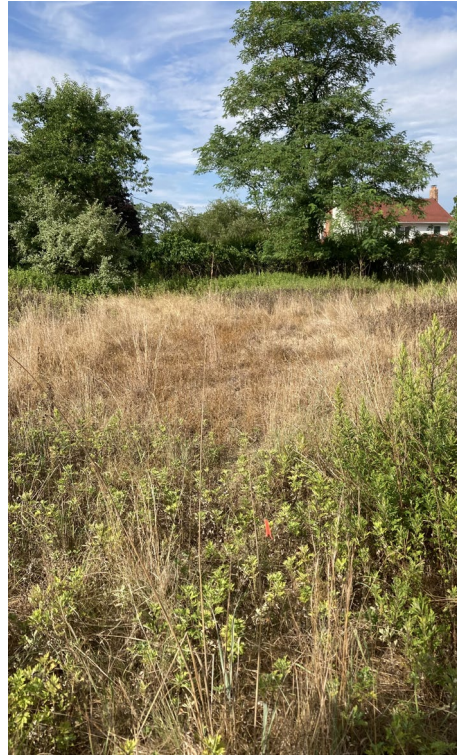
**Photo 2:** View of Site, facing Southwest. Adequate vegetation cover.

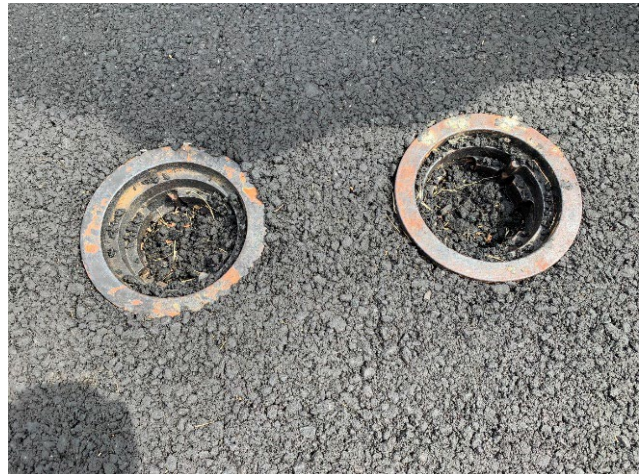
**Photo 4:** Destroyed off-site monitoring well WO-17 shown adjacent to unidentified utility manhole.

Summary of Site Activities and Site Monitoring and Sampling January 2021 through December 2023		
Site Management Activity	Summary of Results	Maintenance/Corrective Measure
Site and Monitoring Well Network Inspection	<p>Annual and post-storm Site inspections were performed on September 7, 2021, November 2, 2021 and August 5, 2022. Fence damage was reported at the eastern and southern perimeters of the Site. TRC confirmed adequate Site security, sufficient vegetative cover, and no issues with Site drainage. During the August 2022 Site inspection, TRC identified that monitoring wells MW-33I, MW-33P, MW-33D, MW-33S, WO-15 and WO-16 were paved over, wells WO-11 and WO-27 were covered in soil as a result of active construction, well WO-17 was missing its cover and filled with asphalt, and wells WO-18 and WO-19 were missing plugs and the covers were replaced with “GAS” covers. All remaining inspected wells were in good condition.</p> <p>TRC returned to the Site on October 12, 2022 to replace the missing well plugs at monitoring wells WO-18 and WO-19, however, the manholes for the wells were filled with asphalt.</p>	Maintenance is required to remove the surface covers and locate the missing monitoring wells. Asphalt should be removed from the monitoring well manholes and the wells should either be rehabilitated or abandoned.
