**MAKO PROPERTIES LLC - BUILDING #3  
48-50 ENTER LANE  
ISLANDIA, NEW YORK**

# **CONSTRUCTION COMPLETION REPORT**

**NYSDEC Site Number: 152-20-30**

**Prepared by:  
CA RICH CONSULTANTS, INC.  
17 Dupont Street  
Plainview, NY 11803-1614  
&  
Tyll Engineering and Consulting PC  
169 Commack Road, Suite H173  
Commack, New York 11725**

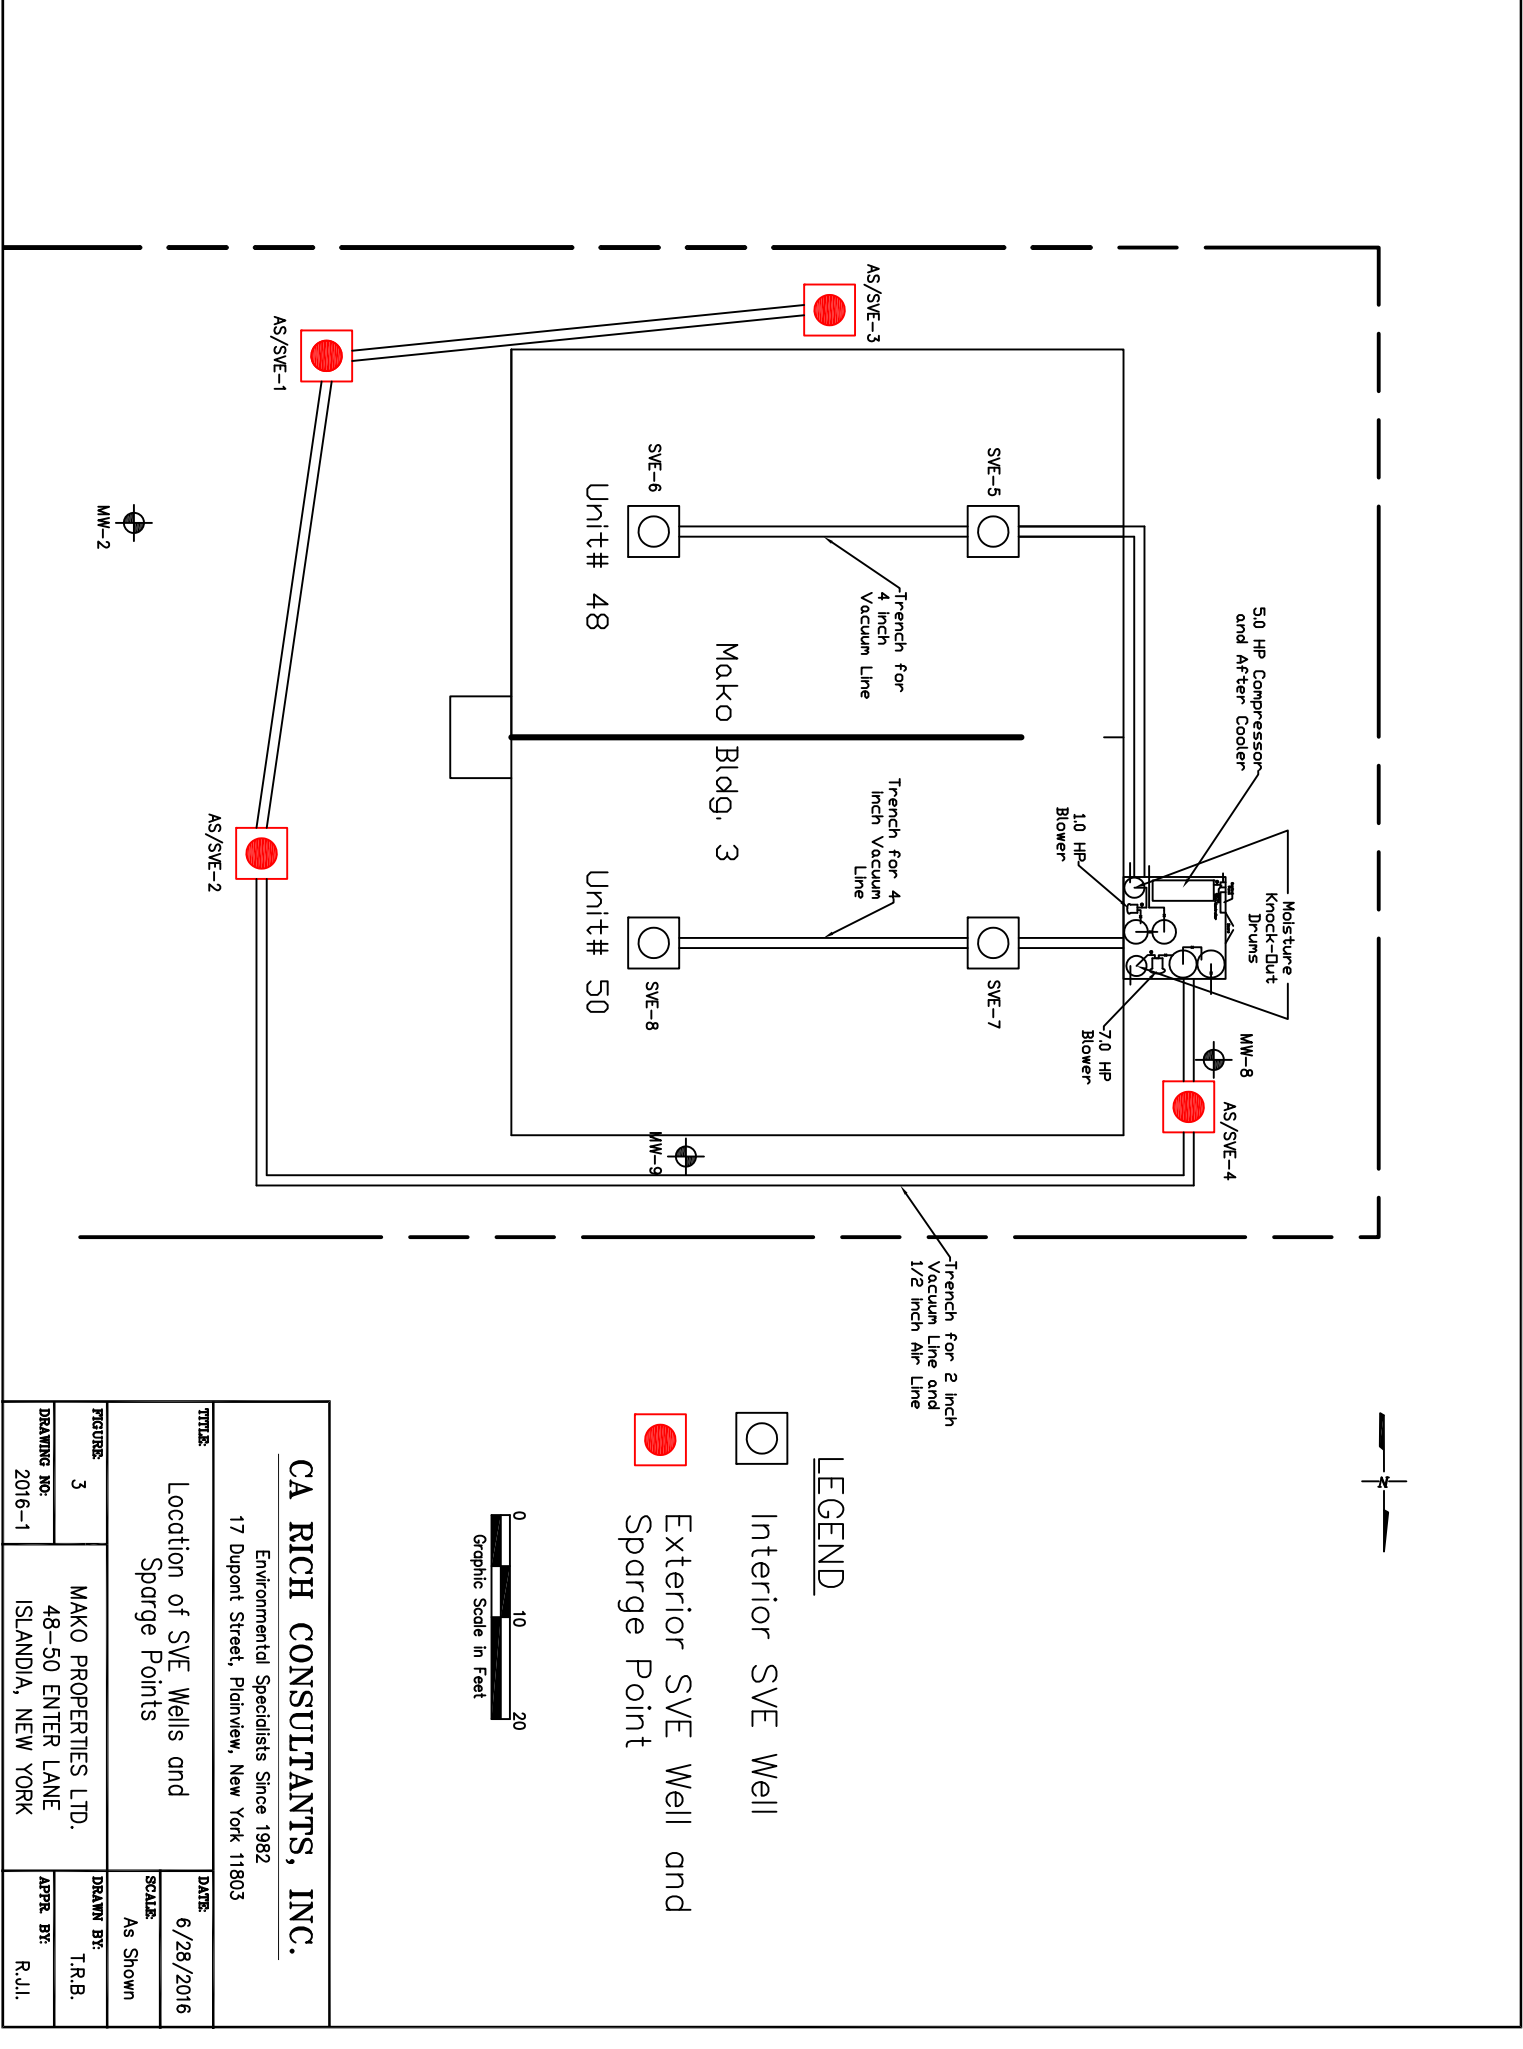
The SVE system includes SVE wells in 8 locations (four beneath the interior portions of Building #3 and four in exterior locations around Building #3). The location of each of these SVE wells is presented on Figure 3.

A total of four AS points were installed on the exterior of Building #3 using a hollow stem auger drill rig at the locations illustrated on Figure 3. Each of the AS points were constructed of 2-inch diameter x 2-foot long 0.020-inch slotted (20 slot) PVC well screens connected to 2-inch diameter PVC pipe. The AS points were placed from approximately 90 to 92 feet below grade. Each AS point was surrounded with a Morie No. 2 sand pack followed by a one-foot-thick bentonite seal. A schematic profile of a typical AS point/SVE well is presented on Figure 5.

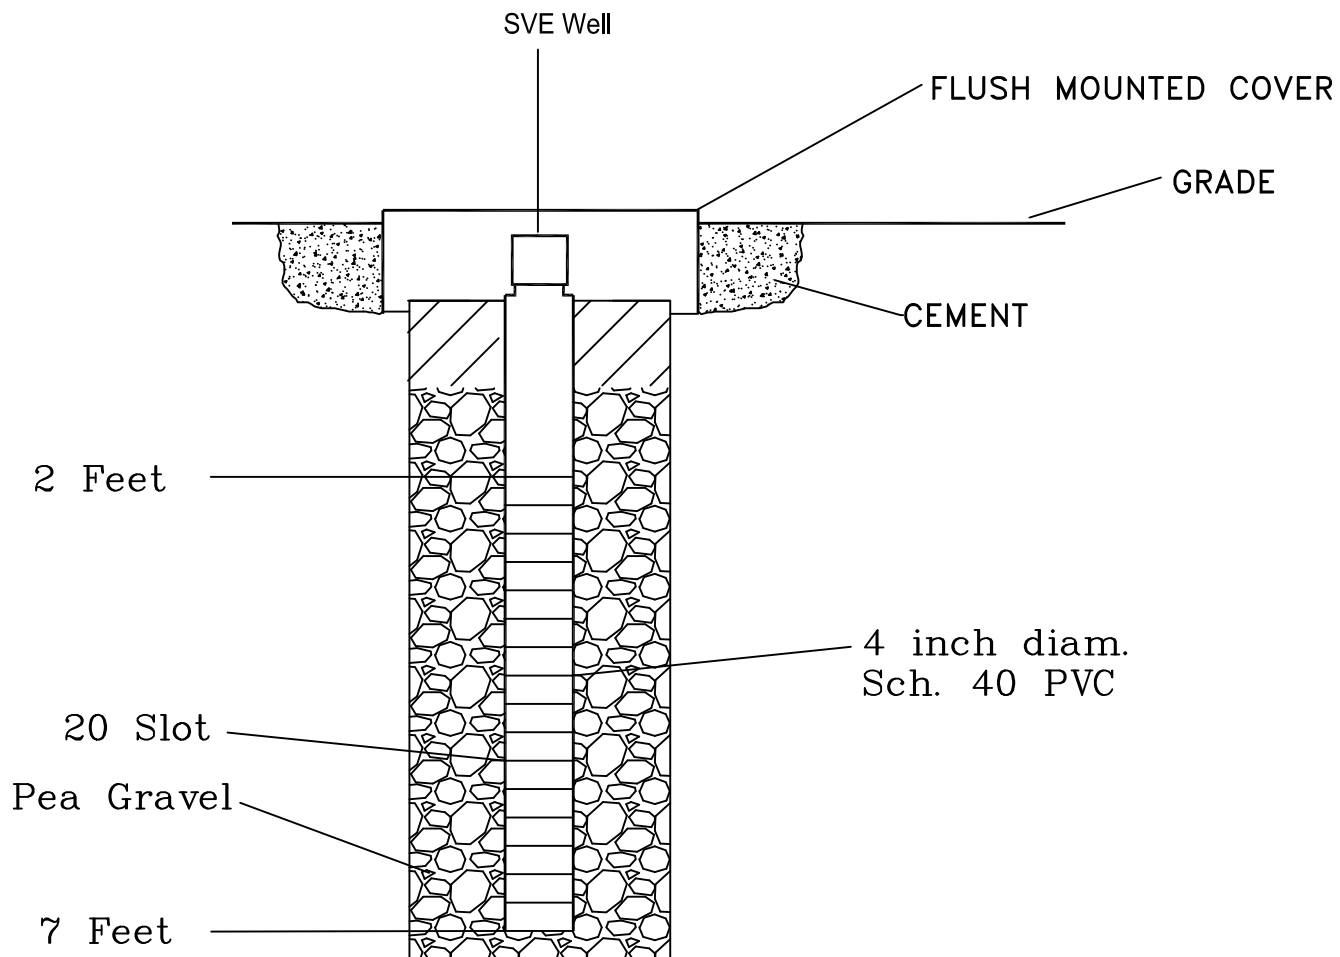
The interior SVE wells consist of five feet of four-inch diameter 20-slot schedule 40 PVC screen installed to a depth of seven feet below grade with two feet of riser above, extending to just below the slab of Building #3. The screen and riser are surrounded by pea gravel and grouted in place with cement. The SVE wells are flush-mounted with bolt-down curb boxes. A schematic profile of the interior SVE wells is presented in Figure 4.

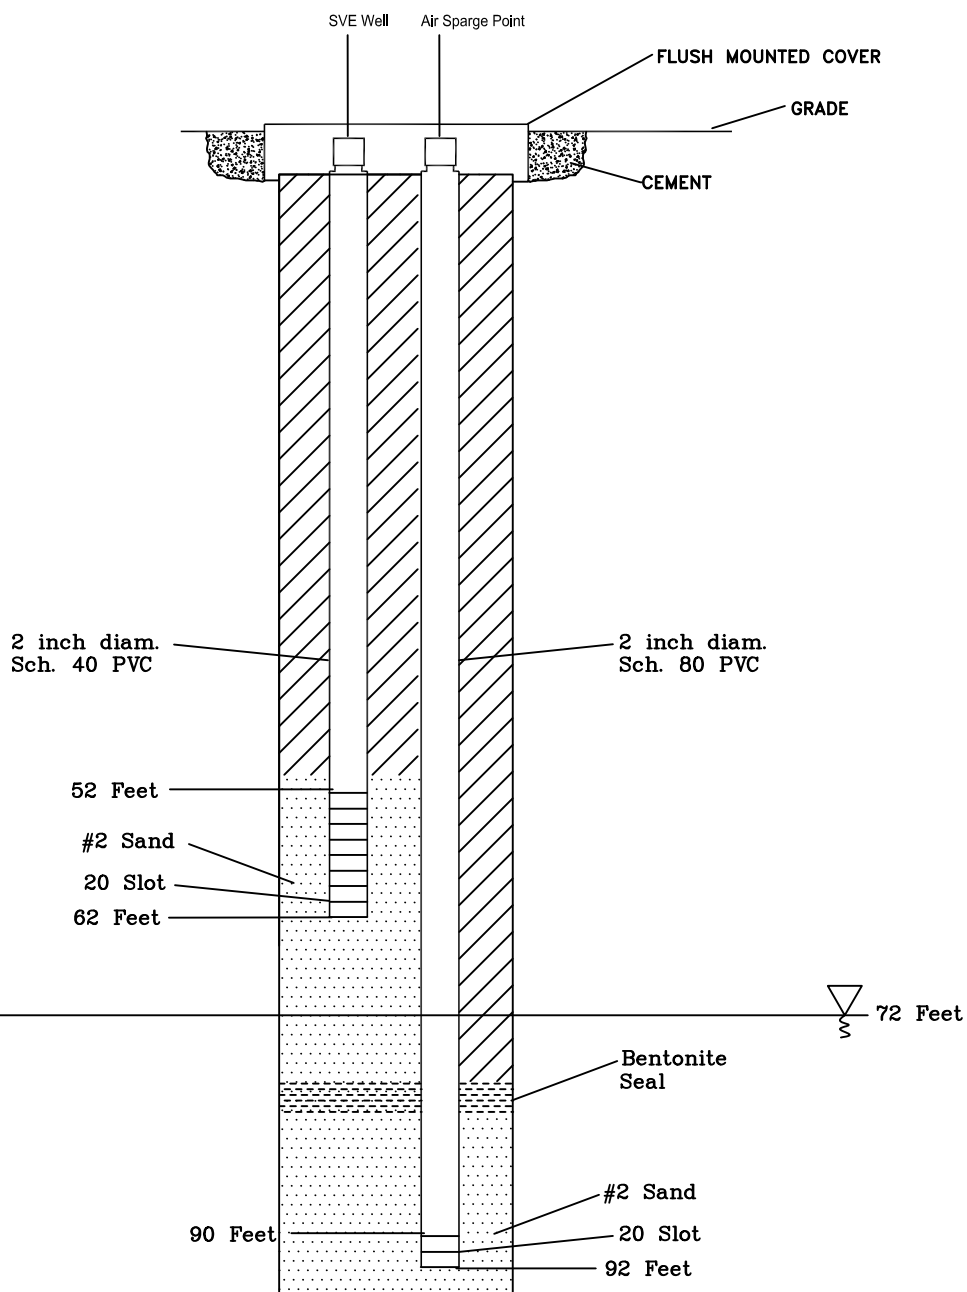
The four exterior SVE wells were installed using a hollow stem auger drill rig in one common borehole along with the four associated AS points discussed below. A section of 2-inch diameter, Schedule 40, 0.020-inch slotted (20 slot) PVC well screen was installed from a depth of 52 to 62 feet below grade. This was followed by PVC pipe to

the ground surface. Morie number 2 sand was placed around the well screens followed by a bentonite seal. Native sand and gravel from the borehole was used as backfill above the seal and a concrete seal was placed at the surface. A schematic profile of the exterior AS points/SVE wells is presented in Figure 5.

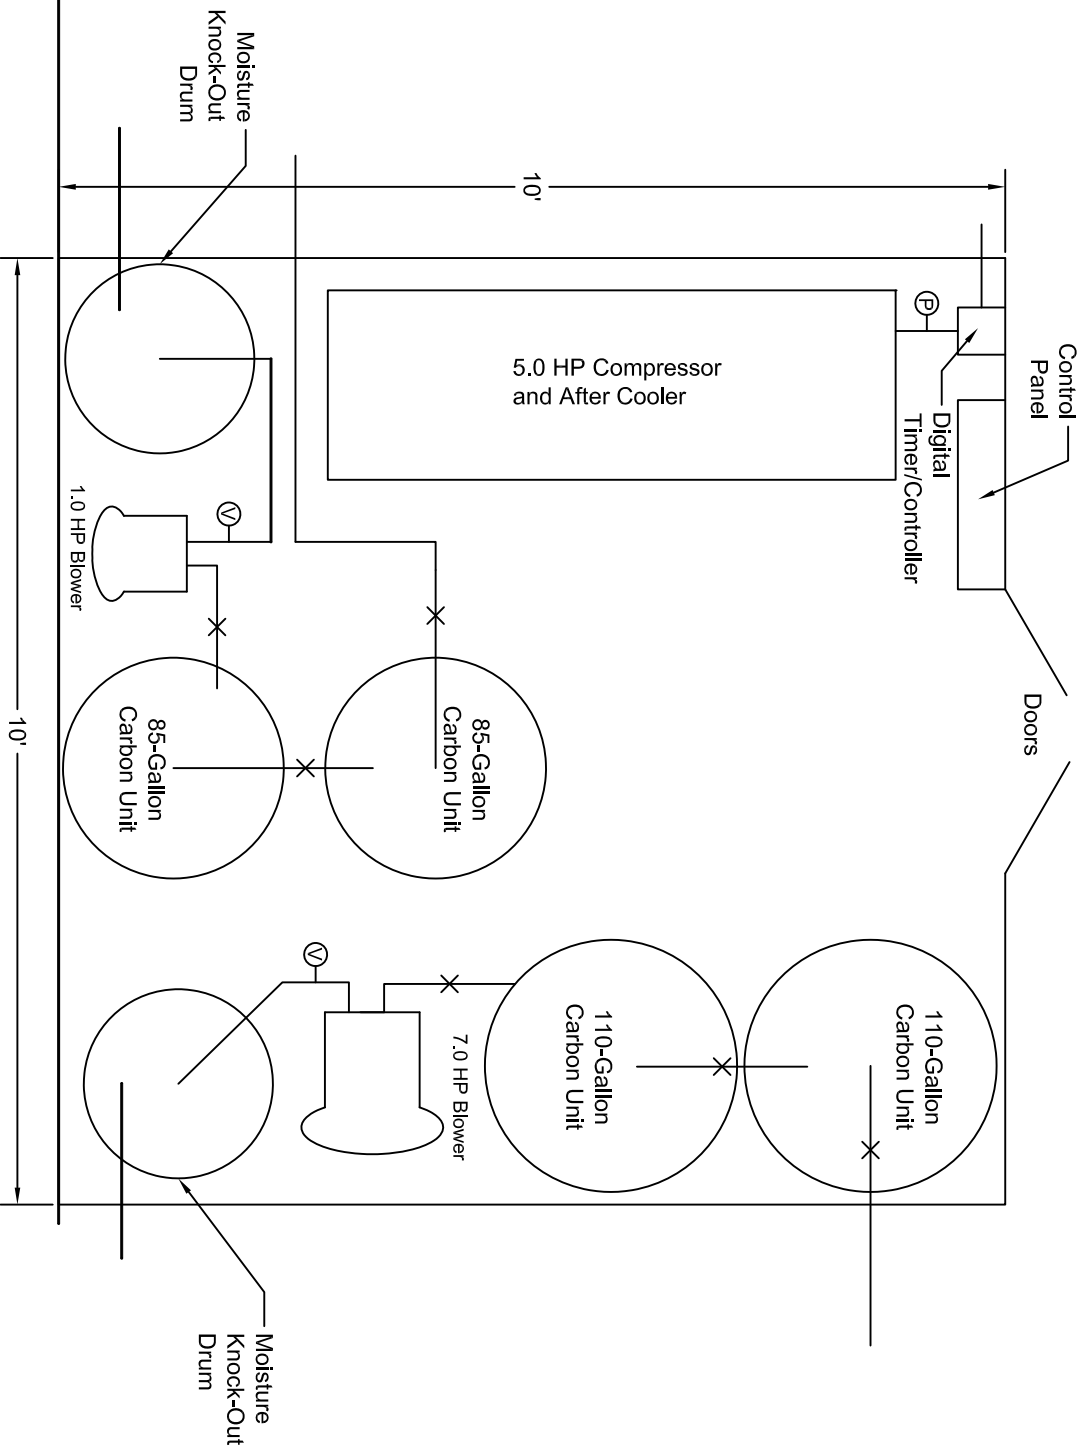
The soil vapor is extracted from the exterior SVE wells using a seven-horsepower regenerative blower capable of producing approximately 250 cfm at 5 inches of water vacuum and is located in a secured equipment shed at the rear of Building #3. The vacuum to the interior SVE wells is supplied by a separate one-horsepower regenerative blower capable of producing approximately 80 cfm at 5 inches of water vacuum and is also located in the equipment shed. The soil vapor collected from each SVE system passes through a moisture knock-out drum, into the blower and flows through a series of vapor-phase carbon units located inside of the shed. The four air pollution carbon barrels are provided by General Carbon. The raw air from the interior SVE passes through two 85-gallon air pollution control barrels (300-pounds each) connected in series. The extracted air from the exterior SVE passes through two 110-gallon air pollution control barrels (400-pounds each) connected in series. A 4-inch PVC discharge stack was attached to the side of the shed with the discharge point above the shed roof. The electrical connection to the system is direct from the blower to a utility panel inside the shed. A schematic of the equipment layout is presented as Figure 6.

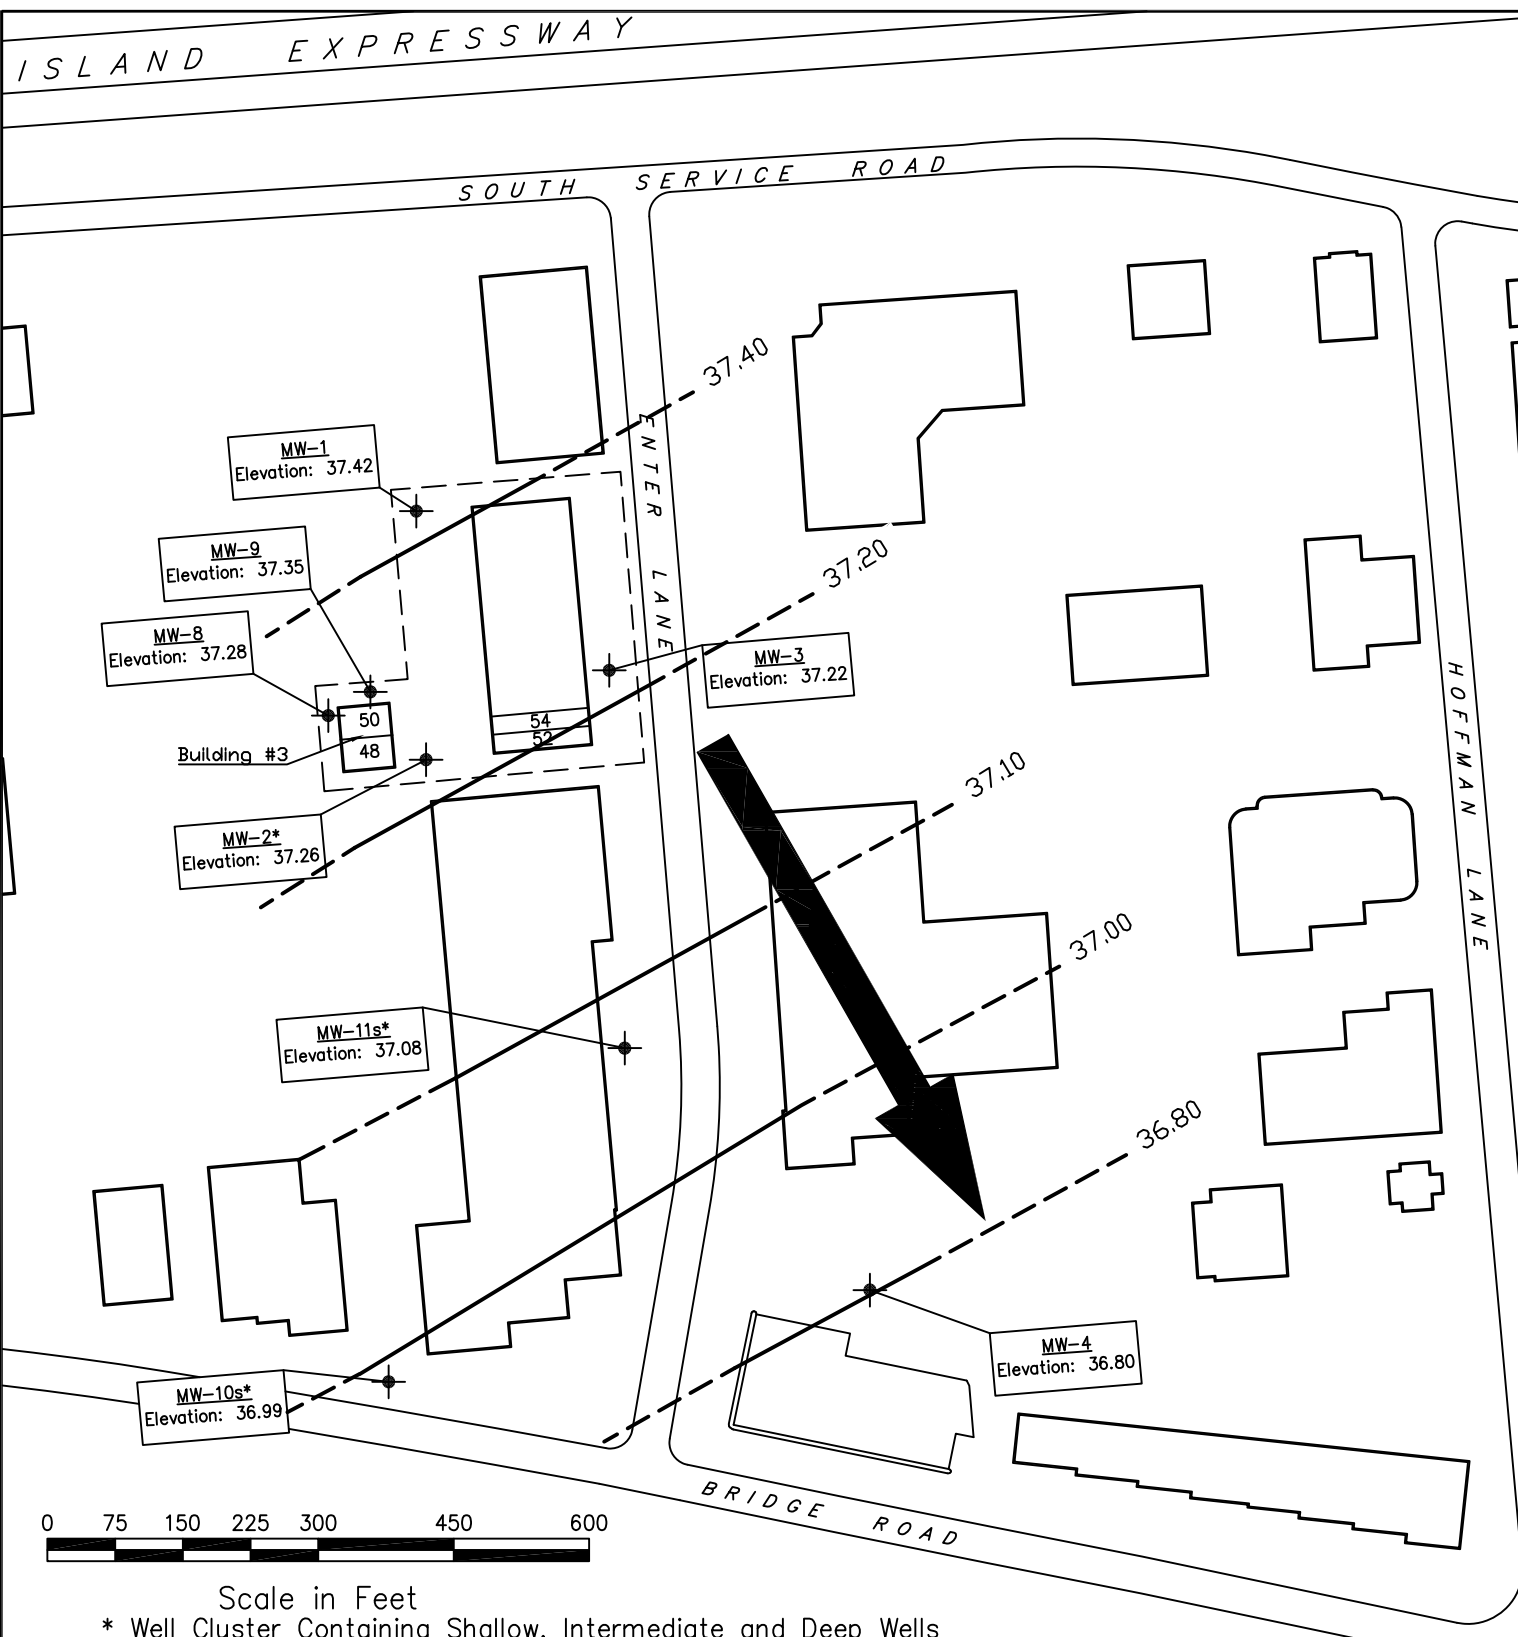
System performance monitoring includes semi-annual groundwater sampling and analysis utilizing a network of 14 on-site and off-site monitoring wells. The monitoring well network includes shallow, intermediate and deep wells ranging in depth from 80 feet to 195 feet below land surface. Monitoring well details are included on Table 2. A map detailing the locations of the wells and the direction of shallow groundwater flow is presented on Figure 7. As shown on Figure 7, the groundwater flow direction beneath the site is to the southeast.

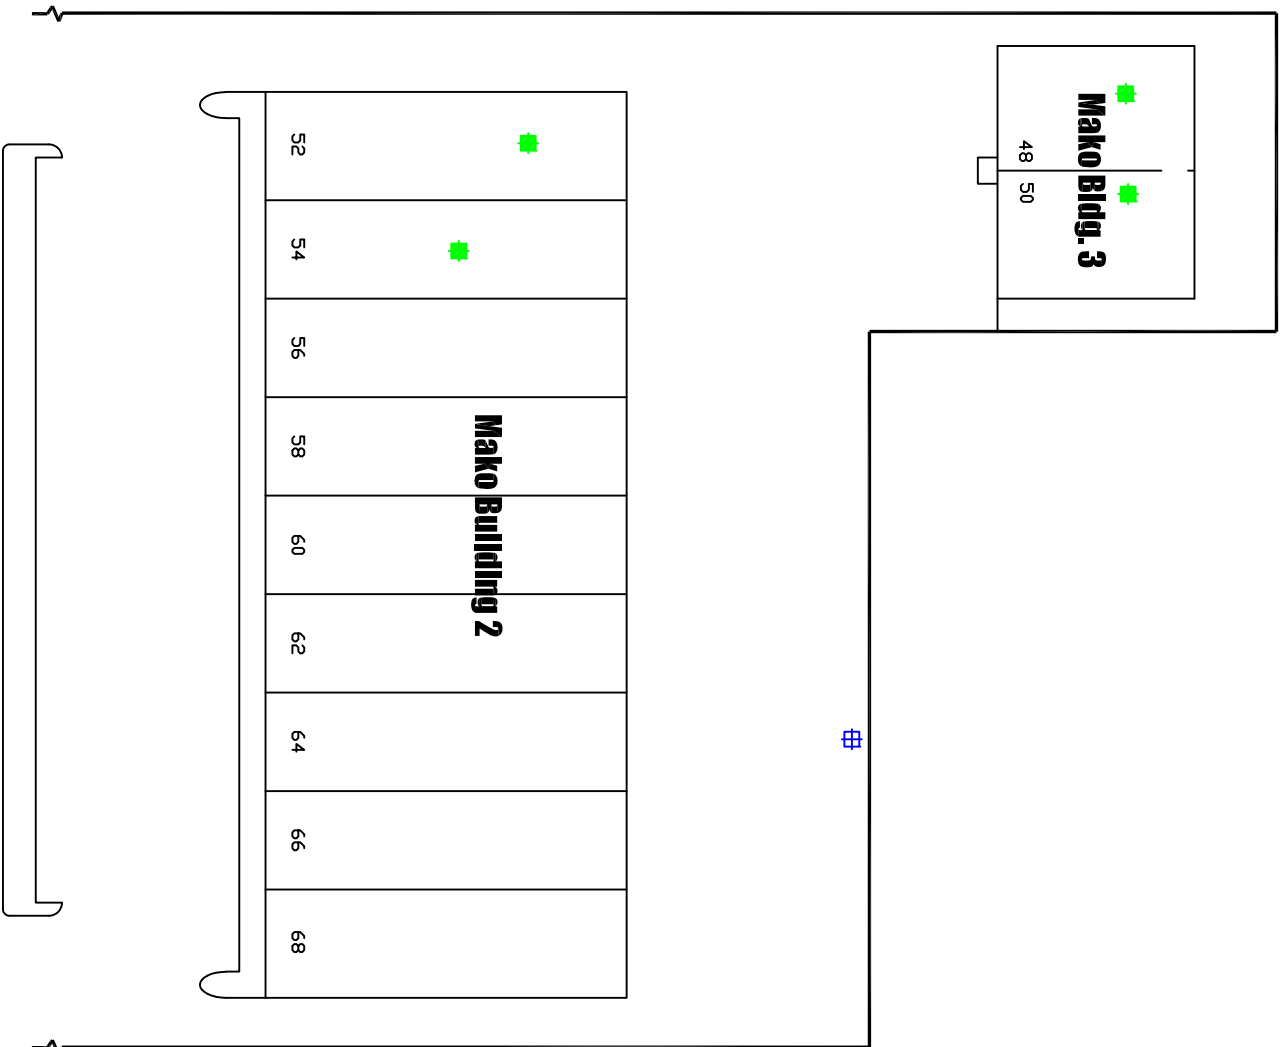
2015, December 2015, and June 2016. In addition, during each sampling event, an exterior ambient air sample was collected. The results of the indoor air monitoring are included on Tables 7, 8, & 9. In general, air quality inside the buildings has remained below NYSDOH action levels. With respect to Building #2 (52 and 54 Enter Lane), the results of this round of indoor air sampling, coupled with the prior results from indoor and sub-slab testing, shows that the levels associated with this building are in the no further action range of the NYSDOH Guidance. Figure 8 illustrates the indoor air sampling locations.

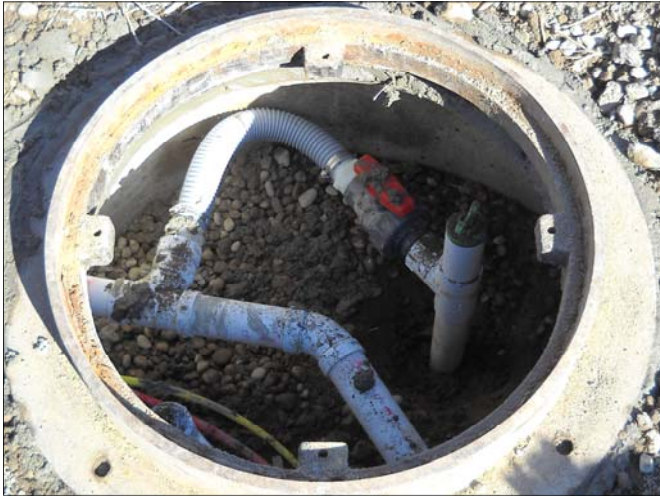
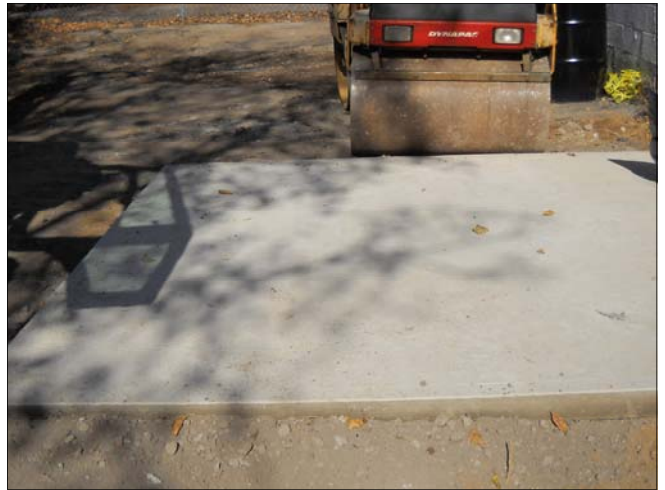
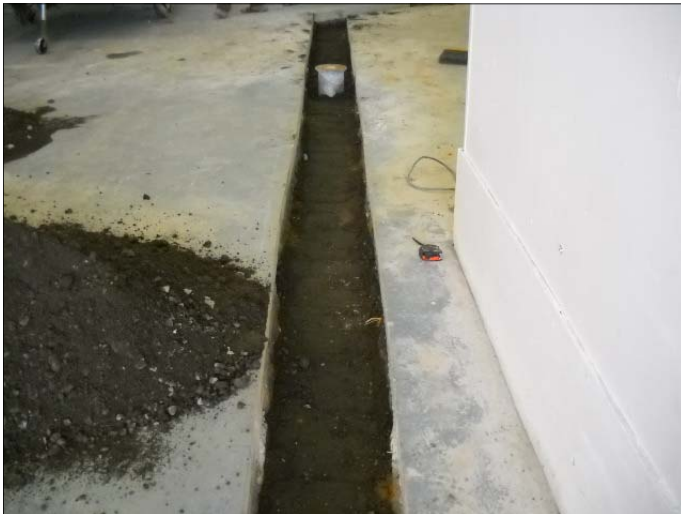
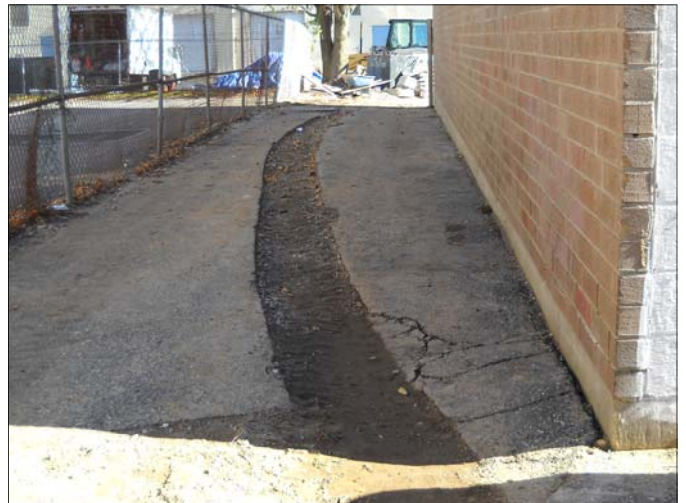
**System Installation 2015**

A combined AS/SVE System was developed and installed at Building #3 for this project. The details of this system are outlined below and in the As-Built Drawings which are included as Figures 3, 4, 5 and 6 of this report. Table 1 of this document provides a summary of the construction details of the SVE wells and AS points.

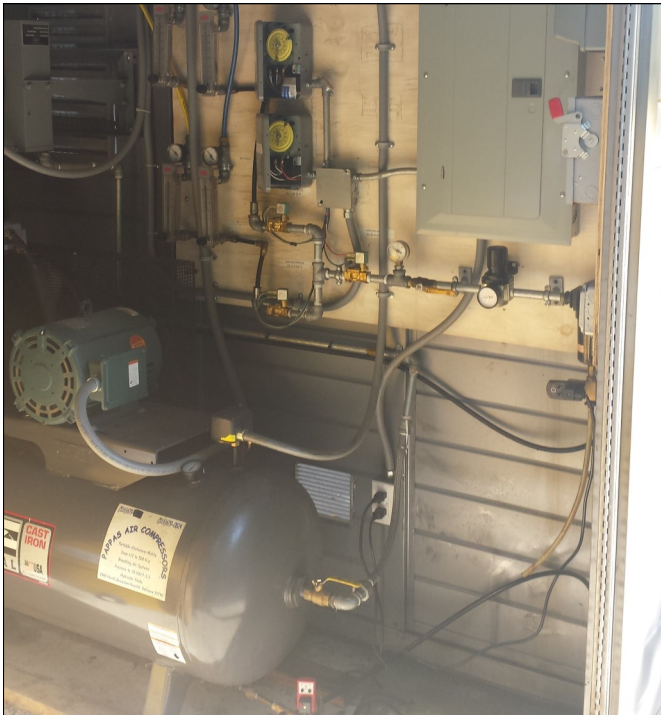
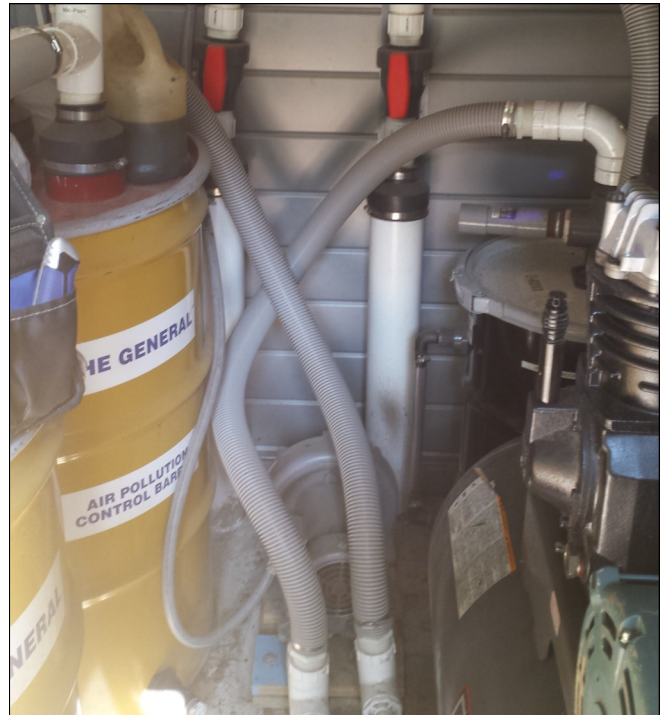
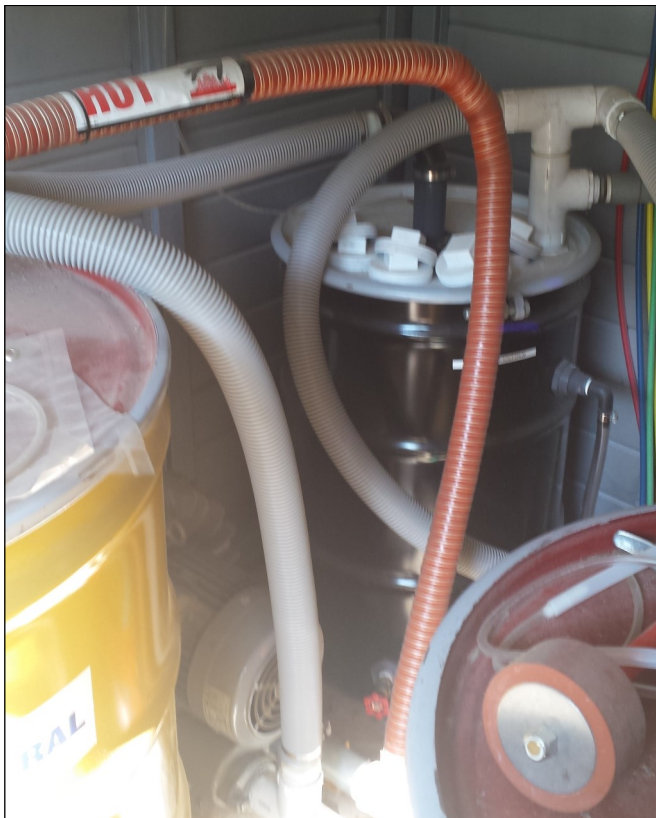
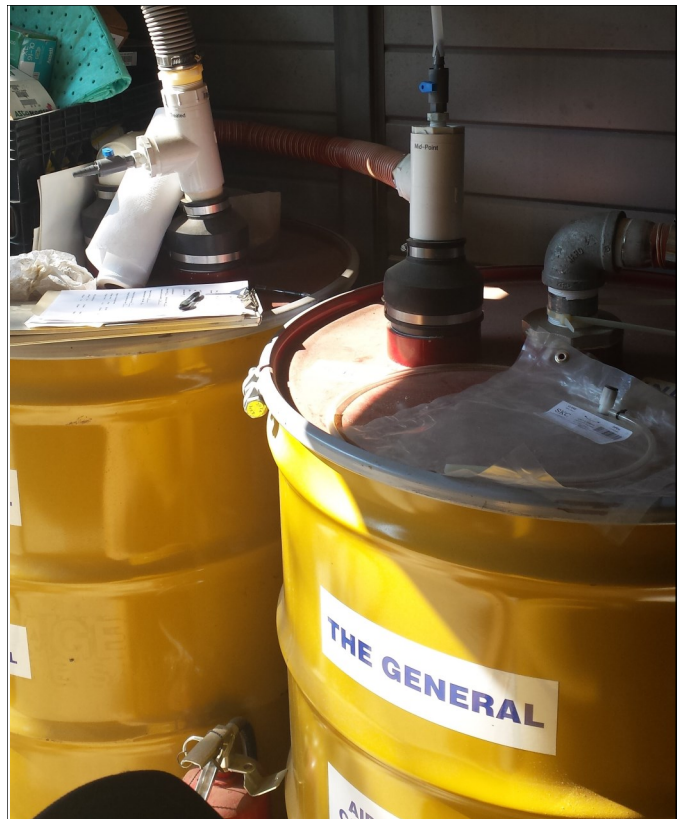
**Treatment Equipment**

Air sparging is achieved using a 7.5-horsepower reciprocating compressor equipped with an after cooler. The air compressor is capable of delivering approximately 24.3 cubic feet per minute (cfm) of air at 175 pounds per square inch (psi) and was placed in the equipment shed. The electrical connection to the system is directly from the air compressor to a utility panel inside the shed.
