Feasibility Study Report

Former Elka Chemical Corporation Site

NYSDEC Site Number: 152239

**Revised
October 11, 2022**

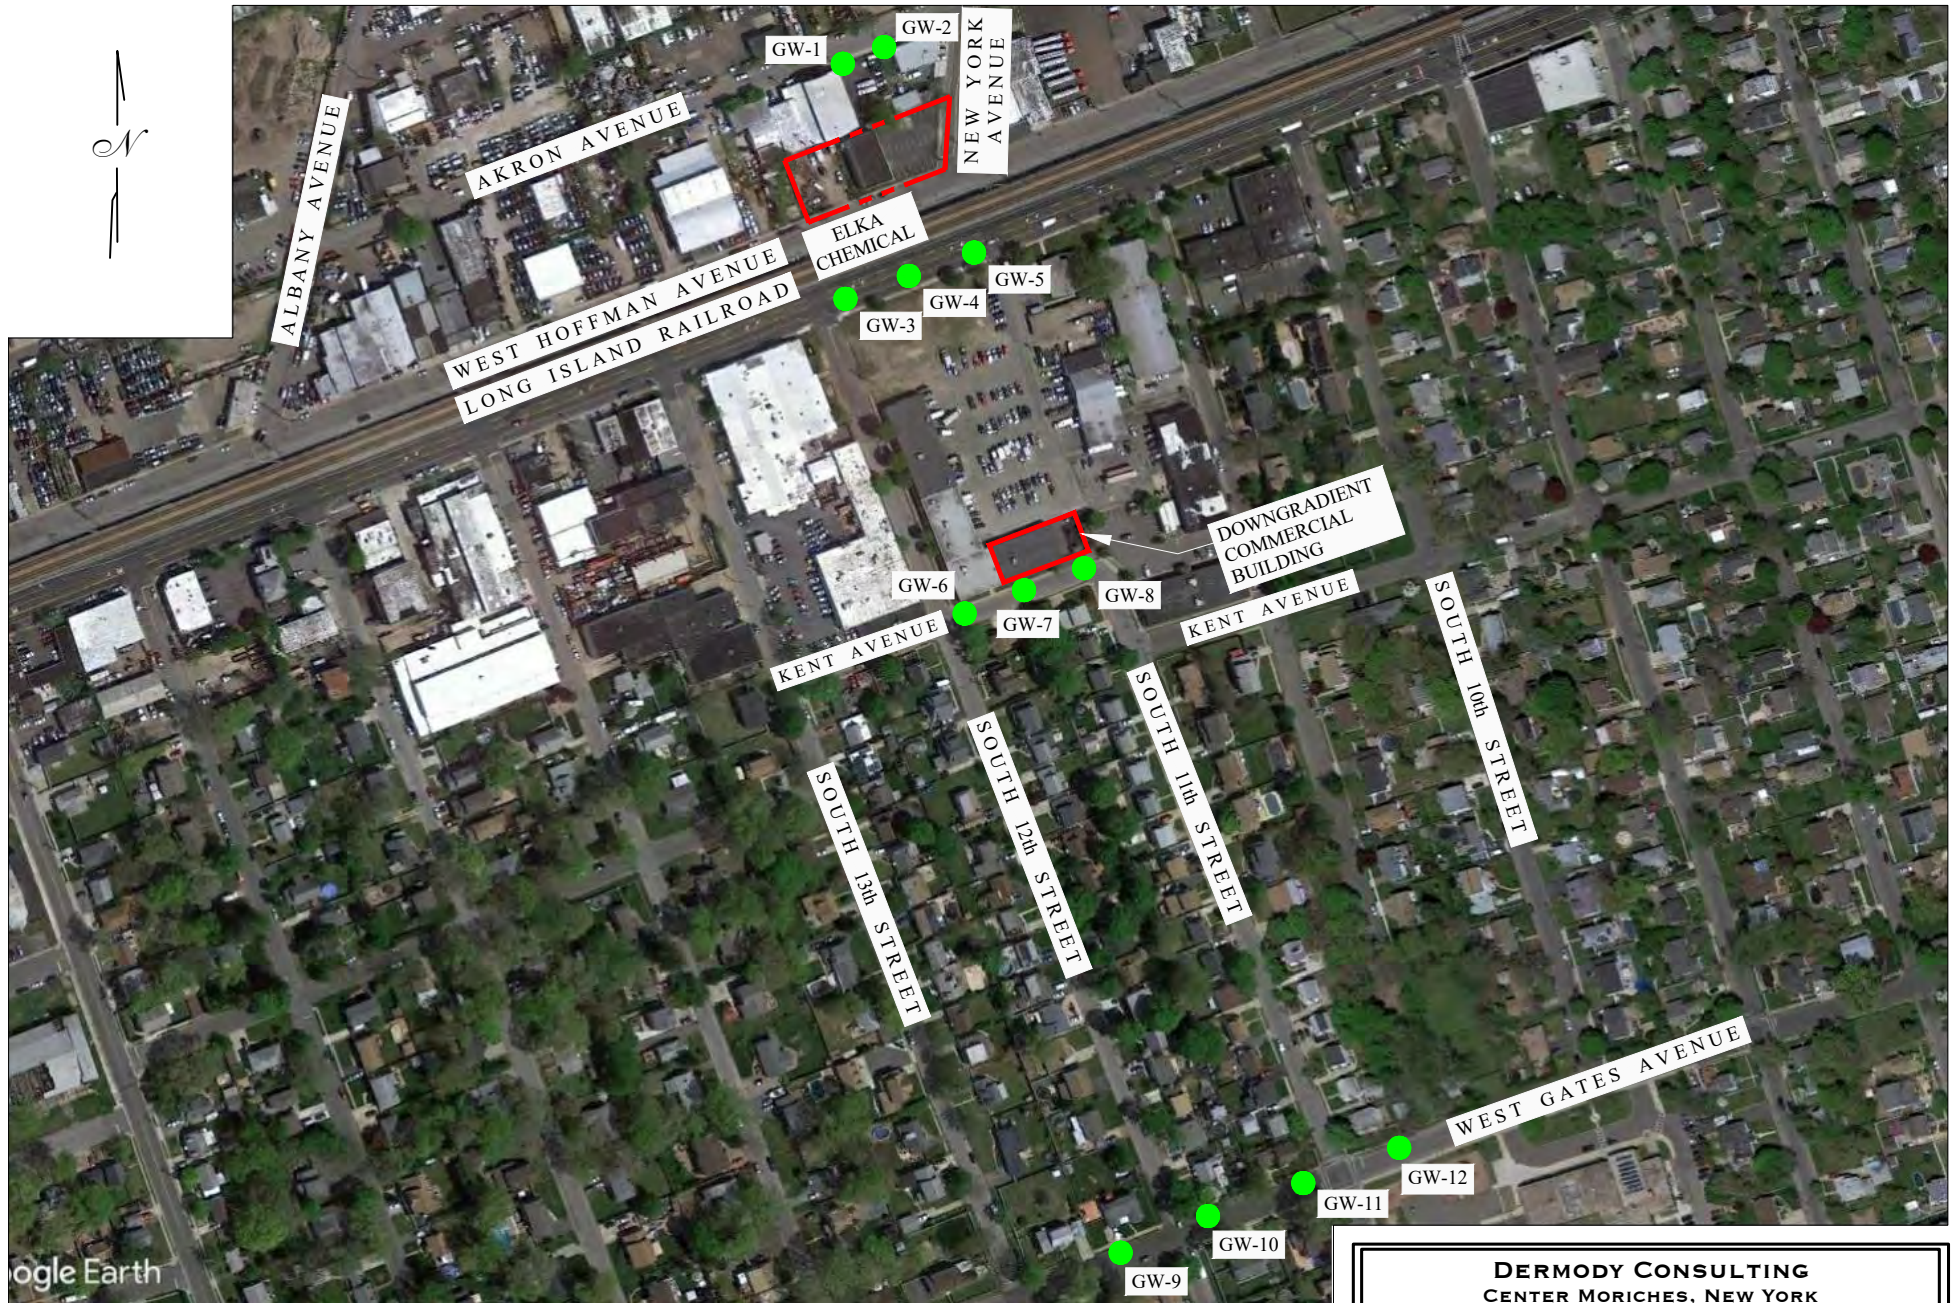
FIGURE 4
OFF-SITE GROUNDWATER
MONITORING WELL LOCATIONS
340 WEST HOFFMAN AVENUE
LINDENHURST, NEW YORK

● GW-1 OFF-SITE GROUNDWATER MONITORING WELL LOCATION

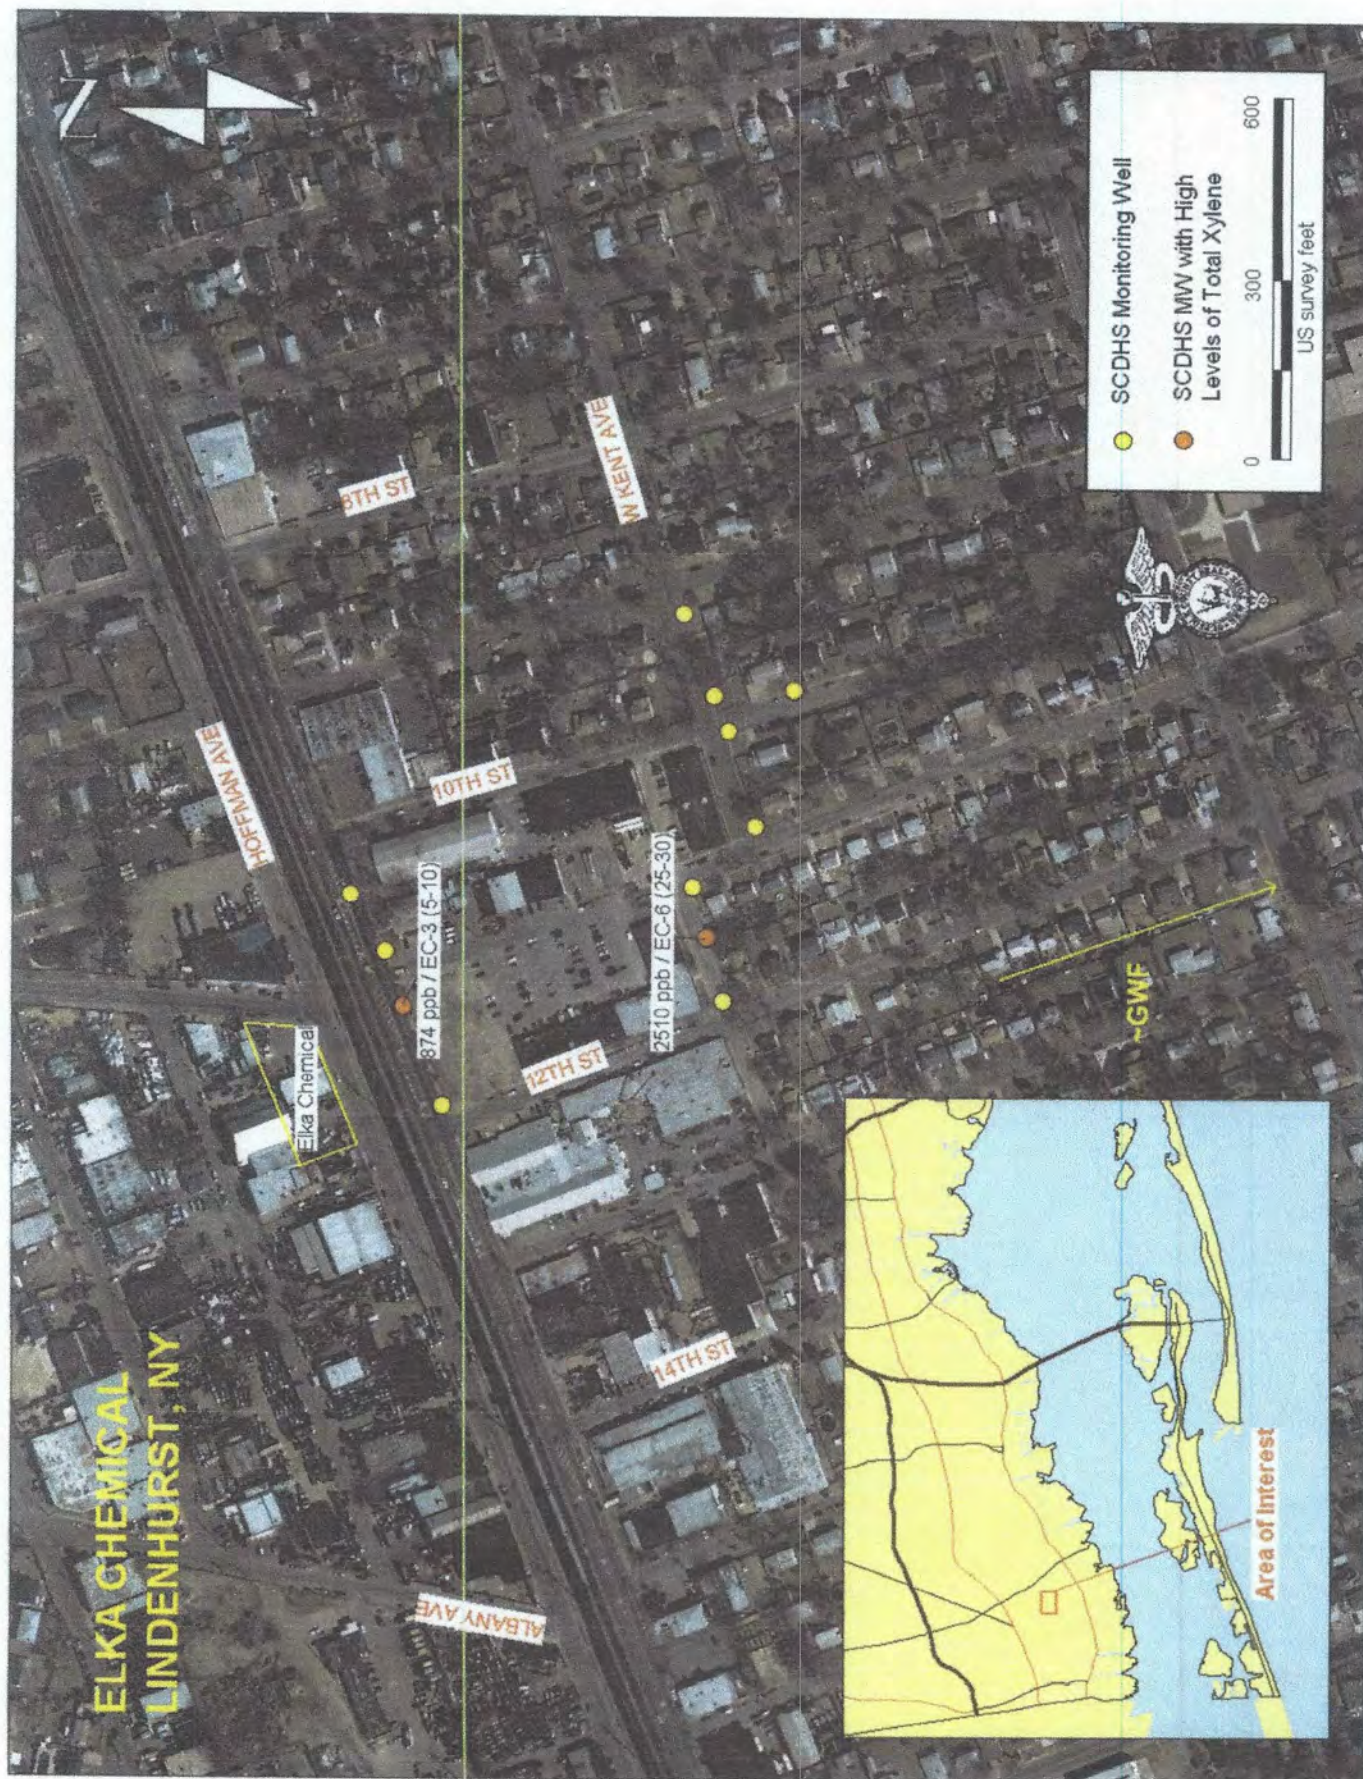
Figure 2: Shows SCDHS Monitoring Wells with the Highest Total Xylene Contamination in Red and the Associated Sample Screen Interval (fbg)
