REMEDIAL INVESTIGATION/ FEASIBILITY STUDY WORK PLAN

EAST HAMPTON AIRPORT SITE

NYSDEC SITE No. 152250

MAY 2021

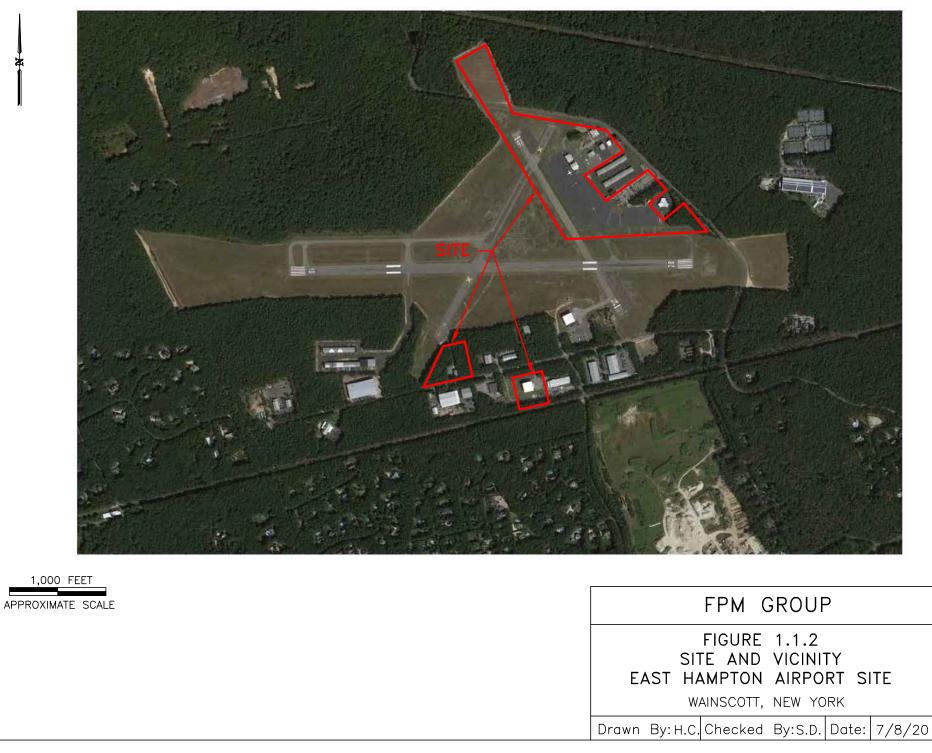
The general location of the Site is presented in Figure 1.1.1. A plan of the Site and its vicinity is included as Figure 1.1.2. The Site is located approximately 3.4 miles west of the Village of East Hampton. The Site is located in a CI commercial/industrial zone and is surrounded by commercial and industrial uses and open undeveloped land. Long Island Rail Road (LIRR) tracks are present to the south of the Site. The nearest residential properties are located to the south of the LIRR tracks.

The portion of the Site that is on the airport property is bounded to the east and northeast by Daniels Hole Road, beyond which undeveloped wooded areas are present, as shown on Figure 1.1.2. The northern-most area of this portion of the Site is just to the north of Daniels Hole Road; this area of the Site is bounded by undeveloped wooded areas. The western and southern areas of this portion of the Site are bounded by an undeveloped wooded area and airport property characterized by open grassy fields and paved runways and taxiways.

A preliminary CSM has been developed for this Site, the boundaries of which are shown on Figure 1.1.2, to describe the existing information regarding contaminants of potential concern, potential sources of contamination, potentially affected media (soil, groundwater, and soil vapor), and transport and exposure pathways that could result in potential receptor exposures. This preliminary CSM synthesizes the available data and will be updated based on the findings of the RI.

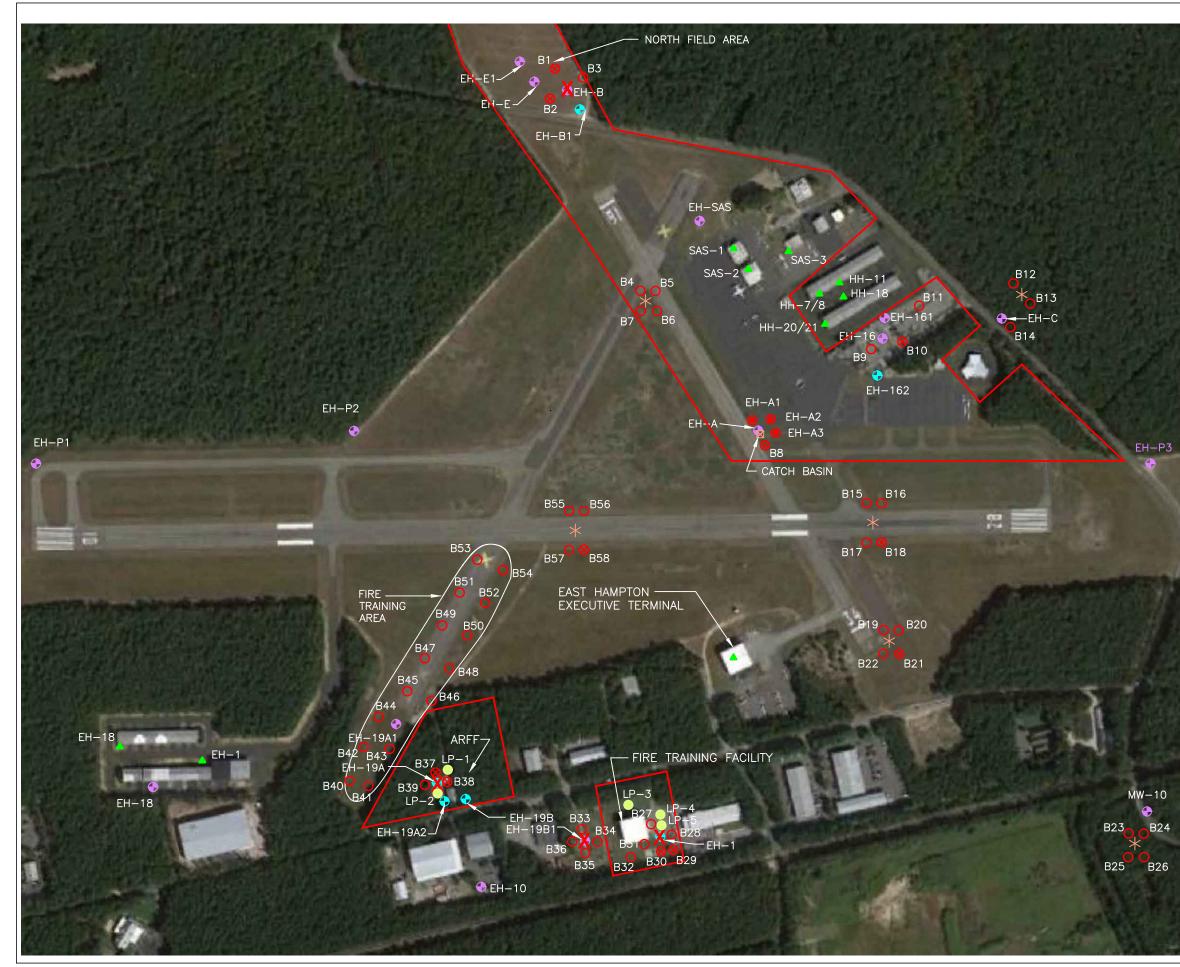
FIGURE 3.1.1 PROPOSED SOIL SAMPLING LOCATIONS EAST HAMPTON AIRPORT SITE WAINSCOTT, NEW YORK

Soil sampling will be conducted at multiple onsite soil boring locations (B1 through B58, open red circles on Figure 3.1.1). These locations were selected to be within and in proximity to areas where PFAS soil impacts exceeding NYSDEC groundwater protection criteria were previously identified (North Field EH-B area, Fire Training Facility EH-1 area, and ARFF Station EH-19A and EH-19B1 areas) or PFAS impacts are suspected, including fire training areas, stormwater runoff areas, and select plane crash sites. In general, each soil boring location in proximity to previous locations where PFAS was identified in soil above groundwater protection criteria will be selected to be between 20 and 40 feet from the previous sample location, with the objective of providing lateral delineation of PFAS impacts to soil in areas with no prior soil sampling data. Soil sample locations in areas not previously assessed or where assessment may not be complete (Northeast Woods plane crash site and aircraft taxiway fire site) will be selected so as to evaluate soil conditions where PFAS is most likely to be present. Exact soil boring locations will be established in the field based on observed conditions, proximity to structures, and similar factors. Soil samples will be collected at several depths in each boring, as described in Section 3.2, to characterize the potential vertical extent of impacts;

- Soil sampling will be conducted at select locations for the NYSDEC DER-10 full list of parameters and 1,4-dioxane, in addition to PFAS. These locations are indicated on Figure 3.1.1 and include two locations in the North Field Area, one location next to Runway 10 at the site of a 1998 plane crash with a reported gas leak, one location at a 1998 plane crash and fuel spill site off the south end of Runway 16, one location at the fuel truck fire site, one location next to Runway 10 where an aircraft/deer collision with a resultant fuel leak was reported, two locations at the ARFF facility, and two locations at the Fire Training Facility. These locations were selected due to reports of fuel spills or the nature of activities that are conducted at the facilities;

Soil sampling and analysis will be performed at select locations in accordance with DER-10 and NYSDEC guidance for emerging contaminant 1,4-dioxane sampling (in addition to PFAS). These locations are identified on Figure 3.1.1 and include two locations in the North Field Area, one location next to Runway 10 at the site of a 1998 plane crash with a reported gas leak, one location at a 1998 plane crash and fuel spill site off the south end of Runway 16, one location at the fuel truck fire site, one location next to Runway 10 where an aircraft/deer collision with a resultant fuel leak was reported, two locations at the ARFF facility, and two locations at the Fire Training Facility. These locations were selected due to reports of fuel spills or the nature of activities that are conducted at the facilities. The samples from the 0 to 0.5-foot interval at these locations will be tested for the full DER-10 list and for 1,4-dioxane.

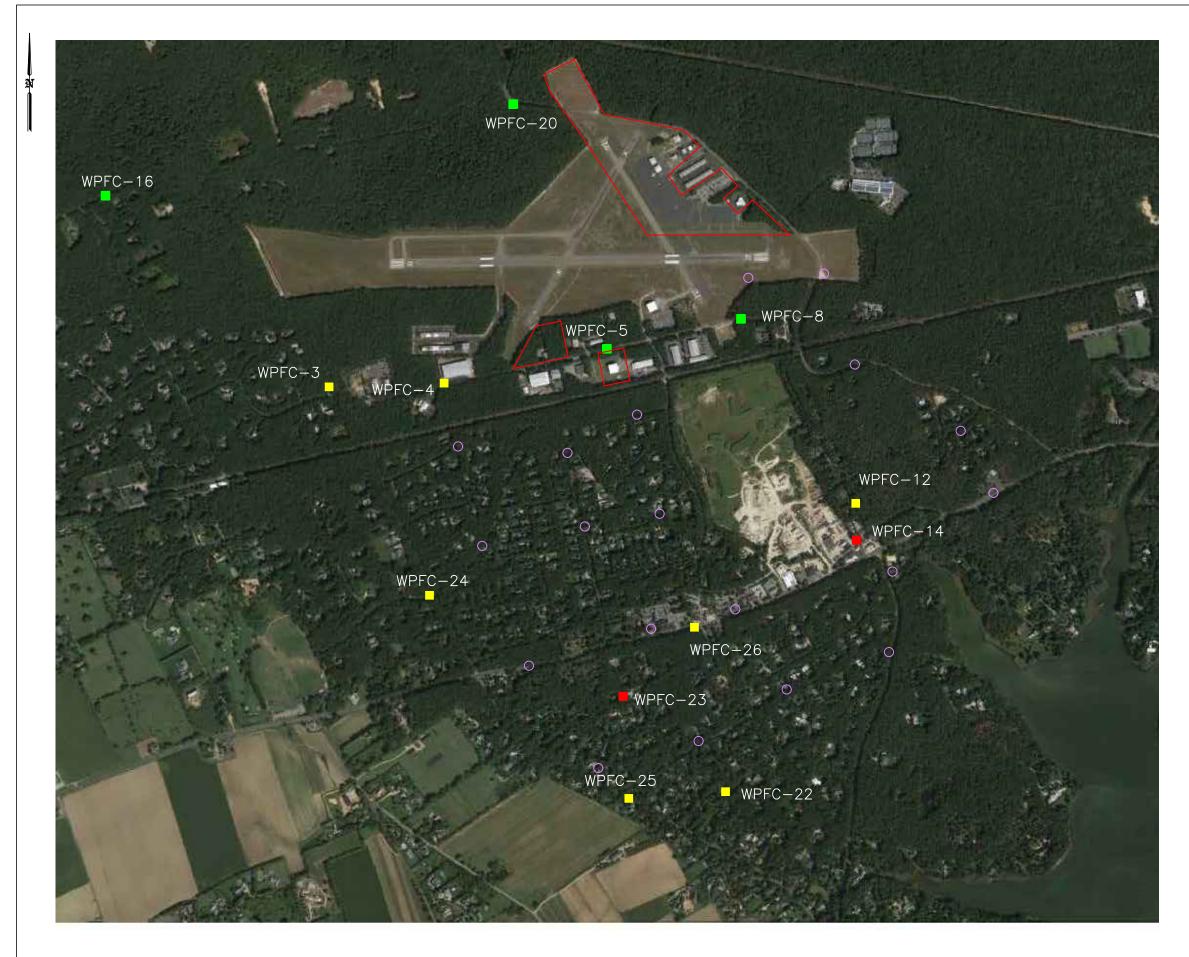
The presently-proposed offsite RI sampling locations are shown on Figure 3.1.3, together with the previous SCDHS vertical profile locations. Note that these proposed locations may be modified, with NYSDEC concurrence, based on a review of the onsite sampling results and

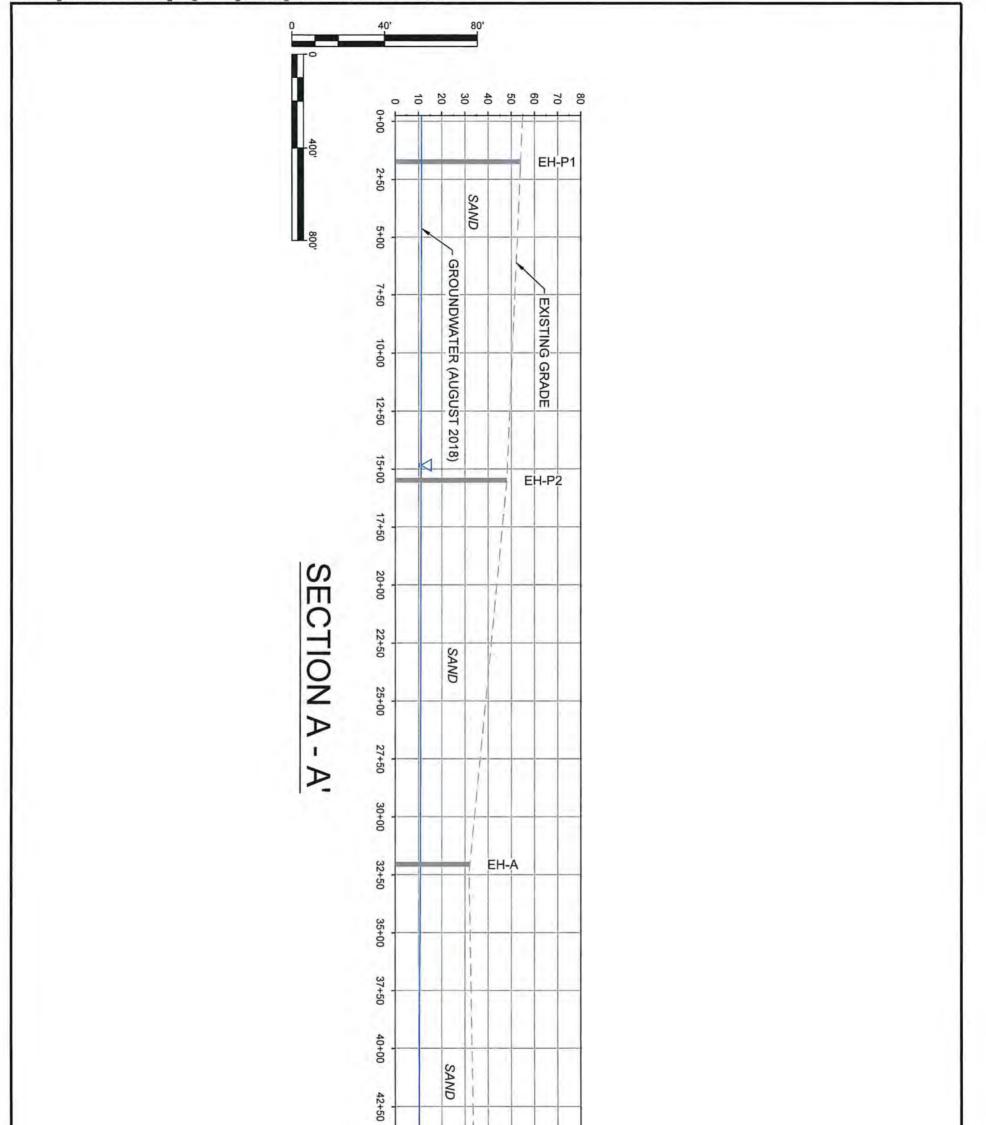
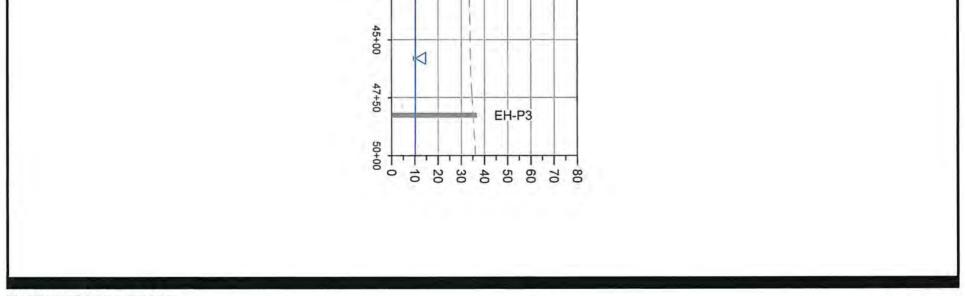
AECOM Figure: 3

New York State Department of Environmental Conservation Wainscott, Suffolk County, New York Project No.: 60566160 Date: September 2018 SECTION A - A'

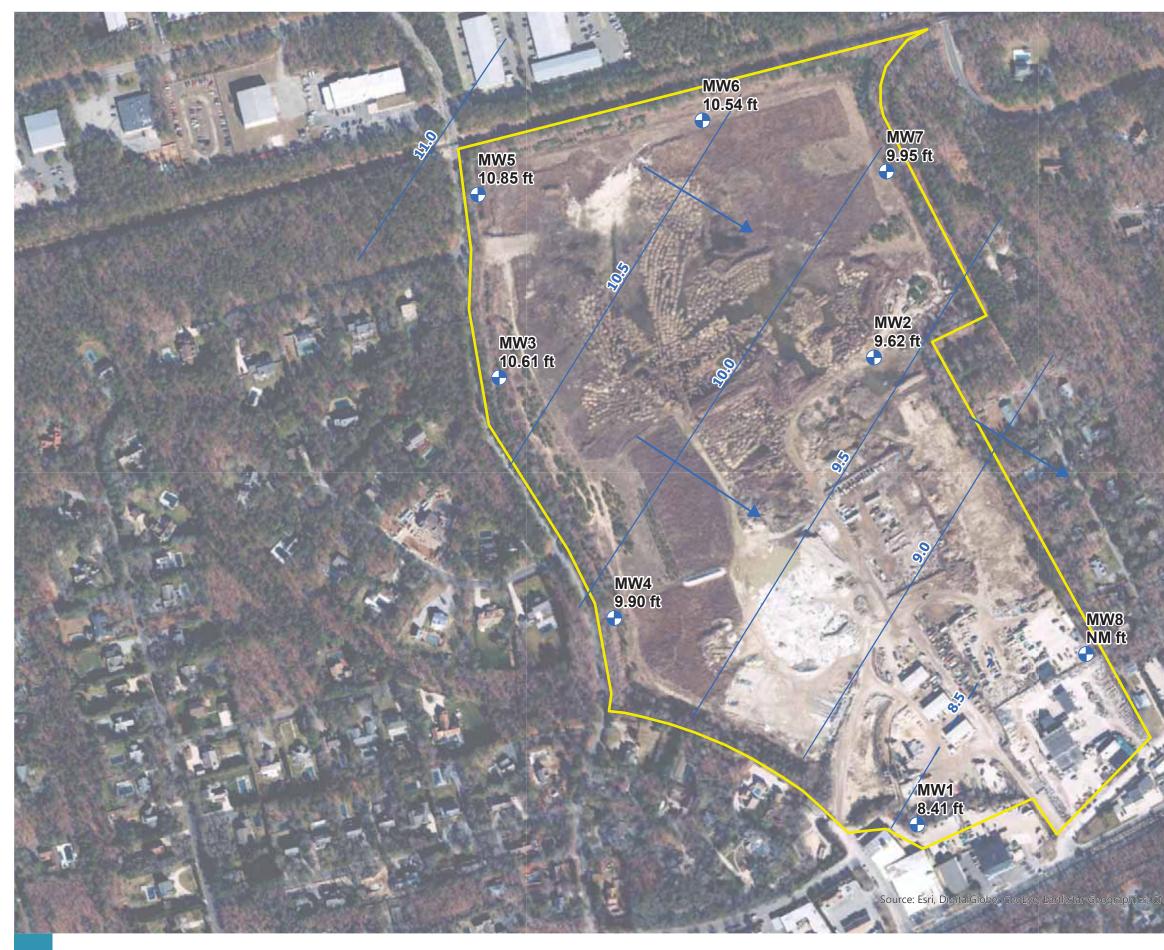
FIGURE 7A

Groundwater Contours
