**HYDROGEOLOGIC ASSESSMENT OF
THE WAINSCOTT COMMERCIAL CENTER
EAST HAMPTON, NEW YORK**

Prepared for
Wainscott Commercial Center, LLC
P.O. Box 1259
Wainscott, New York 11975

November 2018

**Alpha Geoscience
679 Plank Road
Clifton Park, New York 12065**

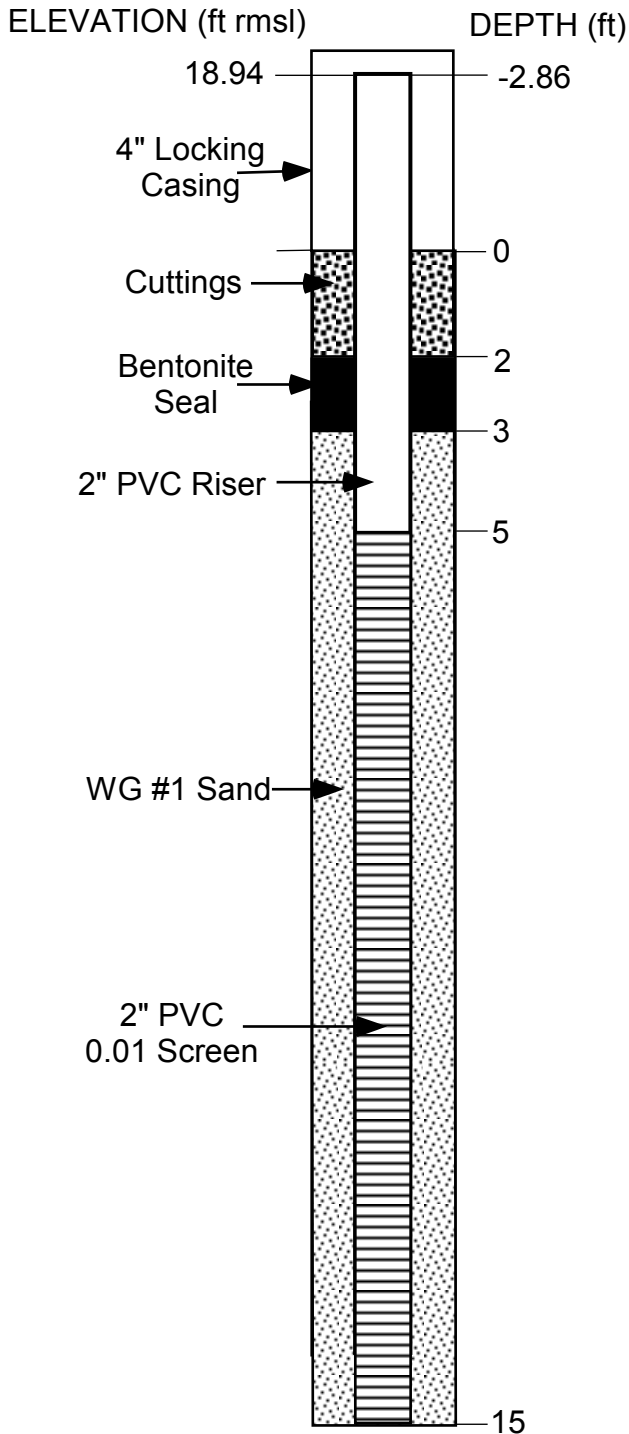
WELL CONSTRUCTION DETAILS

Geologist Steve Trader
 Drilling Contractor Clearwater Drilling
 Type of Well Monitoring Well
 Static Water Level 9.33' Date 6/7/2018
 Measuring Point Top of PVC
 Total Well Depth 15' below grade

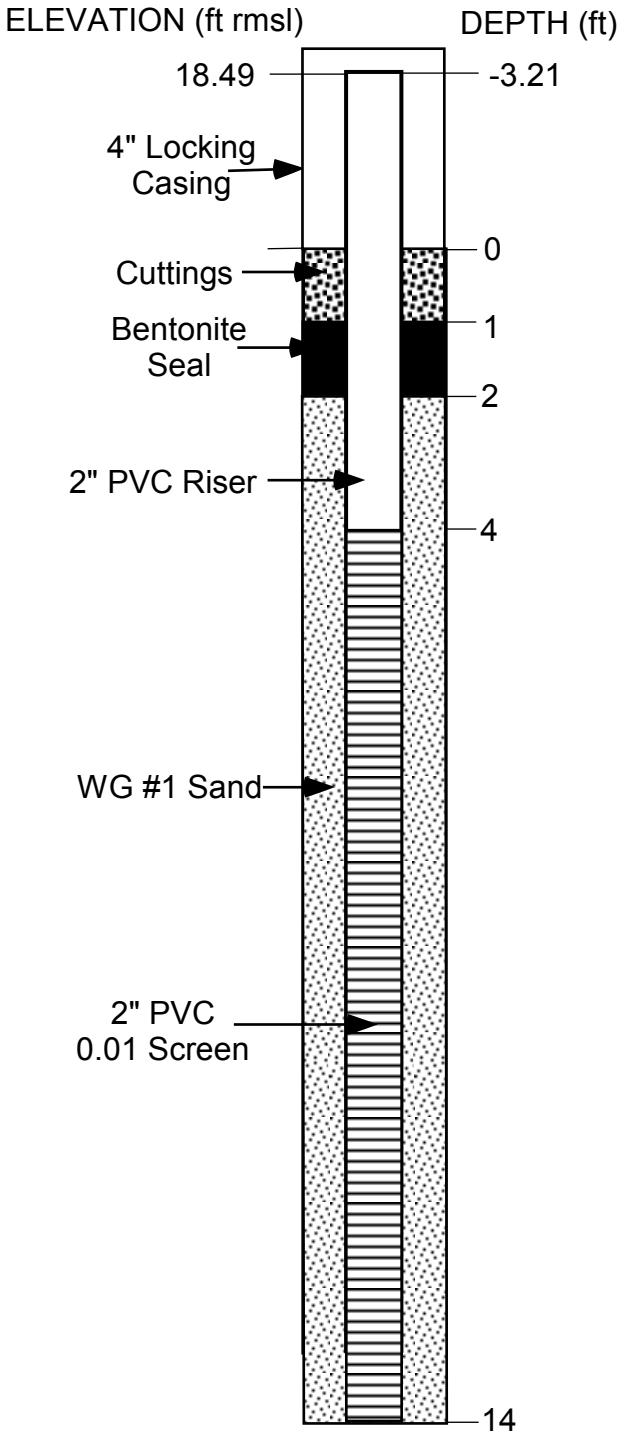
WELL CONSTRUCTION DETAILS

Geologist Steve Trader
 Drilling Contractor Clearwater Drilling
 Type of Well Monitoring Well
 Static Water Level 8.58' Date 6/8/2018
 Measuring Point Top of PVC
 Total Well Depth 14' below grade
