**ENVIRONMENTAL ASSESSMENT OF
THE WAINSCOTT COMMERCIAL CENTER
EAST HAMPTON, NEW YORK**

**Wainscott Commercial Center LLC
P.O. Box 1259
Wainscott, New York 11975**

January 2019

**Samuel Ward Gowan, PhD, PG, CPG
Alpha Geological Services, DPC
679 Plank Road
Clifton Park, New York 12065**

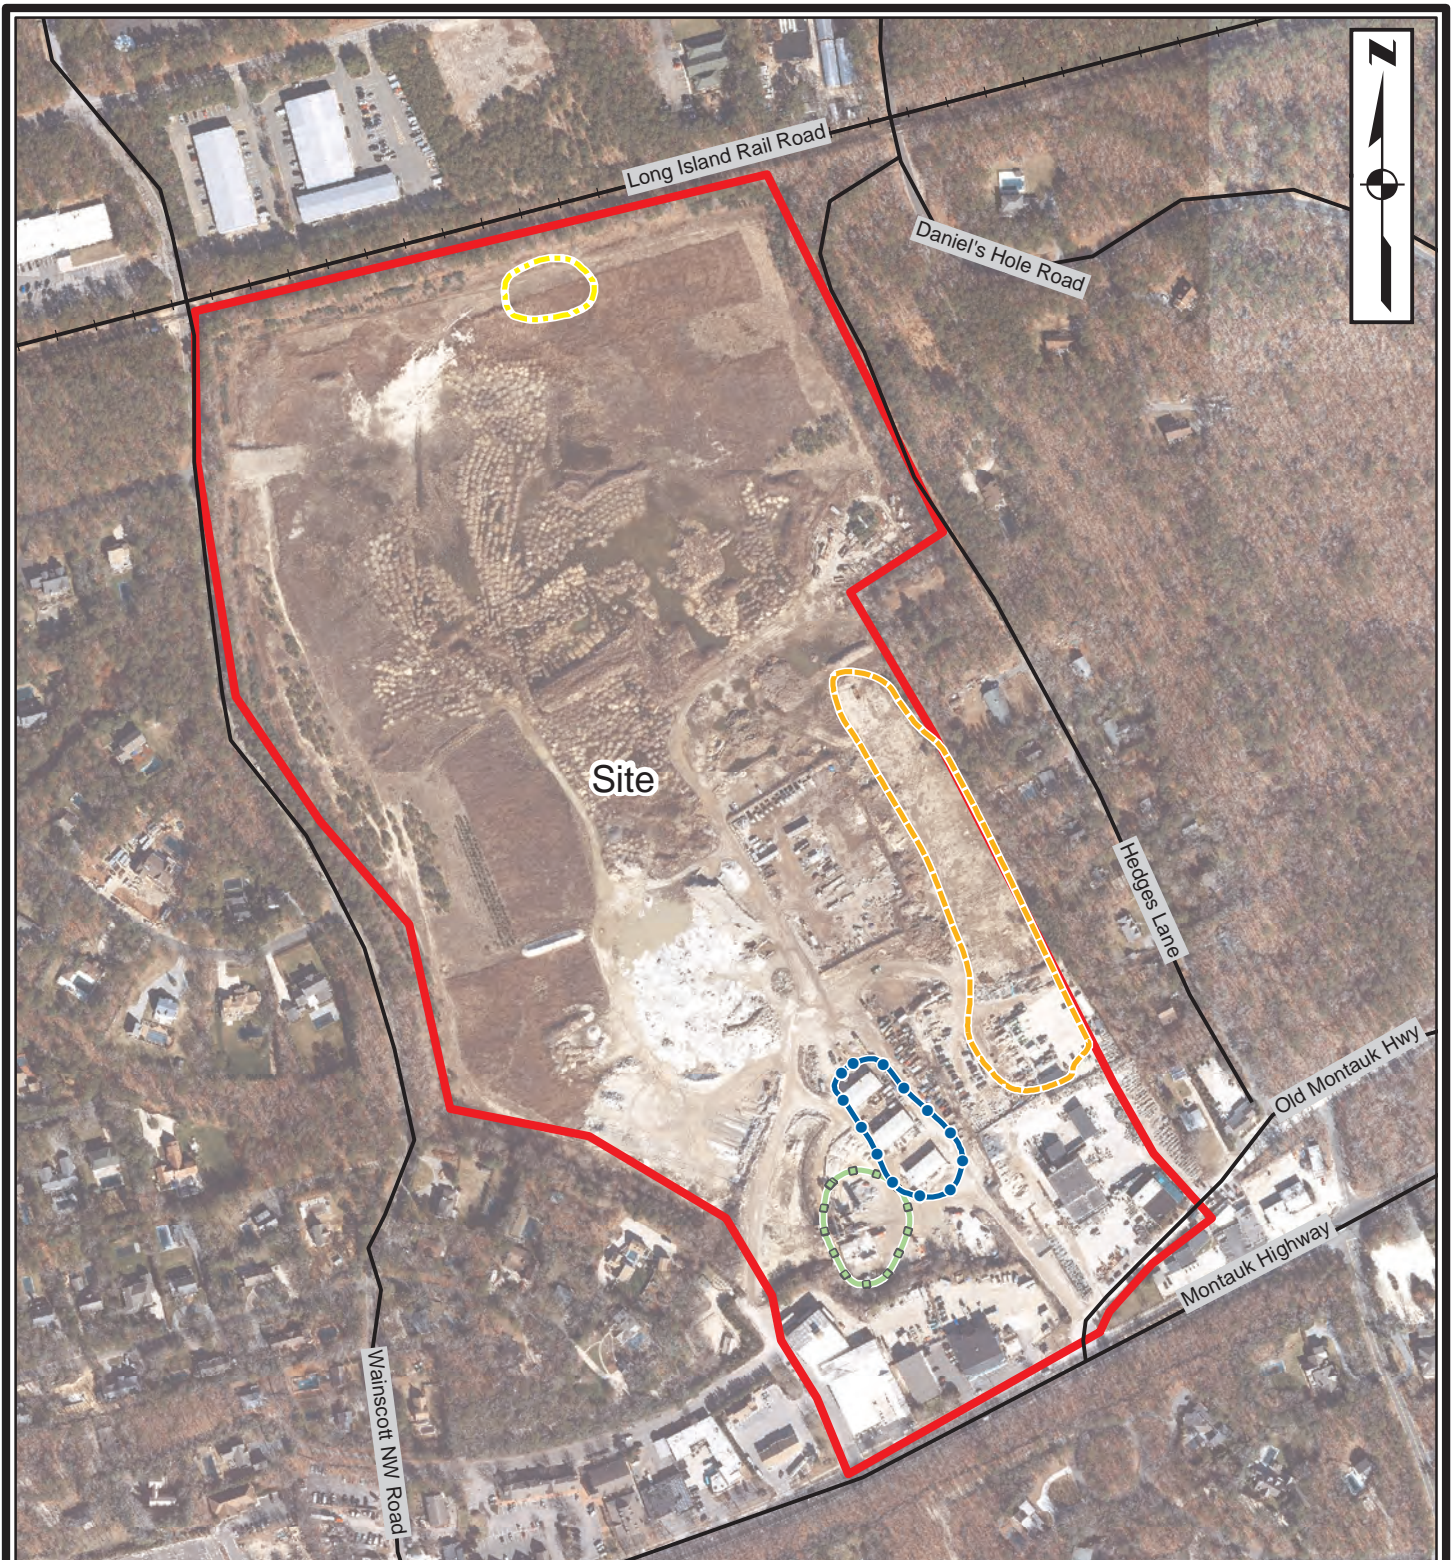
PLATE 2
Depth to Ground Water Below the Land Surface
(Unsaturated Thickness)
12/7/2018 Data

An analysis of the depth to water below the land surface, when ground water was at its highest observed elevation on December 7, 2018, was conducted by comparing a water table contour map with the surface topography. Hydrographs showing that the water levels were at their highest level at the site in December of 2018 are provided on Figure 3. The water table contours were placed on the site topographic map and provided herein as Plate 1. The site topographic map was generated by Fox Land Surveying (Fox) of Westhampton Beach, New York. A copy of the map by Fox is included in Appendix D of the hydrogeologic report (see Appendix B herein). The resulting map of the depth to water is provided as Plate 2.

- ◆ Monitoring Well Location with Depth to Ground Water (DGW) in Feet
- Depth to Ground Water Below the Ground Surface, in Feet
Contour interval is 2 feet. Supplemental 1 foot contours are dashed.

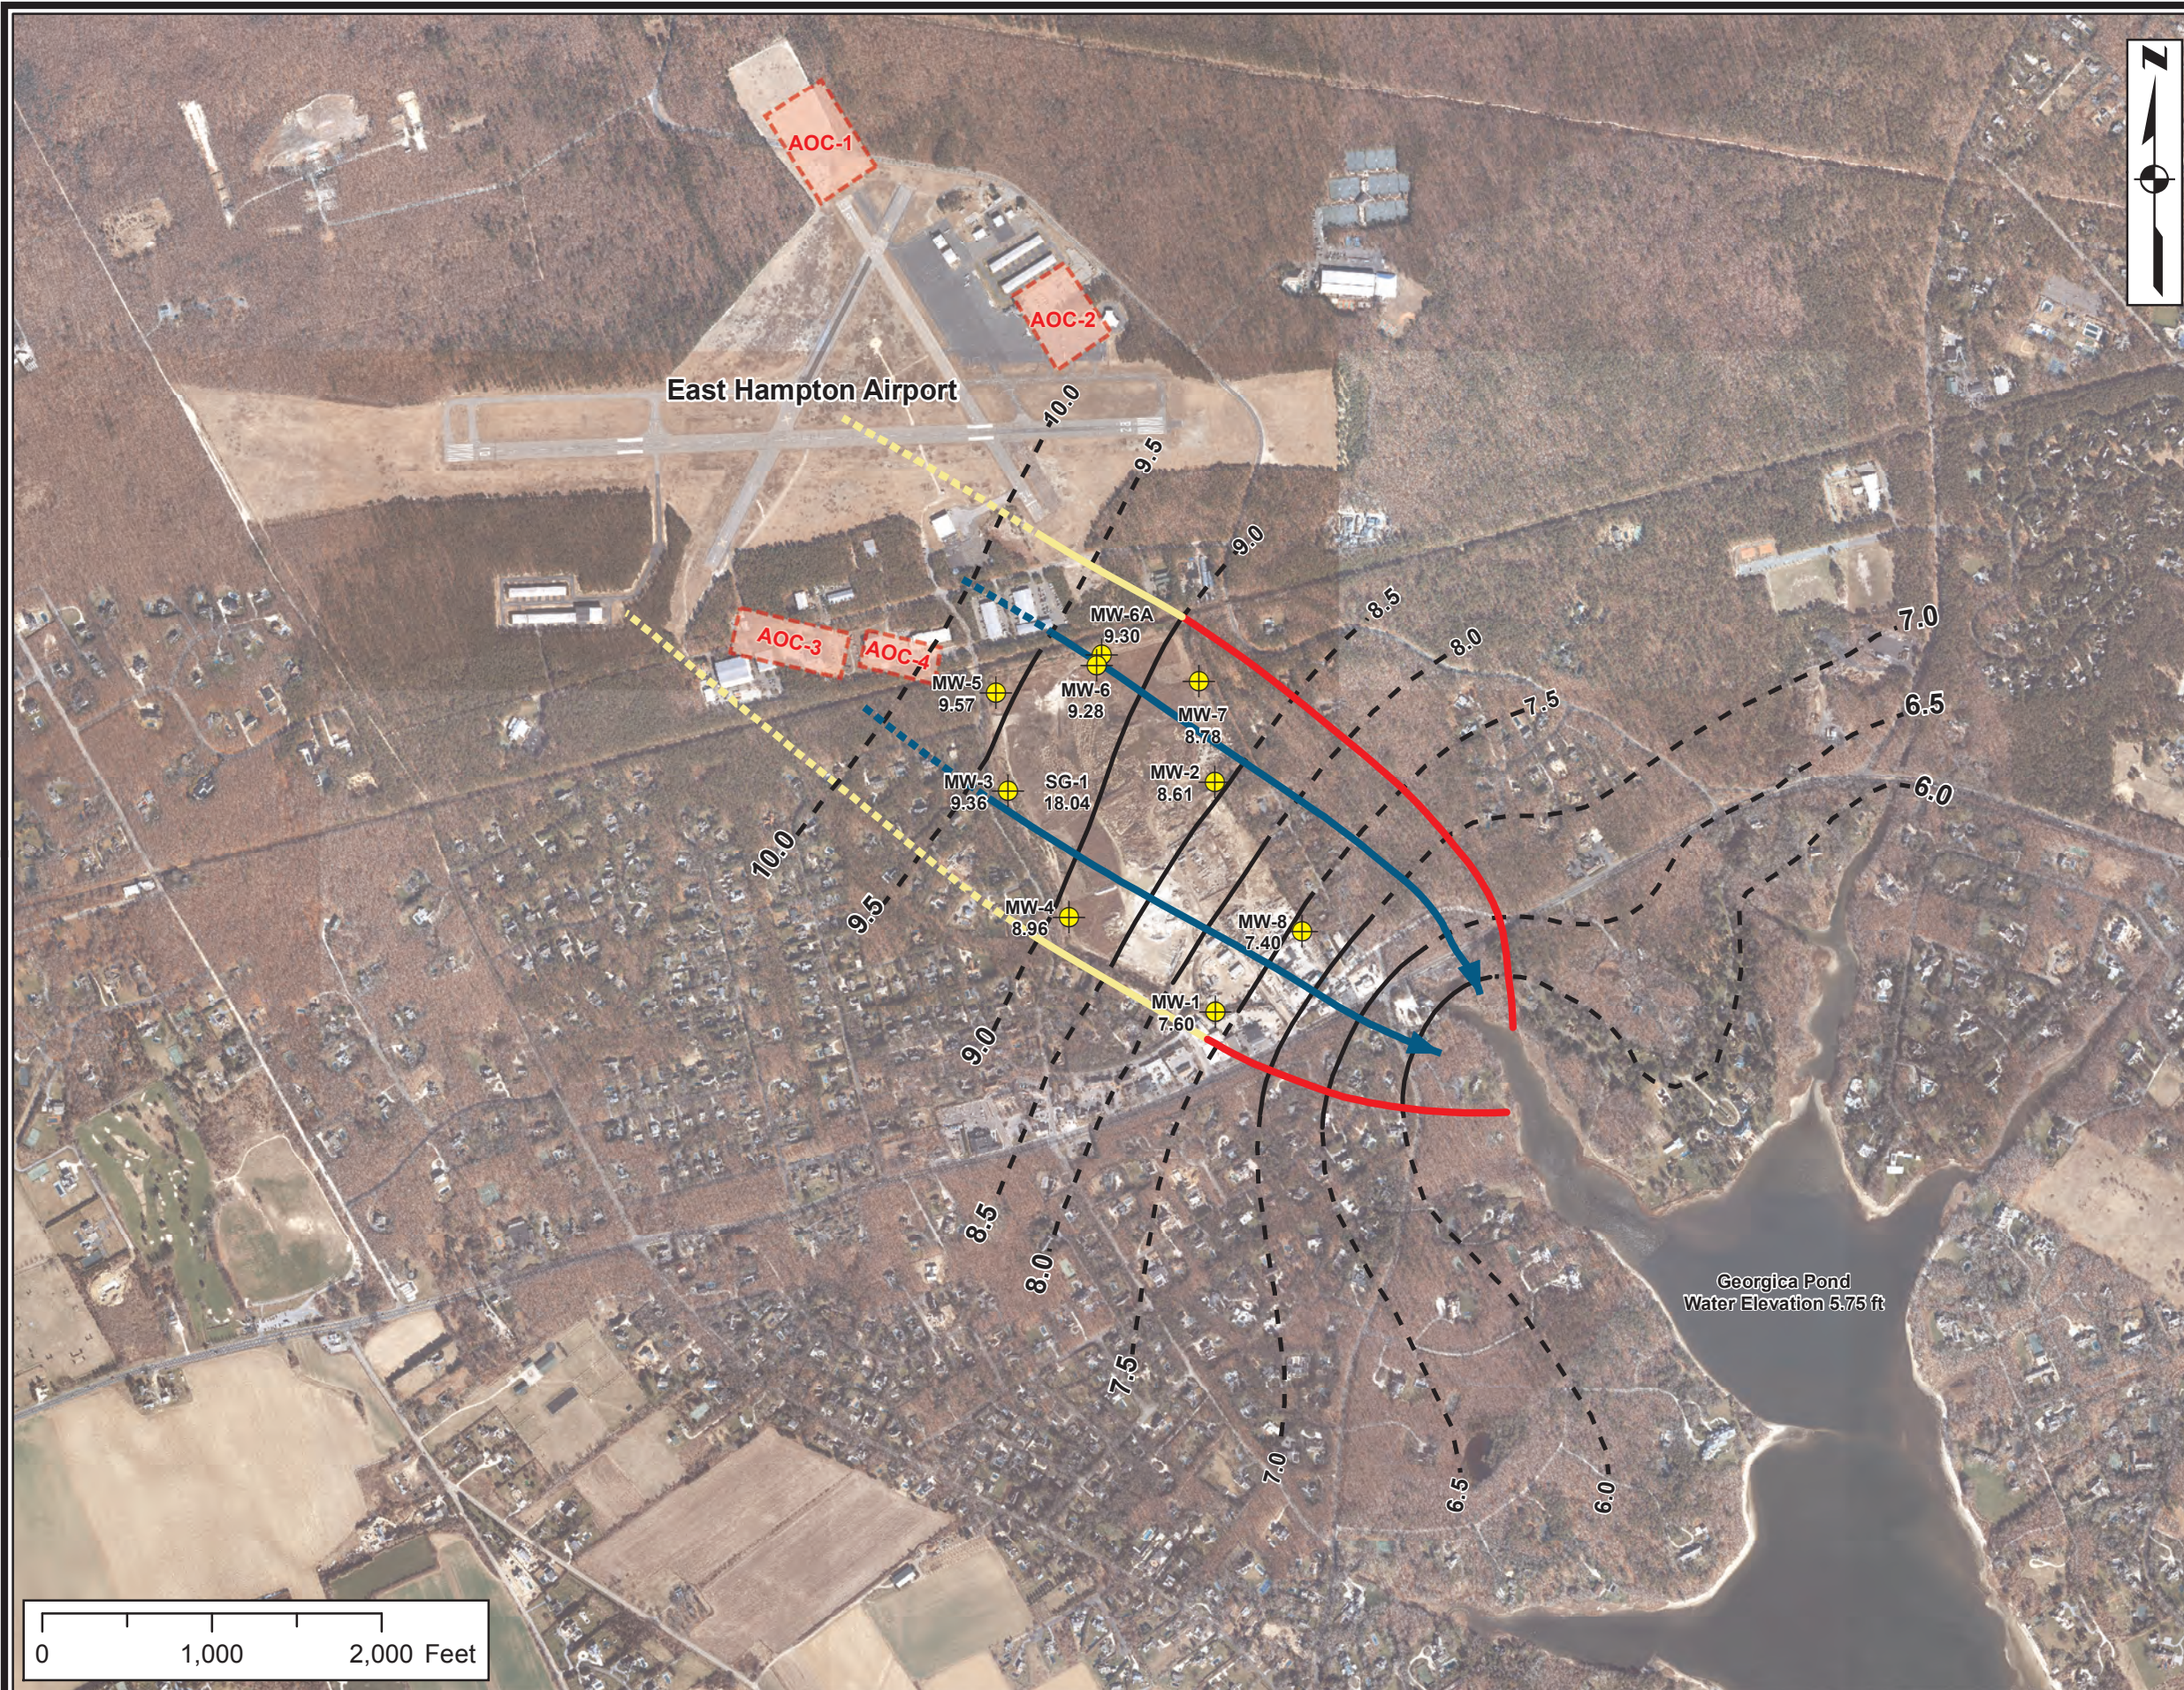
- Monitoring Well with Water Table Elevation in feet
- Ground Water Elevation Contour (dashed where inferred)
- Ground Water Flow Direction
- Boundary of Upgradient Recharge Zone
- Boundary of Down Gradient Area
- Area of Concern for PFOA & PFOS (AECOM, 2018)

The only contaminants of concern found within the ground water at the site are PFOS and PFOA, which were found above the EPA HAL of 70 ppt on both the upgradient and downgradient sides of the site. These results, at a minimum, indicate an upgradient source. The East Hampton Airport and a portion of the East Hampton Industrial Park are directly upgradient and within the recharge zone for ground water passing beneath the site (Figure 6). The NYSDEC contractor, AECOM, found PFOA and PFOS at levels higher than the EPA HAL of 70 ppt (roughly equivalent to 70 nanograms per liter (ng/L) at four locations at the airport (AECOM, 2018). The areas where these compounds were detected above the HALs are provided as areas of concern (AOC) in the AECOM report and are

shown herein on Figure 7. Two of the areas are directly upgradient of the site (AOC-3 and 4, Figure 7). One of these two AOCs (AOC-3) contains the Aircraft Rescue and Firefighting Facility (ARFF) that is located at the East Hampton Airport, and the second AOC (AOC-4) includes the burn (firefighting) training center in the East Hampton Town Industrial Park (AECOM, 2018). The other two AOCs (AOC-1 and 2) are upgradient from the eastern portion of the area of residential well testing by the SCDHS that is provided in Appendix D. These are areas where firefighting foam use was documented by AECOM (2018).

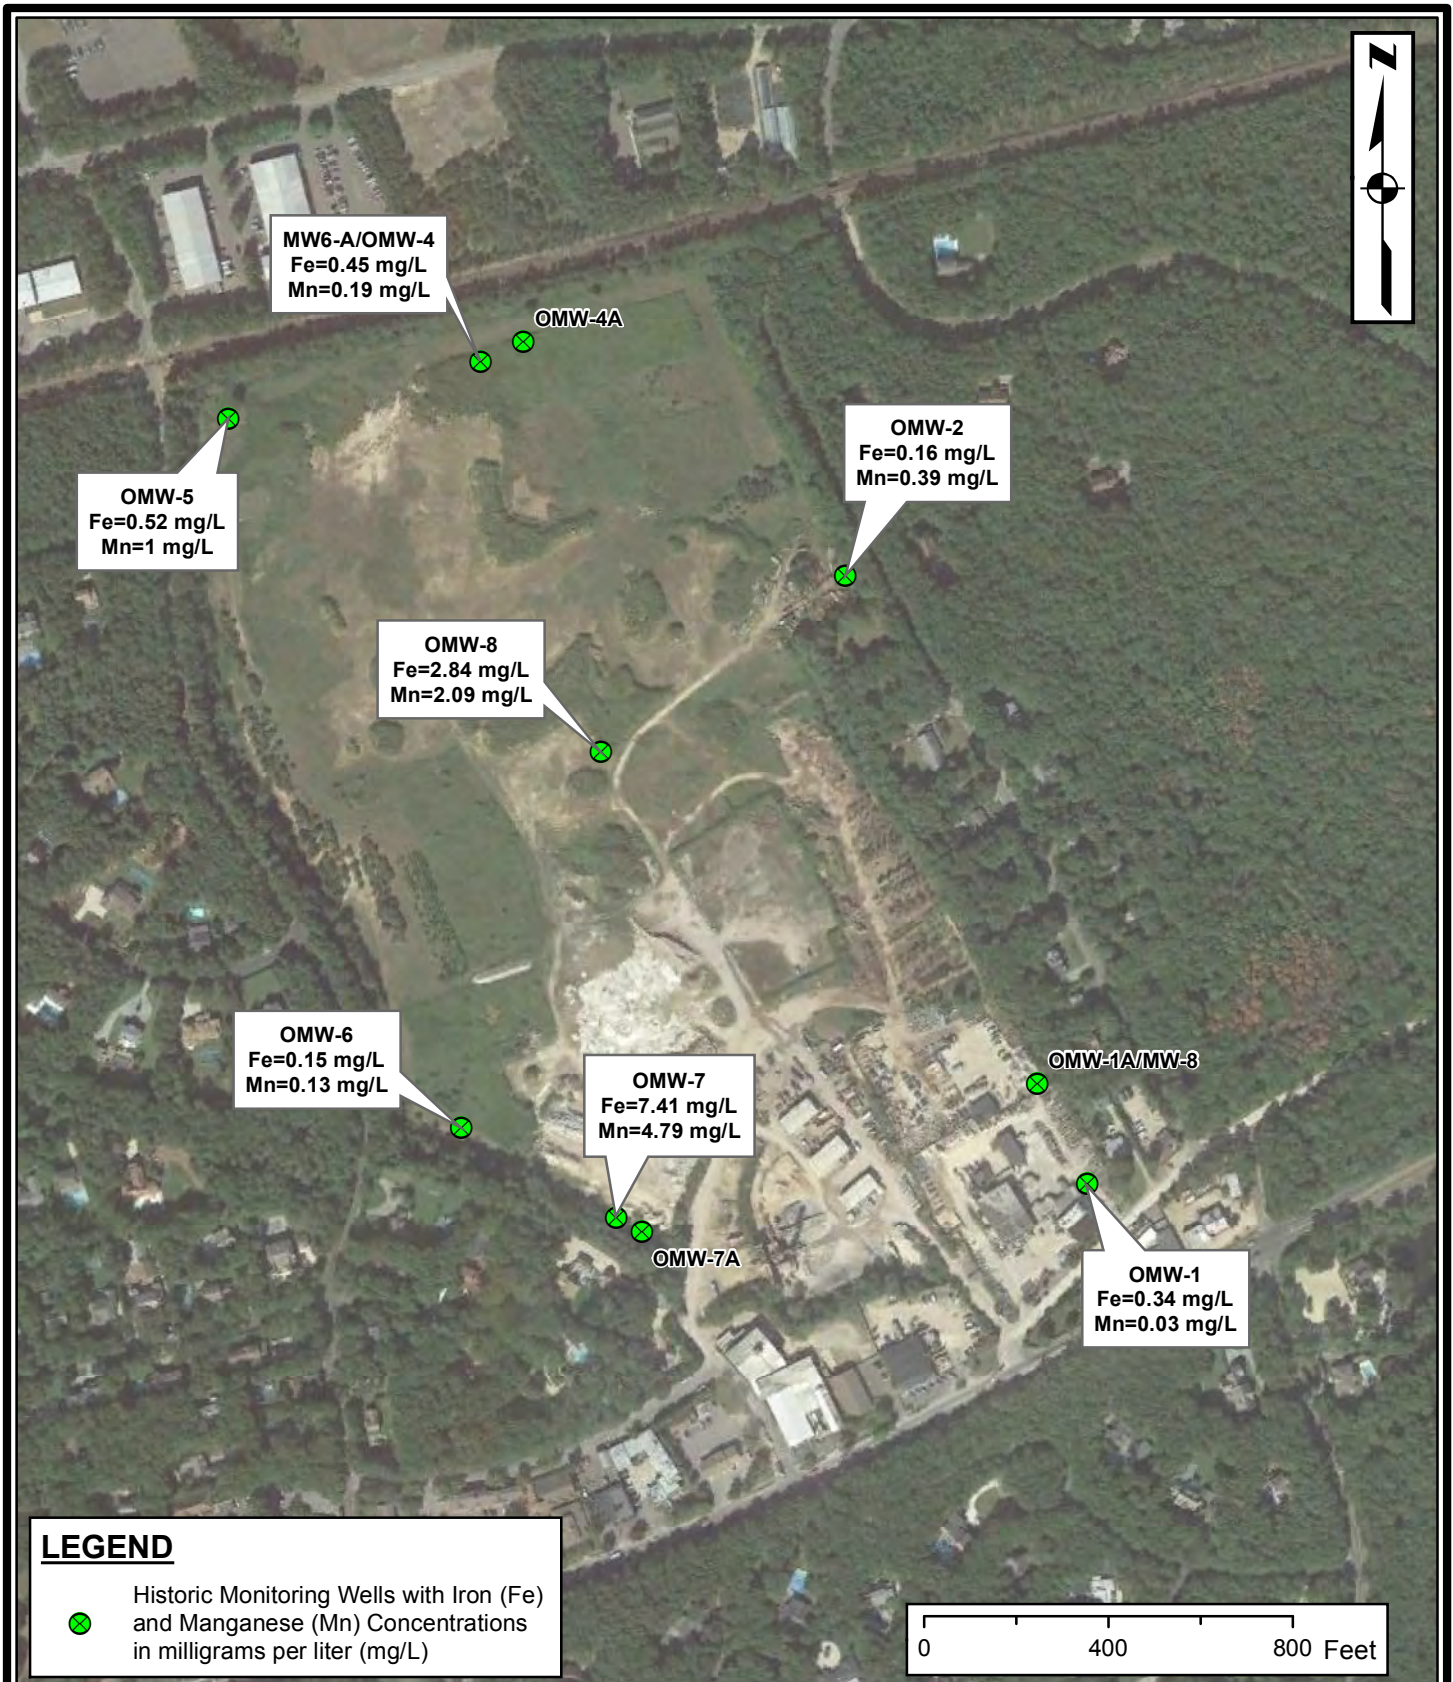
FIGURE 10
 Historic Wells
 With Iron and Manganese
 Concentrations on 12/21/1999

Notes:
 -Basemap: Google Earth Imagery October 1, 2017, accessed September 25, 2018
 -Old Monitoring wells (OMW) located approximately using map by Fox Land Surveying, September 24, 2001
 -Samples taken 12/21/1999

Concentrations of iron and manganese were found in the ground water at levels above the New York State drinking water standards of 0.3 mg/L for each of these metals in both 1999 and 2018 (see Tables 3 and 5 and Figures 10 and 11 in Appendix B). These elevated metals were detected on both the upgradient and downgradient sides of the site in 1999 and primarily on the downgradient side in 2018. Although the iron at the site was close to the averages and within the range of concentrations typically found in Suffolk County Water Supply wells (see Table in Appendix F of Appendix B herein), the manganese concentrations in ground water at the site were slightly higher than the average and the maximums typical for water supply wells in the county. The hydrogeologic investigation results (Appendix B) indicate that at least some, and possibly all, of the elevated iron and manganese is coming from offsite sources upgradient from the site. Regardless, a sampling plan was developed to assess whether the site soils are a potential source. The hydrogeologic results did not identify a particular area of the site; consequently, testing of metals in the soil was conducted throughout the entire site.

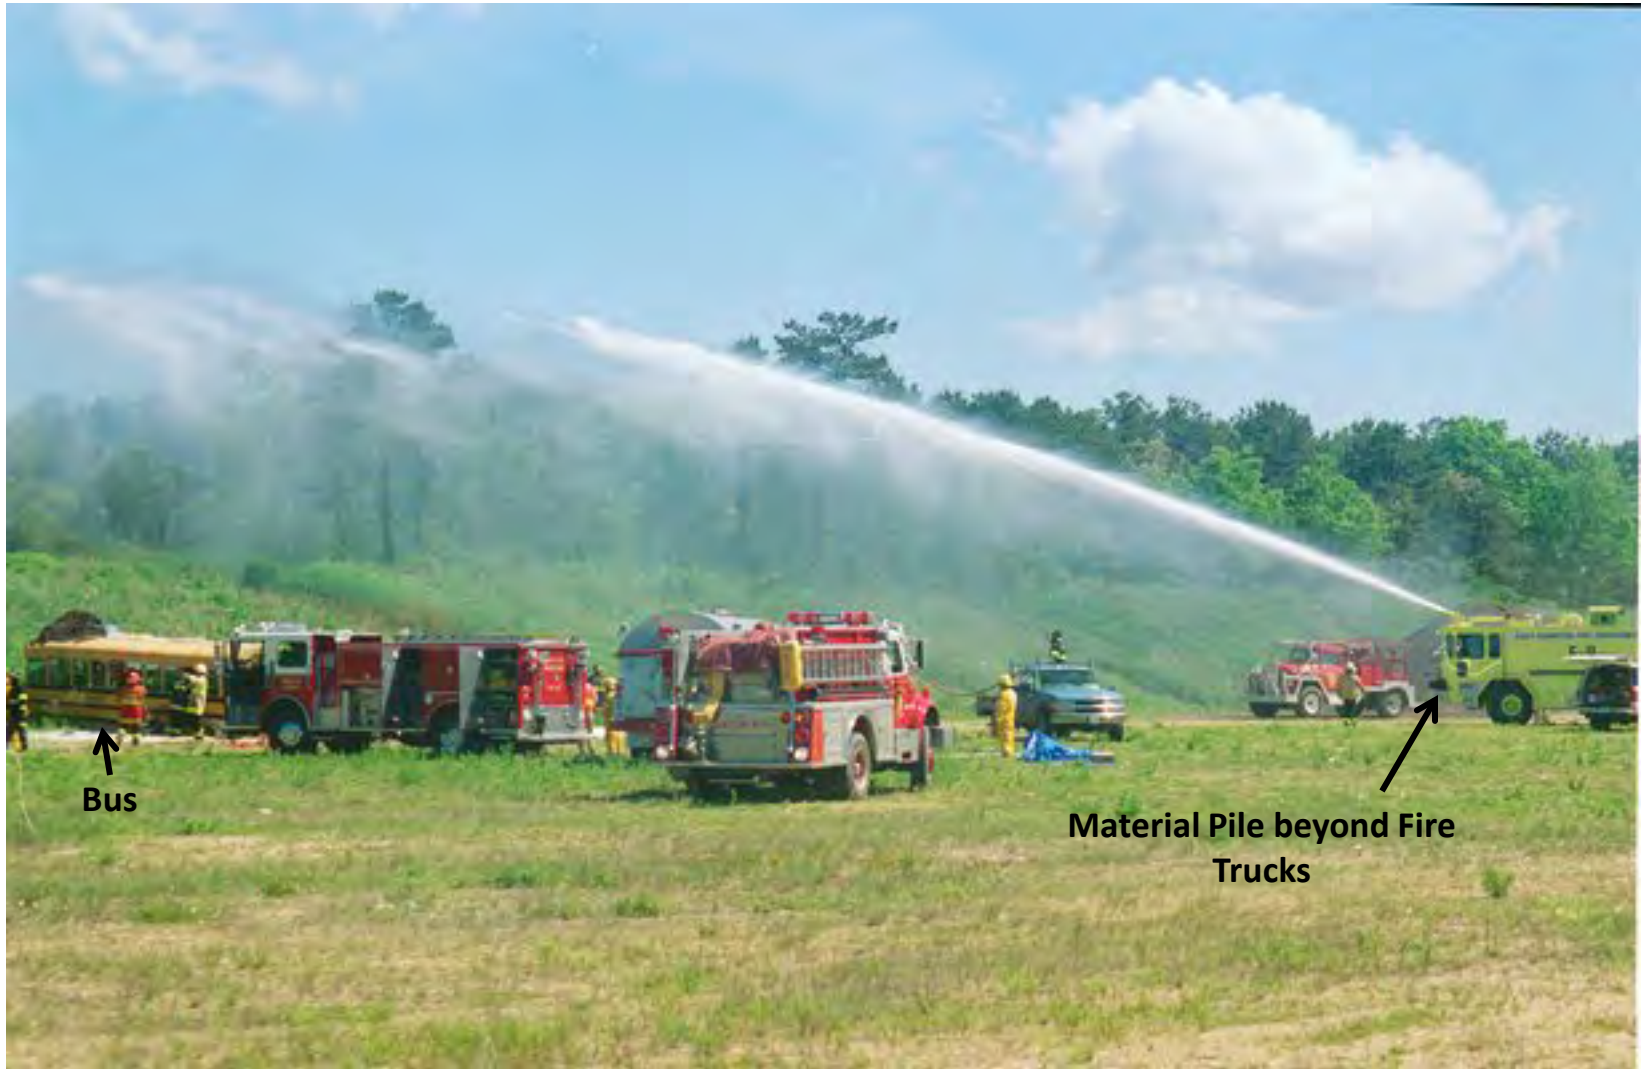
Photograph E-1: June 2000 from Michael Wright, *Homeowner Sues Over Well Contamination*, Southampton Press, March 22, 2018

↑
Bus

↑
Material Pile beyond Fire
Trucks

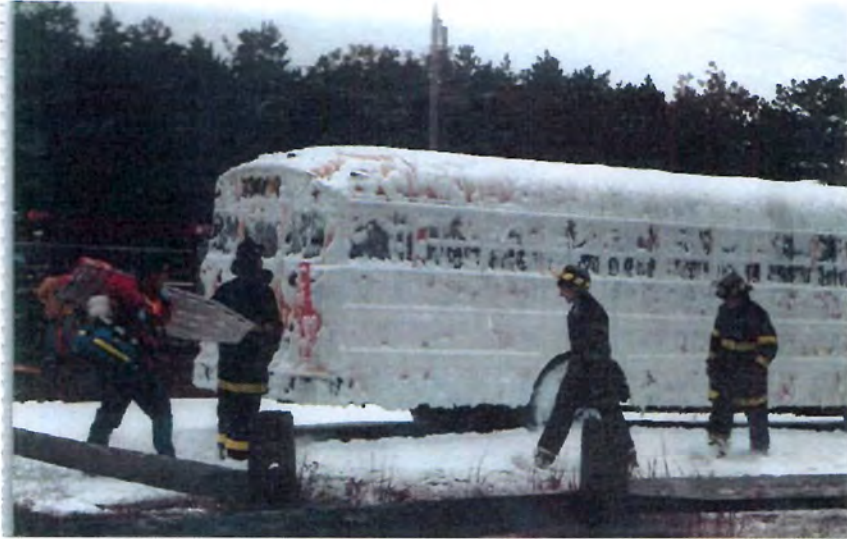
Photo of mass casualty training exercise performed by the local fire department, near well EH-16

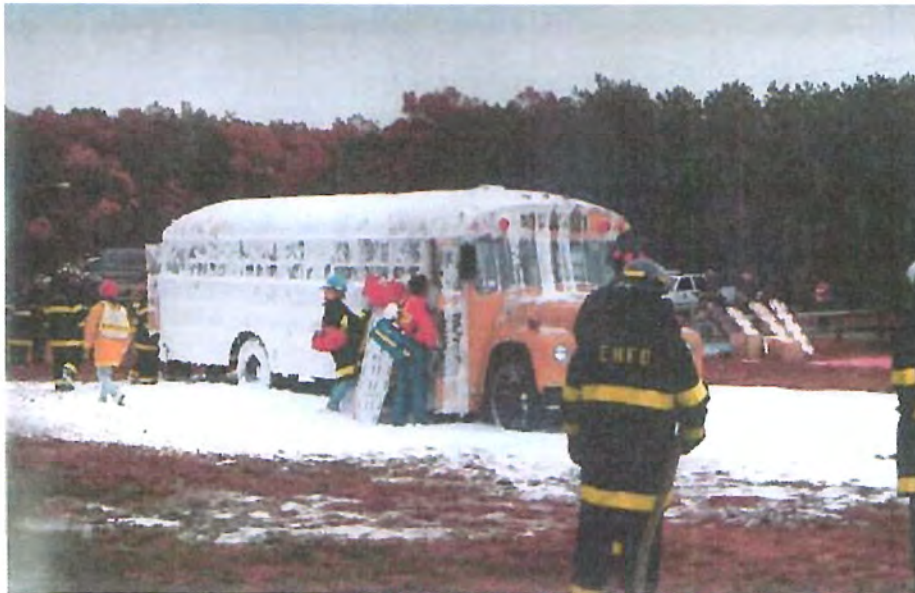
Photo of mass casualty training exercise performed by the local fire department, near well EH-16
