# Groundwater and Soil Investigation at the BOMARC Facility, Westhampton N.Y. In Accordance with Suffolk County Legislative Resolution No. 1065-2018

# **Suffolk County Department of Health Services**

September 2020

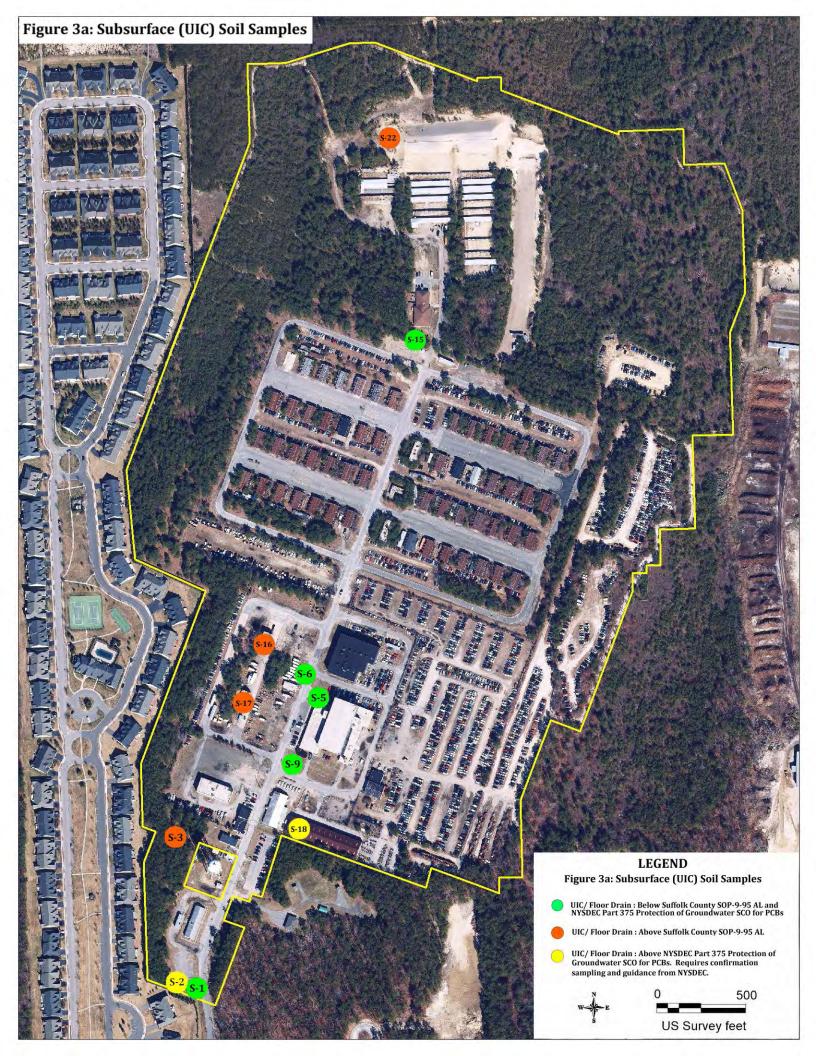
Four of eleven UIC structures sampled had concentrations of VOCs, SVOCs and/or metals that exceeded Suffolk County standard SOP 9-95, indicating that remediation will be required (see Figure 3a for overview of UIC results). Some of the contaminants detected above standards include: benzene, xylene, chrysene, trimethylbenzene, methyl ethyl ketone, cadmium, chromium, barium, copper and lead. It is not uncommon for these contaminants to concentrate in UIC structures, leading to elevated concentrations that require remediation.

Principal contaminants found in the UIC samples above SOP-9-95 cleanup criteria include benzene, xylene, chrysene, trimethylbenzene, methyl ethyl ketone, cadmium, chromium, barium, copper and lead.

The groundwater and soil sampling data was reported to and discussed with the NYSDEC and the New York State Department of Health. Four UIC systems will require remediation under Suffolk County SOP 9-95. Two additional UICs may require remediation due to PCB contamination. Suffolk County will work with the NYSDEC in developing appropriate remedial action due to PCB contamination in many of these UICs.

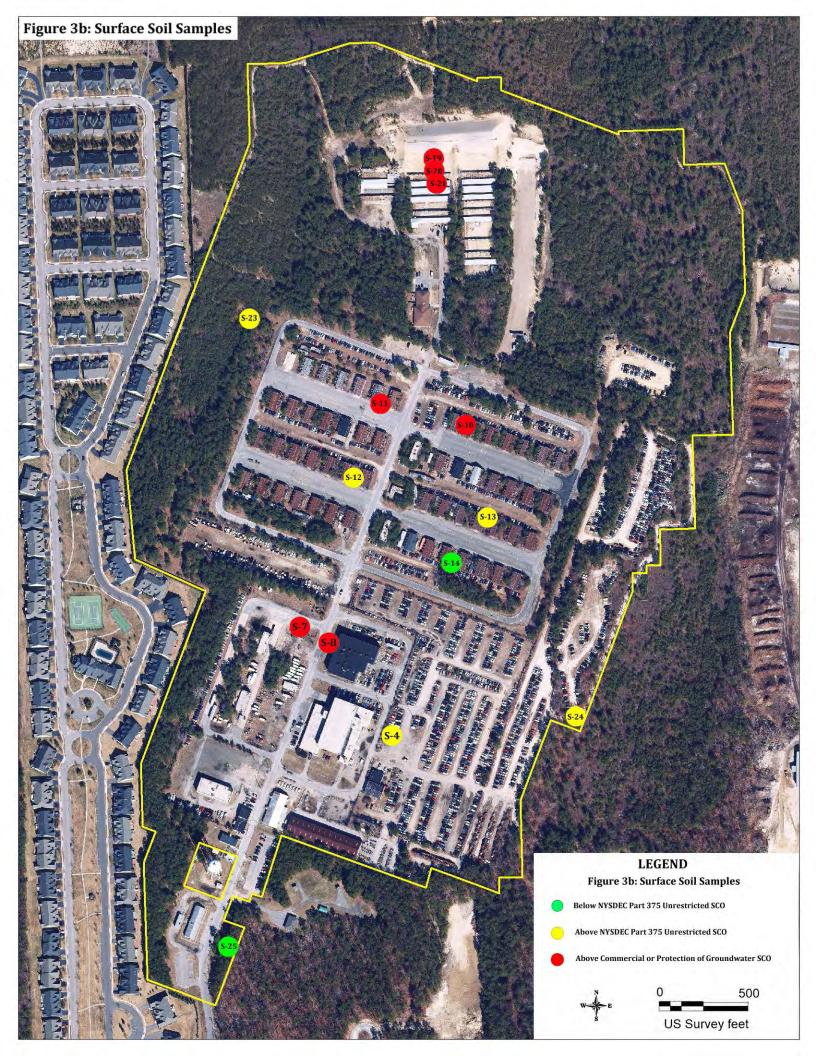
Eight of the fourteen surface soil samples exceeded NYSDEC Unrestricted Use SCOs for VOCs, SVOCs and/or metals (see Figure 3b for overview of surface soil results). Six of those samples also exceeded the Commercial or Protection of Groundwater SCOs, which are possible future remedial goals due to site use and groundwater status. Some of the contaminants detected above the SCOs include: xylene, lead, copper, arsenic, and barium. It should be noted that the sample sites selected were targeted as areas of potential contamination and are not representative of the entire site. Of these six elevated samples, one was an ash sample from the new fireworks burn box, three were soil samples from the shooting range, one was from stained soil adjacent to an aboveground tank, and one was from soil adjacent to a concrete pad suspected of previous hazardous material storage. Elevated concentrations of contaminants in these samples could be expected.

Principal contaminants found in the surface soil samples above Part 375 cleanup criteria include PCBs, lead, xylene, chrysene, barium and arsenic.

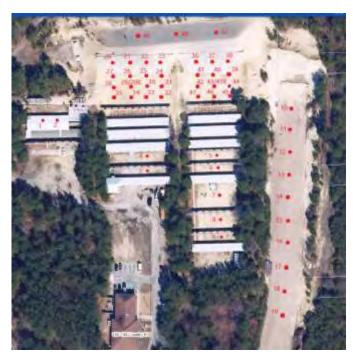
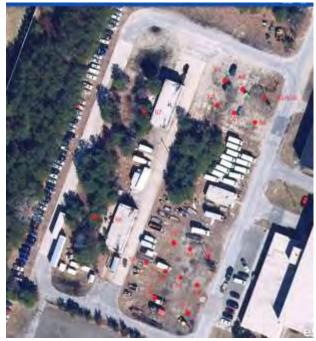
The sampling scope primarily focused on further evaluation of the firing ranges and an area south of the firing range where automobiles were being stored. Seventy samples were obtained from two grids in these areas, and were only analyzed for the presence of PCBs. Three of the seventy samples were obtained at a deeper interval (6-8 inches from surface). Refer to the site figures below for all grid sample locations.

PCB concentrations were generally low or non-detect within the surface grids. The PCB levels detected in the pistol range were significantly lower than those found in the samples taken in the April/May 2019 testing. Results from the initial and supplemental soil sampling are summarized in Table 3, below. The sample IDs have the prefix "S" for the initial sampling round and "SS" for the supplemental sampling round. All positive detections are in red. Analytical laboratory reports for this supplemental sampling effort are included in Appendix E.

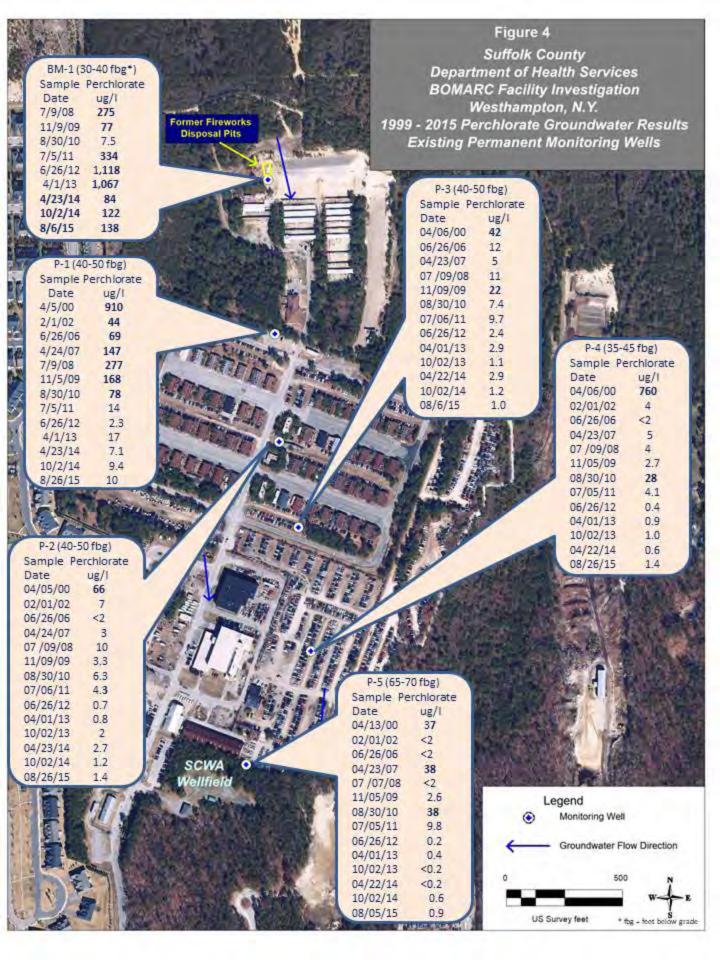
A previous groundwater investigation was initiated at the site in late 1998 due to perchlorate impacts observed in the Suffolk County Water Authority (SCWA) Old Country Road Wellfield located downgradient of the facility. The subsequent groundwater investigation included the installation and sampling of eighteen profile wells at that time. The purpose and scope of this investigation was to determine if a Suffolk County Police fireworks disposal pit located on the northwest side of the police shooting range was the source of the perchlorate contamination observed in the SCWA supply wells. The investigation identified a perchlorate groundwater plume on the site, initiating from the fireworks disposal pit. A south to slightly southeast groundwater flow direction was determined to exist on the site, generally travelling from the fireworks disposal area toward the SCWA wellfield. A treatment system was installed at the SCWA wellfield to remove the perchlorate. Six monitoring wells were sampled for perchlorate annually or bi-annually until 2015. The perchlorate concentrations in these wells exhibited considerable fluctuations during the monitoring period, particularly in the well located nearest to the fireworks disposal pit, BM-1 (Figure 4).

In order to obtain PFAS information from the groundwater at the BOMARC facility, the six existing monitoring wells discussed above as part of the 1998-perchlorate investigation were sampled for PFAS in early 2018. Although the locations and depths of these wells were ideally situated to monitor impacts from the fireworks disposal pit located to the west of the police shooting range, data obtained from these wells, although limited, were used to provide some quickly attainable information with respect to PFAS concentrations on a portion of the site. The PFOS and PFOA results of the 2018 sampling effort indicated that PFOS and PFOA were detected in all six of the monitoring wells sampled (Figure 5). Two samples exhibited concentrations in excess of the recently adopted NYSDOH MCL of 10 ng/l individually for PFOS and PFOA: BM-1 - PFOS 13.5 ng/l; and P-4-PFOA 10.4 ng/l. BM-1 is located next to the former fireworks disposal pit, and P-4 is located within the vehicle impound yard.

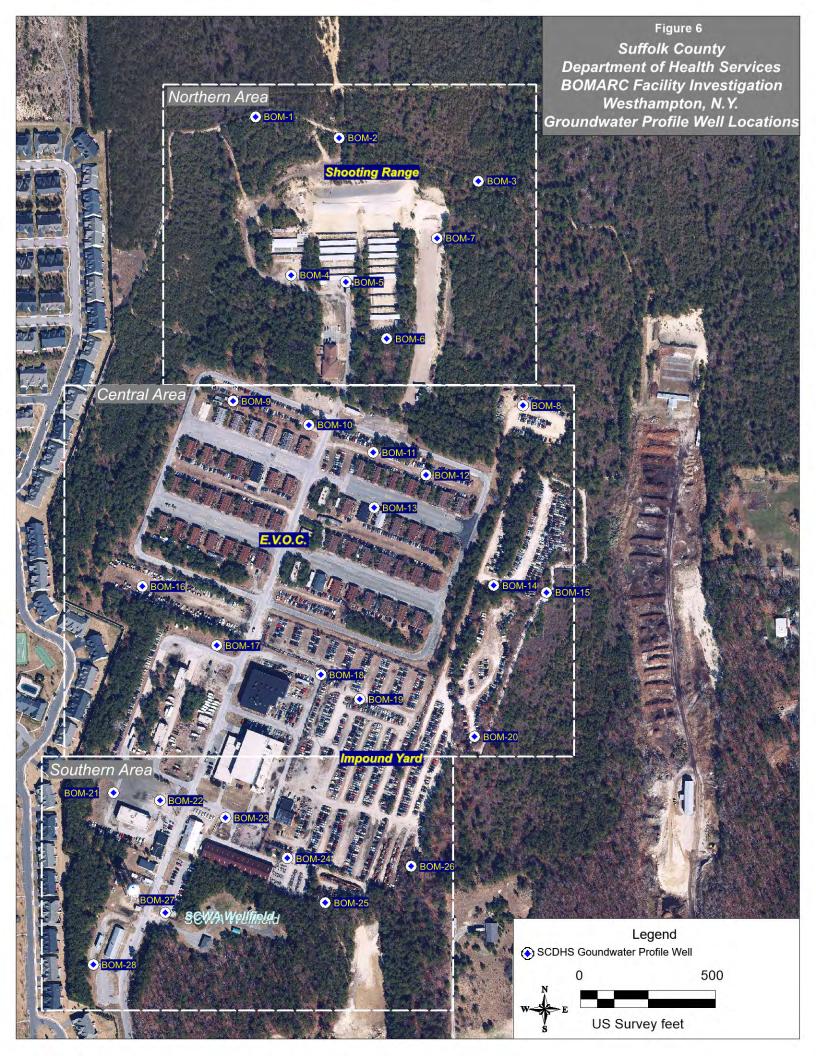
This groundwater investigation was designed to provide an initial snapshot of the overall quality of the groundwater at the BOMARC site. The site is a relatively large site, with approximately 100 acres of area in current use. The site also has a long history of different uses that may have resulted in historic impacts to the groundwater. Currently there are three primary site uses: the police shooting range, located on the northern portion of the site; the emergency vehicle obstacle course (EVOC) which is located generally in the center of the site; and an Impound Yard which is primarily located in the southern portion of the site, however there are also many vehicles stored in the central portion of the site as well. The profile wells were arranged in five generalized east-west transects running from the north to the south of the site (Figure 6). To the extent practicable, the transects were oriented perpendicular to the south-southeast groundwater flow direction which was observed in the 1998 perchlorate investigation. It should be noted that all of the wells are not located along straight line transects because of necessary siting adjustments due to

localized constraints. Wells were also located upgradient or downgradient of specific site uses and/or potential contamination source areas (e.g., well BOM-13 was located downgradient of the current fireworks disposal area).

Two transects were located in the Northern Area which consists of the police shooting range. The most northern transect (wells BOM-1, BOM-2 and BOM-3) is located north of the shooting range and was placed upgradient of the currently active portion of the site. The second transect in this area (BOM-4, BOM-5 and BOM-6) is located downgradient of the police shooting range. Two transects were located in the Central Area of the site that contains the EVOC area and portions of the Vehicle Impound Yard. BOM-9 through BOM-13 are located on the northern portion of the EVOC area, downgradient of the police shooting range, and BOM-16 through BOM-20 are located within the northern portion of the main Vehicle Impound Yard, downgradient of the EVOC area. A final transect consisting of wells BOM-21 through BOM-26 is generally located on the southern portion of the active site. BOM-8, BOM-14, BOM-15 and BOM-20 are located on the eastern portion of the site in an area that contains impounded vehicles separated from the main portions of the site. BOM-27 is located in close proximity to the SCWA Old Country Road Wellfield at the southern end of the site, and BOM-28 is the southernmost well located on the western side of the site. Figure 7 illustrates the locations of the wells on the 1962 aerial photograph, in order to provide context to the well locations relative to the active areas when the missile base was in operation.

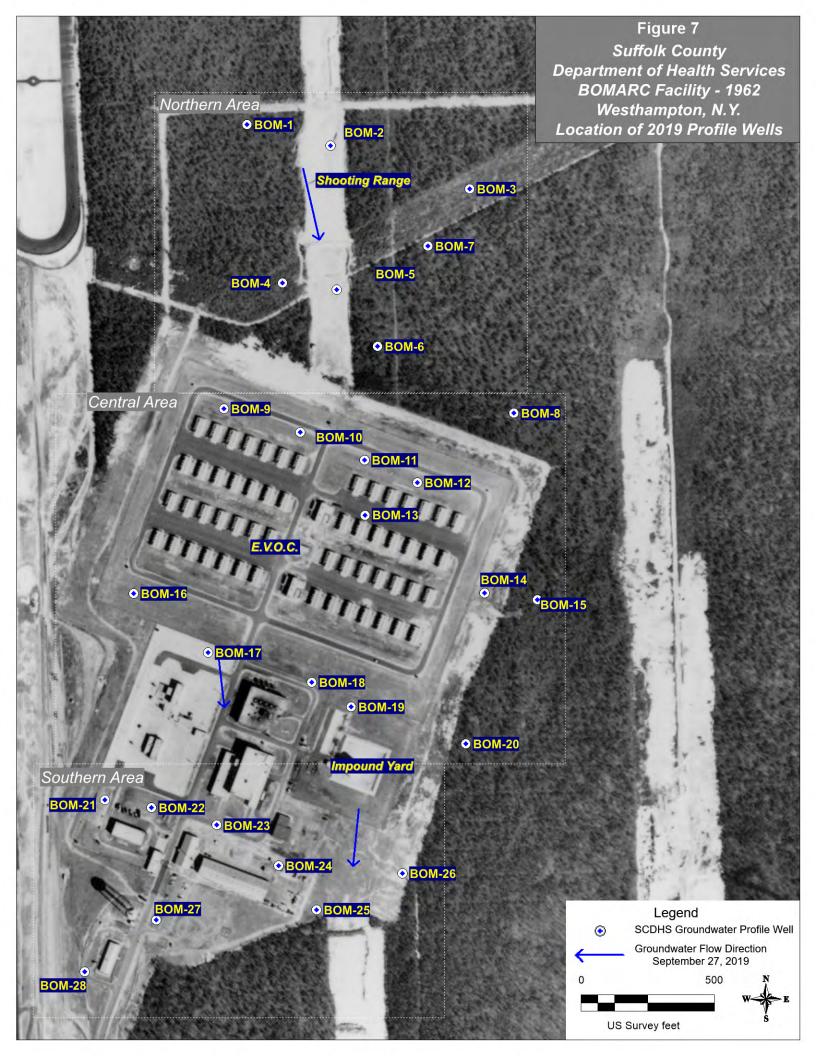
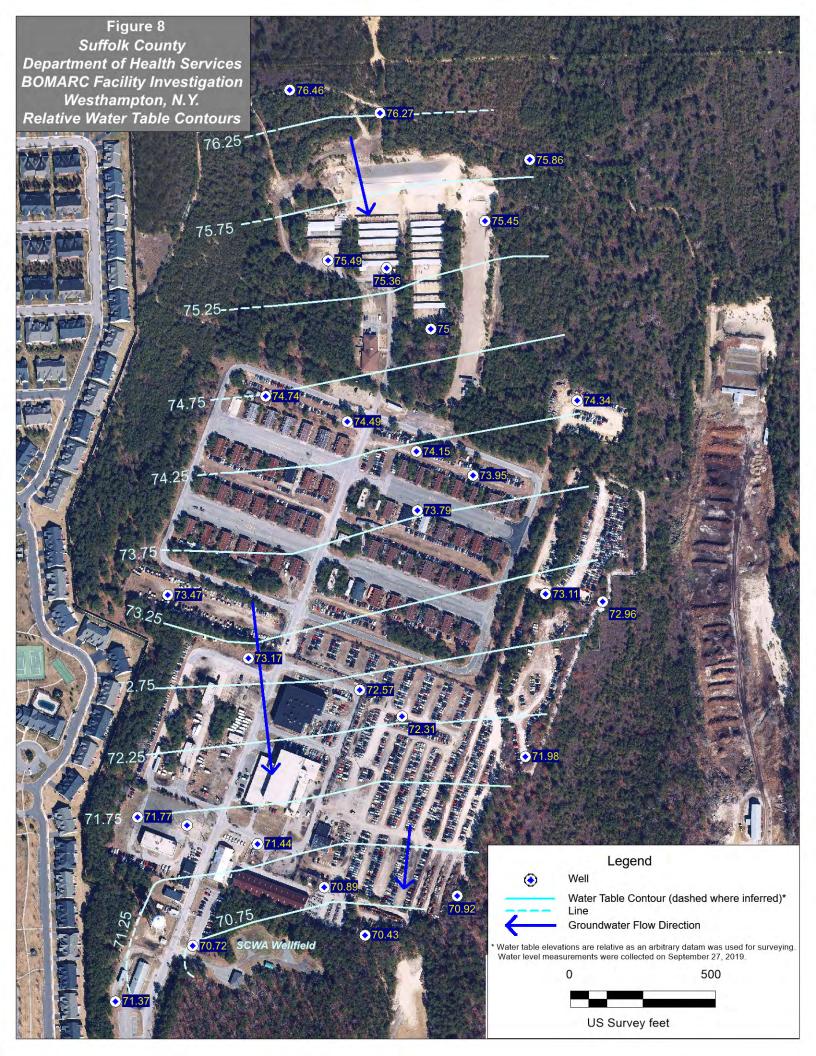
In order to determine an updated site-specific groundwater flow direction, 27 of the 28 wells installed were surveyed to a relative benchmark, and groundwater level measurements were collected. The tops of the well casings were surveyed as measuring points after profiling and sampling of the wells was completed, with the wells screened near the top of the water table. Sufficient time was allowed for the wells to equilibrate since the last well was sampled in July. Water level measurements were recorded on September 27, 2019, and

The water level measurement data was used to calculate relative water table elevation heights observed in each of the wells. This information was used to construct groundwater table elevation contours (Figure 8). Groundwater flows perpendicular to the water table elevation contours.

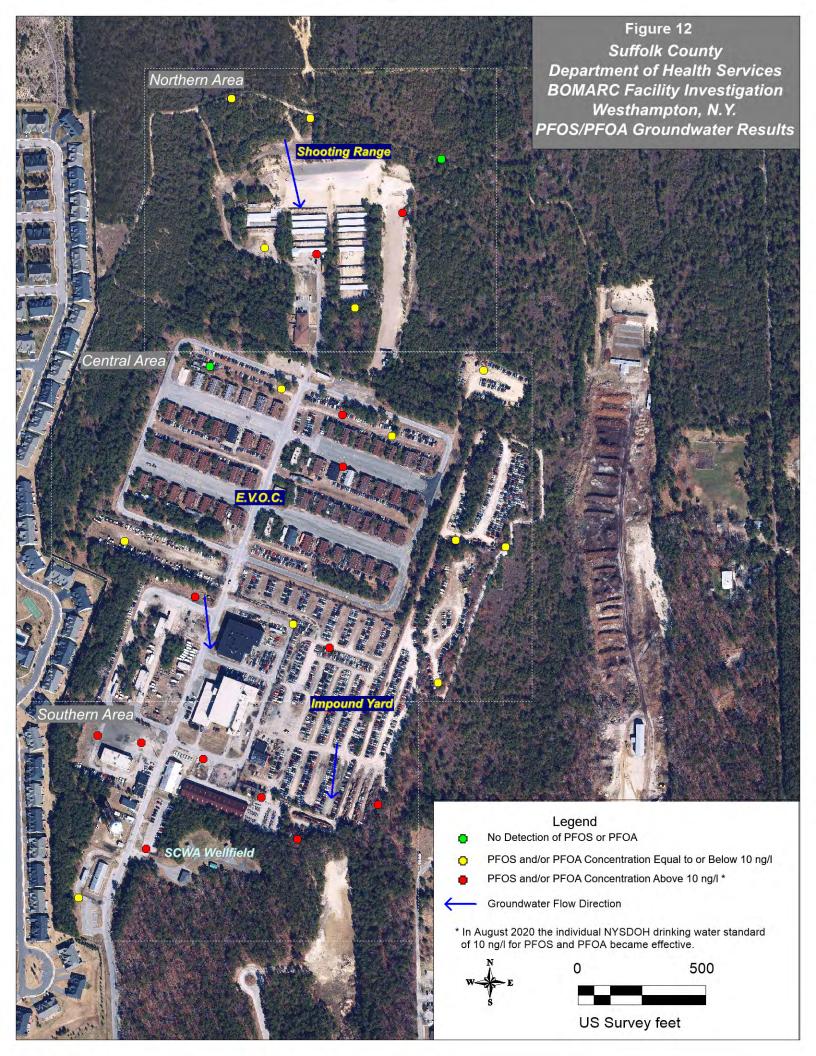
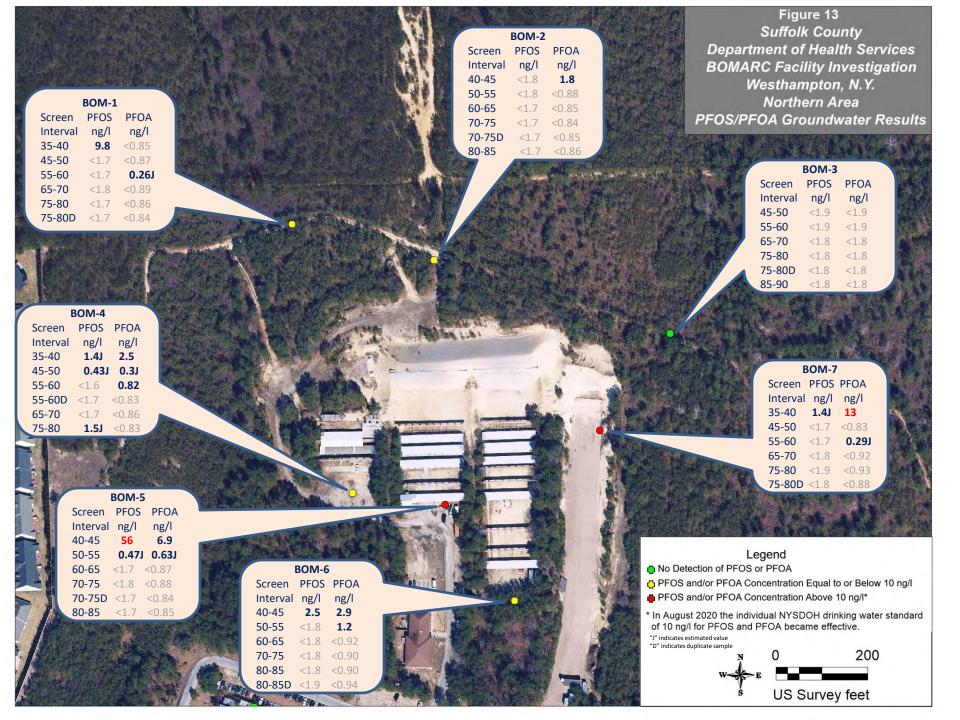
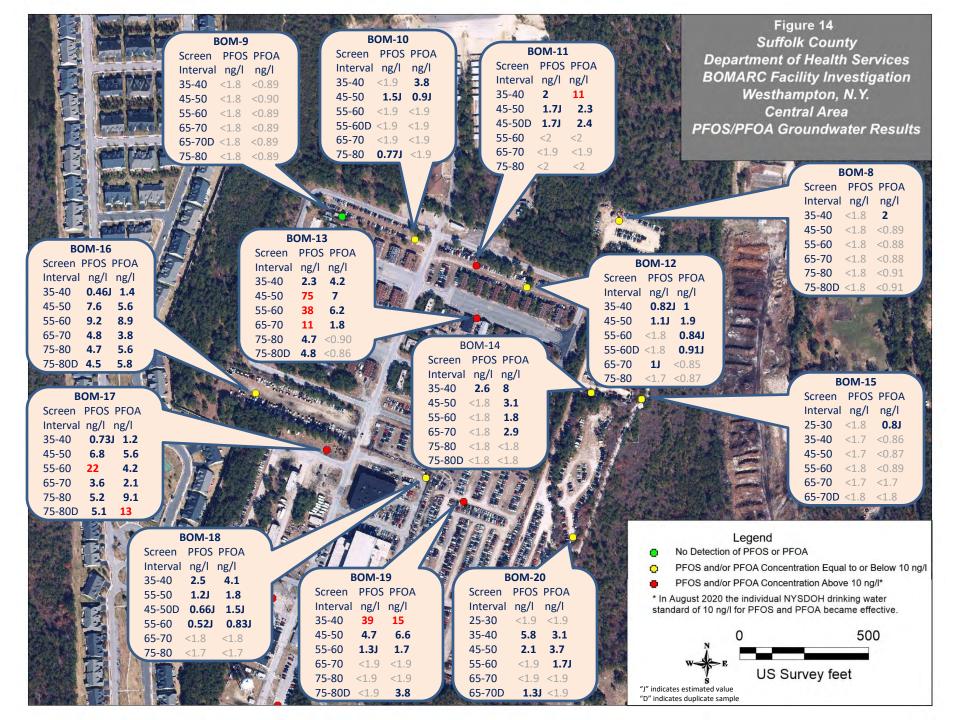
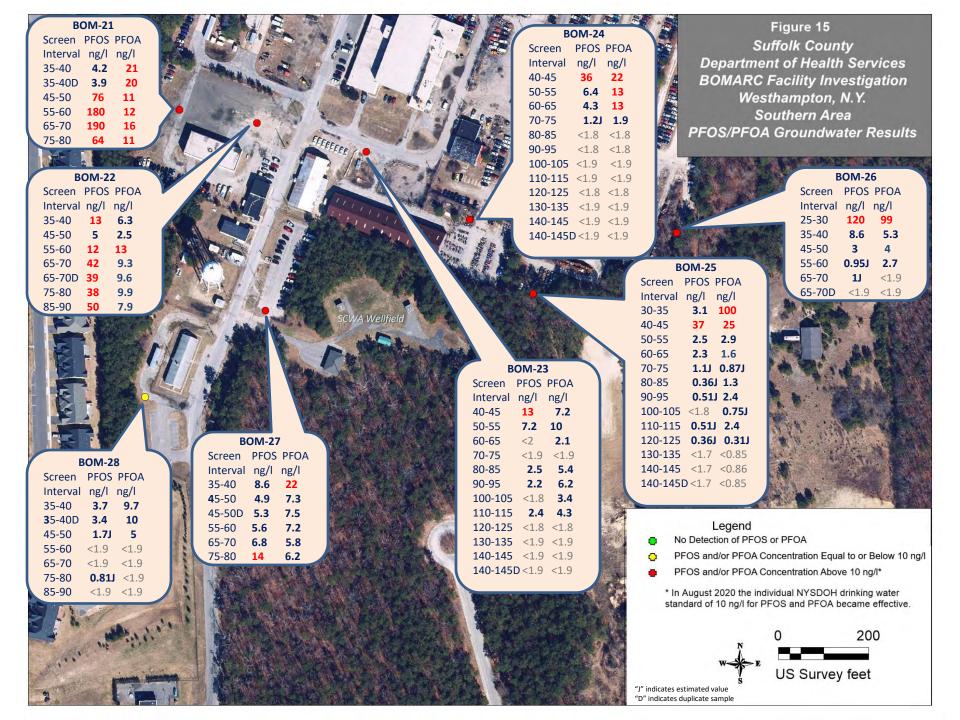
Thirteen profile wells had PFOS and/or PFOA concentrations in excess of the recently adopted New York State MCLs of 10 ng/l for each (see Figures 12-15 for an overview of PFAS results).

Twenty-one different PFAS parameters were analyzed in each of the samples. Seventeen of the twenty-one PFAS parameters were detected. Twenty-six of the twenty-eight profile wells had at least one PFAS parameter detected (Figure 12). The NYSDOH has recently adopted drinking water standards (MCLs) for PFOS and PFOA, each at 10 ng/l. Figure 13 through Figure 15 illustrate the well locations and profile sample level PFOS and PFOA results for the wells located in the Northern, Central, and Southern Areas of the site.

Twenty-seven samples and 3 duplicate samples in thirteen different profile wells had PFOS and/or PFOA concentrations in excess of the recently adopted New York State MCLs of 10 ng/l. The profile wells that exhibited at least one PFOS and/or PFOA concentration exceeding 10 ng/l are summarized in Table 7.
