FORMER BOMARC SITE  
100 OLD COUNTRY ROAD  
WESTHAMPTON, NEW YORK  
NYSDEC SITE: 152262

## PFAS SOURCE AREA INVESTIGATION WORK PLAN

PWGC Project Number: SHD2504

**PFAS SOURCE AREA INVESTIGATION WORK PLAN  
FORMER BOMARC SITE (152262)**

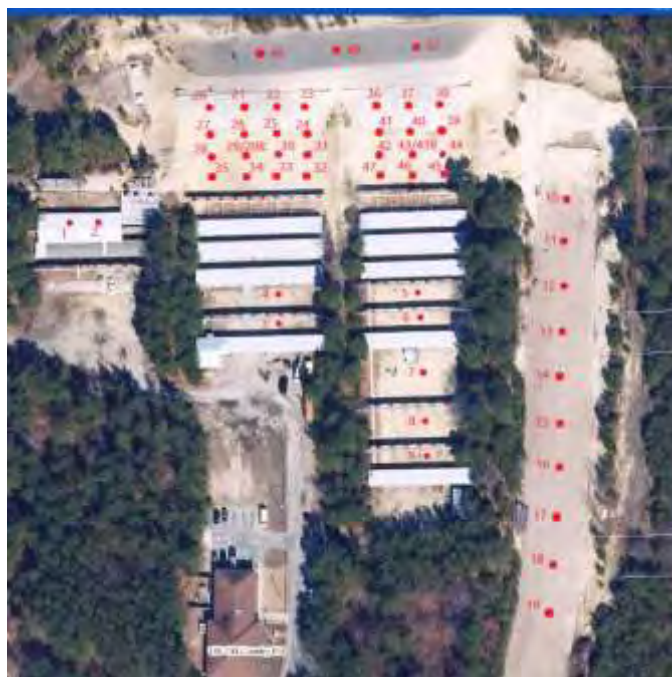
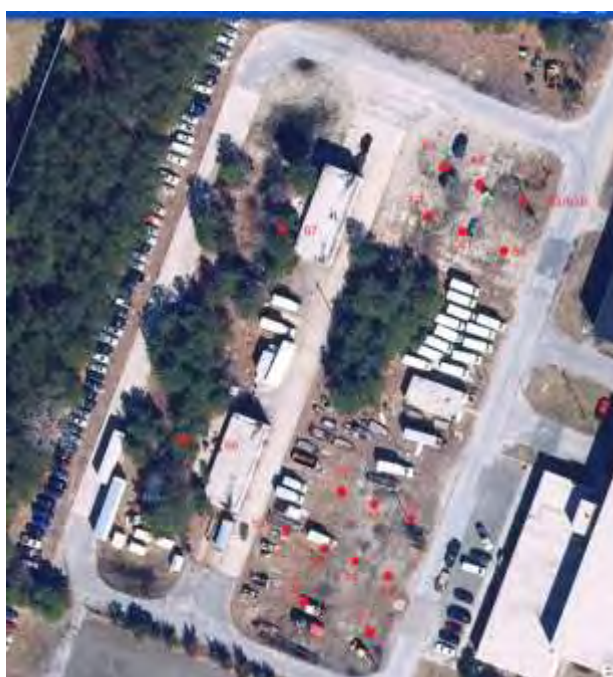
The sampling scope primarily focused on further evaluation of the firing ranges and an area south of the firing range where automobiles were being stored. Seventy samples were obtained from two grids in these areas, and were only analyzed for the presence of PCBs. Three of the seventy samples were obtained at a deeper interval (6-8 inches from surface). Refer to the site figures below for all grid sample locations.

PCB concentrations were generally low or non-detect within the surface grids. The PCB levels detected in the pistol range were significantly lower than those found in the samples taken in the April/May 2019 testing. Results from the initial and supplemental soil sampling are summarized in Table 3, below. The sample IDs have the prefix “S” for the initial sampling round and “SS” for the supplemental sampling round. All positive detections are in red. Analytical laboratory reports for this supplemental sampling effort are included in Appendix E.

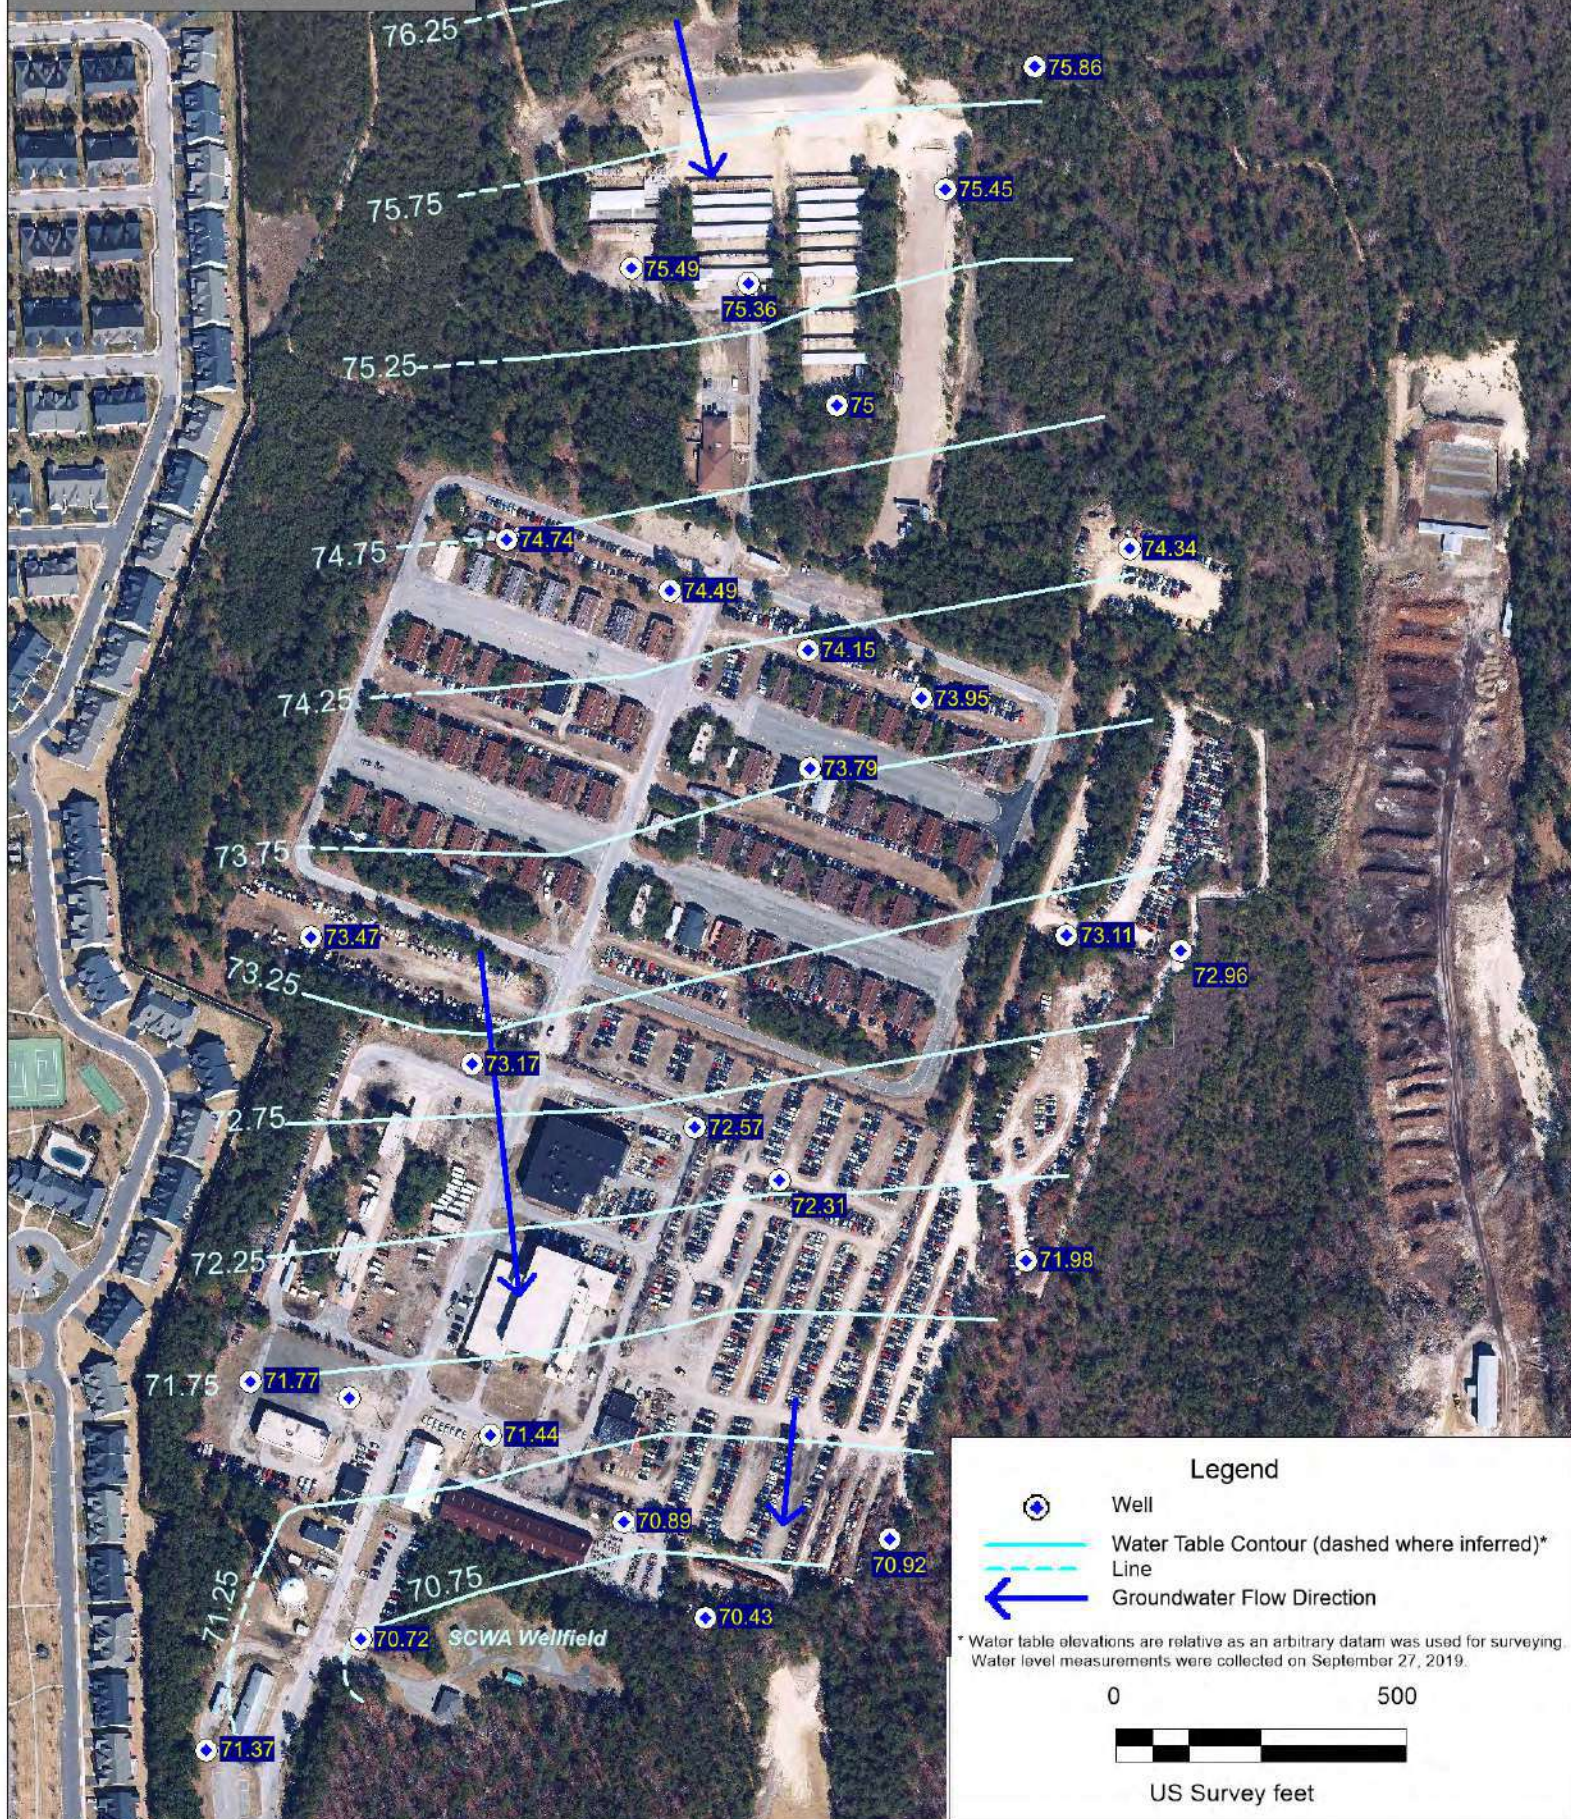
**Figure 8**  
**Suffolk County**  
**Department of Health Services**  
**BOMARC Facility Investigation**  
**Westhampton, N.Y.**  
**Relative Water Table Contours**

The water level measurement data was used to calculate relative water table elevation heights observed in each of the wells. This information was used to construct groundwater table elevation contours (Figure 8). Groundwater flows perpendicular to the water table elevation contours.
