**RE: Brookhaven Calabro Airport, 135 Dawn Drive, Shirley, NY; Spill No. 18-10934 – Investigation Summary**

135 Dawn Drive  
Shirley, NY  
NYSDEC Spill # 18-10934

GW Profiling Investigation (June 2019 - July 2019)  
Groundwater Analytical Results (ug/L)

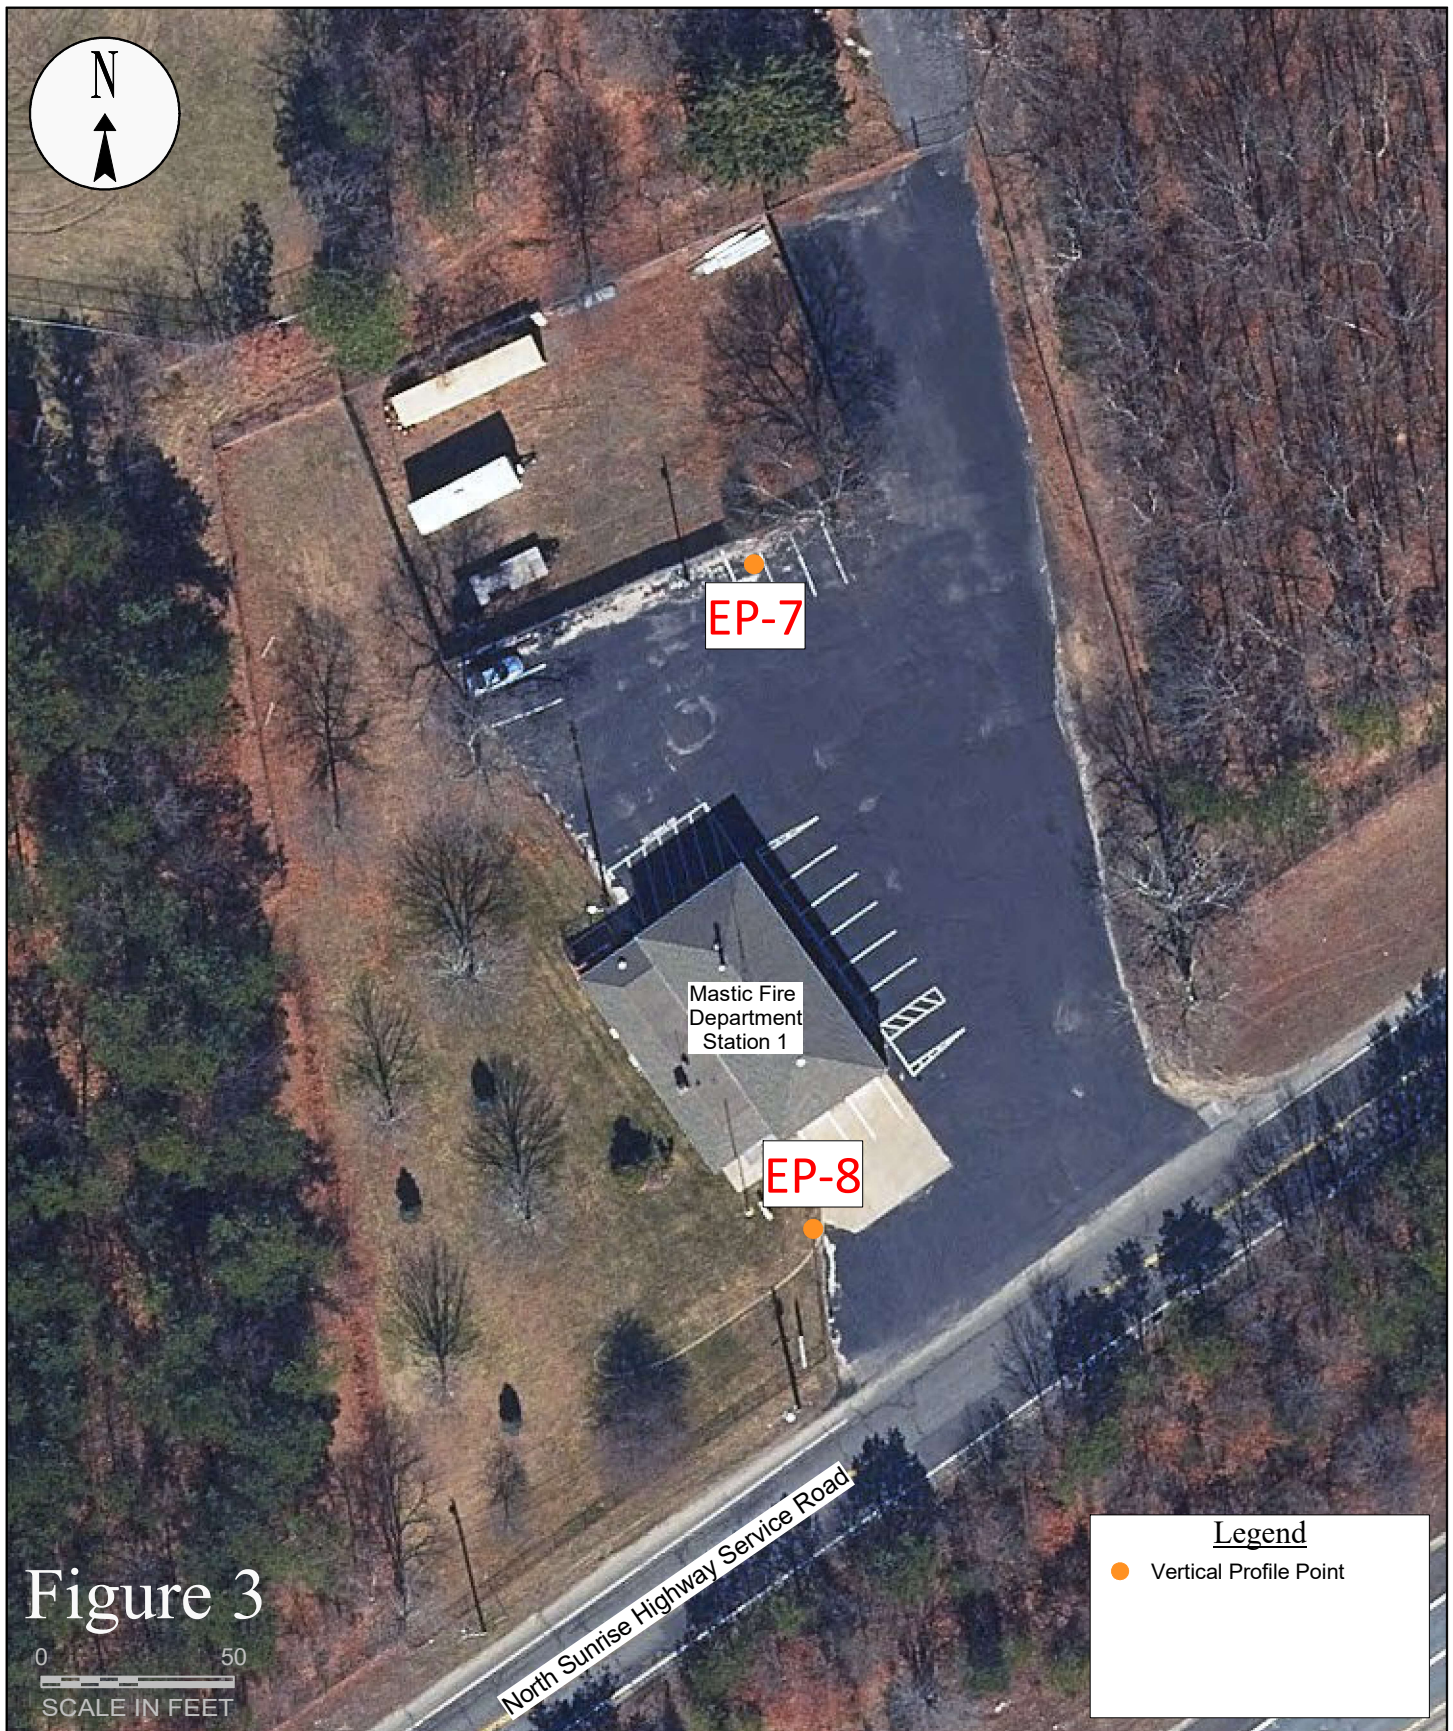
## Site Map

Mastic Fire Department Station 1  
Sunrise Service Road North  
Shirley, NY  
NYSDEC Spill #18-10934

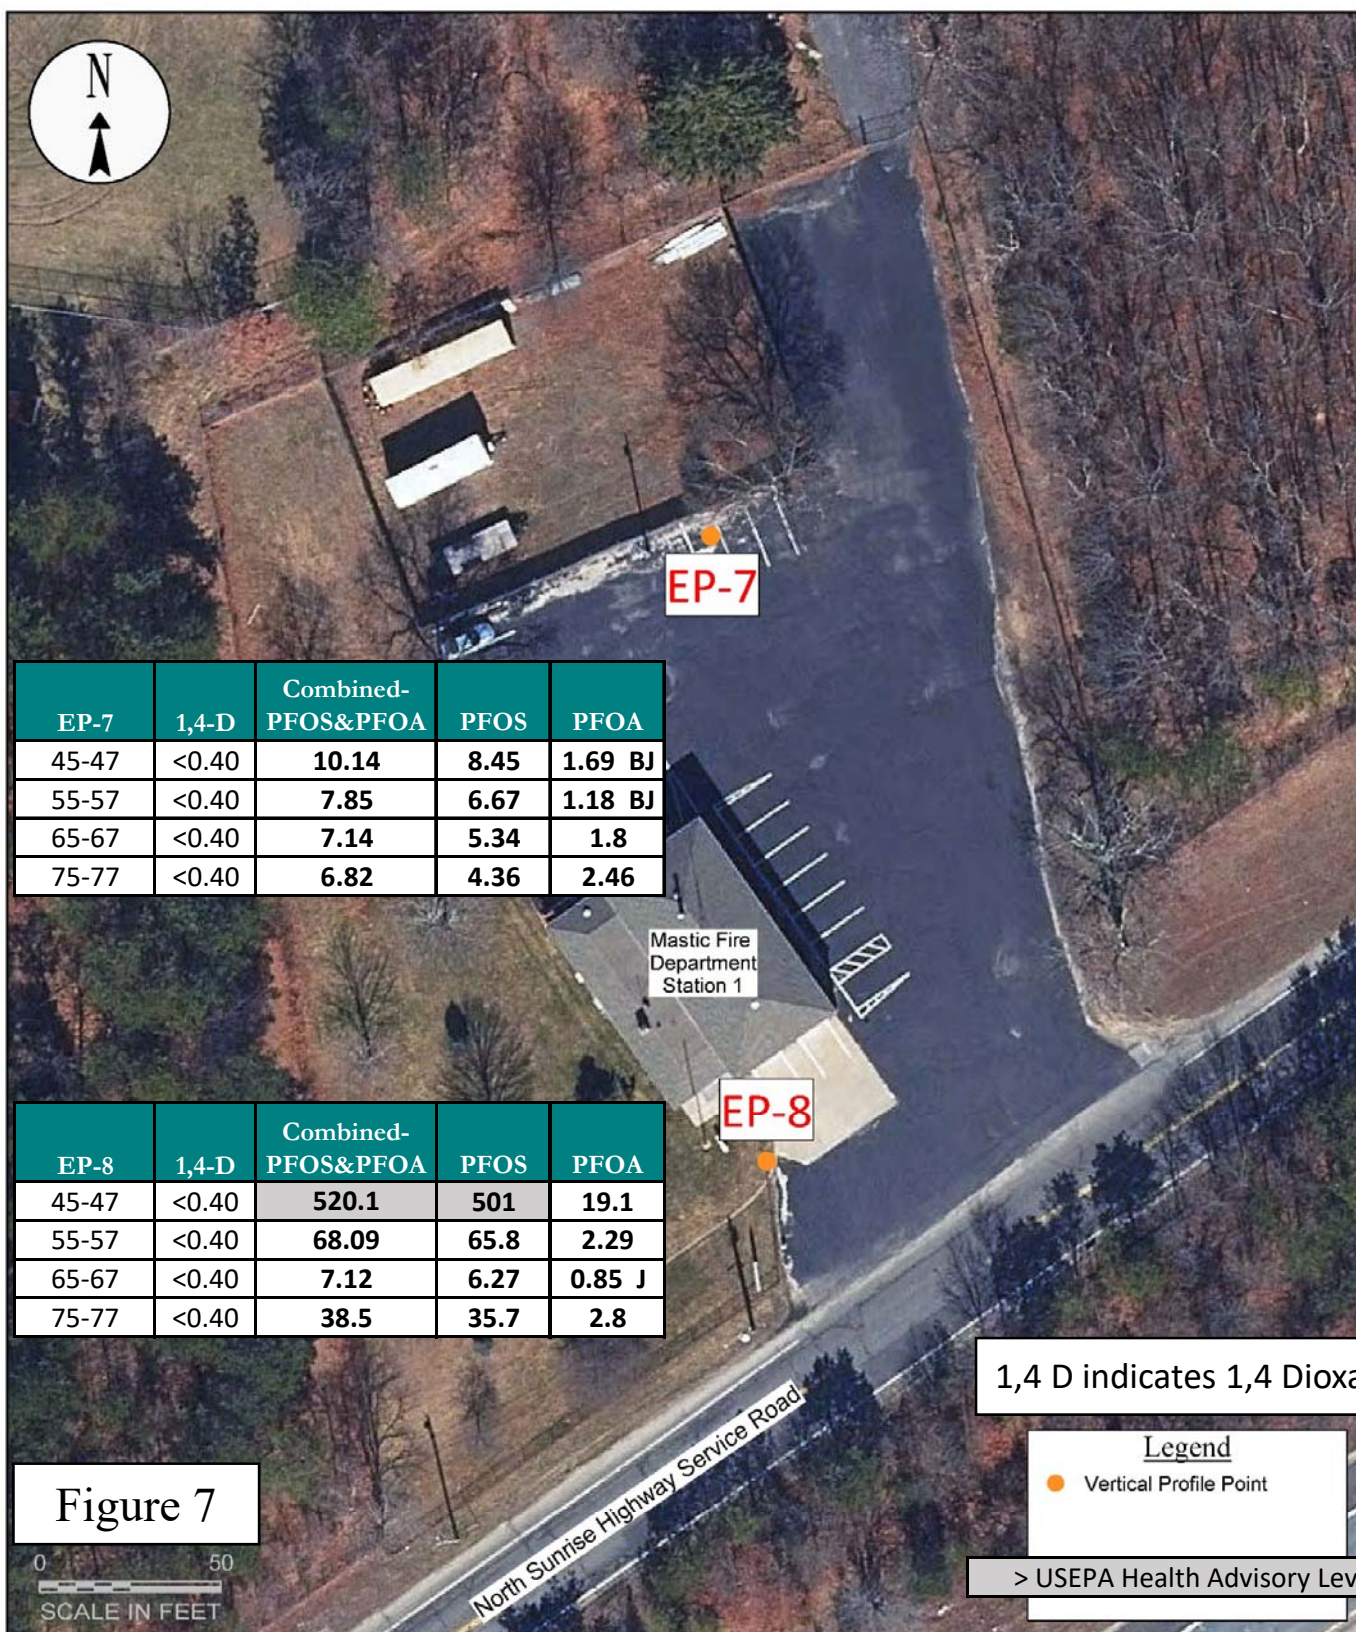
| EP-7 | 1,4-D | Combined-PFOS&PFOA | PFOS | PFOA |
| 45-47 | <0.40 | 10.14 | 8.45 | 1.69 BJ |

GW Analytical Results  
PFAs (ng/L)  
1, 4 Dioxane (ug/L)  
June 2019 - July 2019

Mastic Fire Department Station 1  
Sunrise Service Road North  
Shirley, NY  
NYSDEC Spill #18-10934

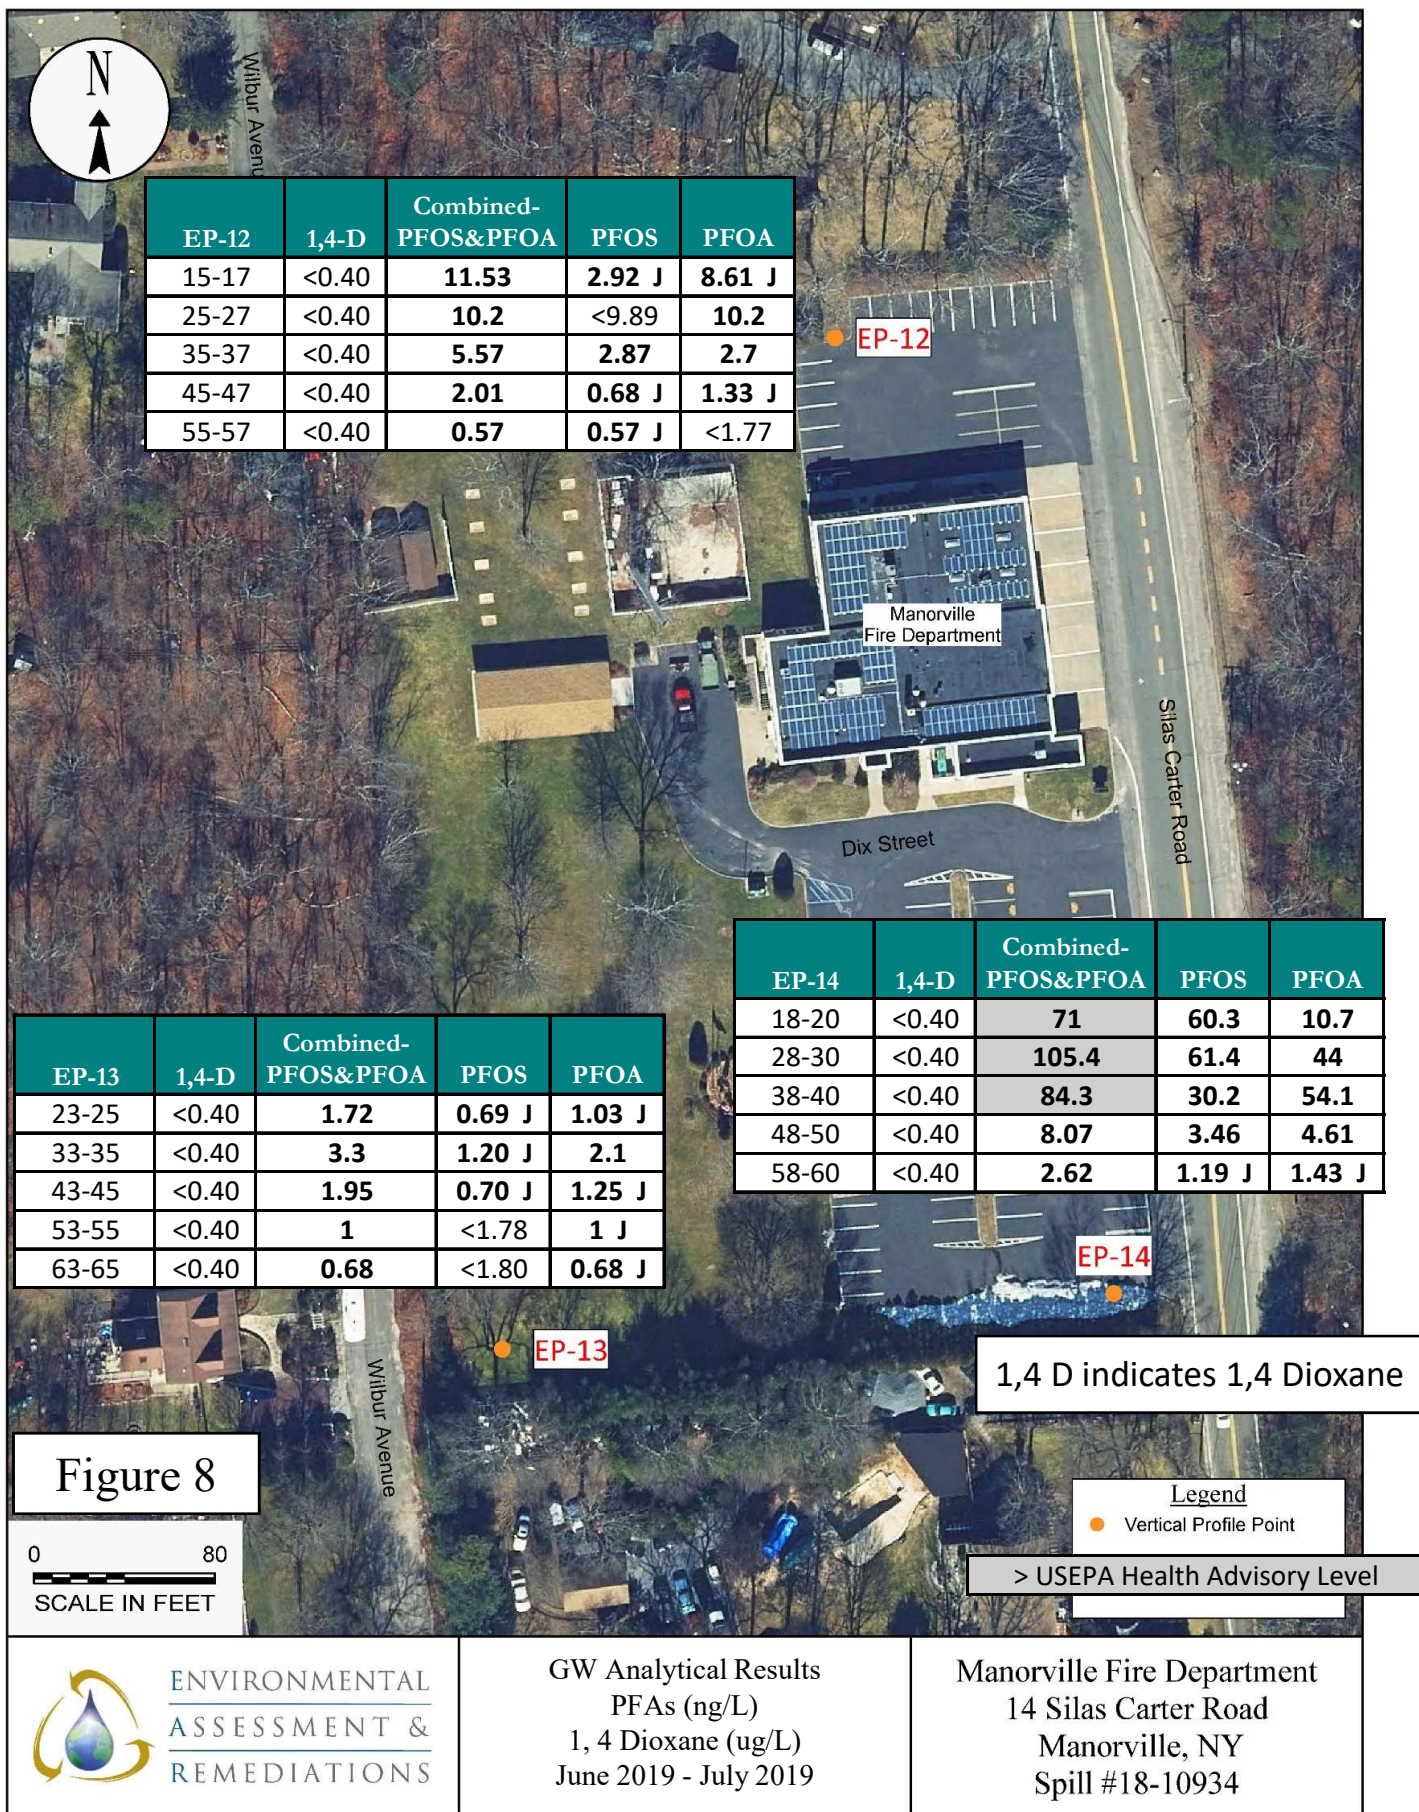
Figure 8: Manorville FD - 14 Silas Carter Road, Manorville, NY - 1, 4 Dioxane Concentrations (ug/L) & PFAS Concentrations (ng/L)

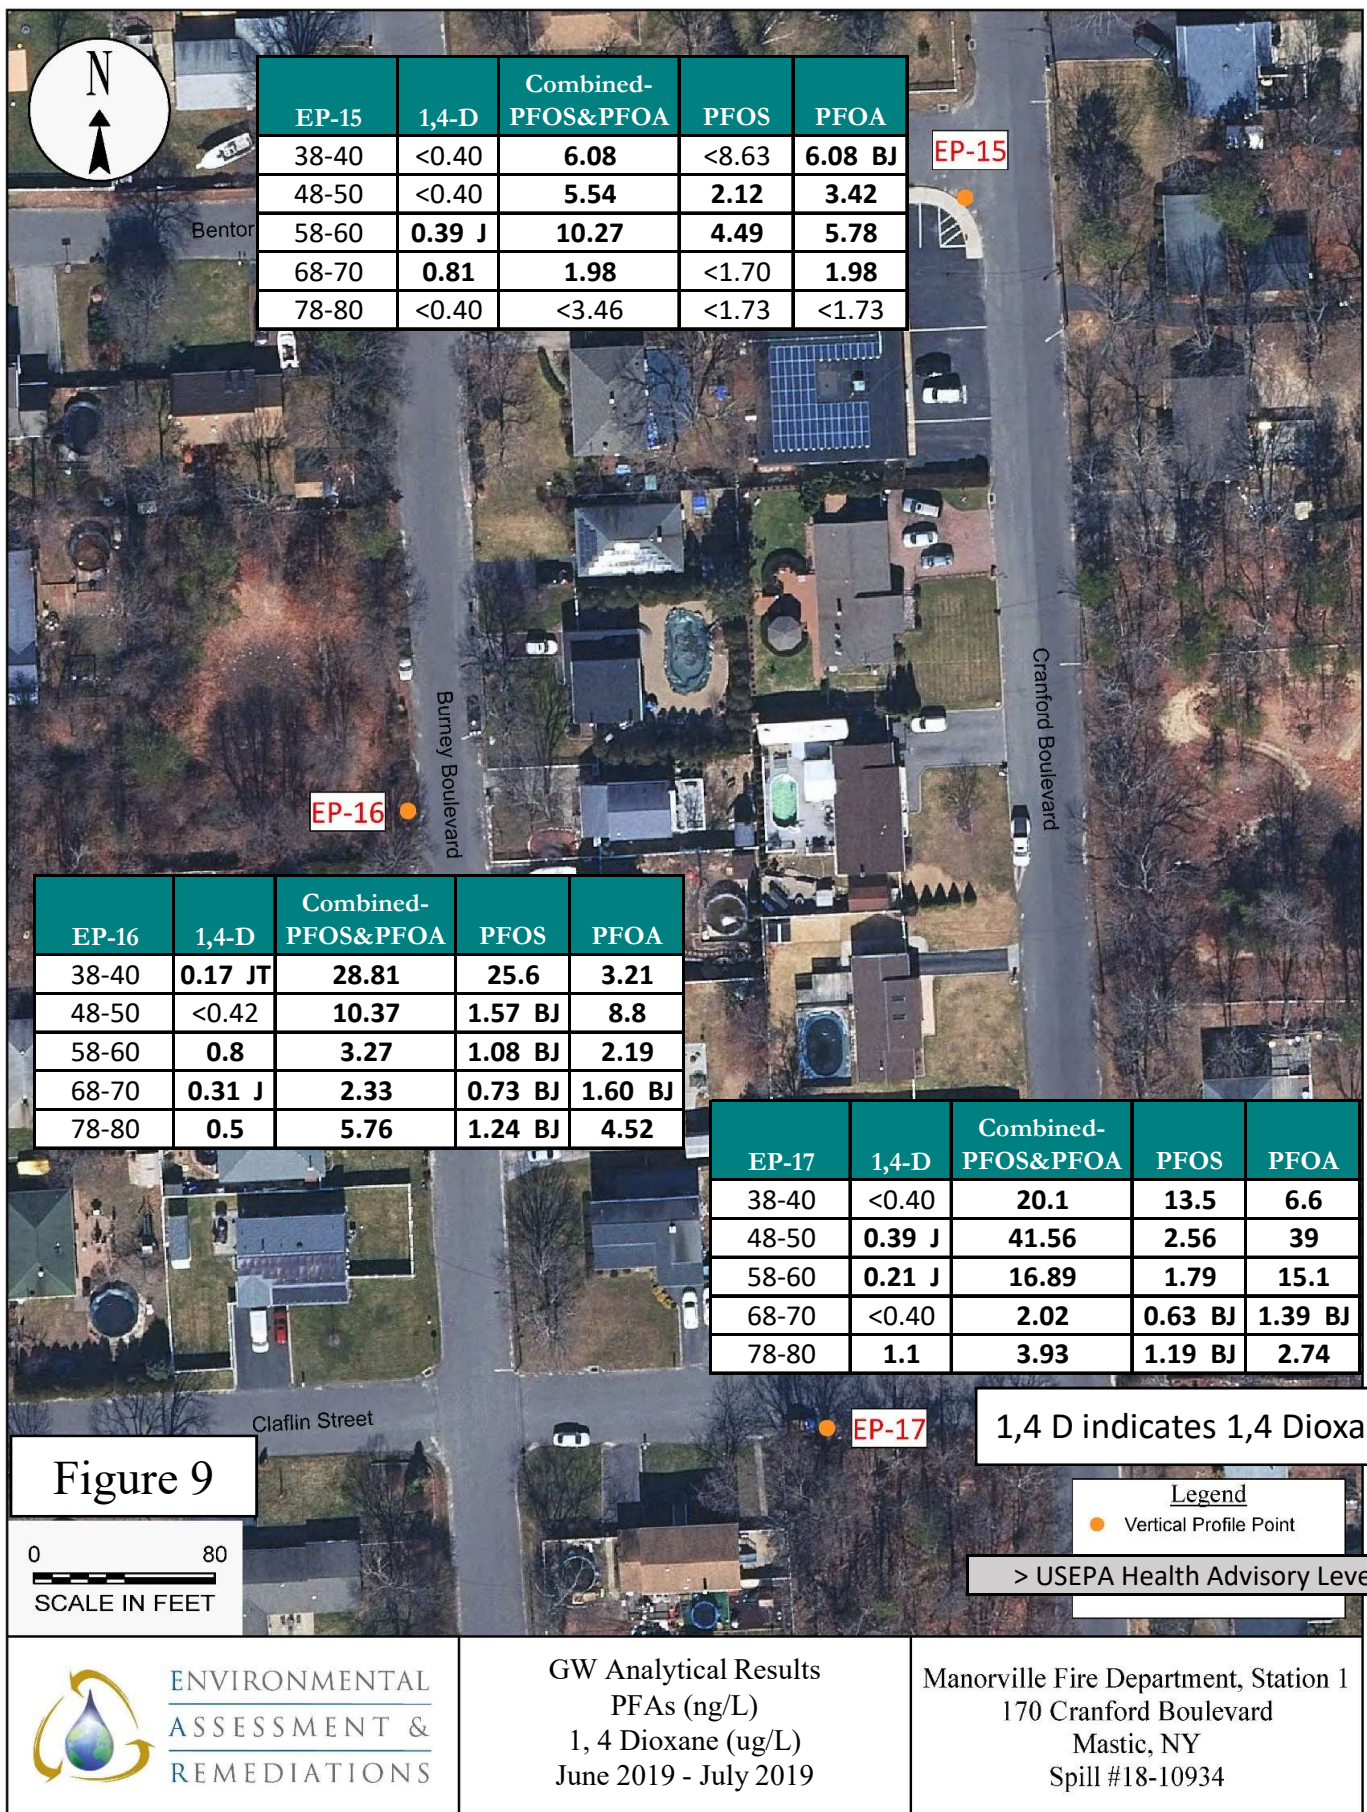
Figure 9: Manorville FD Station 1 - 170 Cranford Boulevard, Mastic, NY - 1, 4 Dioxane Concentrations (ug/L) & PFAS Concentrations (ng/L)
