# **Initial Subsurface Investigation Report Weld Shop Facility**

January 31, 2005

Northern Car Crushers  
Weld Shop Facility  
Route 9  
Keeseville, New York

ESPC Project 20041039

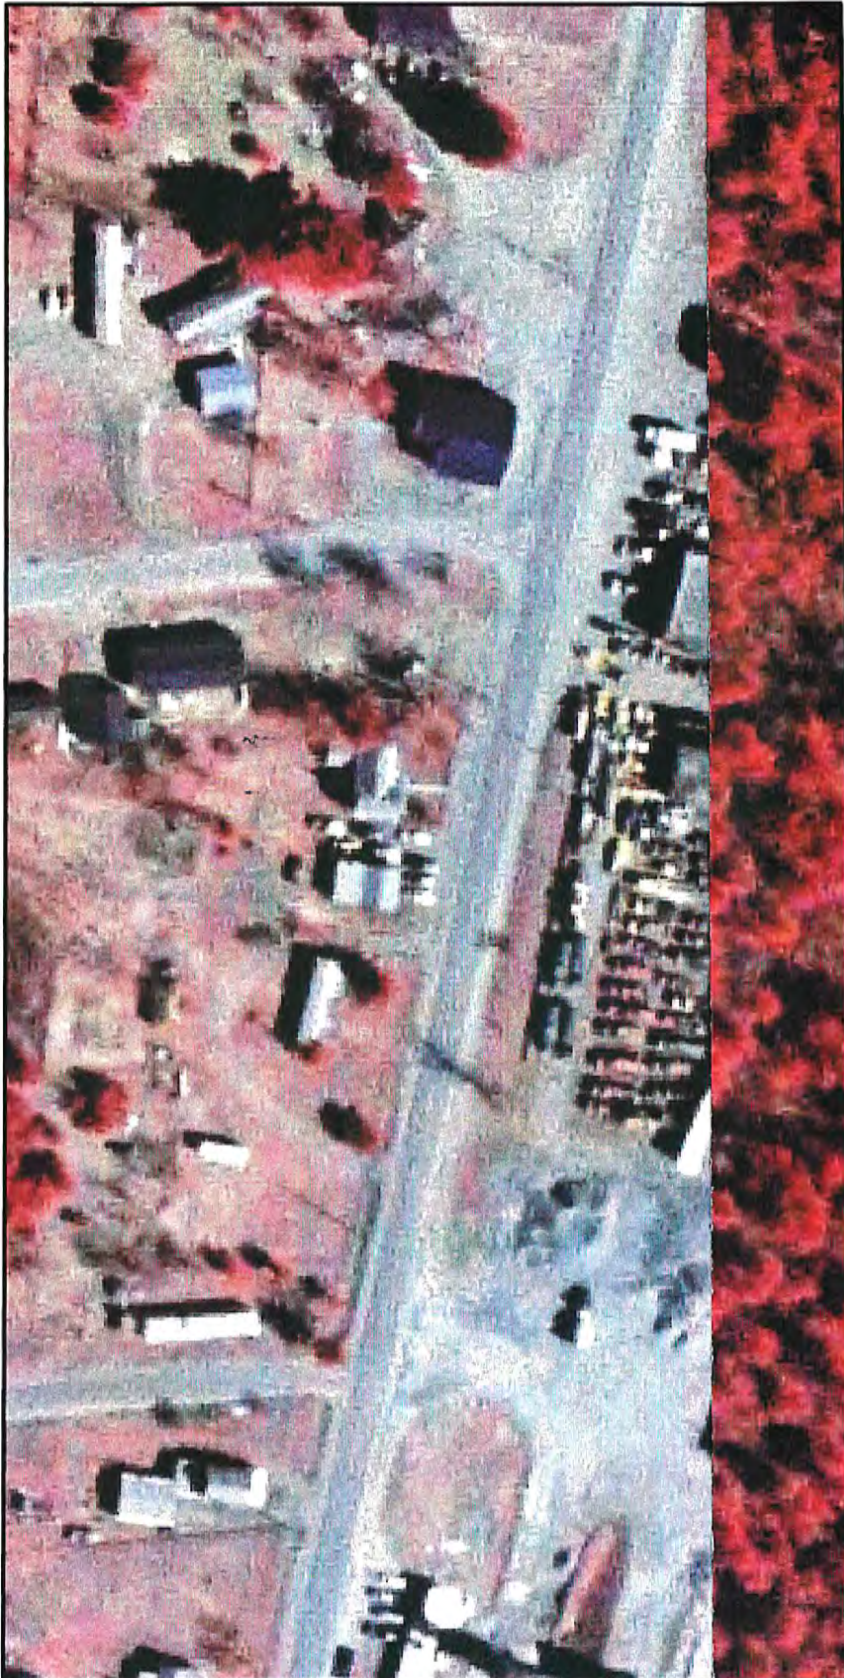
Test pits were excavated at previously identified locations in accordance with the Work Plan, and as shown on the Site Map in Appendix A:

- TP – 1D ~ on and beside the loading dock to the east of the maintenance building; and,
- TP – 2D ~ the former storage location of two car crushers in the yard. To the east of TP-1D.
