Former Weld Shop

1823 Route 9 South

REMEDIAL INVESTIGATION WORK PLAN

June 13, 2018
Revised: July 25, 2018

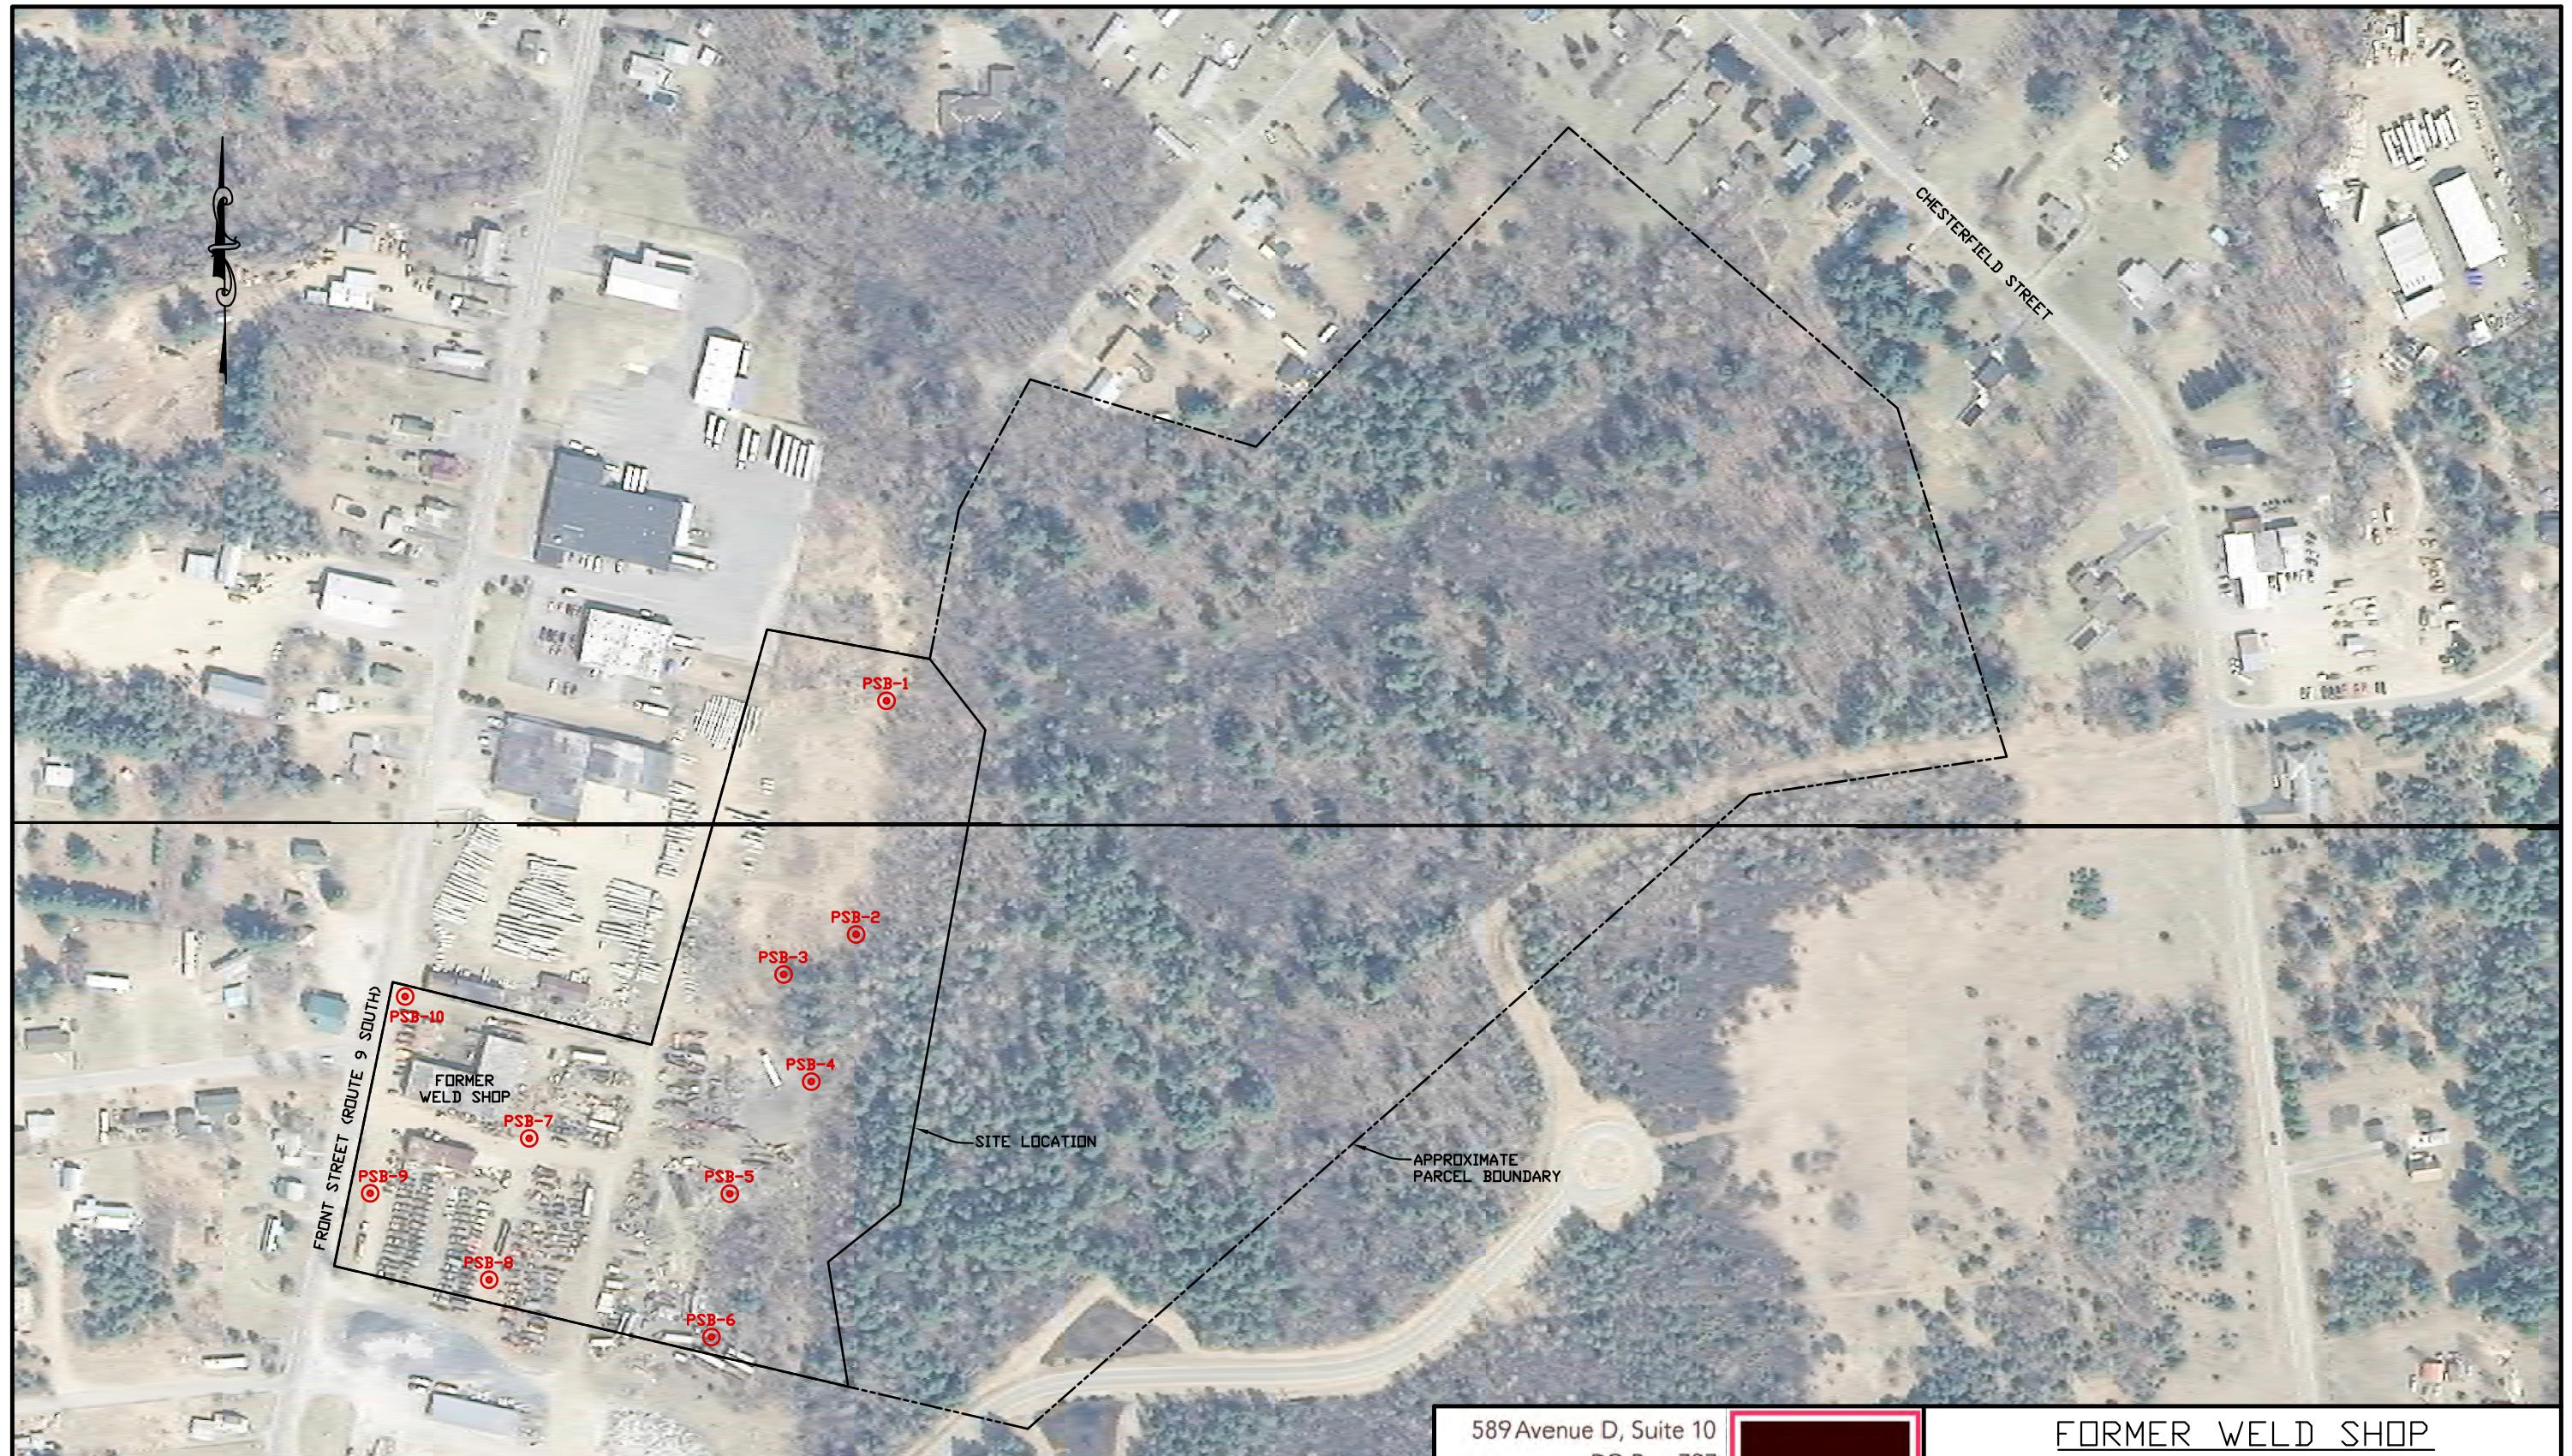
DATE: 5/29/18 DWG. #: 1 SCALE: 1"=240' DRN.: TB APP.: AR

3. PSB-1 = PROPOSED SOIL BORING

The site has largely been investigated by previously conducted work; however, to confirm a current comprehensive site-wide understanding and to develop a more comprehensive site conceptual model, KAS will install ten (10) soil borings to the soil/groundwater interface. A proposed boring location map has been included in Appendix A. A geoprobe rig will be used to install the soil borings to an estimated depth of 20 feet below ground surface (bgs) or approximately 2-5 feet into saturated soils, whichever is encountered first. Soils will be visually observed, screened for volatile organic compounds (VOCs) using a properly calibrated photoionization detector (PID) continuously during drilling and soil types logged. The contaminants of concern would be VOCs, semi-volatile organic compounds (SVOCs) and polychlorinated biphenyls (PCBs) given the storage of various vehicles and equipment

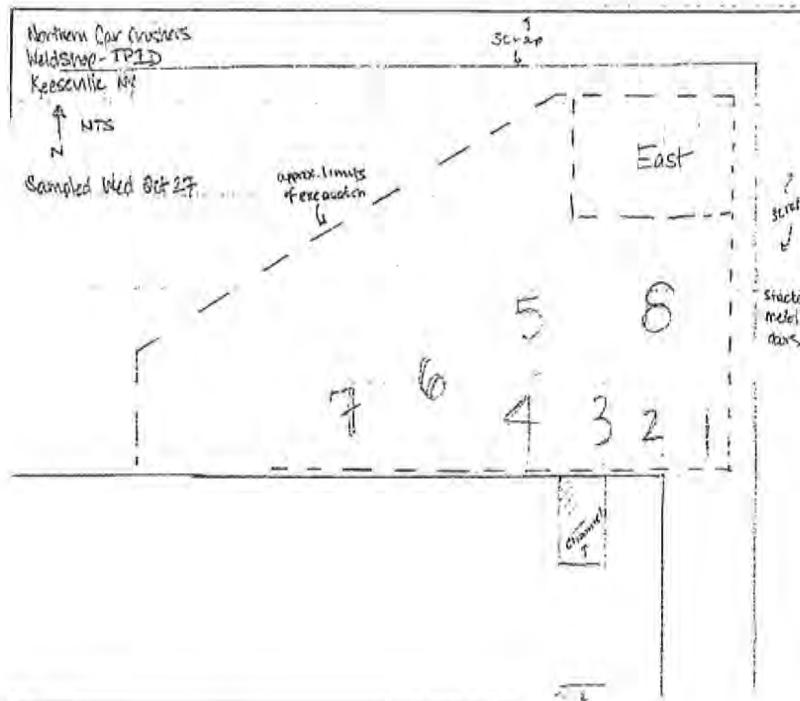
Soils in Test Pit 1D were primarily medium brown to orange brown moist sands. The average PID reading in soils in the test pit was 57 ppm, and the peak PID reading was 190 ppm. Black, tar-like soil was removed from channels in the concrete pad and stockpiled with the soil. The top 12" of soil was stained. At 3' below grade, a strong, sweet odor was encountered in the test pit.

- 0-12" Sand, with oily, dark lenses & 25% gravel
12-36" Medium orange - brown very fine sand, dry
36-60" Medium brown fine sand, moist
60-102" Light orange brown well graded sand, moist. Cobbles (10%) at 85"+
102" Groundwater

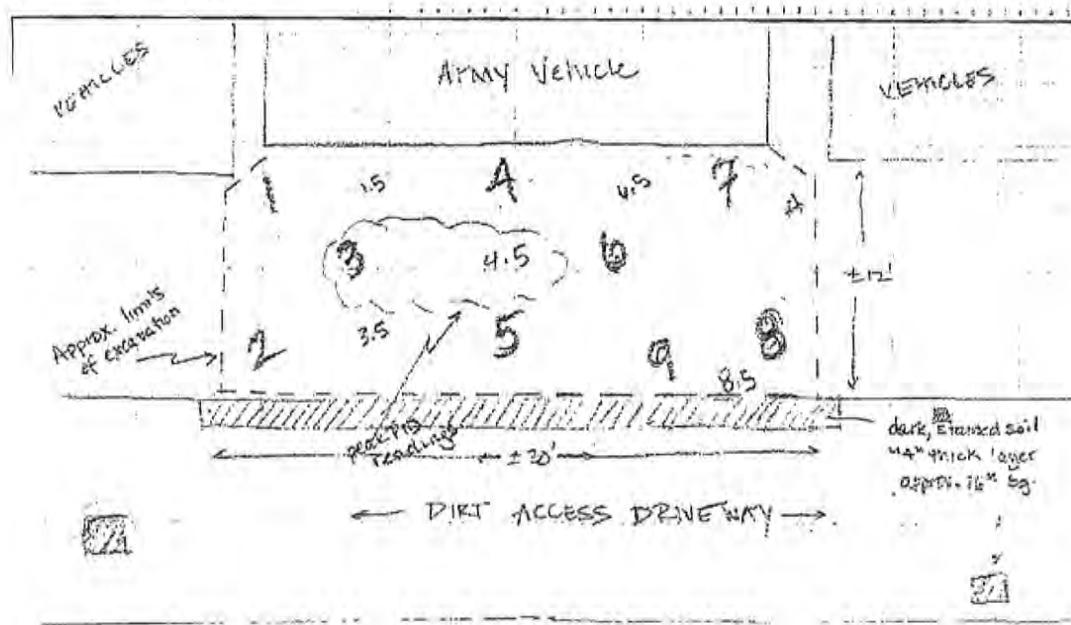
The soils in TP-2D were primarily medium brown to orange brown silty sands. Soils in the top 12" of the test pit were dark brown with visible stained lenses. The average PID reading in soils in the test pit was 2.2 ppm, and the peak PID reading was 20 ppm. A characterization sample was collected from the soils in the center of the excavation, approximately 1.5' below grade.

Vertically, the test pit was excavated to approximately 3' below grade, at the point where PID readings were non-detectable. An approximately 6" lens of stained soil was present along the western test pit boundary, but the excavation was limited horizontally to the west by a large army vehicle.

The excavation expanded to the east into the access driveway, tracing a dark, stained layer of soil approximately 16" below grade and 4" thick. It was hypothesized that the staining extended below the dirt access driveway. To confirm this, three additional test pits, each equivalent to two-bucket volumes, were excavated within the dirt driveway. These samples were located approximately 30' apart, and each exhibited the same soil profile as the eastern boundary of Test Pit 2D. The excavation was terminated to maintain the functionality of the driveway.

→ N
Northern Car Crushers
Weld Shop ~ TP 2D
Keeseville, NY
NTS

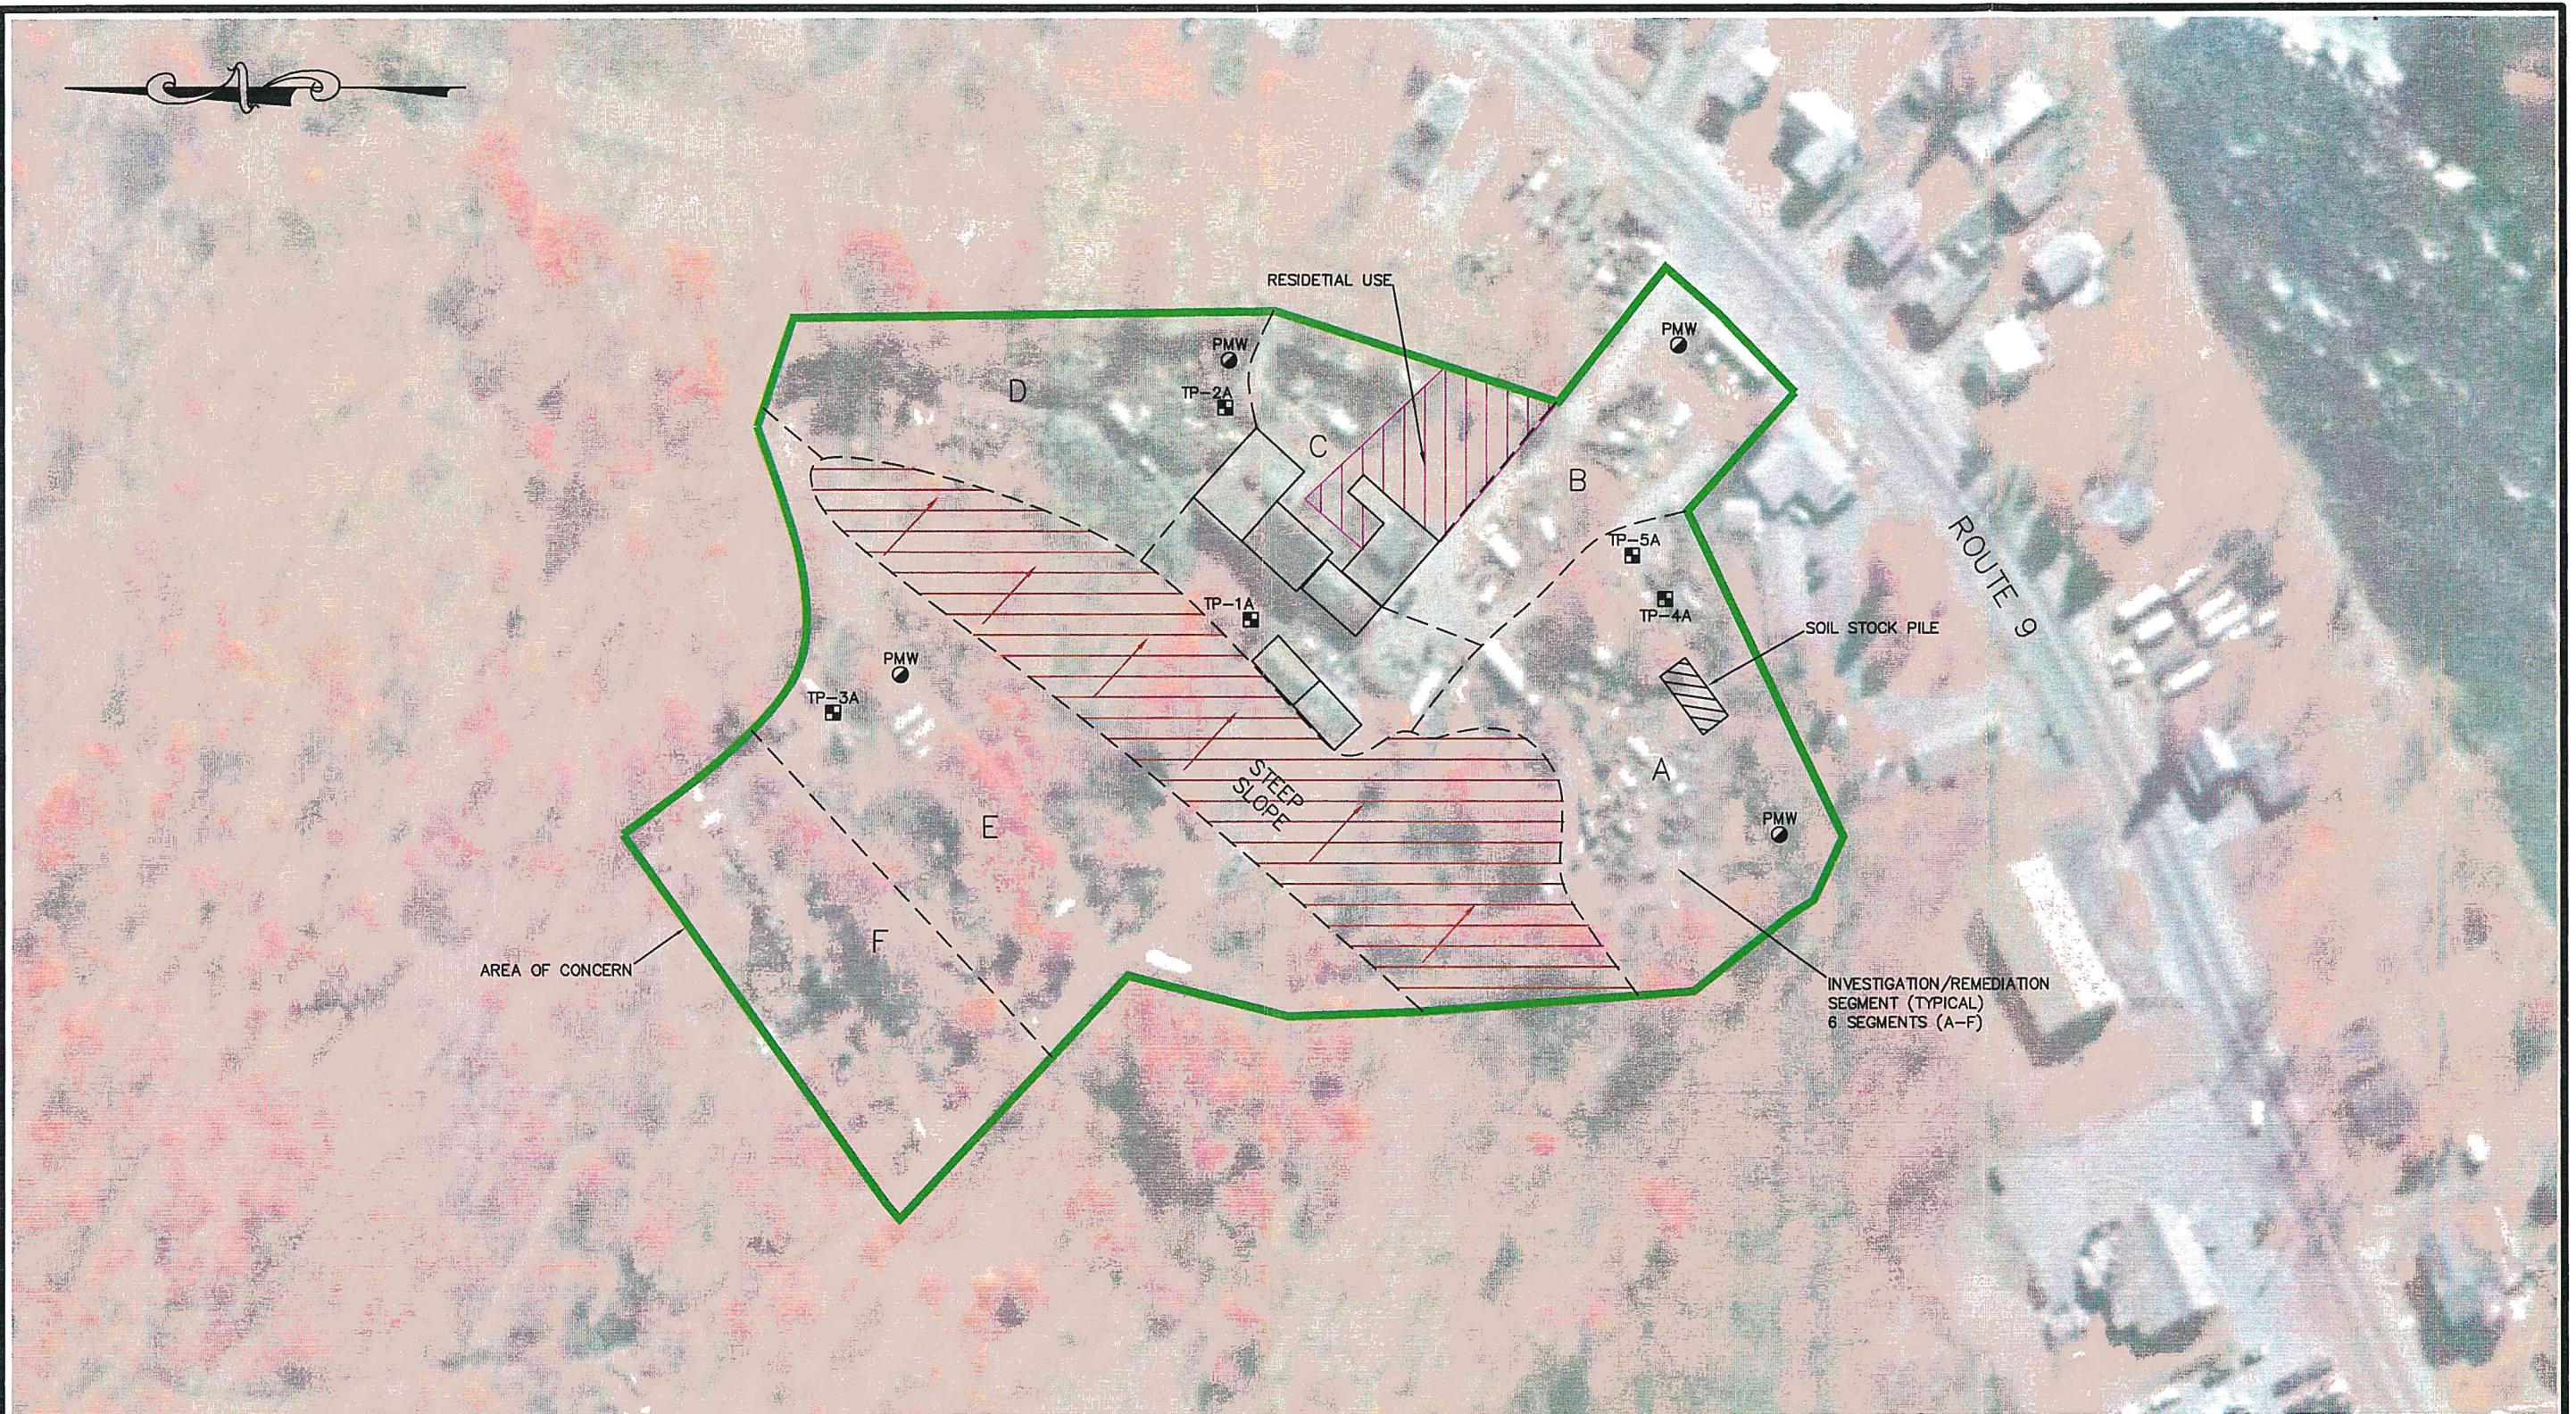
- TP-4A TEST PIT LOCATION (CONDUCTED FALL 2004)
PMW PROPOSED MONITORING WELL

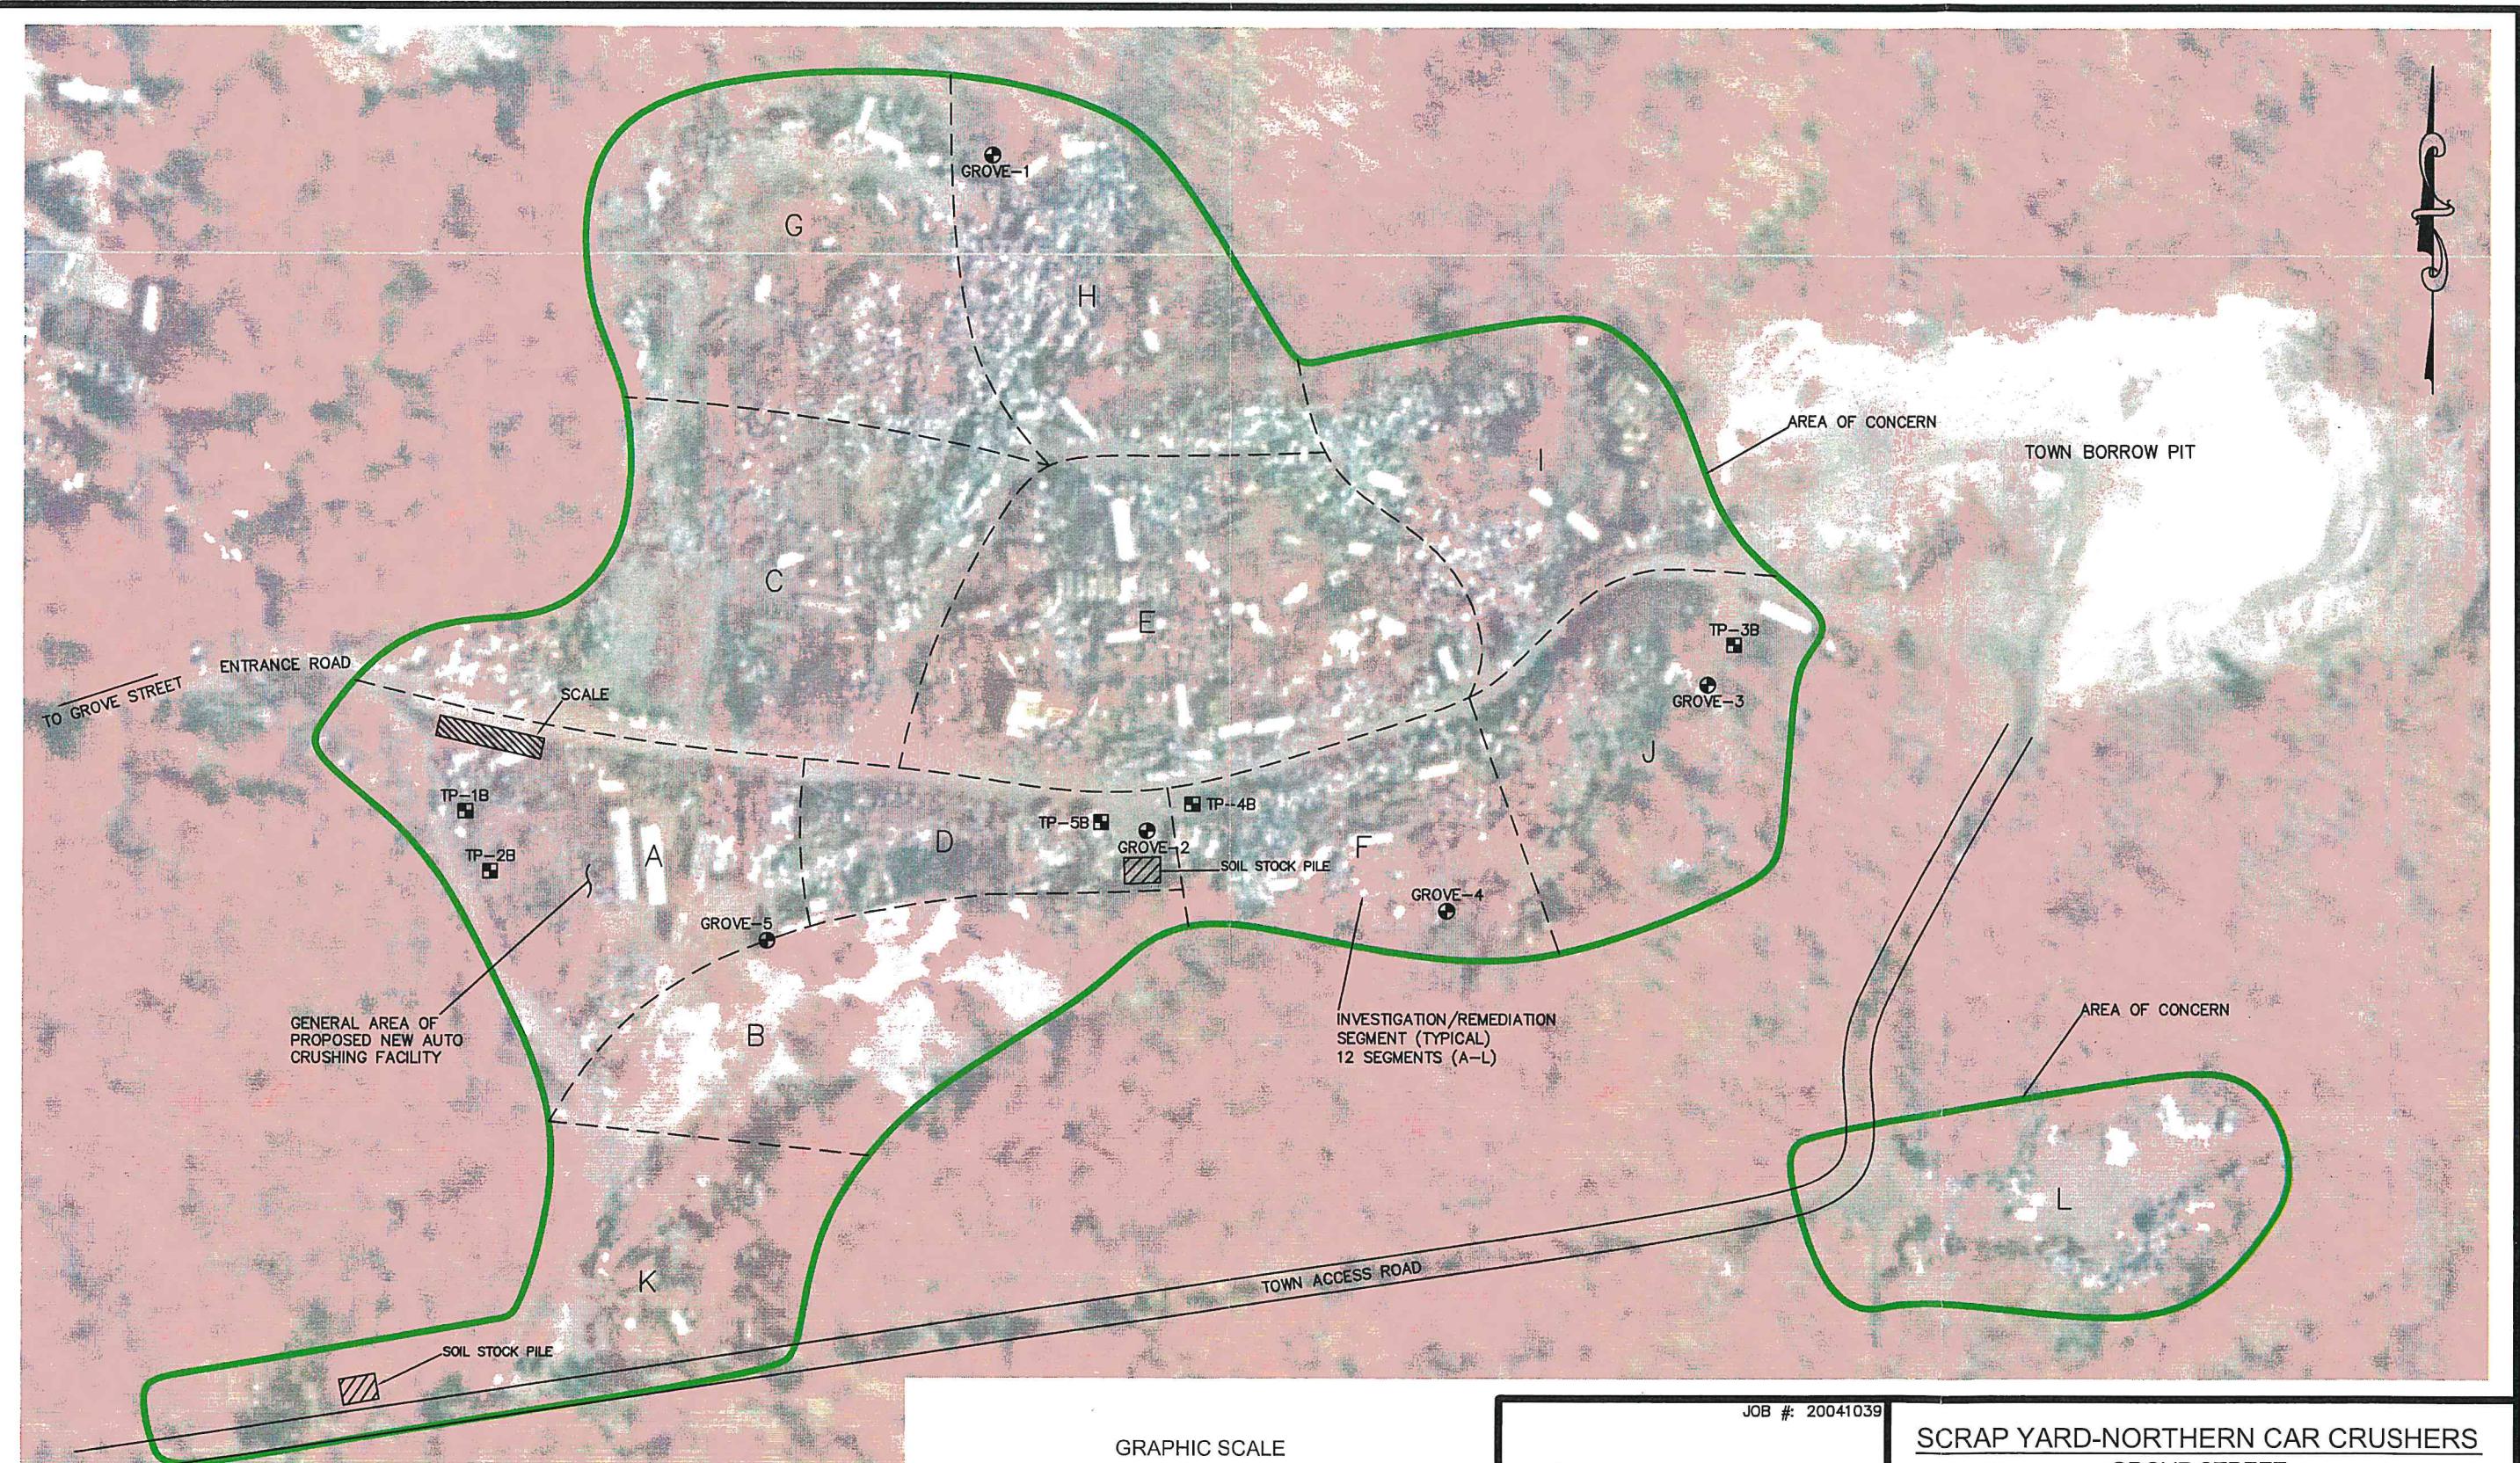
- TP-4B TEST PIT LOCATION (CONDUCTED FALL 2004)
GROVE-1 MONITORING WELL (INSTALLED 1/06)

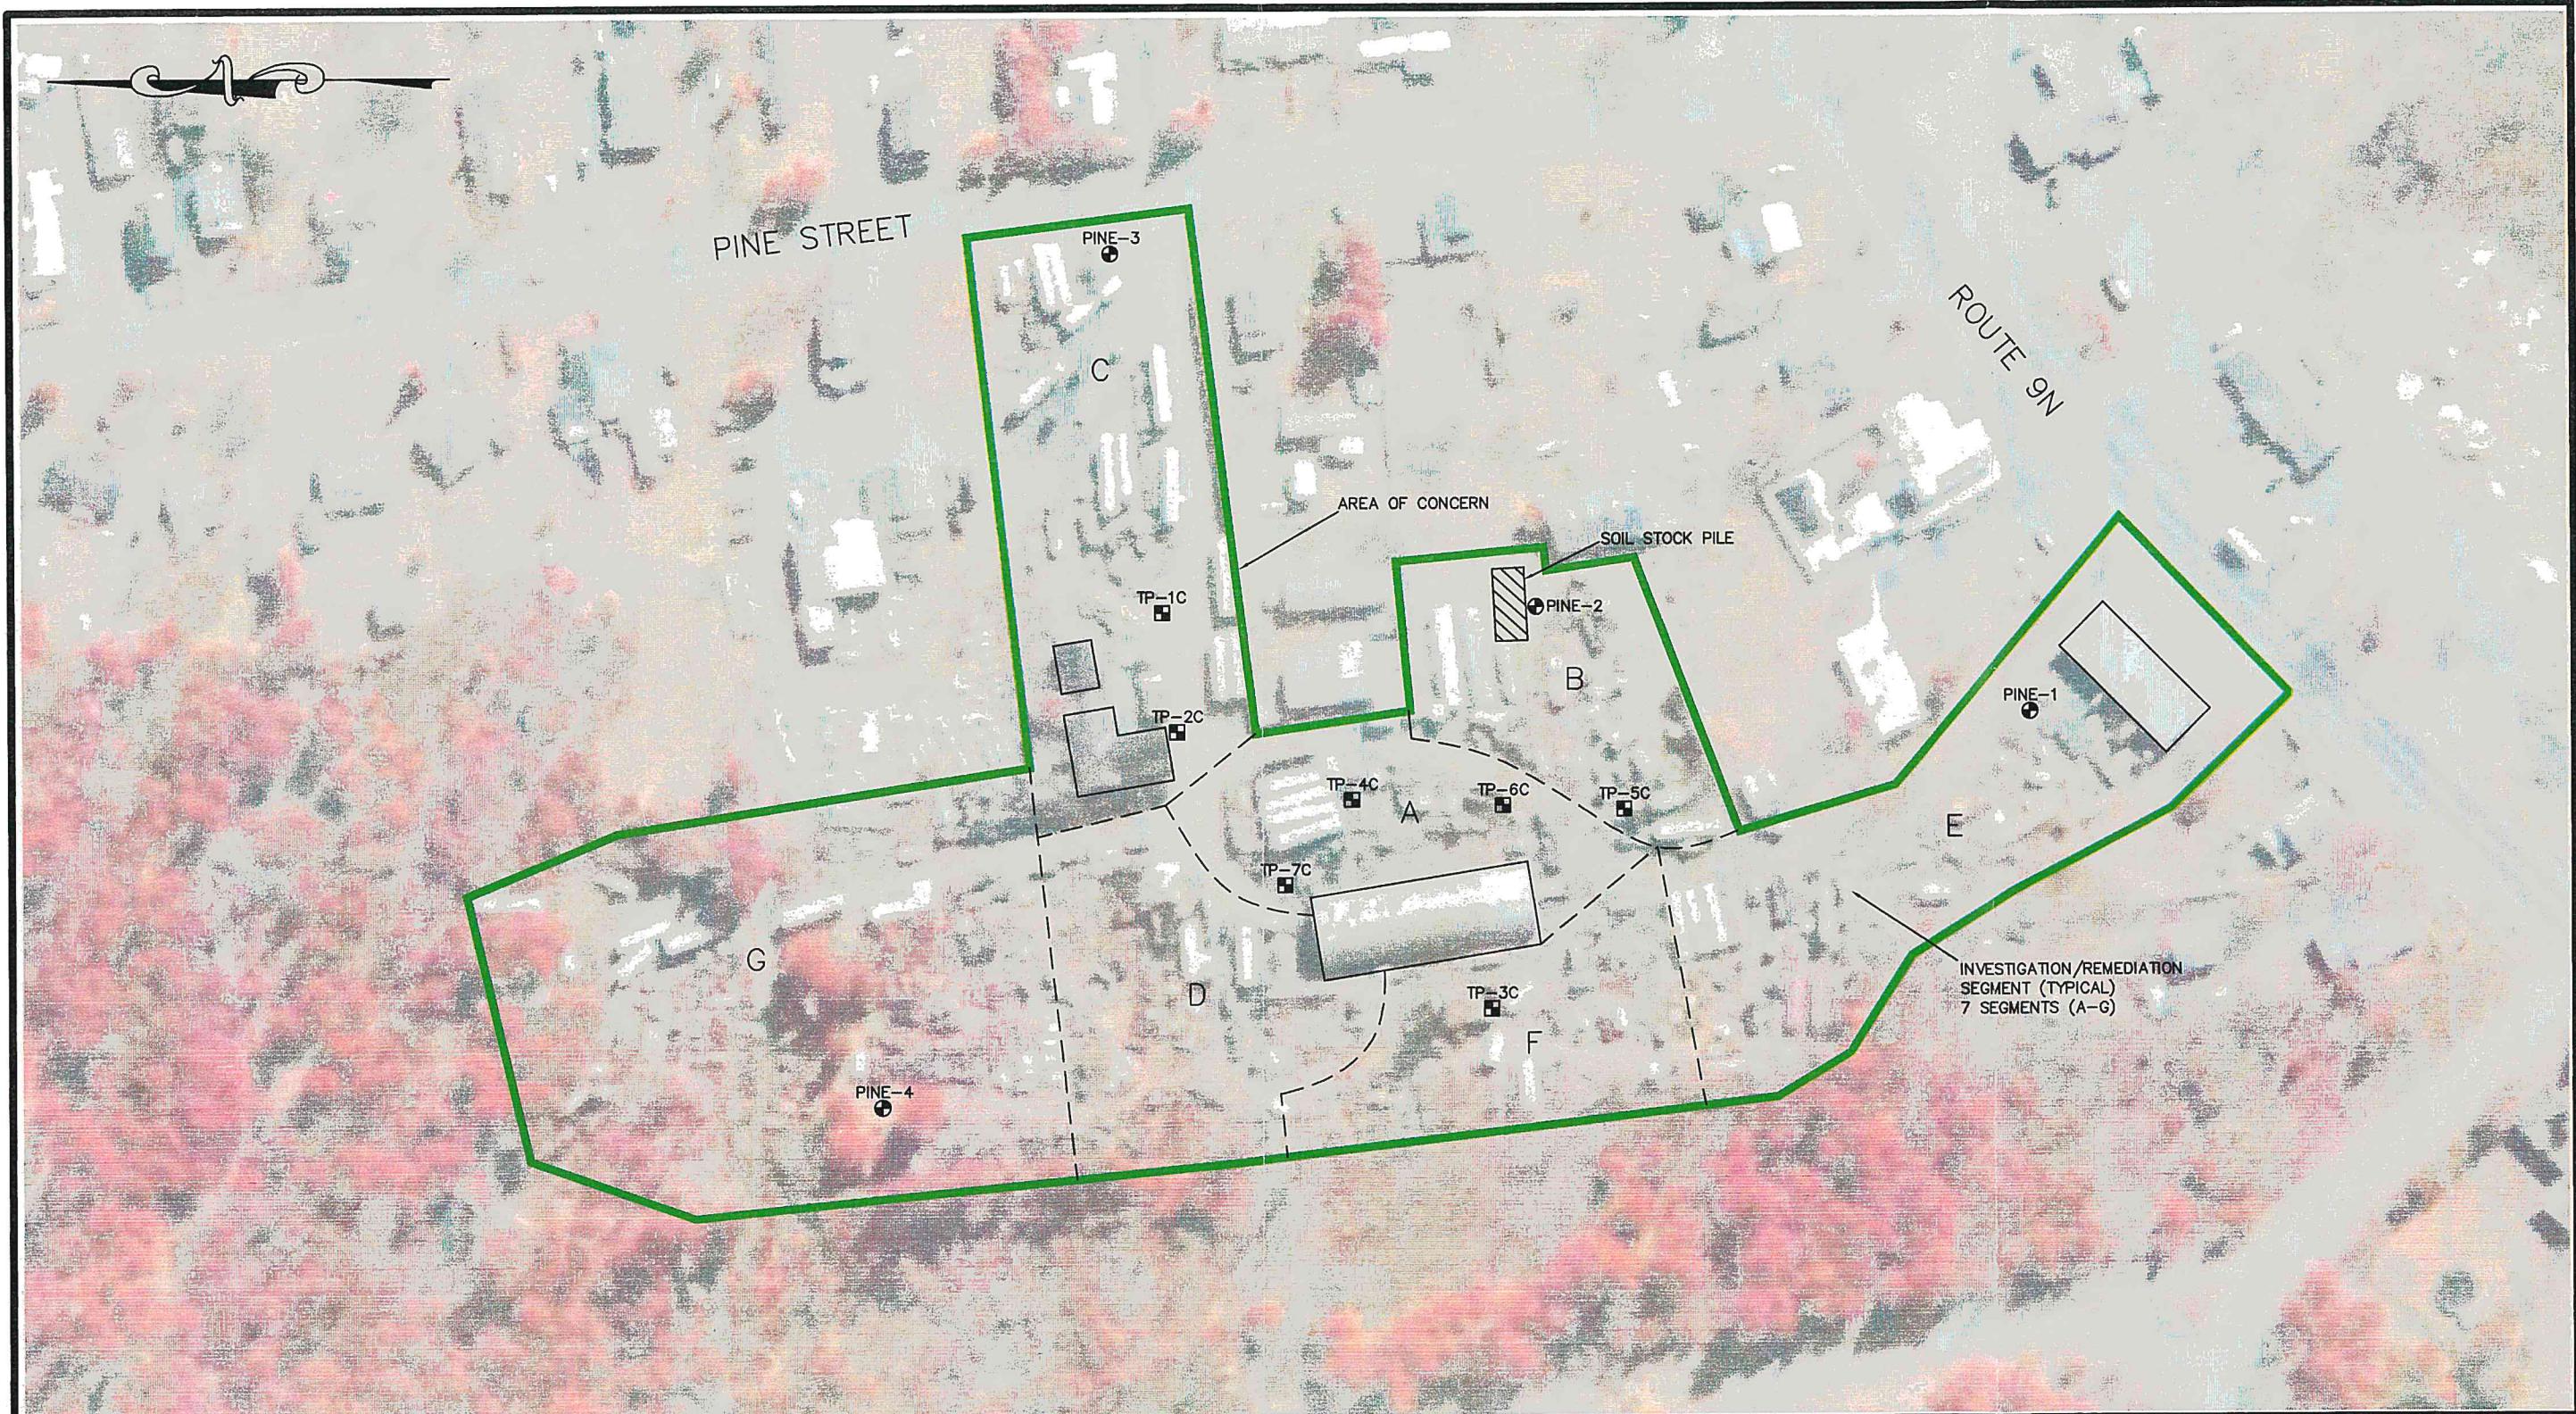
TP-4C TEST PIT LOCATION (CONDUCTED FALL 2004)
PINE-1 MONITORING WELL (INSTALLED 7/06)

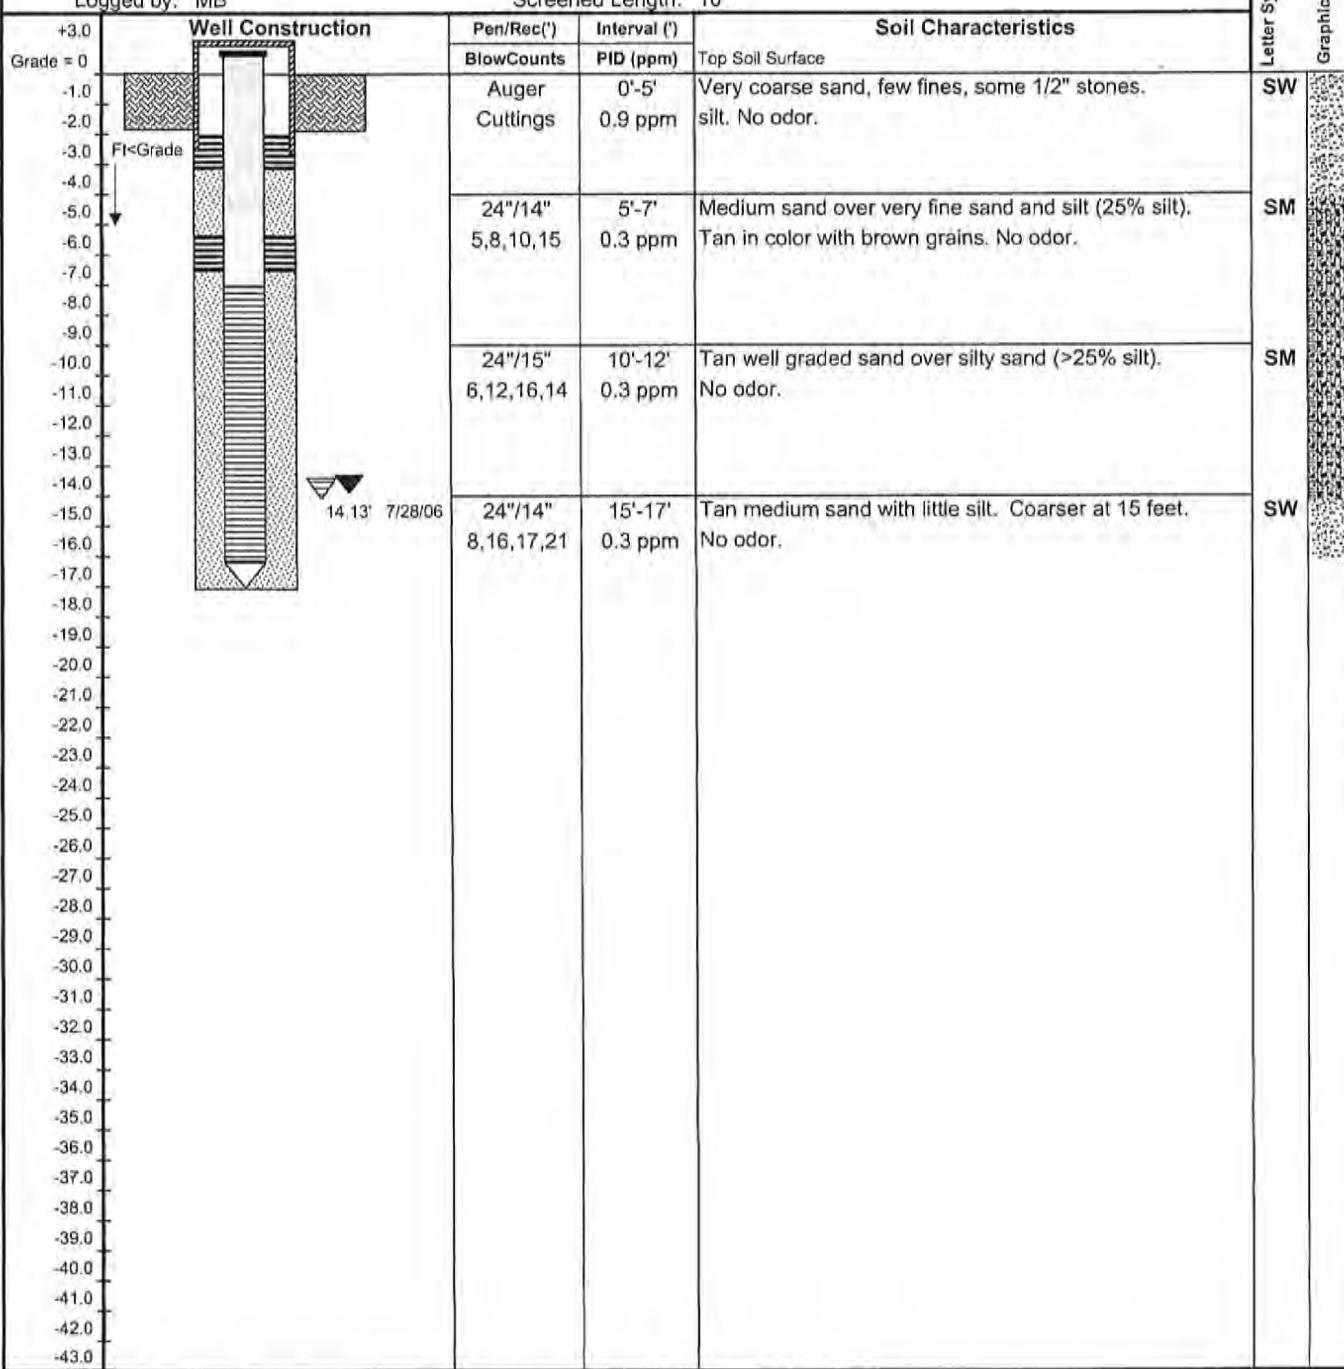
- Well Box with locking Cover, Set in Cement.
- Existing Surface.
- Bentonite Seal Placed in Annulus.
- Grade #1 Silica Sand Pack Placed in Annulus.
- Drill Cuttings Placed in Annulus.
