SUBJECT: Addendum: Geomembrane Damage to the Top of Landfill (3/14/96)

Re: Pelham Bay Landfill Closure
Contract No. 876-HP
Letter No. 78

RE: Pelham Bay Landfill, Cover and Protection of Work
GSE Lining Technology, Inc. Project Number XA4790

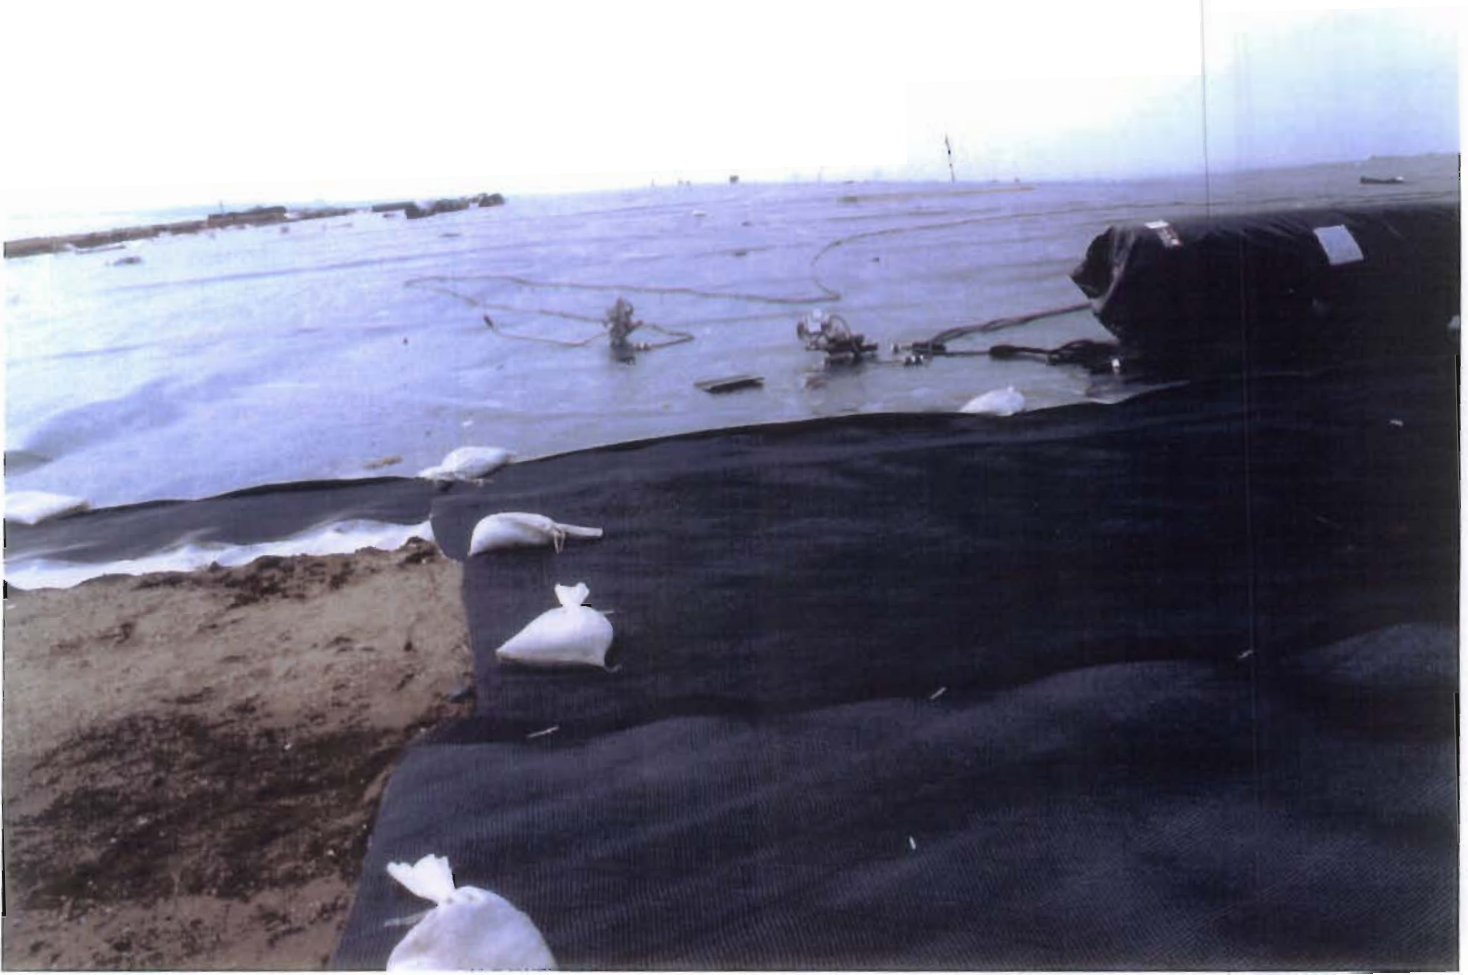
Photo No. 2. View of Pond B and Landfill Geomembrane Layer. (August 18, 1995)

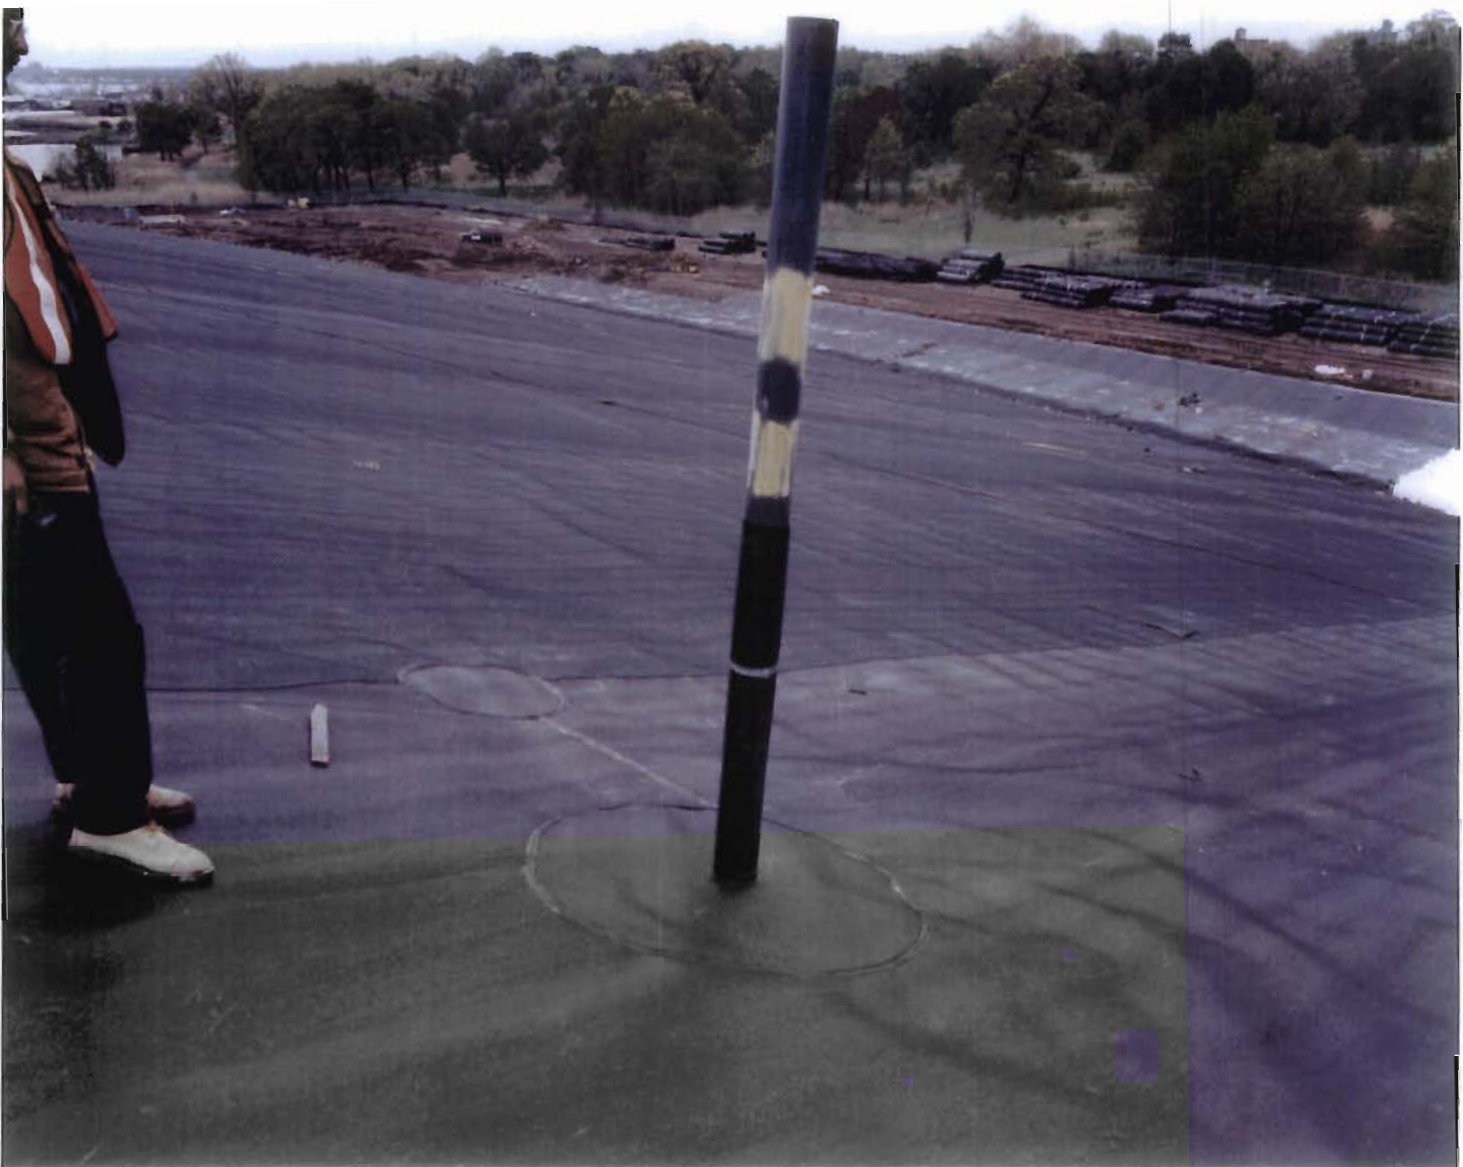
Photo No. 4. Seaming of Textured and Smooth HDPE Geomembrane at Top of Landfill
(September 27, 1995)

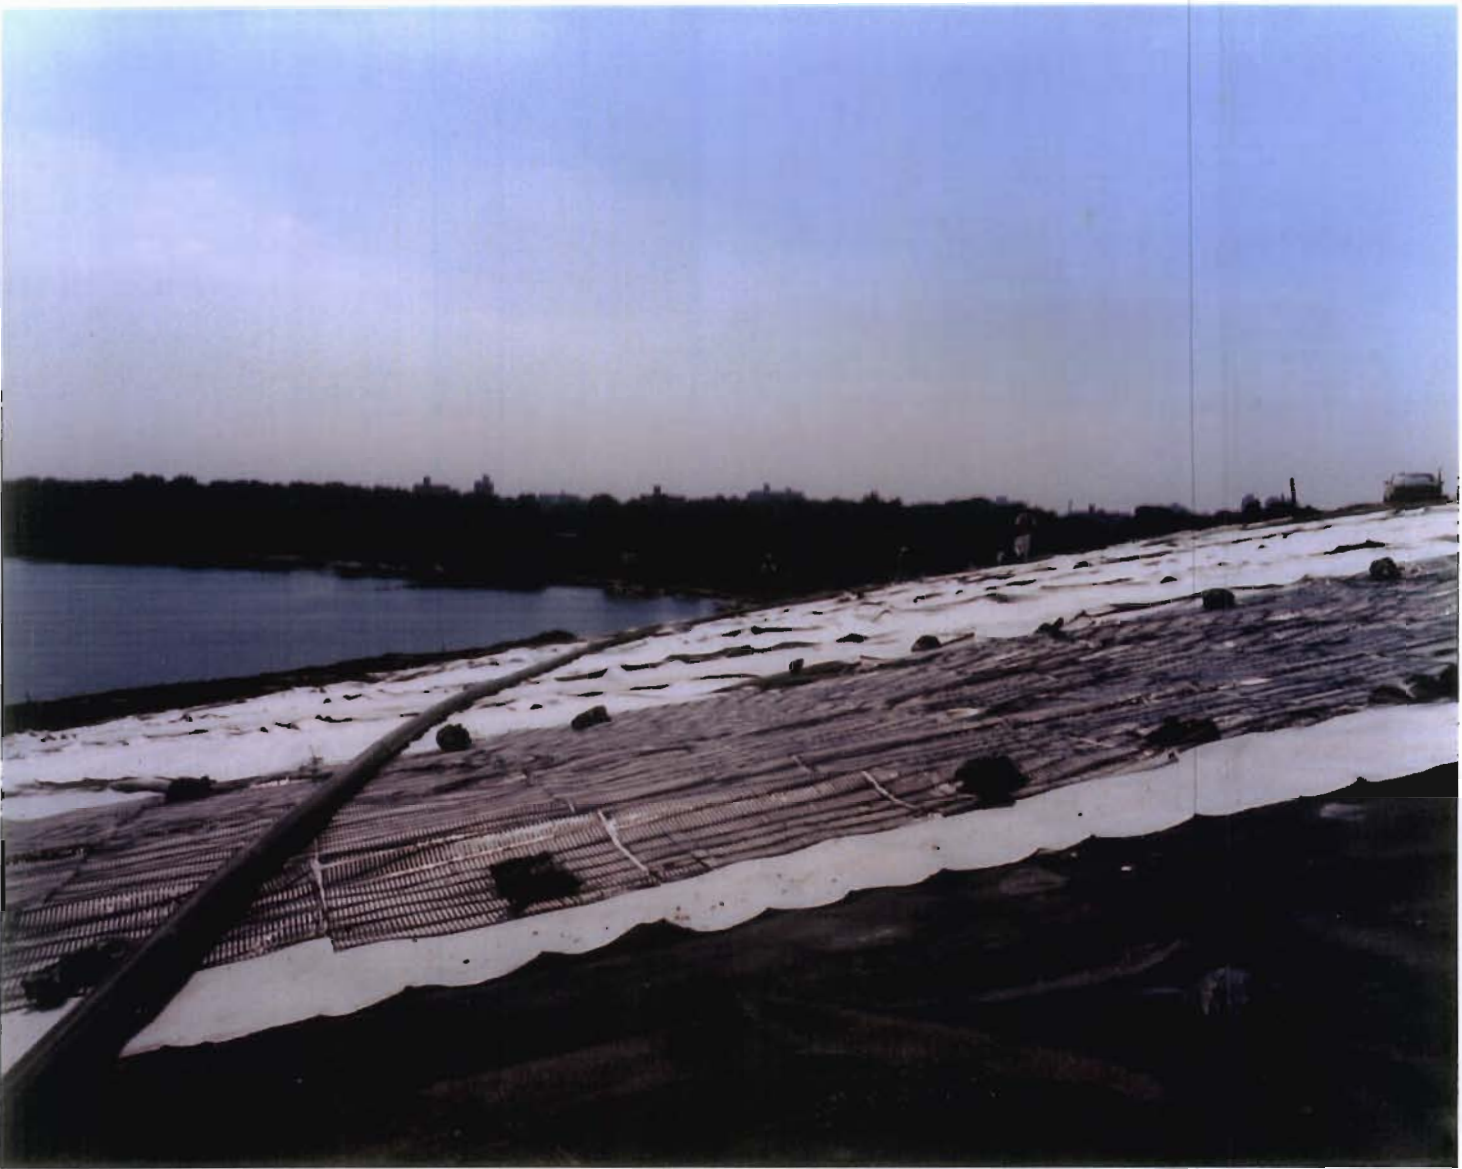
Photo No. 7. Geocomposite Layer. (June 26, 1995)

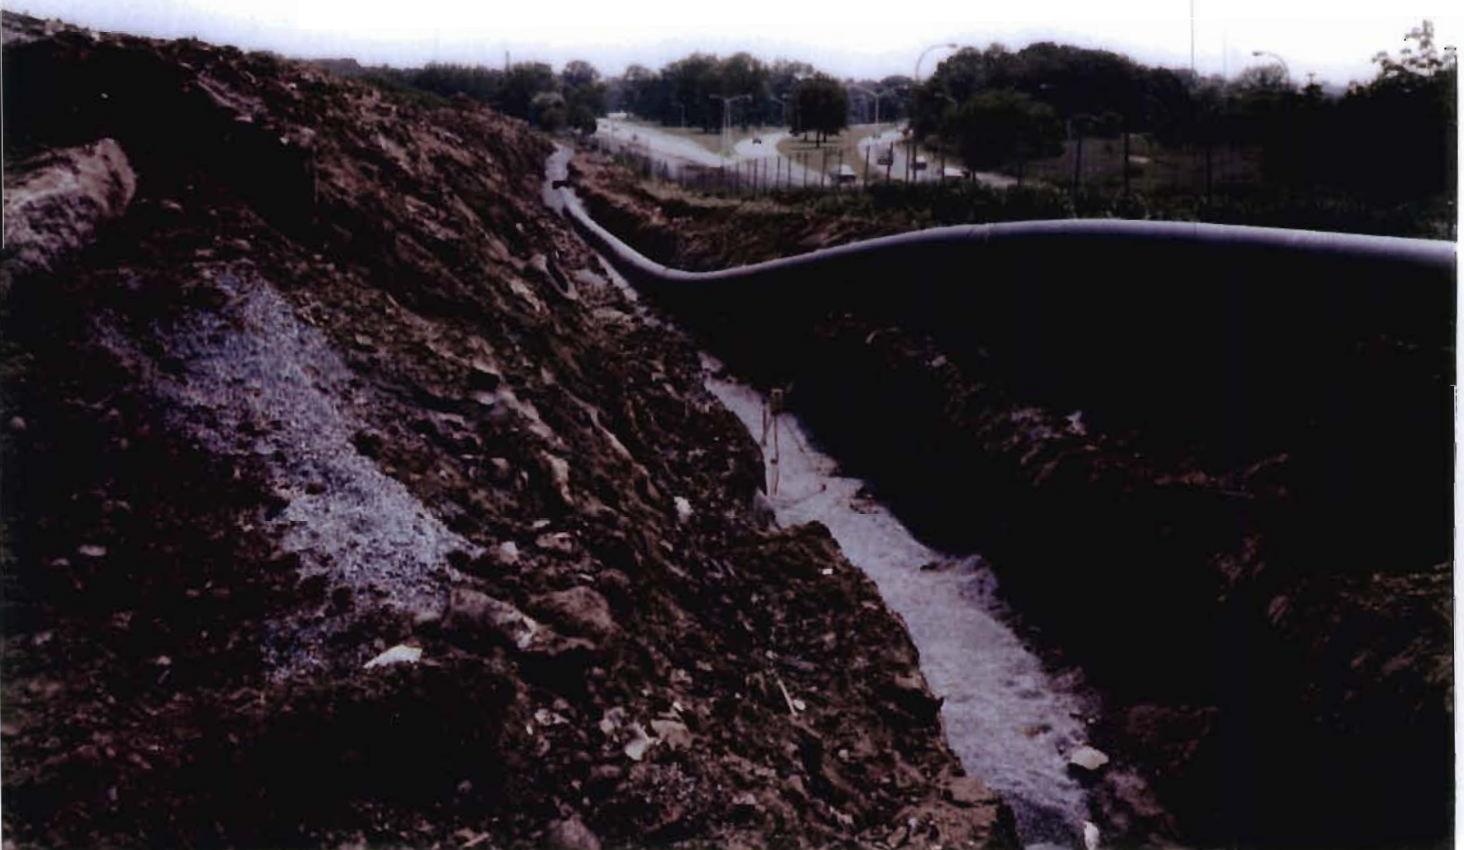
Photo No. 8. LFG Collection Pipe Installation over Geocomposite Layer
(with Geogrid Reinforcement). (August 1, 1995)

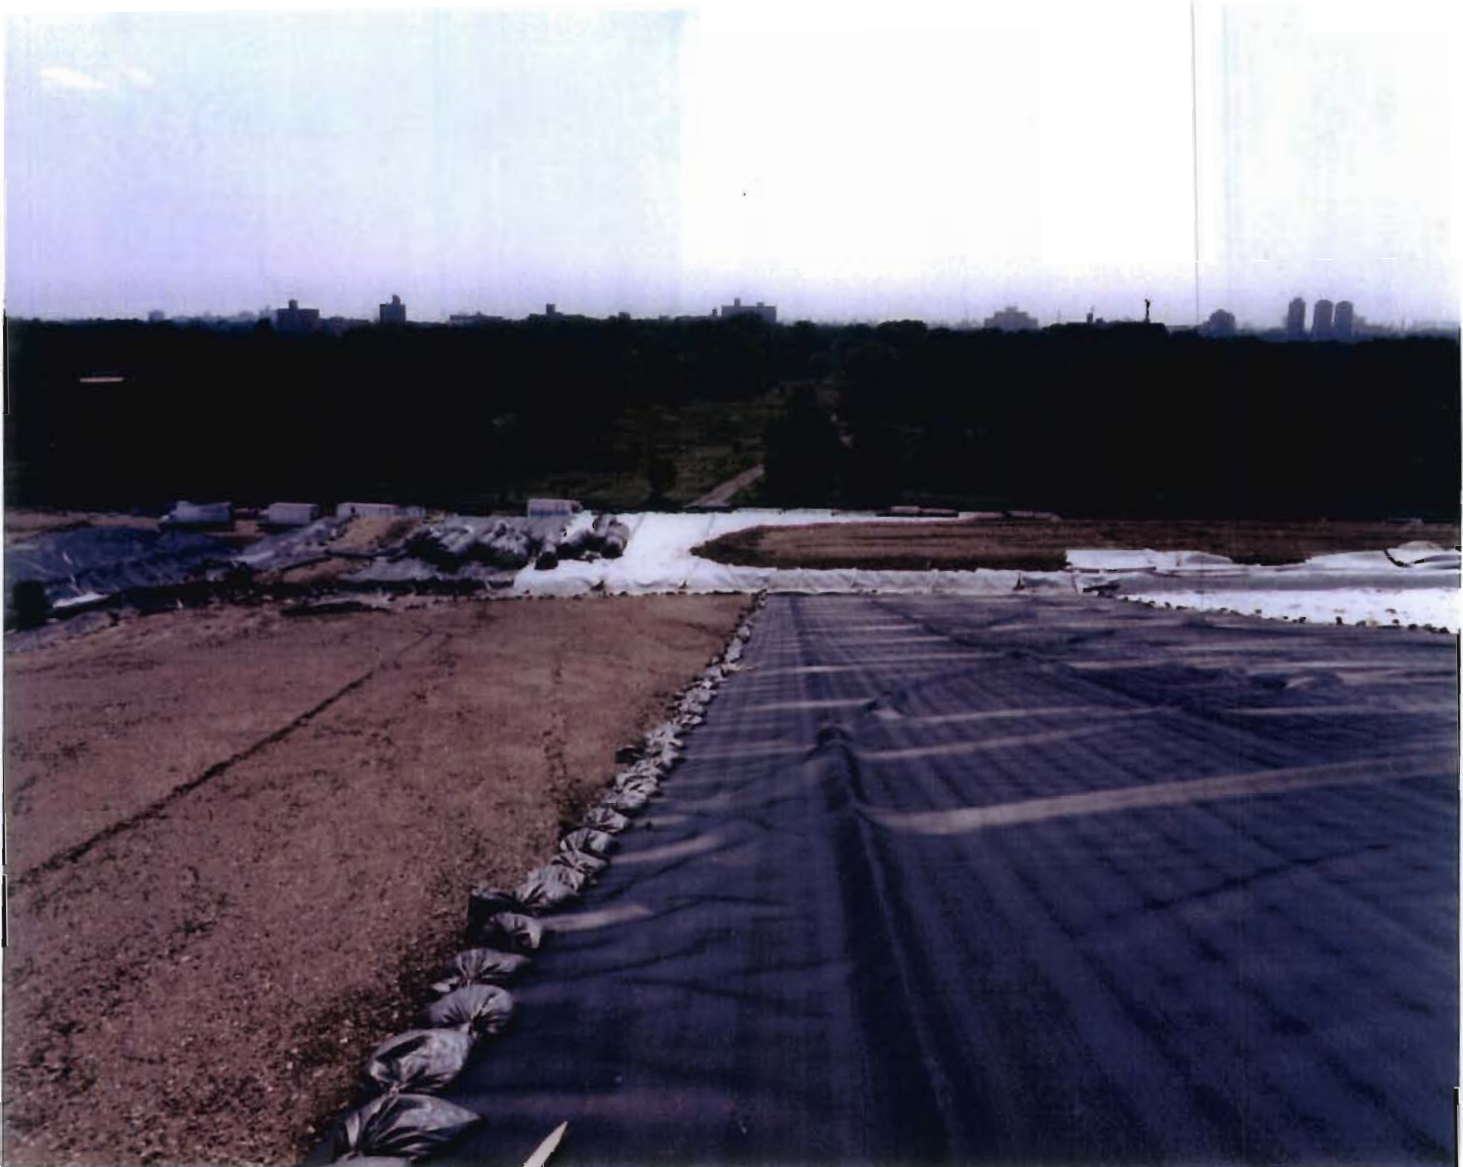
Photo No. 9. Installation of 30" Diameter HDPE Pipe Connection between
Ponds B and C. (June 7, 1995)

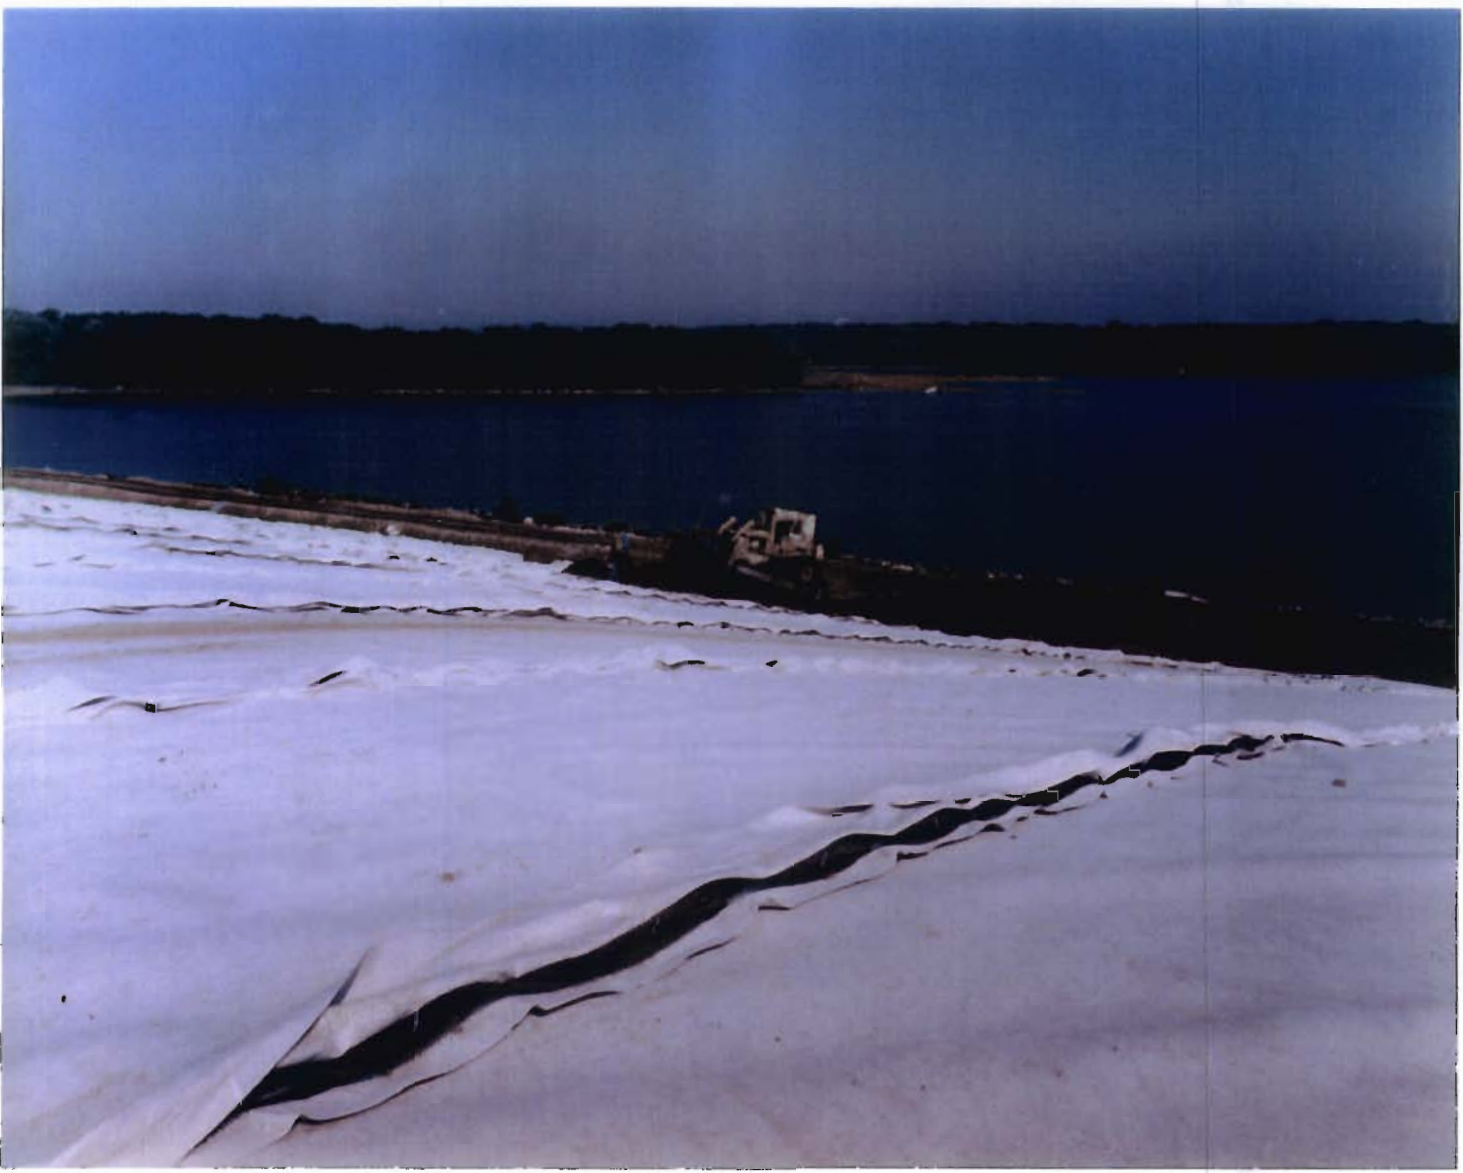
Photo No. 10. Roadway Construction. (June 7, 1995)

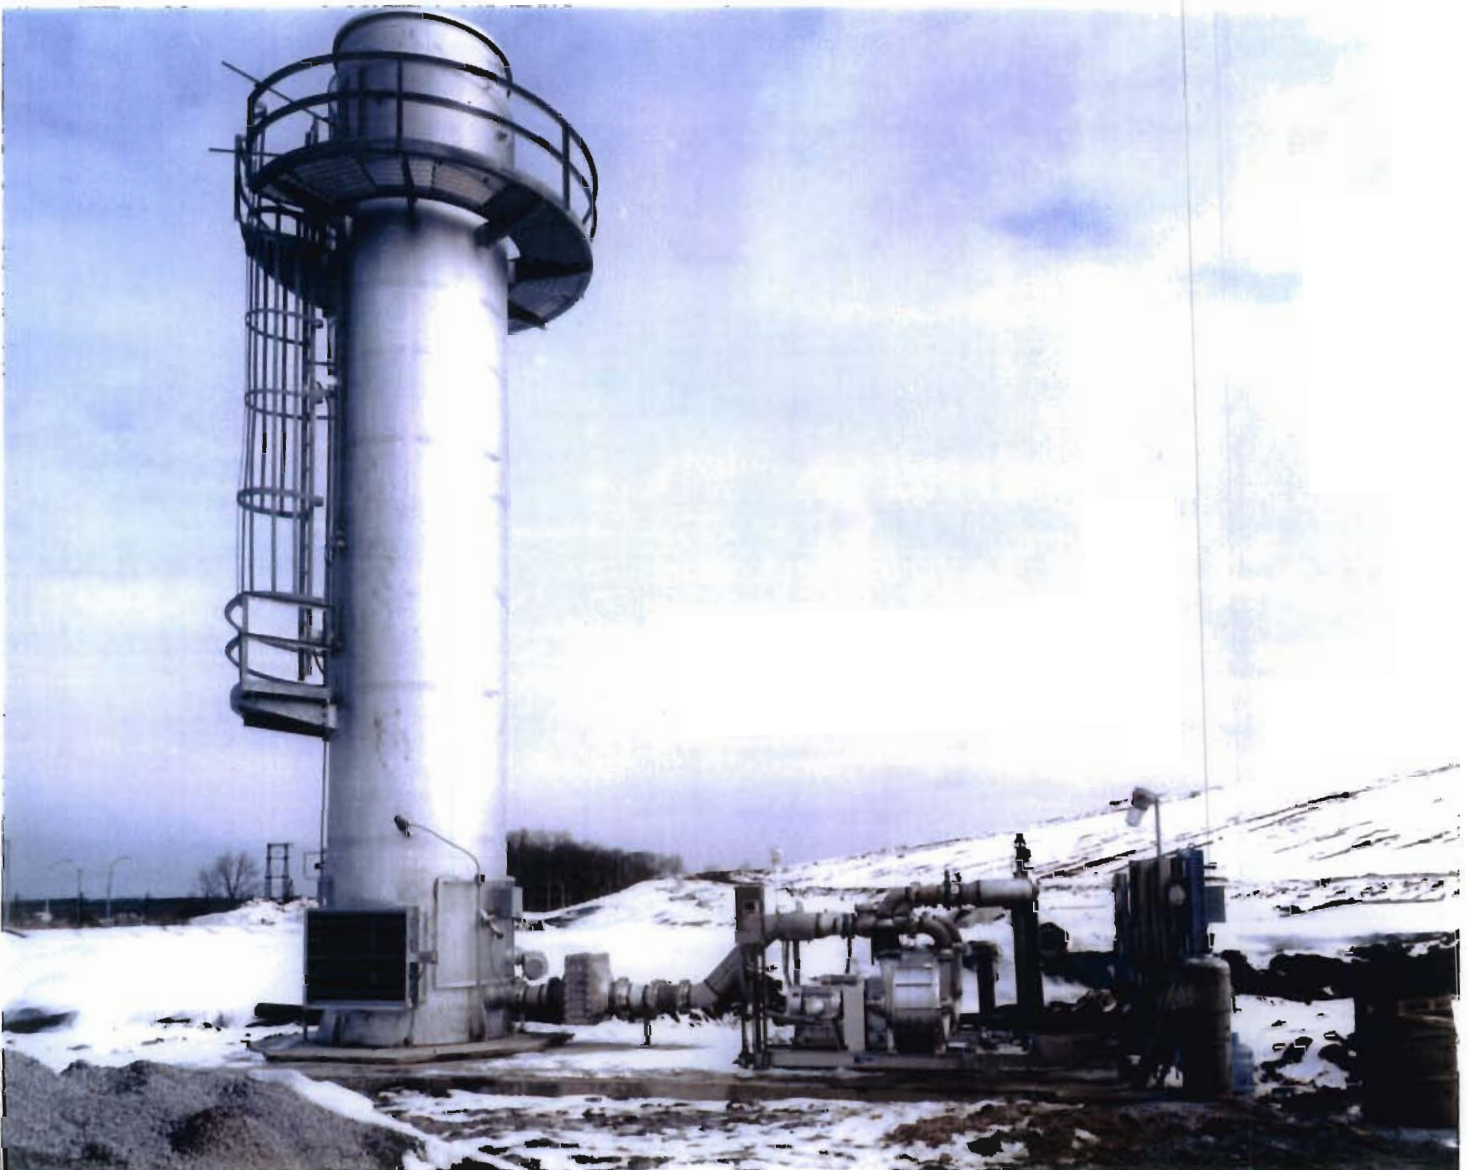
Photo No. 12. Covering LFG Collection Line with Barrier Protection Material.
(July 12, 1995)
